**YEAR 4 (2011)**  
**ANNUAL MONITORING REPORT**  
**JARMANS OAK RESTORATION SITE**  
**ONslow COUNTY, NORTH CAROLINA**

**(CONTRACT D06069-A)**  
**FULL DELIVERY PROJECT**  
**WHITE OAK RIVER BASIN**  
**CATALOGING UNIT 03030001**

**October 2011**

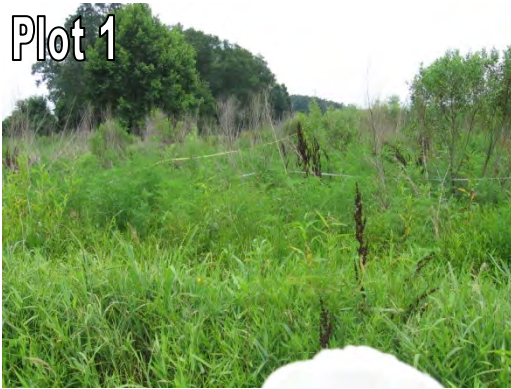
Plot 1

Vegetation sampling across the Site was above the required average density with an overall average of 460 planted stems per acre. Two of the fourteen plots had low densities of planted stems (plots 1 and 5 with 121 and 243 planted stems per acre, respectively) as the result of ponded water from a previous beaver impoundment. Beaver management is now occurring on the Site and will continue as necessary. No additional vegetation problem areas were noted during the Year 4 (2011) monitoring season. The Site will be replanted in the areas that were affected by the inundation before the start of the 2012 growing season.
