**Johnson Site Stream Restoration
Mitigation Plan / As-Built Report
EEP Project # 197
2008**

June 2008

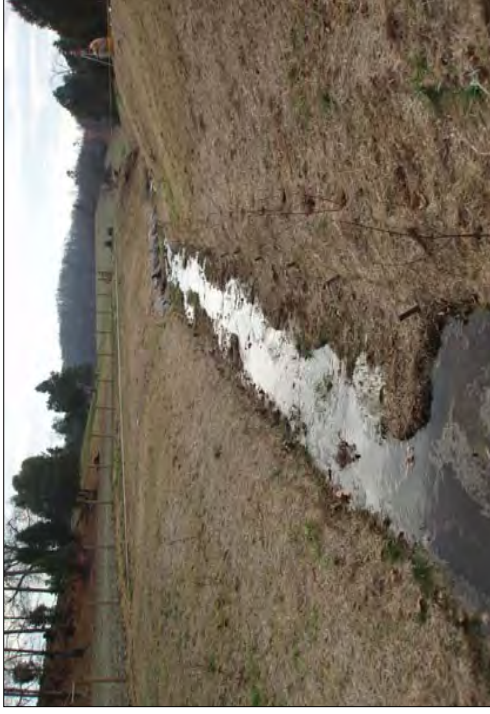
River Basin:	Yadkin
Watershed:	Johnson, As-Built
XS ID	XS - 1, Riffle
Drainage Area (sq mb):	0.17
Date:	12/12/2007
Field Crew:	B. Roberts, T. King

SUMMARY DATA	
Bankfull Elevation:	788.6
Bankfull Cross-Sectional Area:	7.6
Bankfull Width:	8.7
Flood Prone Area Elevation:	789.7
Flood Prone Width:	18
Max Depth at Bankfull:	1.1
Mean Depth at Bankfull:	0.9
W / D Ratio:	10.0
Entrenchment Ratio:	2.1
Bank Height Ratio:	1.0

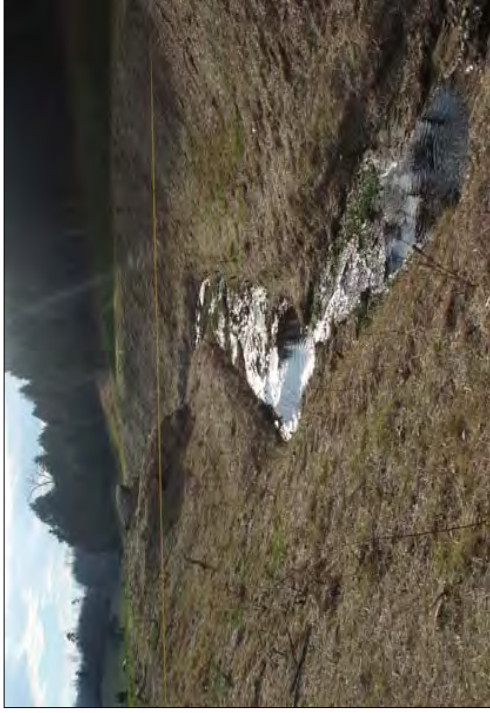
River Basin:	Yadkin
Watershed:	Johnson, As-Built
XS ID	XS - 2, Pool
Drainage Area (sq mi):	0.17
Date:	12/12/2007
Field Crew:	B. Roberts, T. King

SUMMARY DATA	
Bankfull Elevation:	786.5
Bankfull Cross-Sectional Area:	13.7
Bankfull Width:	11.0
Flood Prone Area Elevation:	788.5
Flood Prone Width:	25.7
Max Depth at Bankfull:	2.0
Mean Depth at Bankfull:	1.2
W / D Ratio:	8.8
Entrenchment Ratio:	2.3
Bank Height Ratio:	1.0

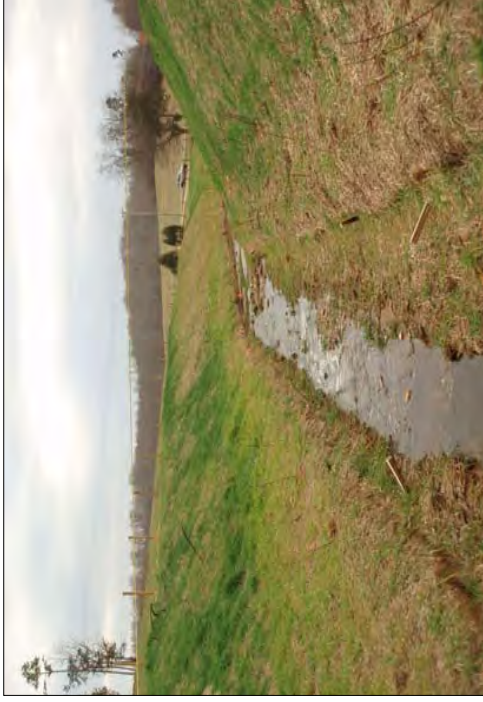
River Basin:	Yadkin
Watershed:	Johnson, As-Built
XS ID	XS - 3, Riffle
Drainage Area (sq mb):	0.17
Date:	12/12/2007
Field Crew:	B. Roberts, T. King

SUMMARY DATA	
Bankfull Elevation:	776.9
Bankfull Cross-Sectional Area:	7.2
Bankfull Width:	8.2
Flood Prone Area Elevation:	778.0
Flood Prone Width:	15
Max Depth at Bankfull:	1.1
Mean Depth at Bankfull:	0.9
W / D Ratio:	9.3
Entrenchment Ratio:	1.8
Bank Height Ratio:	1.0

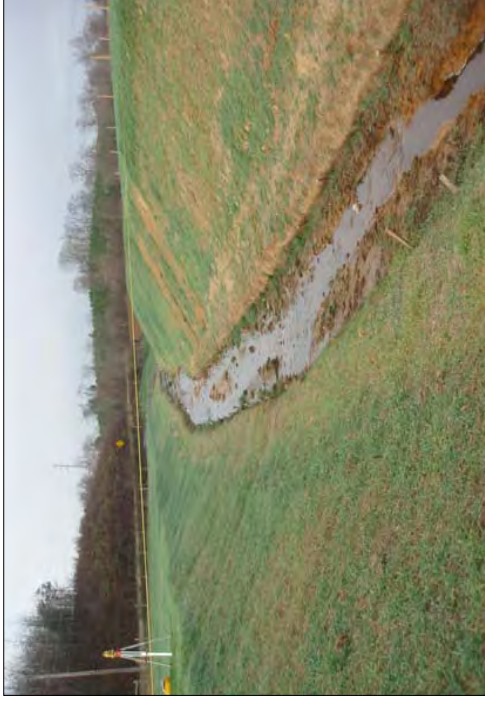
River Basin:	Yadkin
Watershed:	Johnson, As-Built
XS ID	XS - 4, Riffle
Drainage Area (sq mb):	0.17
Date:	12/13/2007
Field Crew:	B. Roberts, T. King

SUMMARY DATA	
Bankfull Elevation:	767.1
Bankfull Cross-Sectional Area:	9.7
Bankfull Width:	8.7
Flood Prone Area Elevation:	768.5
Flood Prone Width:	18
Max Depth at Bankfull:	1.4
Mean Depth at Bankfull:	1.1
W / D Ratio:	7.8
Entrenchment Ratio:	2.0
Bank Height Ratio:	1.0

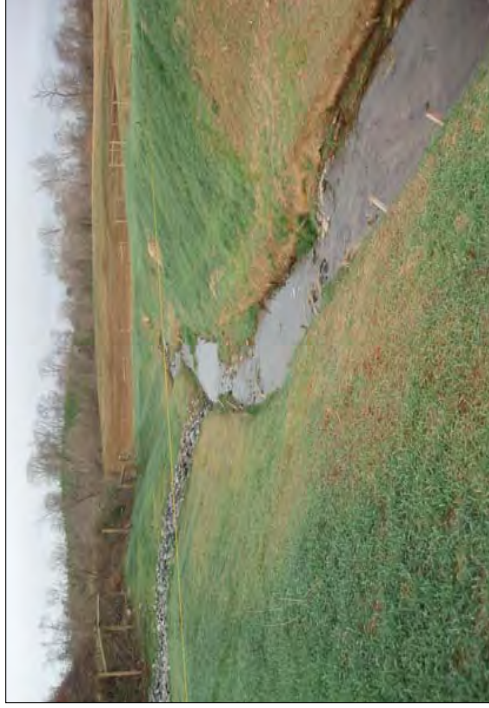
River Basin:	Yadkin
Watershed:	Johnson, As-Built
XS ID	XS - 5, Pool
Drainage Area (sq mb):	0.17
Date:	12/13/2007
Field Crew:	B. Roberts, T. King

SUMMARY DATA	
Bankfull Elevation:	763.3
Bankfull Cross-Sectional Area:	11.9
Bankfull Width:	9.0
Flood Prone Area Elevation:	765.5
Flood Prone Width:	21.0
Max Depth at Bankfull:	2.2
Mean Depth at Bankfull:	1.3
W / D Ratio:	6.8
Entrenchment Ratio:	2.3
Bank Height Ratio:	1.0
