**Johnson Site Stream Restoration
Project No. 197
2008 Monitoring Report (Final): Year 1 of 5**

June 2009

Prepared for: NCDENR-EEP
1652 Mail Service Center
Raleigh, NC 27699-1652

Prepared by: Jordan, Jones, and Goulding
9101 Southern Pine Blvd., Suite 160
Charlotte, NC 28273

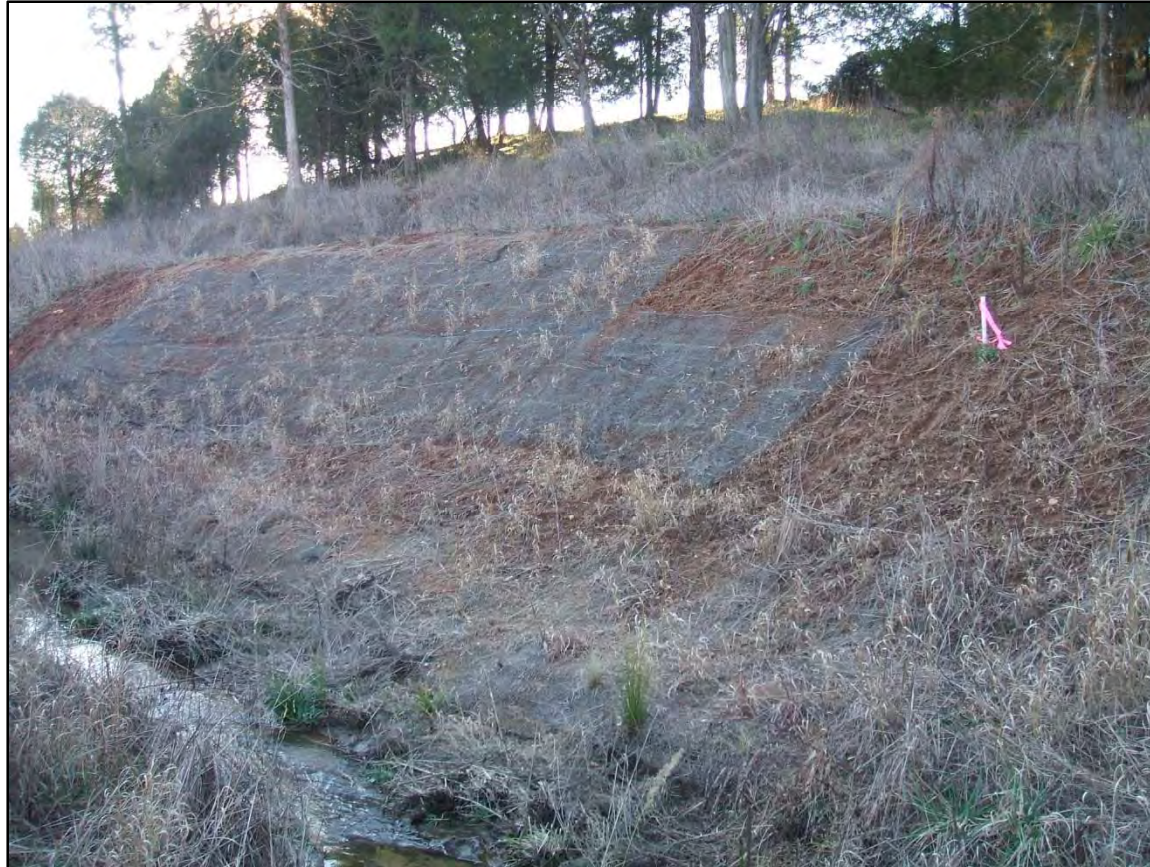
Feature Issue	Station Numbers	Suspected Cause	Photo ID #
Bare Bank	3+66-3+90	Banks lacking vegetation protections-RB	1
	8+43-9+07	Banks lacking vegetation protections-RB

1. Bare Banks (1/2009)

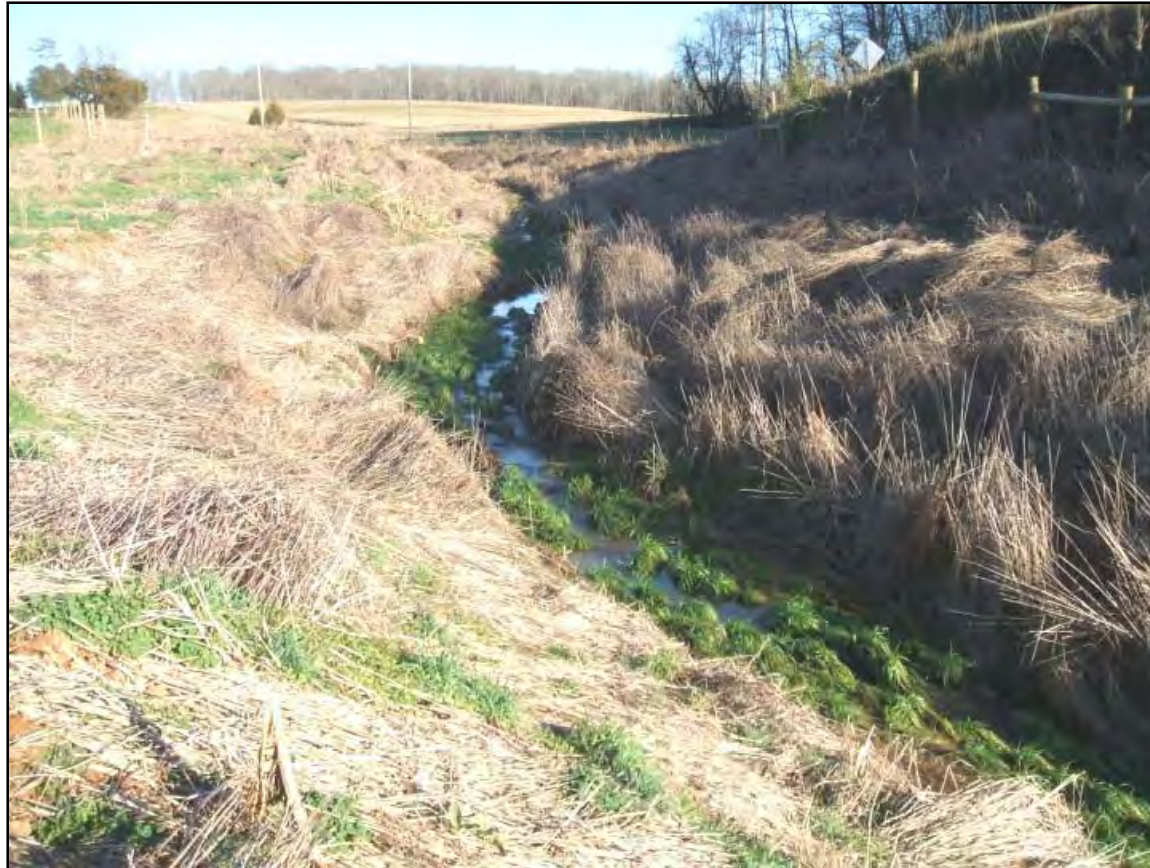
Feature Issue	Station Numbers	Suspected Cause	Photo ID #
In-Stream Vegetation	0+36-1+20	Vegetation growing in middle of channel	1
	1+92-2+39		
	2+90-3+29		
	4+40-4+47

1. In-Stream Vegetation (1/2009)
