**UT to Little Hunting Creek (Johnson Site)
Stream Restoration
Project No. 197
2009 Monitoring Report: Year 2 of 5**

November 2009 (Revised May 2010)

Prepared for: NCDENR-EEP
1652 Mail Service Center
Raleigh, NC 27699-1652

Prepared by: Jordan, Jones & Goulding
9101 Southern Pine Blvd., Suite 160
Charlotte, NC 28273

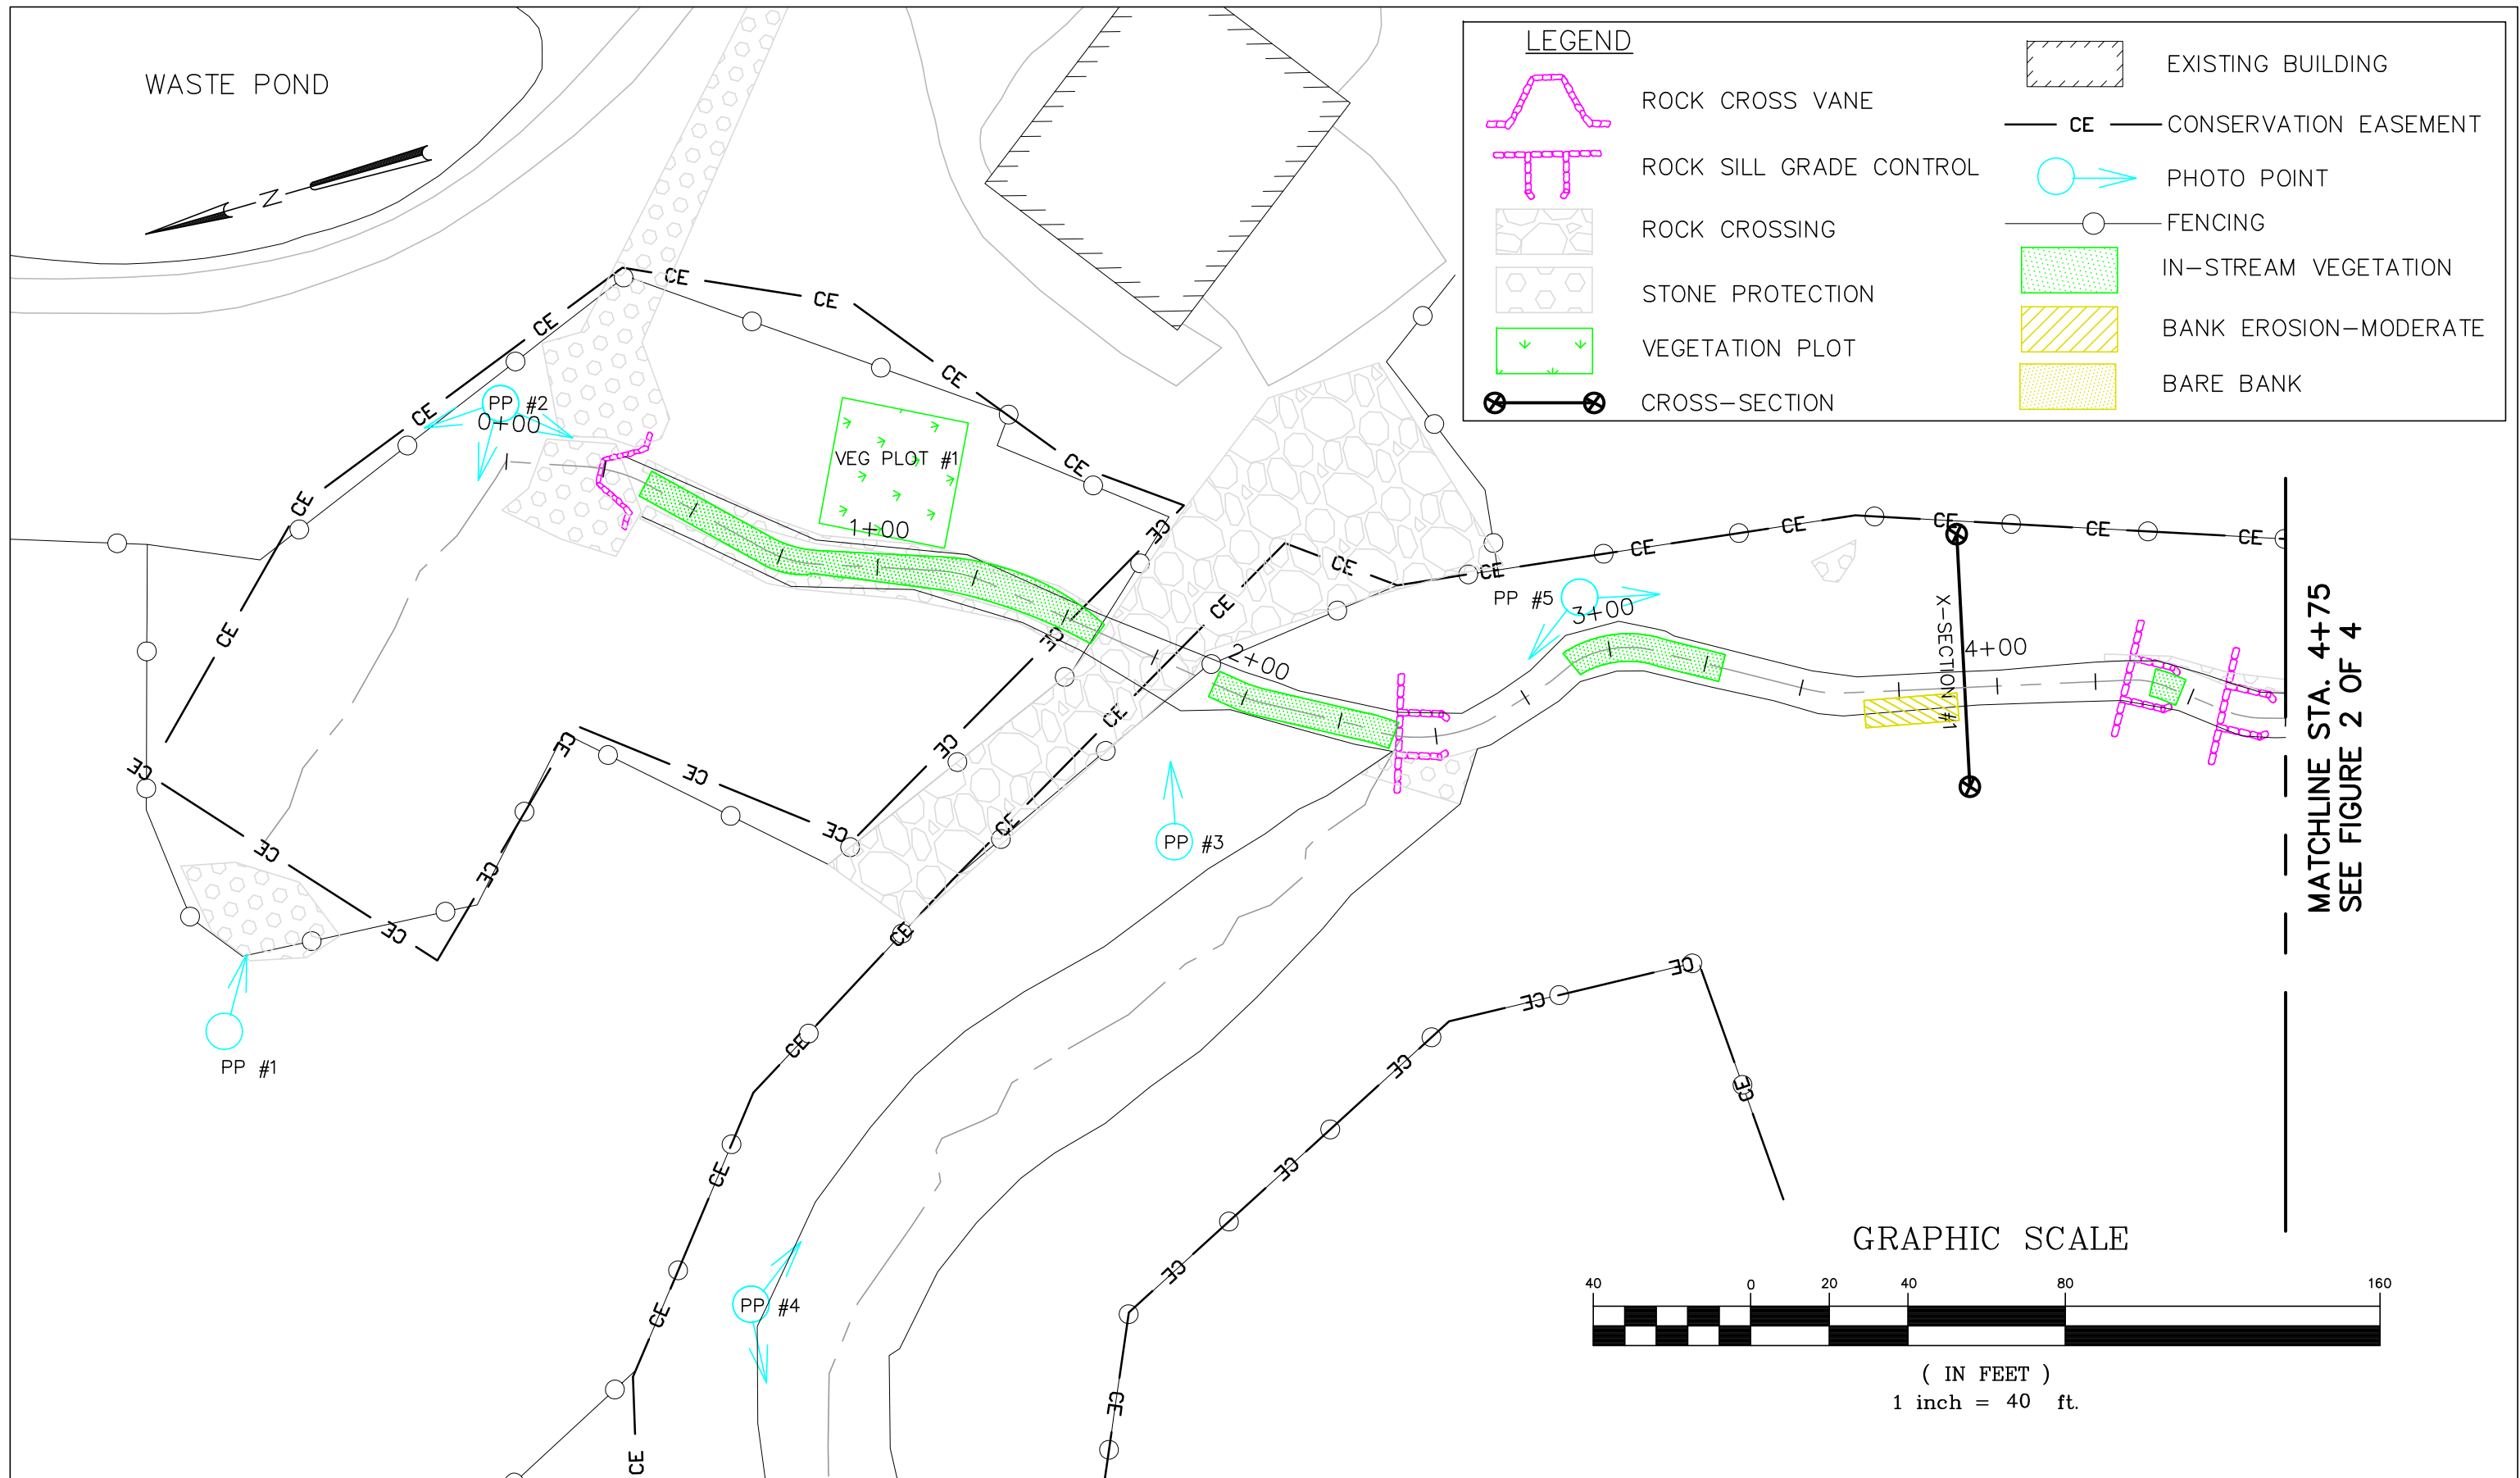
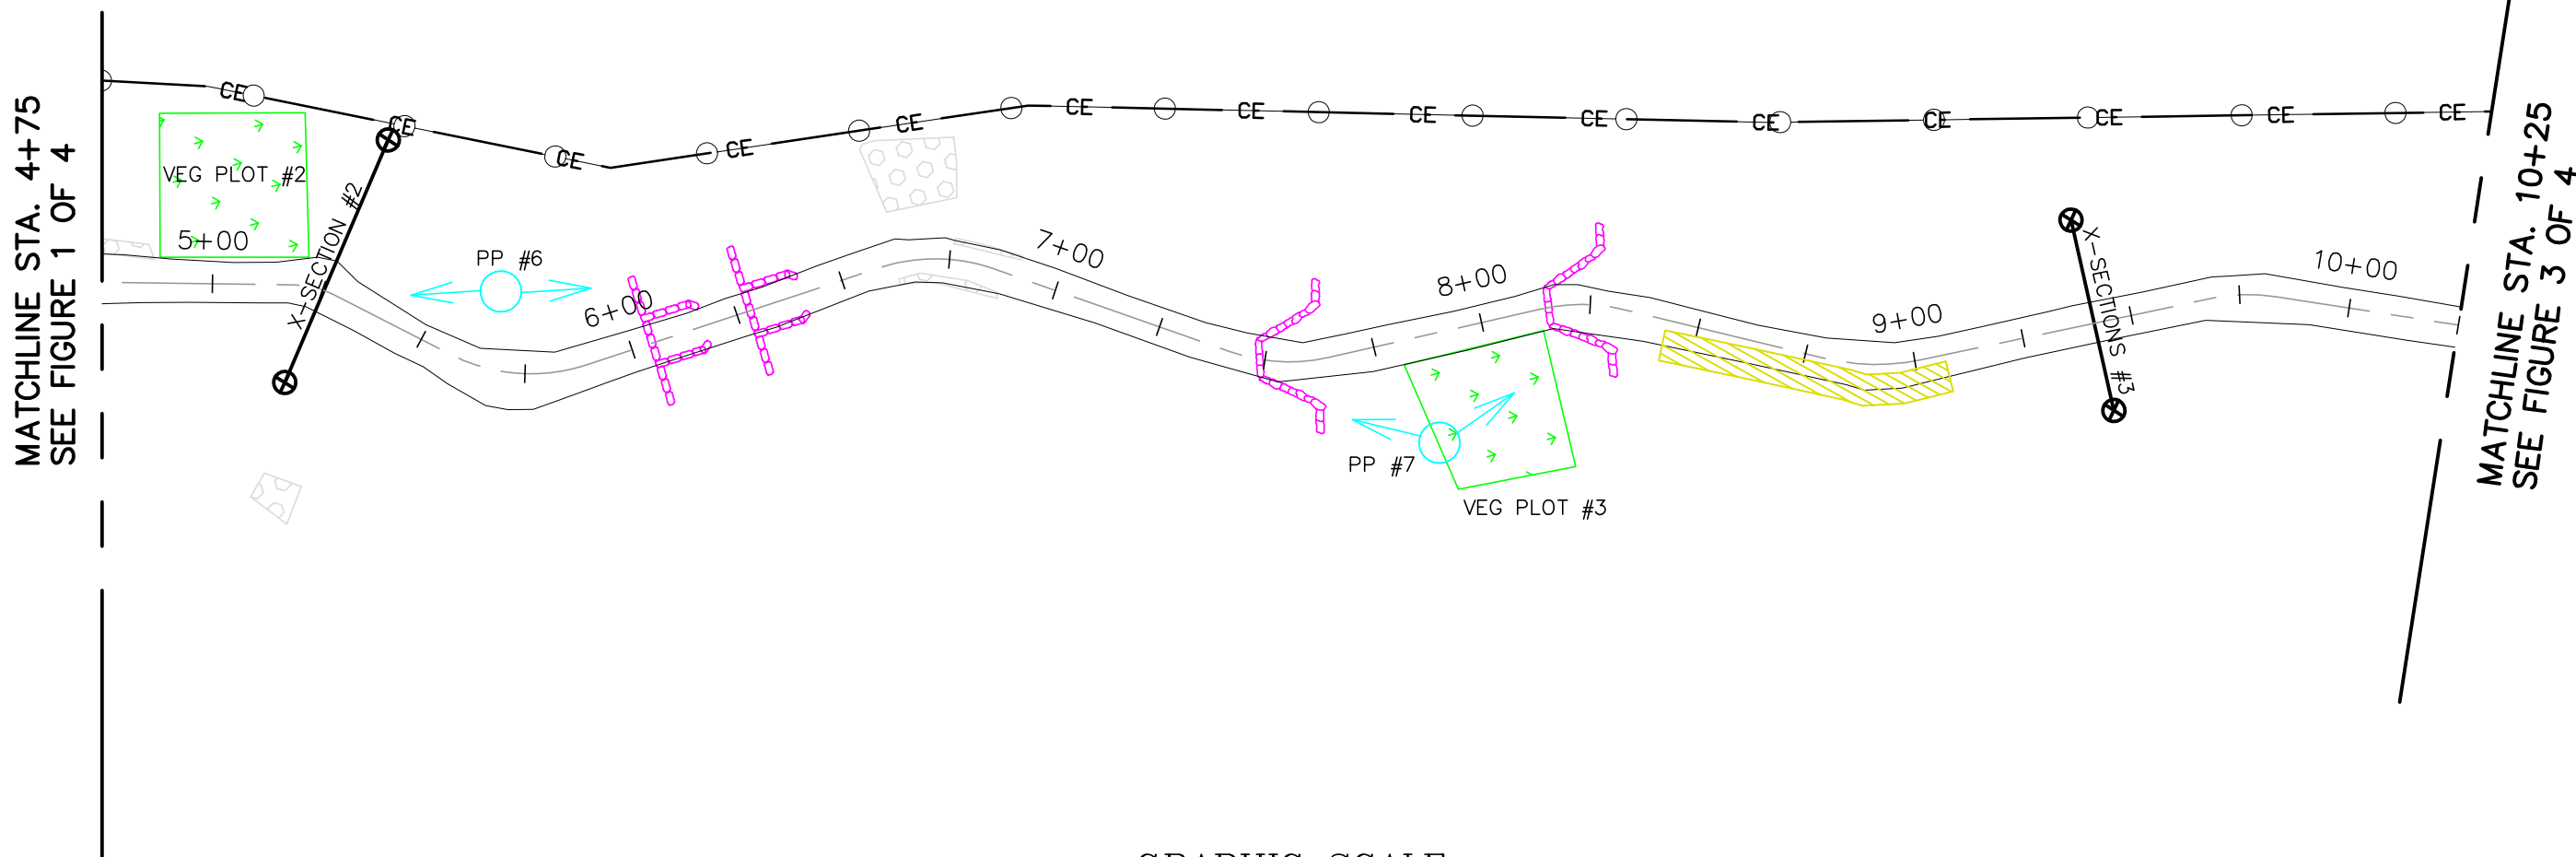
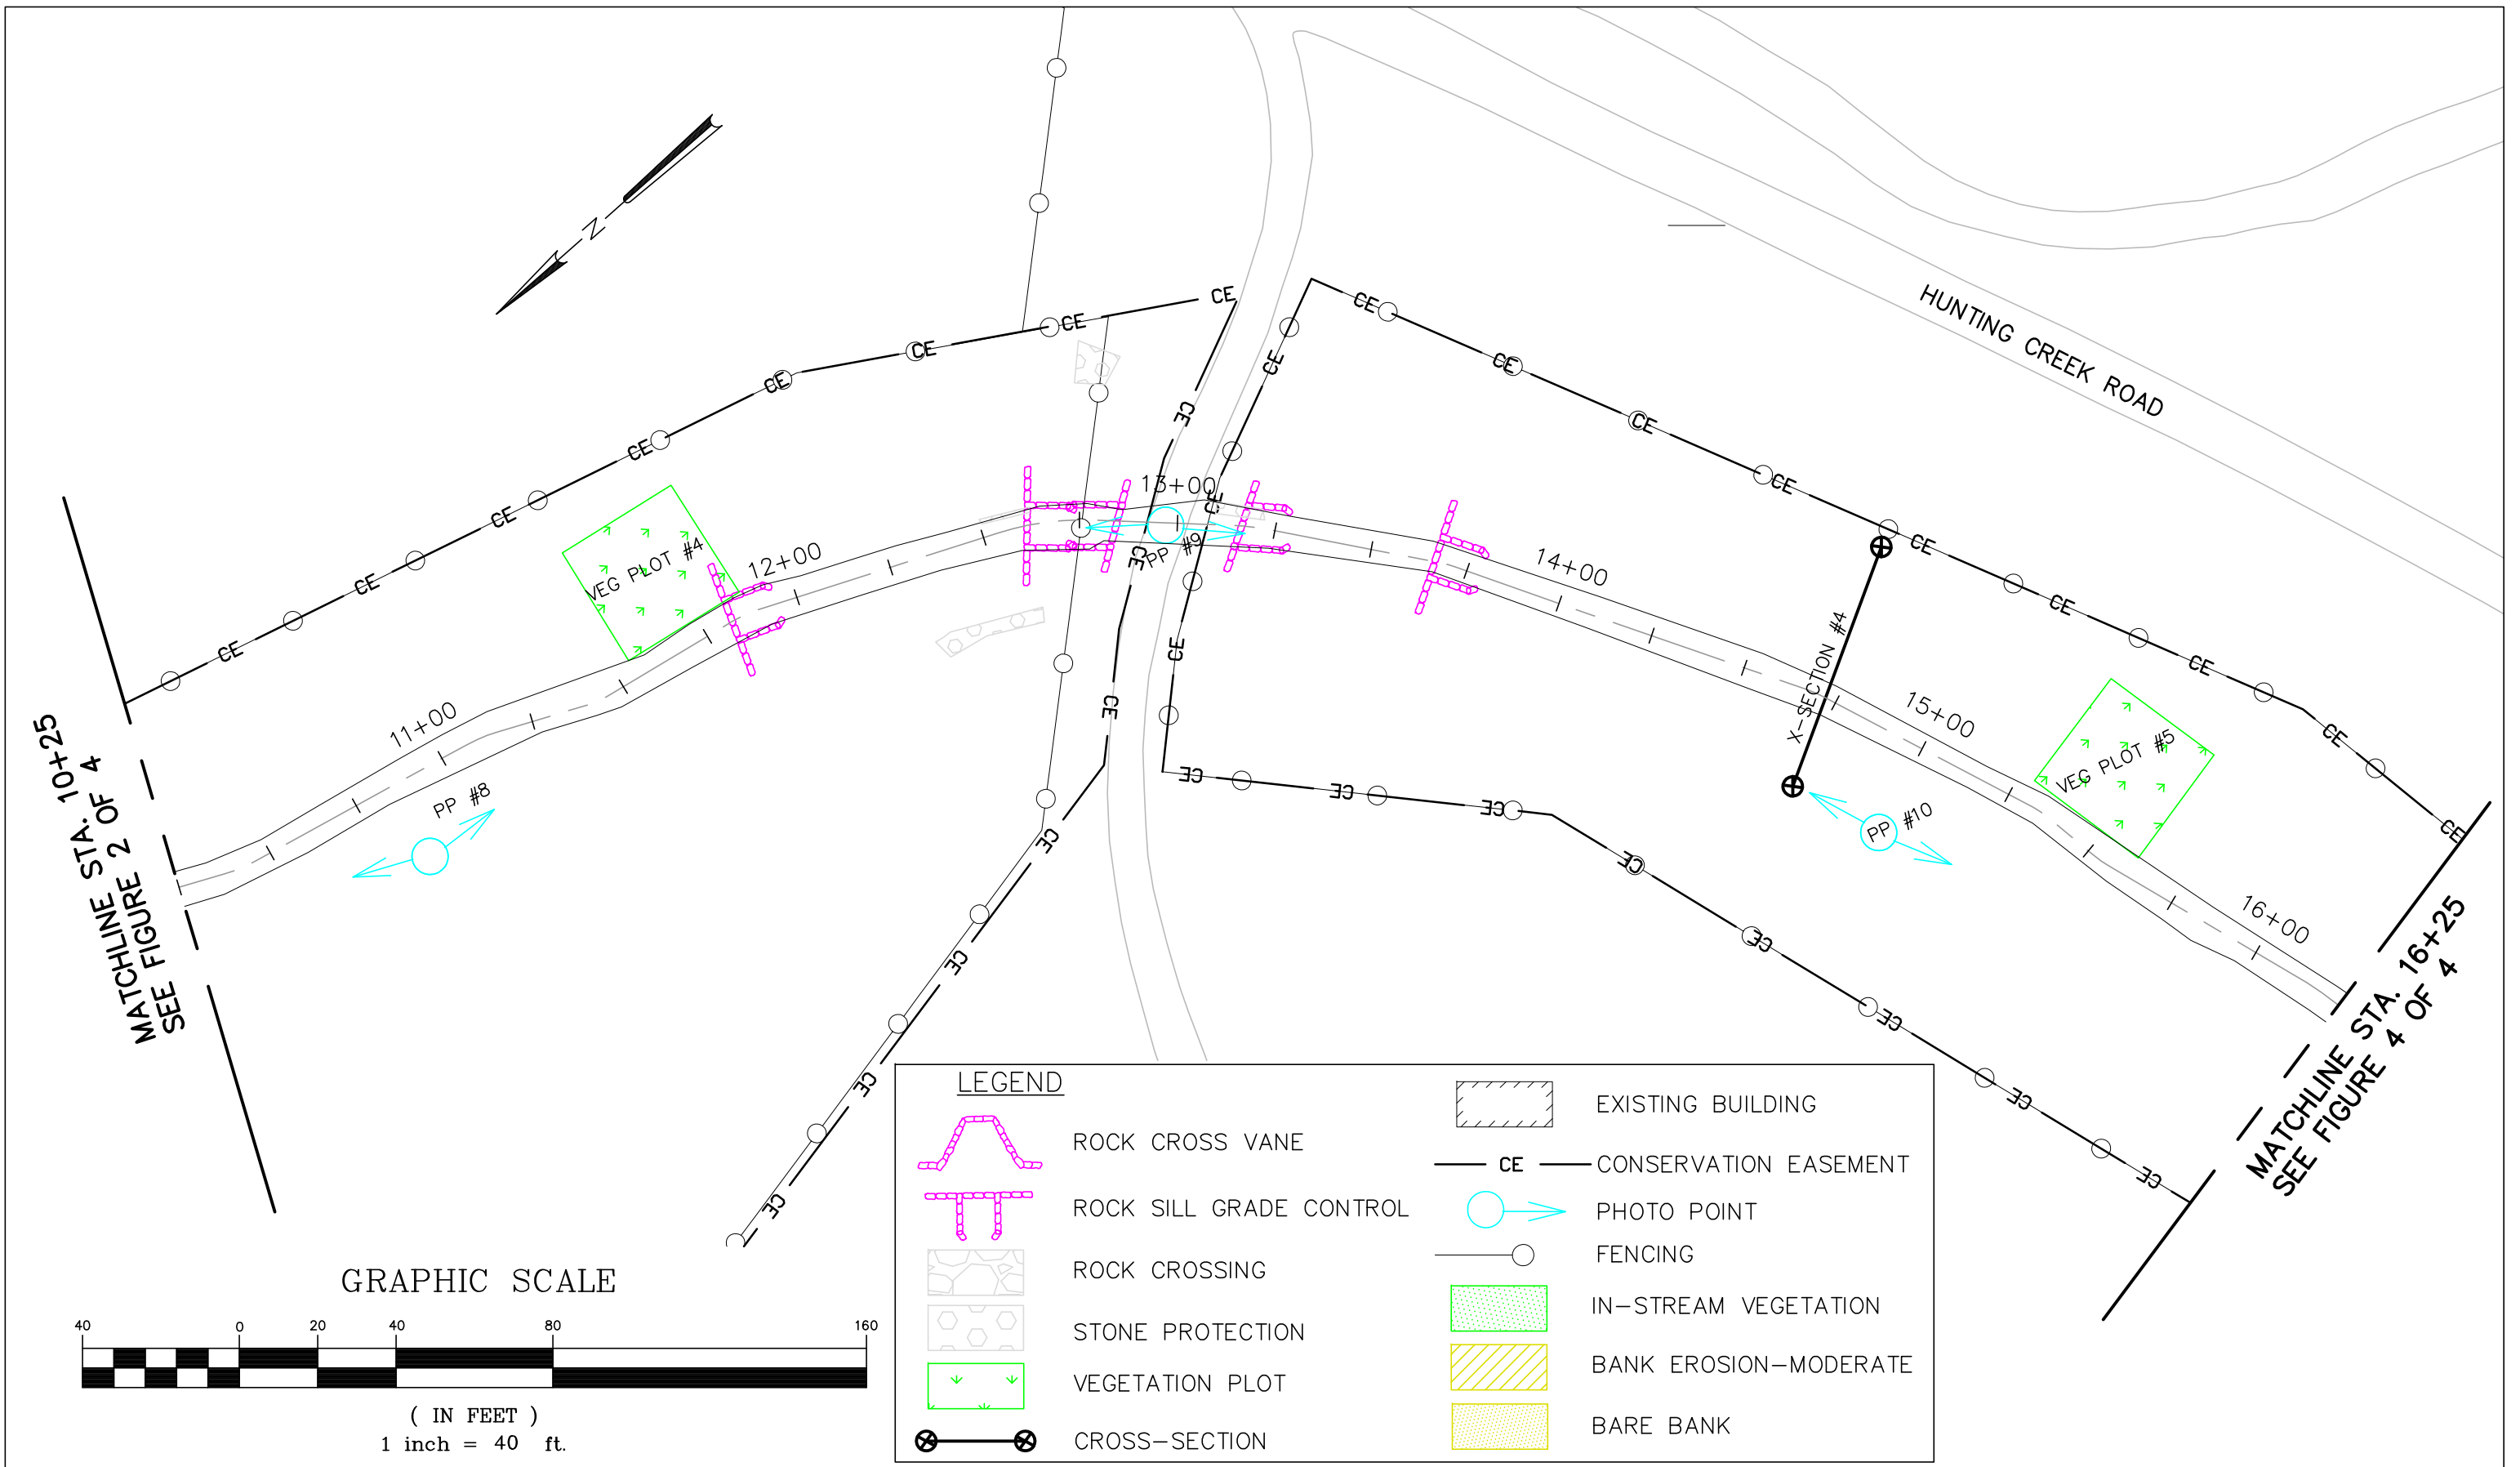
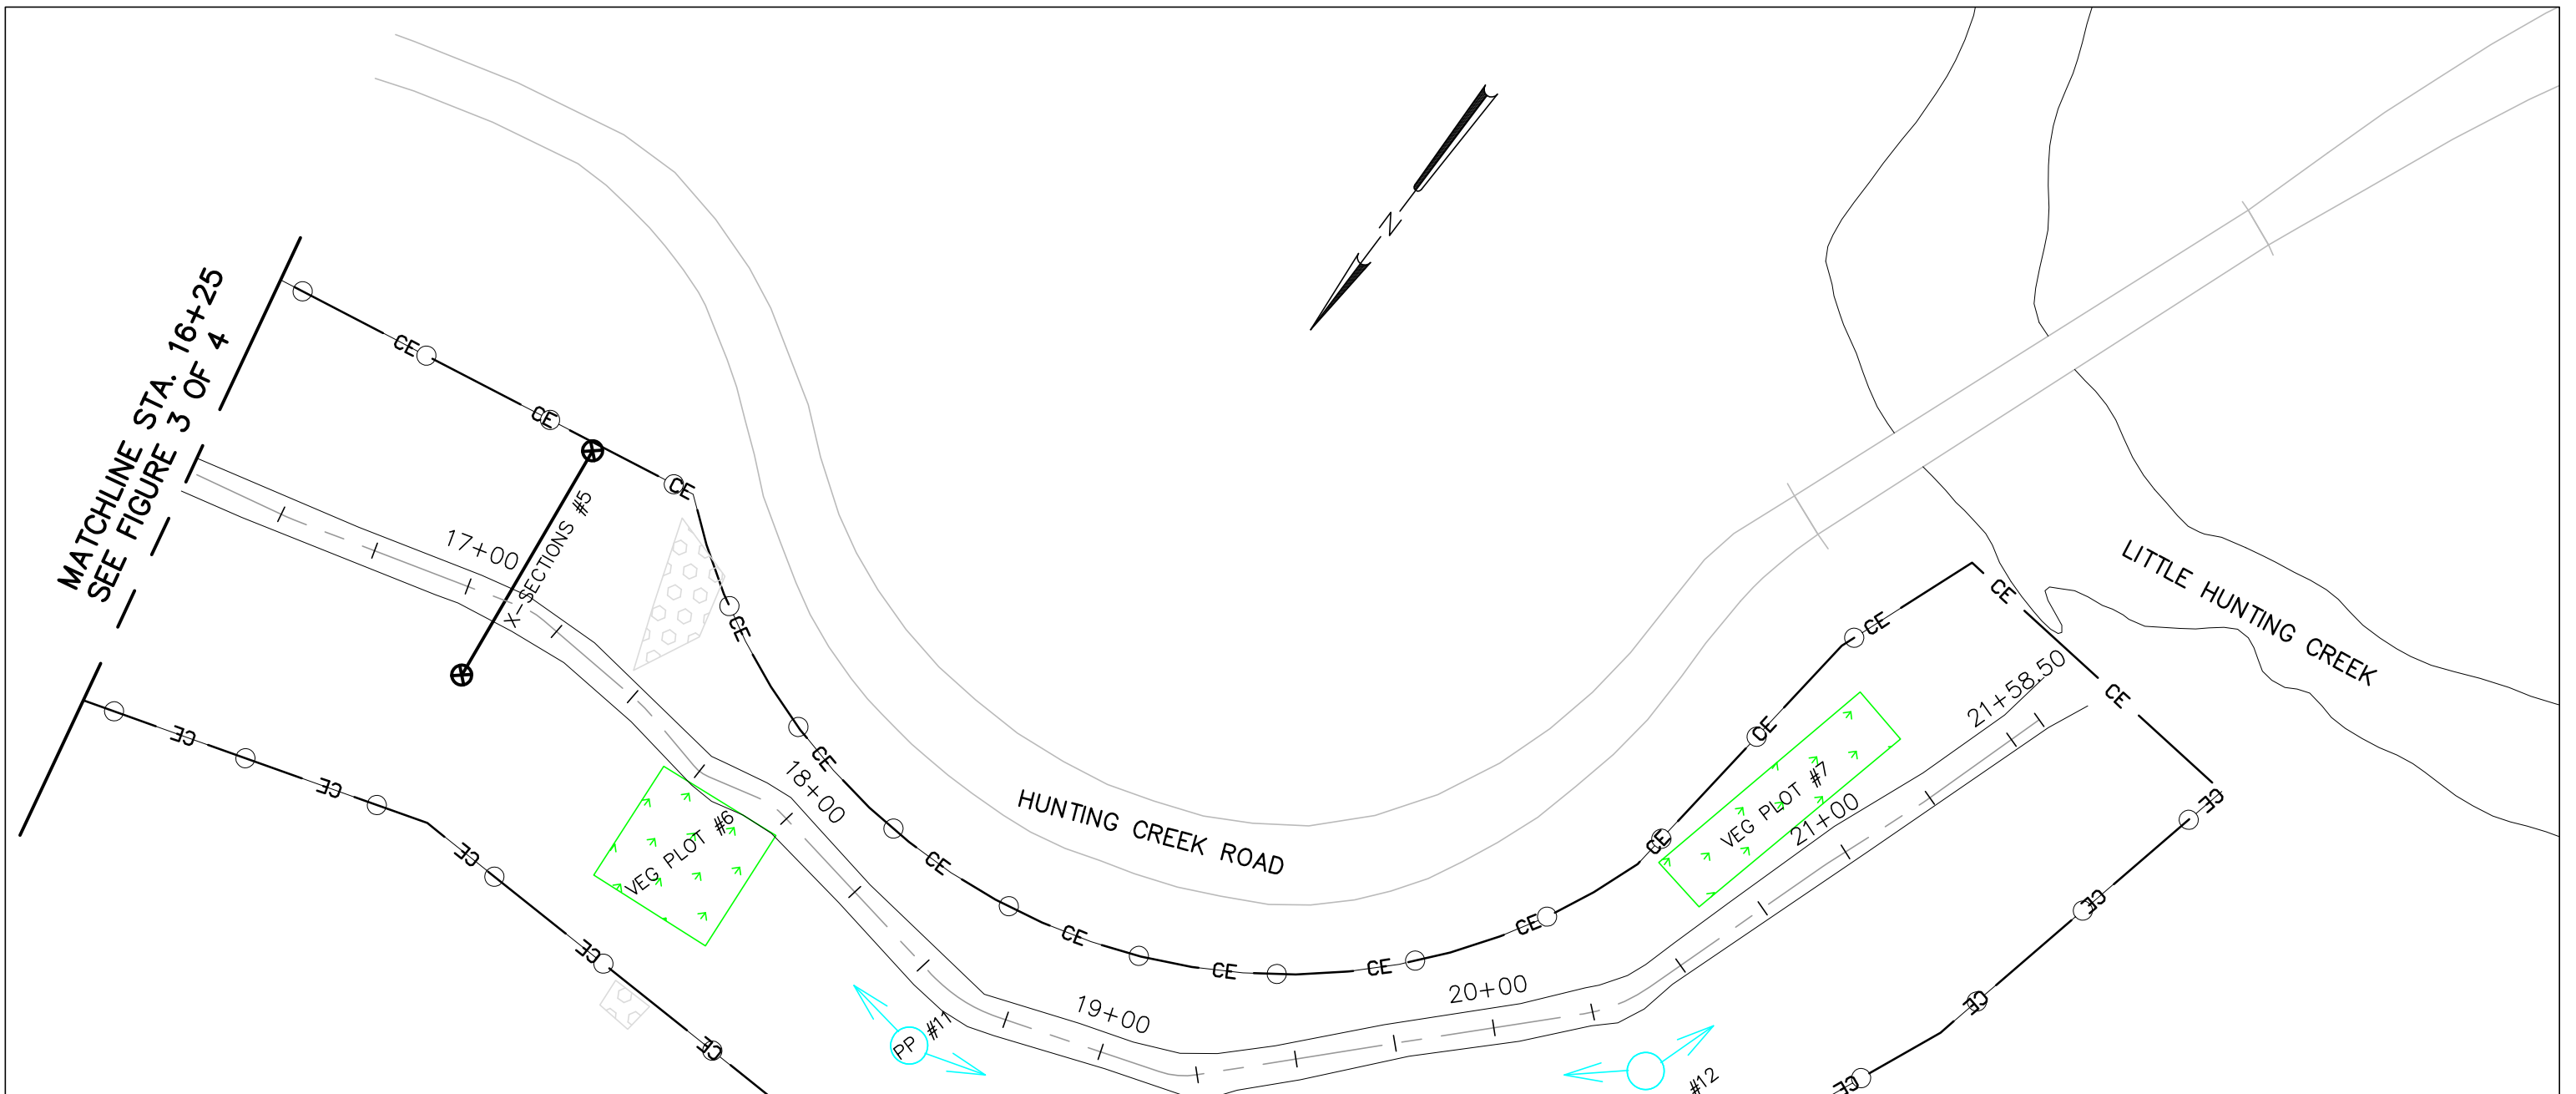
APPENDIX 1.2
 CURRENT CONDITION PLAN VIEW

- The pattern, profile, and dimension of the restored channel appear stable.
- There are several areas with bare banks due to lack of vegetation growth. One area has resulted in moderate bank erosion (approximate station 10+15 and 15+71).
- All structures appear to be in good condition.

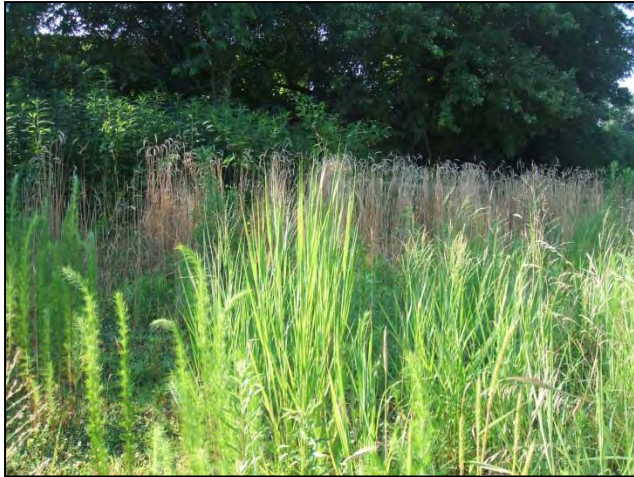
| Vegetation Plot ID | Vegetation Survival Threshold Met (Y/N) | % survivability |
|---|--|---|
| Plot 1 | N | 55% |

Monitoring Plot 1 (6/2009)

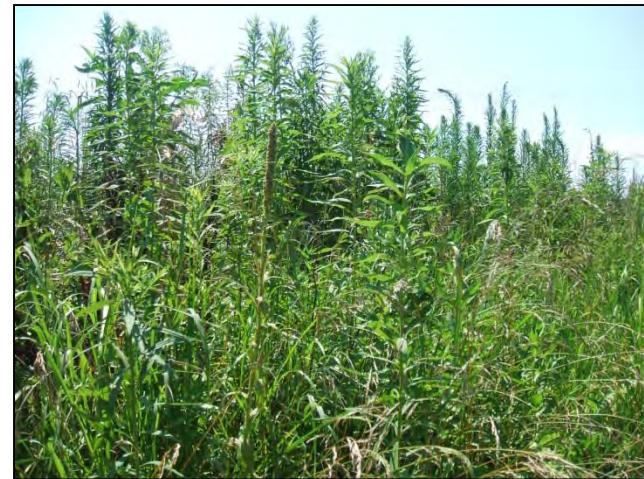
| Vegetation Plot ID | Vegetation Survival Threshold Met (Y/N) | % survivability |
|---|--|---|
| Plot 4 | N | 44% |

Monitoring Plot 4 (6/2009)

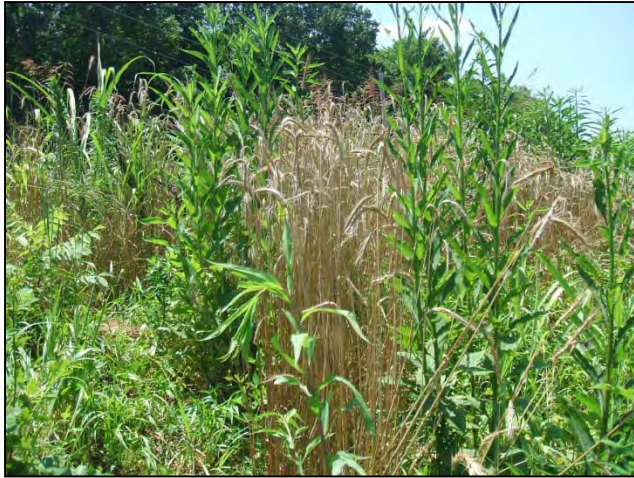
| Vegetation Plot ID | Vegetation Survival Threshold Met (Y/N) | % survivability |
|---|--|---|
| Plot 5 | N | 75% |

Monitoring Plot 5 (6/2009)

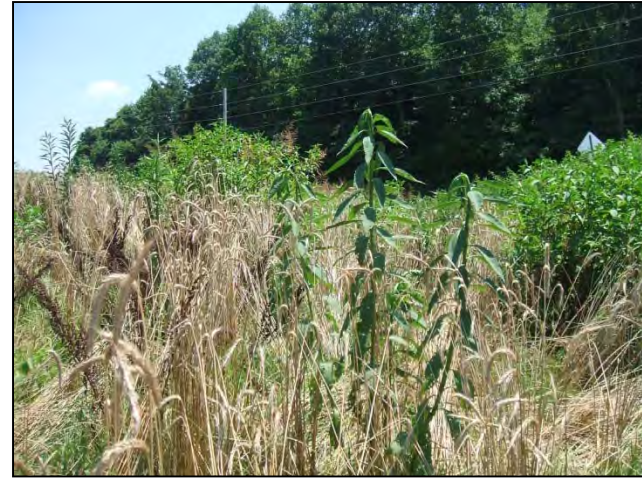
| Vegetation Plot ID | Vegetation Survival Threshold Met (Y/N) | % survivability |
|---|--|---|
| Plot 6 | N | 50% |

Monitoring Plot 6 (6/2009)

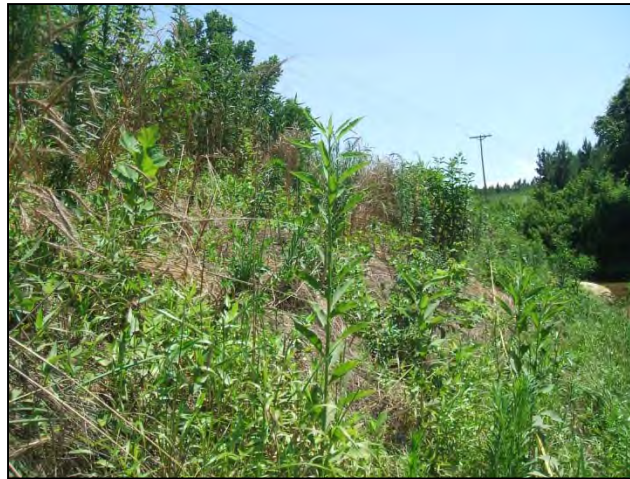
| Vegetation Plot ID | Vegetation Survival Threshold Met (Y/N) | % survivability |
|---|--|---|
| Plot 7 | N | 47% |

Monitoring Plot 7 (6/2009)
