**UT to Little Hunting Creek (Johnson Site)
Stream Restoration
EEP Project No. 197
2010 Monitoring Report: Year 3 of 5**

**Construction Completed: November 2007
Submission Date: September 2011**

Jordan, Jones and Goulding
309 East Morehead Street, Suite 110
Charlotte, NC 28202

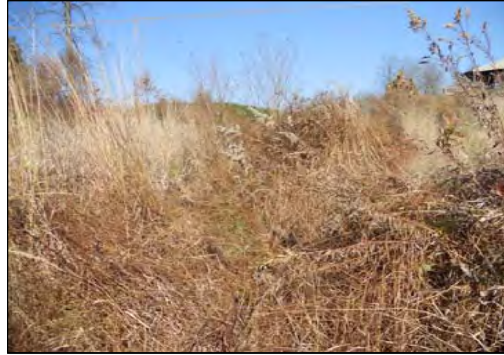
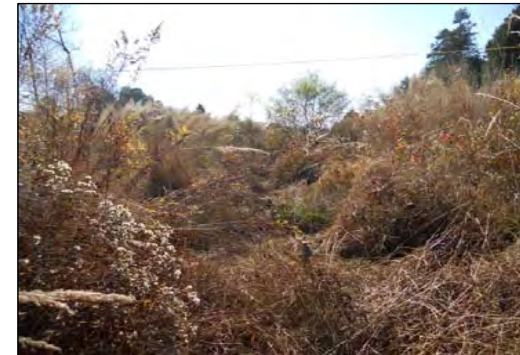
Project Name	Hunting Creek
EEP Project Number	197
Cross-Section ID	XS-1, Riffle, 3+92
Survey Date	11/2010

SUMMARY DATA	
Bankfull Elevation (ft)	788.58
Bankfull Cross-Sectional Area (ft²)	9.50
Bankfull Width (ft)	13.01
Flood Prone Area Elevation (ft)	790.09
Flood Prone Width (ft)	22.73
Bankfull Mean Depth (ft)	0.73
Bankfull Max Depth (ft)	1.51
W/D Ratio	17.82
Entrenchment Ratio	1.75
Bank Height Ratio	2.48

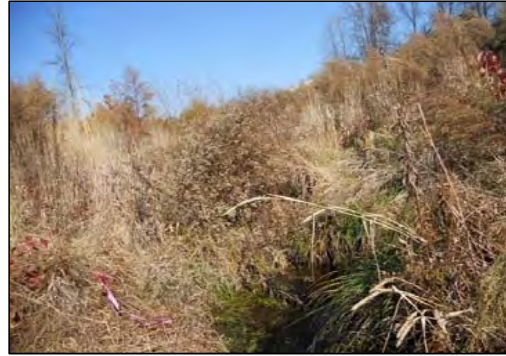
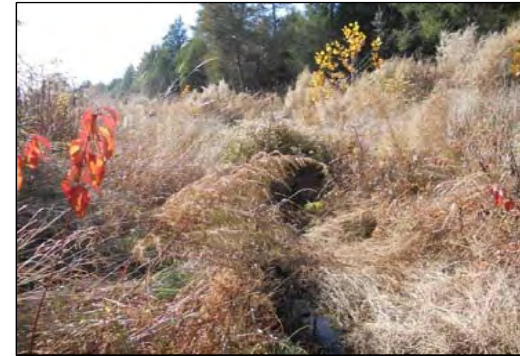
Project Name	Hunting Creek
EEP Project Number	197
Cross-Section ID	XS-2, Pool, 5+25
Survey Date	11/2010

SUMMARY DATA	
Bankfull Elevation (ft)	786.51
Bankfull Cross-Sectional Area (ft²)	13.44
Bankfull Width (ft)	12.78
Flood Prone Area Elevation (ft)	788.75
Flood Prone Width (ft)	29.65
Bankfull Mean Depth (ft)	1.05
Bankfull Max Depth (ft)	2.24
W/D Ratio	12.17
Entrenchment Ratio	2.32
Bank Height Ratio	2.94

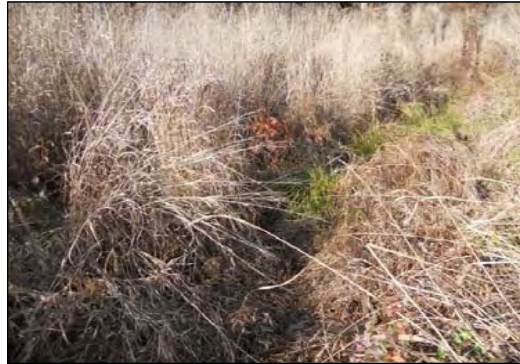
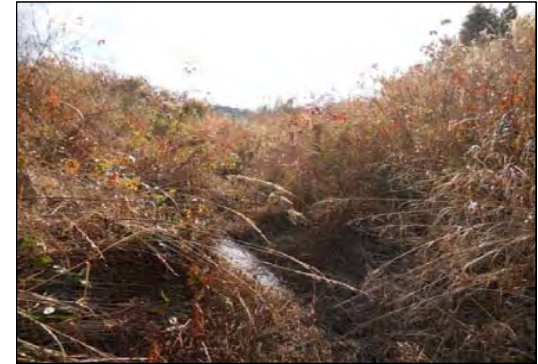
Project Name	Hunting Creek
EEP Project Number	197
Cross-Section ID	XS-3, Pool, 9+41
Survey Date	11/2010

SUMMARY DATA	
Bankfull Elevation (ft)	776.91
Bankfull Cross-Sectional Area (ft²)	6.54
Bankfull Width (ft)	9.77
Flood Prone Area Elevation (ft)	777.95
Flood Prone Width (ft)	16.73
Bankfull Mean Depth (ft)	0.67
Bankfull Max Depth (ft)	1.04
W/D Ratio	14.58
Entrenchment Ratio	1.71
Bank Height Ratio	7.36

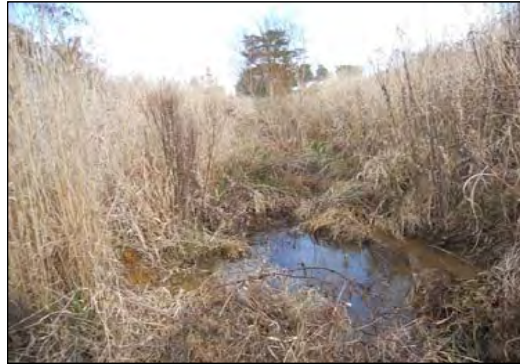
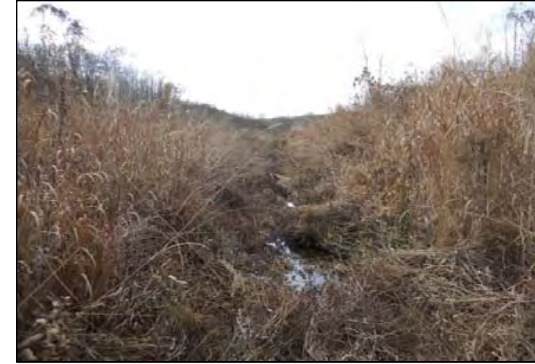
Project Name	Hunting Creek
EEP Project Number	197
Cross-Section ID	XS-4, Riffle, 14+72
Survey Date	11/2010

SUMMARY DATA	
Bankfull Elevation (ft)	767.14
Bankfull Cross-Sectional Area (ft²)	7.48
Bankfull Width (ft)	9.92
Flood Prone Area Elevation (ft)	768.35
Flood Prone Width (ft)	16.39
Bankfull Mean Depth (ft)	0.75
Bankfull Max Depth (ft)	1.21
W/D Ratio	13.23
Entrenchment Ratio	1.65
Bank Height Ratio	4.93

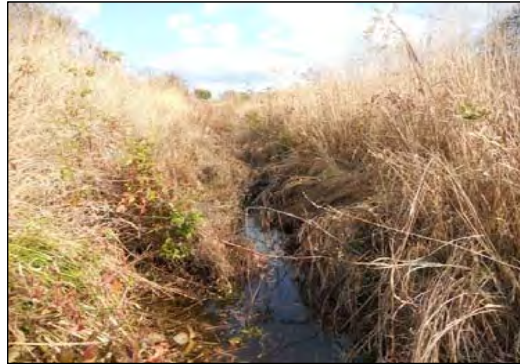
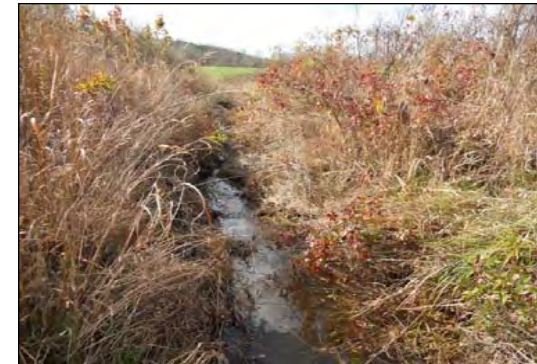
Project Name	Hunting Creek
EEP Project Number	197
Cross-Section ID	XS-5, Riffle, 17+10
Survey Date	11/2010

SUMMARY DATA	
Bankfull Elevation (ft)	763.30
Bankfull Cross-Sectional Area (ft²)	10.10
Bankfull Width (ft)	7.97
Flood Prone Area Elevation (ft)	765.97
Flood Prone Width (ft)	21.58
Bankfull Mean Depth (ft)	1.27
Bankfull Max Depth (ft)	2.67
W/D Ratio	6.28
Entrenchment Ratio	2.71
Bank Height Ratio	2.81
