# OVERHILLS STREAM AND WETLAND RESTORATION MONITORING REPORT (YEAR 1 OF 5)

Harnett County, North Carolina  
NCEEP Project Number 199

Status of Plan: Final  
Submission Date: March 2008

Stantec Consulting Services Inc  
801 Jones Franklin Road, Suite 300  
Raleigh, NC 27606

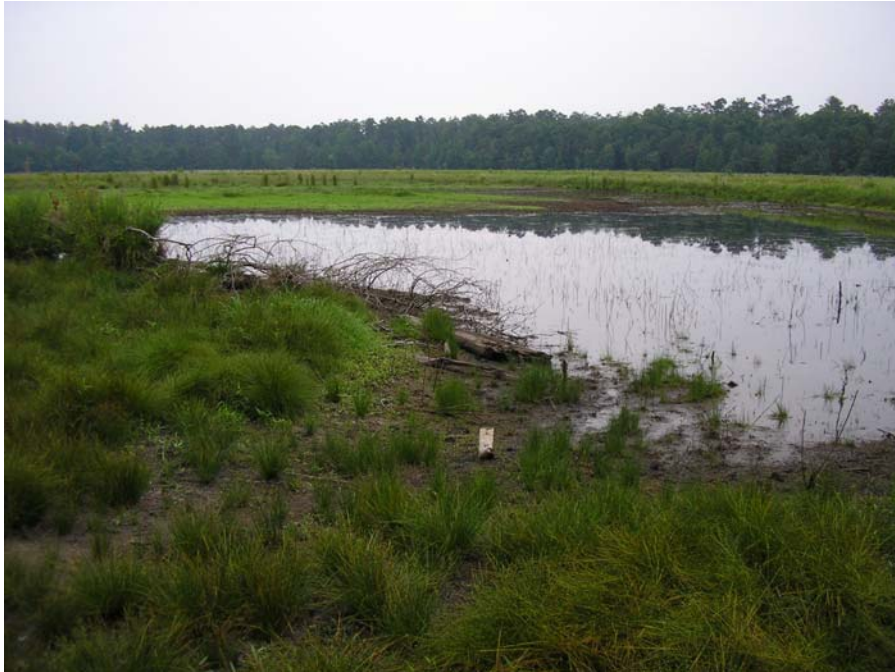
In addition to the four failing vegetation plot sites, several vegetation problem areas exist on site. These sites are referred to as VPA 1, 2, & 3 on the Integrated Problem Area Plan View located in Appendix D. In VPA 1 and 2, standing water had been present for a substantial length of time, causing the majority of the planted vegetation to die (Photos 1 & 2 in Appendix A2). VPA 3 is currently overrun with invasive species, primarily *Lespedeza* (Photo 3). *Lespedeza* is a major problem on this project site, as it is also invading berms and most high areas (Photo 4).

Photo 1. Flooding in VPA-1 facing northeast. Ponding caused vegetation failure. (6/13/07)

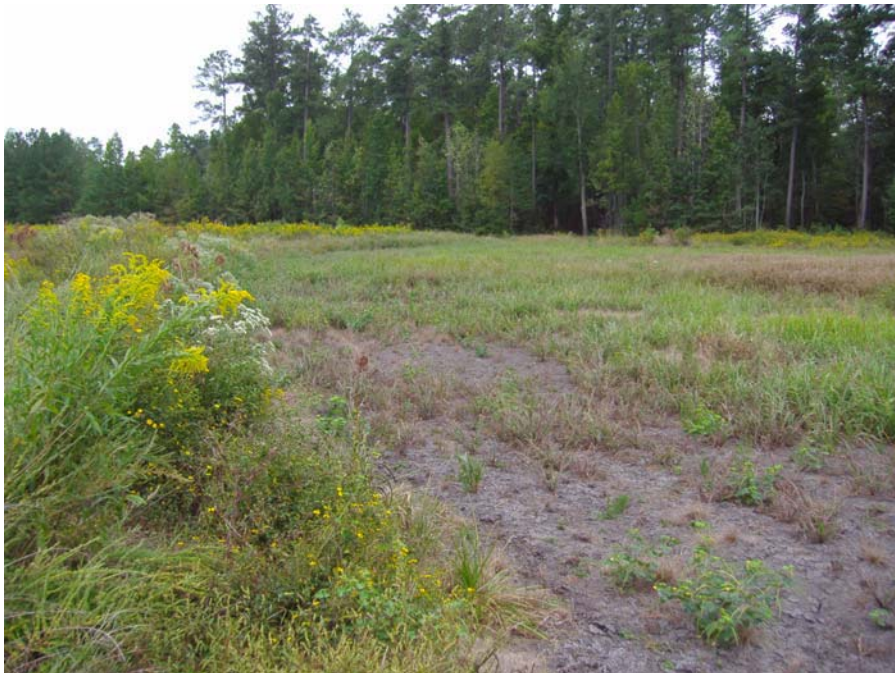
Photo 2. Dried pond in VPA1 facing southwest. Note absence of woody vegetation. (10/2/07)

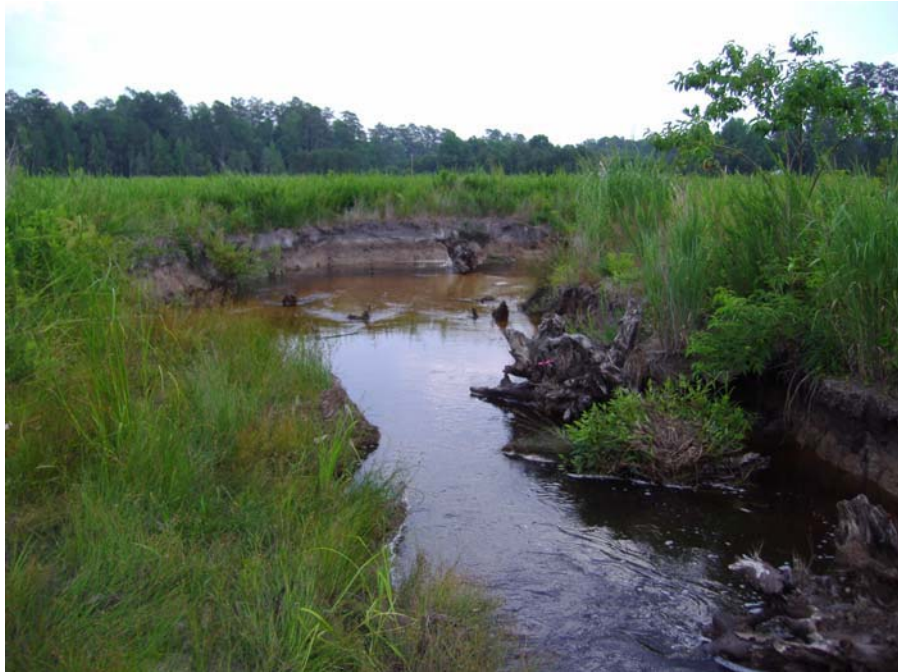
A major stream problem area is located from station 33+00 to 44+00 (1100 linear feet) where the stream has experienced serious failure. At Station 33+00 a head cut has developed and produced massive erosion around the bend at this location (see SPA Photos 1 & 2 in Appendix B3 and Appendix D Integrated Problem Areas Plan View). Downstream from this head cut, most of the in-stream structures have failed (SPA Photos 3 & 4). Erosion around the structures has forced the banks to migrate as much as seven feet, making this section of stream extremely unstable. Mid-channel bar formation is also occurring along the reach (SPA Photo 5). The headcut and downstream problems are apparent in the longitudinal profile of the channel. The survey data suggest that this section of the stream may not have been transitioned to the existing stream properly. The designed pattern and structures were not appropriate for a channel with this gradient. The log cross-vane structures on this reach do not match the goals of the design. Instead of notching the log arms that connect to the vane, the log arms were simply “buted” up against one another (SPA Photo 3). There was also a lack of geotextile fabric in the installation and the angle of the structure was not optimal to reduce near bank shear stress and bank scour. Other major issues include the presence of a beaver dam near Station 6+30 (Photo 6). The dam is causing a hydraulic jump, producing scour downstream.

Photo 1. Looking downstream at the start of the head cut at Station 33+00 (7/4/07)

With the extent of the existing deterioration of this 1100 linear foot portion of the restoration reach, it will not be possible to repair the stream around the failed structures, or to rebuild or replace structures without addressing the characteristics of the stream. The stream has migrated vertically and is actively migrating horizontally. There are too many failed structures and the potential for future bank erosion and additional horizontal migration is too great for a simple repair. The stream channel in this location has eroded below a clay layer into a highly erosive sandy soil layer which will continue to create stability problems. The channel should be realigned with the appropriate pattern, dimension, and structures that will adequately transition from the higher elevation of the restoration to the receiving stream which is at a lower elevation. There is room on the right side of the existing alignment to be able to develop a new pattern that will provide the correct channel dimensions, grade control structures, and step pools needed to dissipate energy though this section of the reach. This action will stop the head cut from continuing upstream causing further damage to the restored channel. The majority of the materials needed for construction could be salvaged from the impaired reach.

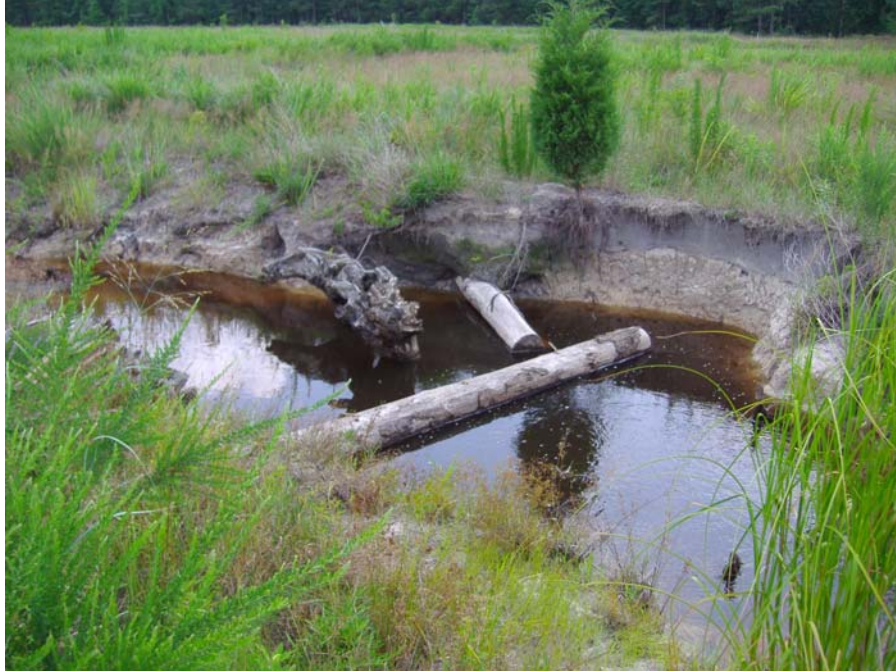
Photo 3. Failed log cross-vane structure downstream of the headcut. The logs were not notched together, allowing the arms to separate from the cross log. (7/4/07)

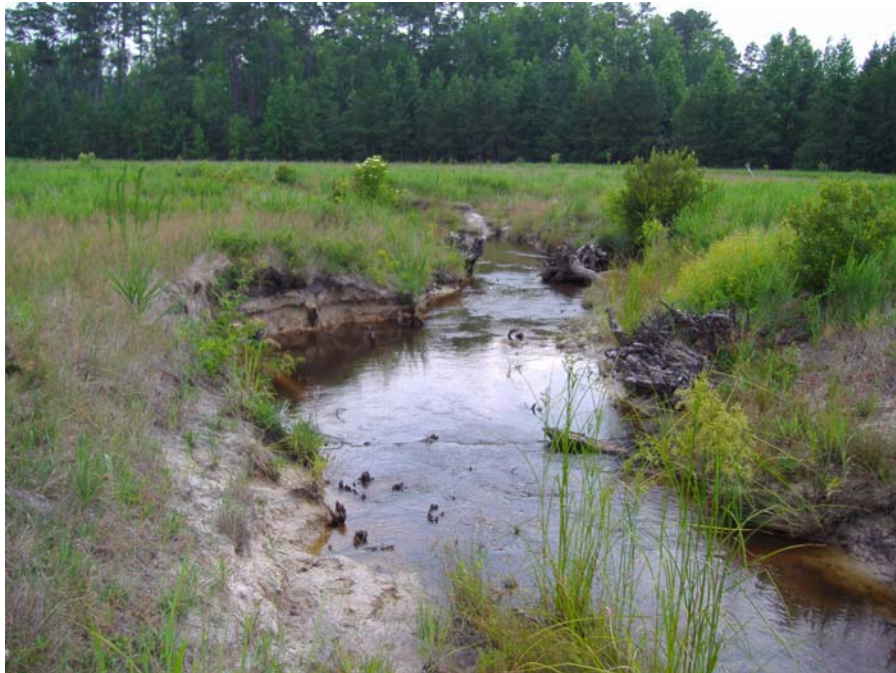
Photo 4. Typical example of a structure that has been washed away and resultant bank erosion (7/4/07)

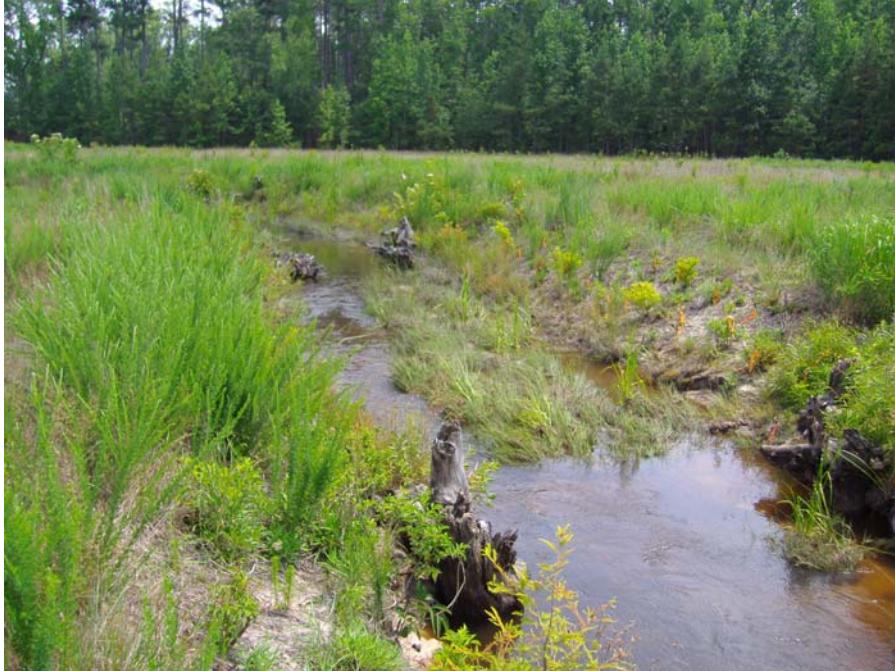
Photo 5. Mid-channel bars forming in the failed restoration channel (7/4/07)

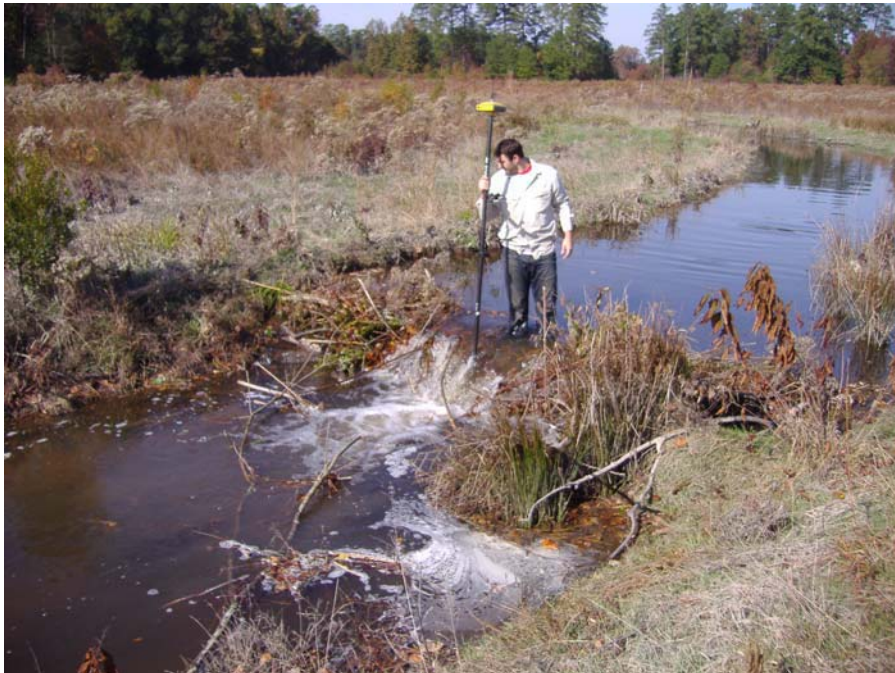
Photo 6. Beaver dam located at Station 6+30 (11/9/07)

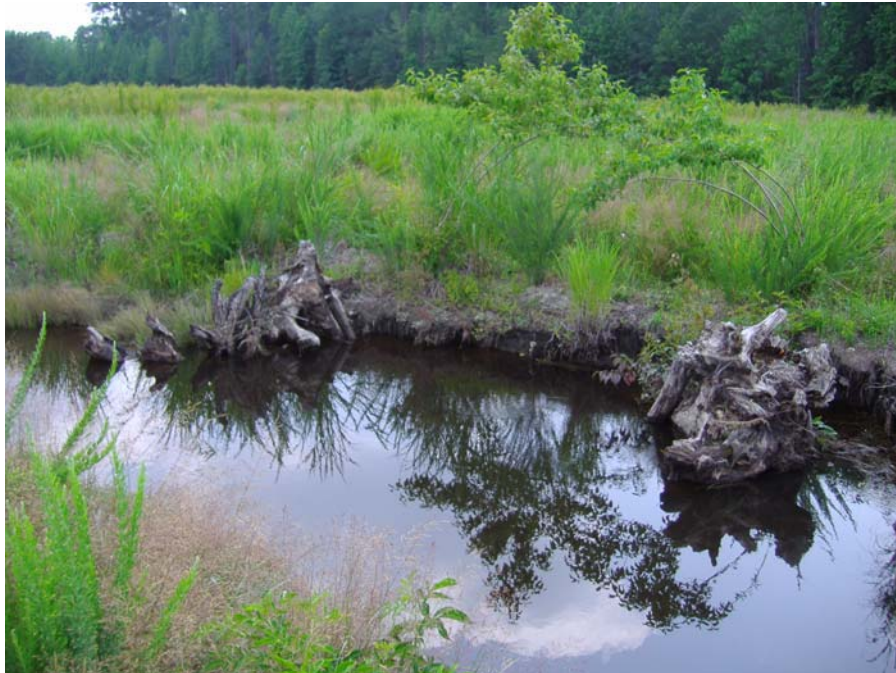
Minor erosion problem areas were found from station 0+00 to station 32+00 of the restoration reach (Photo 7). Erosion causes were attributed to failure at the root wad in some cases and shear stress in others. Shear stress is caused by high velocity flows towards the outside of the meander. The placement and/or installation of some root wads has caused scouring, along with bank erosion and migration from

Photo 8. Example of eddies that have caused scouring and erosion around the toes and banks of the root wad structures (7/4/07)

eddies that form around and behind the root wad structures (SPA Photo 8). The problem areas here can be fixed with simple hand grading of the banks and live stake planting around the toe of the structures. This will help stabilize the banks and limit the amount of erosion and degradation currently occurring. The hand grading should bring the banks back to a reasonable slope to the top of the banks or the berms on either side. These areas should be addressed to prevent additional erosion and migration from occurring. See Exhibit Table B1 and representative photos in Appendix B as well as the map in Appendix D for more information.

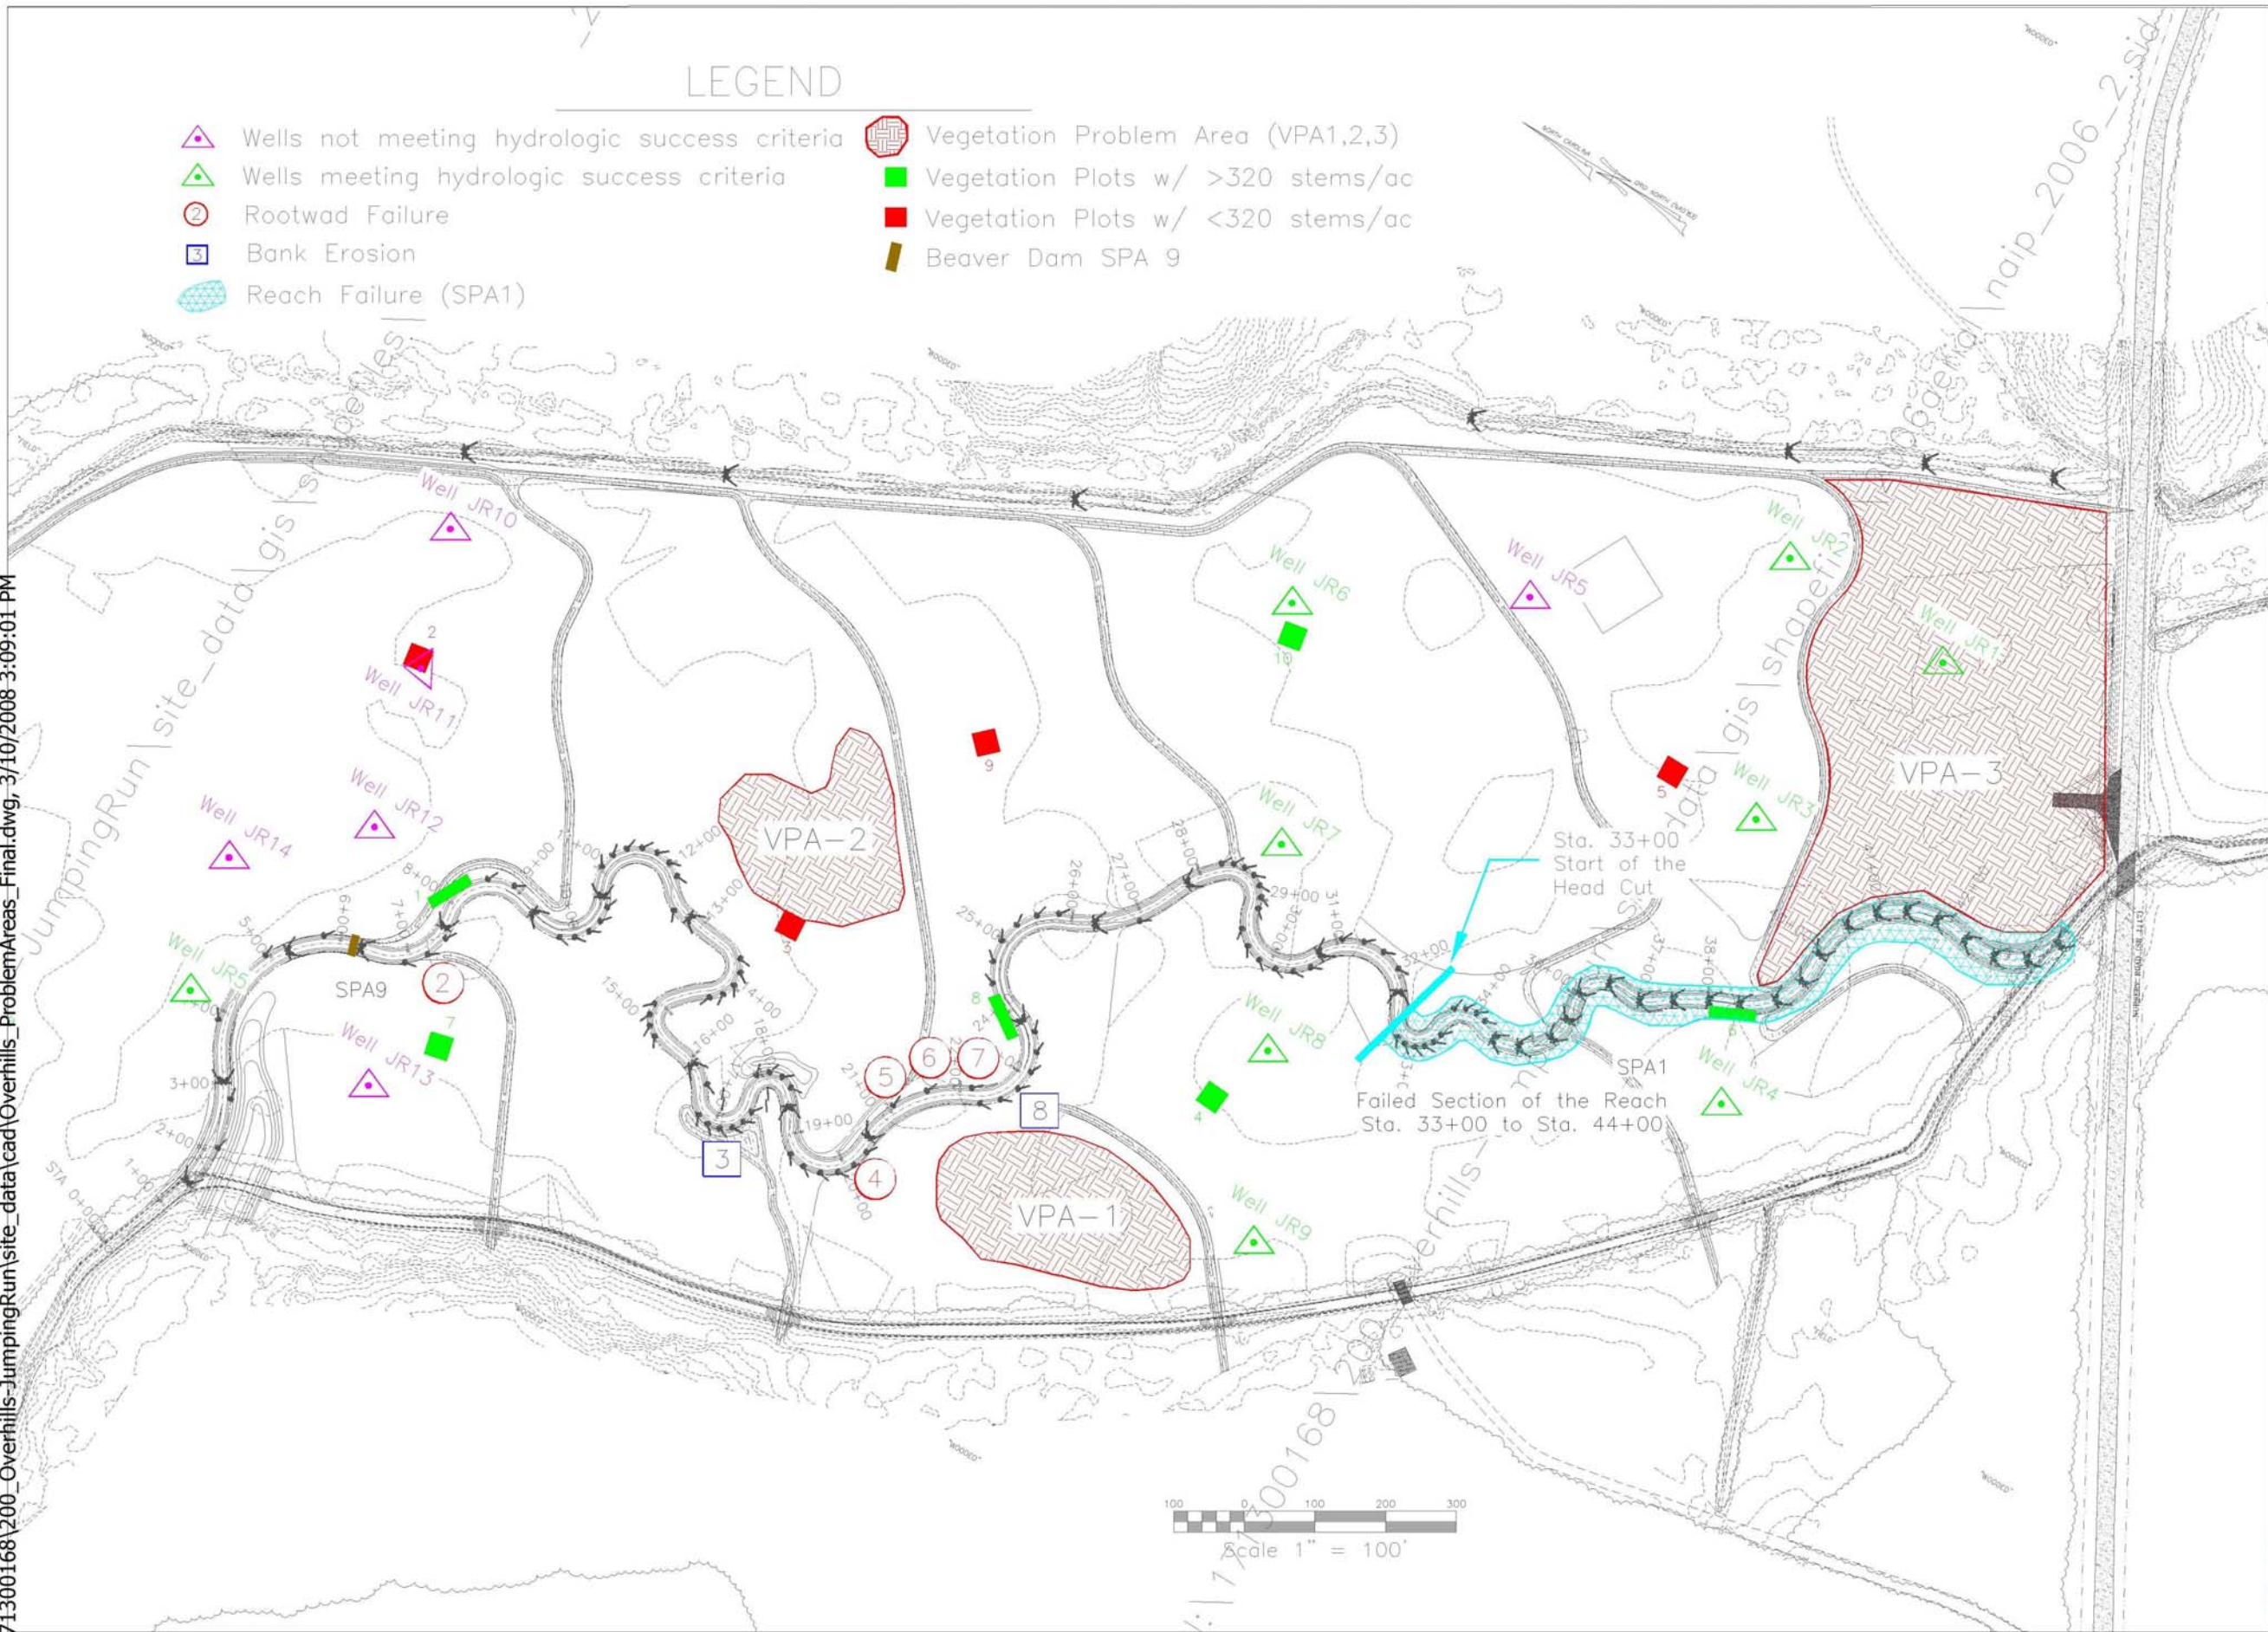
OVERHILLS  
STREAM RESTORATION MONITORING  
ASSESSMENT  
APPENDIX D  
CURRENT CONDITIONS PLAN VIEW

- ▲ Wells not meeting hydrologic success criteria
- ▲ Wells meeting hydrologic success criteria
- 2 Rootwad Failure
- 3 Bank Erosion
- Reach Failure (SPA1)
- Vegetation Problem Area (VPA1,2,3)
- Vegetation Plots w/ >320 stems/ac
- Vegetation Plots w/ <320 stems/ac
- Beaver Dam SPA 9
