OVERHILLS STREAM AND WETLAND RESTORATION MONITORING REPORT (YEAR 2 OF 5)

Harnett County, North Carolina
NCEEP Project Number 199

Status of Plan: Final
Submission Date: April 2009

Stantec Consulting Services Inc
801 Jones Franklin Road, Suite 300
Raleigh, NC 27606

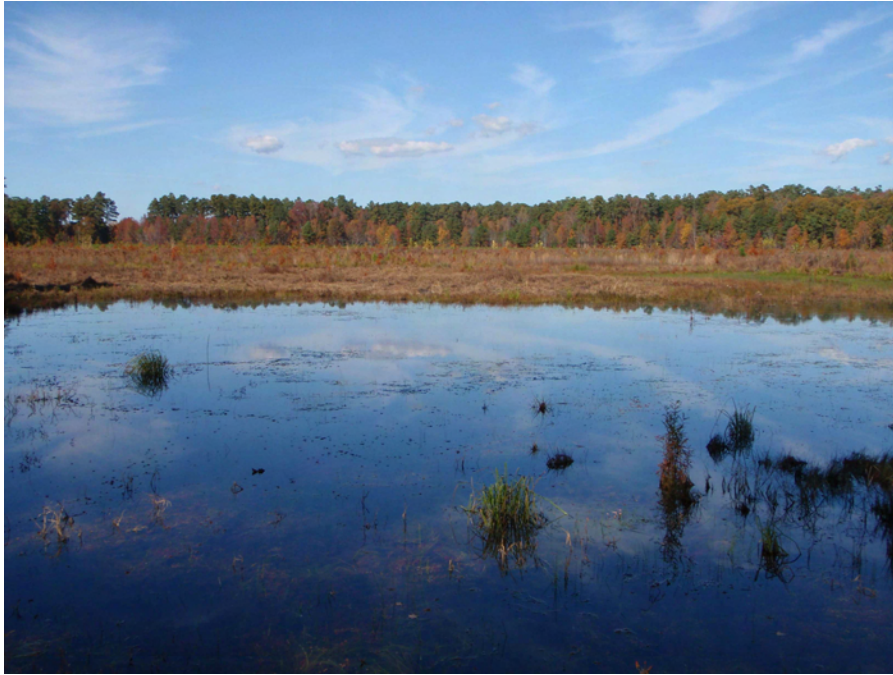
Feature/Issue	Station # / Range	Probable Cause	Photo #
Death of trees and plants	VPA1 & VPA2	Persistent flooding	1 & 2
Invasive/exotic species	VPA3	Invasion of <i>Lespedeza</i>	3

Photo 1. Flooding in VPA-1 facing northeast. Ponding causing vegetation failure (11/07/2008).

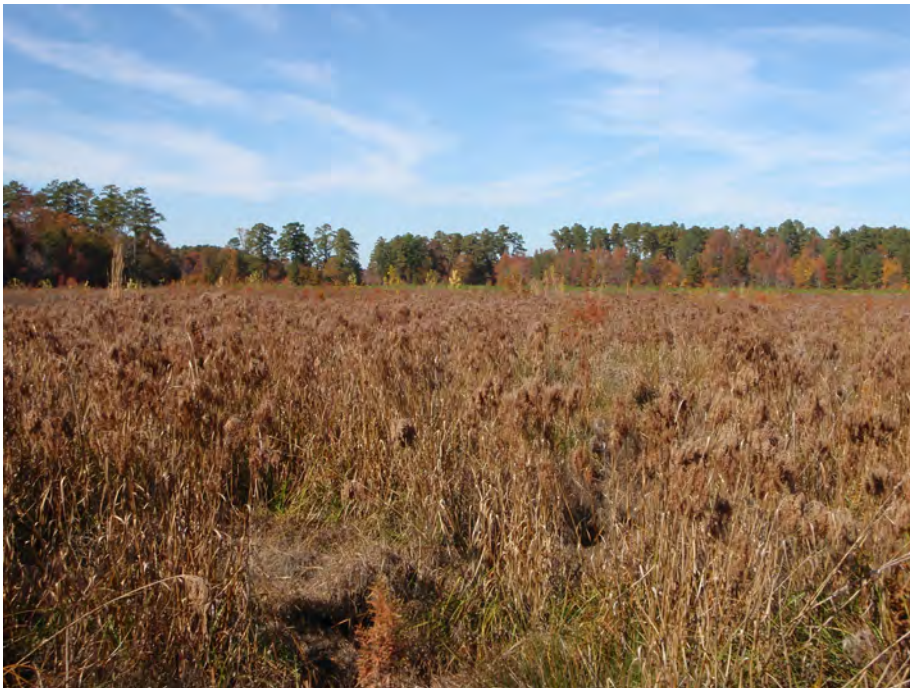
Photo 2. Frequent ponding in VPA-2 causing lack of woody vegetation (11/07/2008).

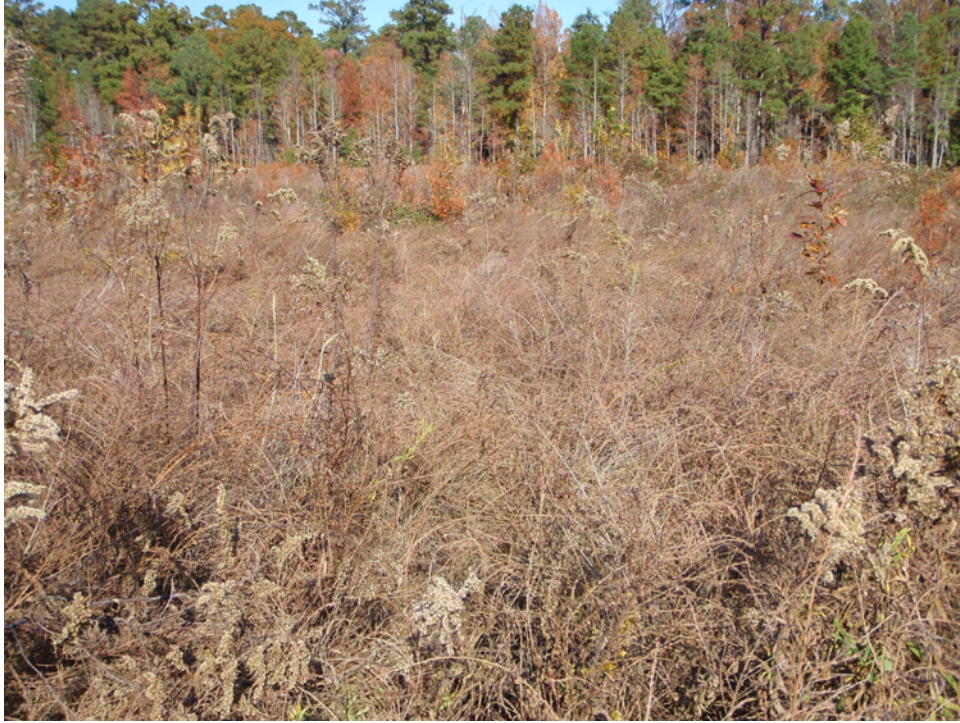
Photo 3. Invasive species, *Lespedeza*, in VPA3 (11/07/2008).

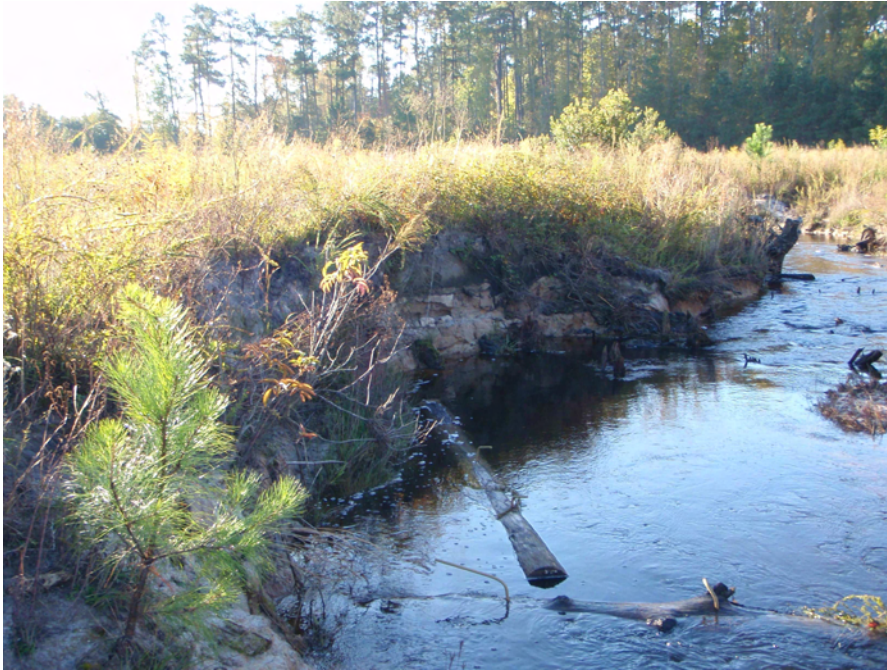
A major stream problem area is located from station 32+60 to 44+00 where the stream has experienced serious failure. At the downstream end of the Upper Reach, a headcut was first noted to have developed near Station 32+80 in Year 1 monitoring. This headcut continues to move steadily upstream, appearing to have moved approximately 20 feet upstream to Station 32+60 since last year. The headcut most likely first began at the location where the design changes from a C to E type channel between the Upper and Lower reaches at Station 33+00. Downstream from this headcut, most of the in-stream structures have failed. Erosion around the structures has forced the banks to migrate as much as seven feet, making this section of stream extremely unstable (SPA Photo 1&2). Mid-channel bar formation is also occurring along the reach (SPA Photo 5). The headcut and downstream problems are apparent in the longitudinal profile of the channel. The survey data suggest that this section of the stream may not have been transitioned to the existing stream properly. There was a lack of geotextile fabric in the installation and the angle of the structure was not optimal to reduce near bank shear stress and bank scour.

Overhills/Jumping run Creek Restoration Project - EEP No. 199					
MAJOR PROBLEM AREAS					
Feature/Issue	Stream Reach	Station # / Range	Probable Cause	ID	Photo #
Headcut	Lower reach	33+00	In-stream structural failure	SPA 1	1
Bank Erosion/Migration	Lower reach	33+00 to 44+00	Headcut formation, in-stream structural failure	SPA 1	1 & 2
Mid-channel Bar Formation	Lower reach	33+00 to 44+00	In-stream structural failure	SPA 1	5
Scour/Sedimentation	Upper reach	6+30	Beaver dam	SPA 9	3
Scour/Sedimentation	Upper reach	23+15	Beaver dam	SPA 9	NA
Scour/Sedimentation	Upper reach	27+77	Beaver dam	SPA 9	NA
MINOR PROBLEM AREAS					
Bank Erosion/Bare Floodplain	Upper reach	0+00 to 32+00	Excess near bank shear stress	SPA 2-8	4

Photo 1. Looking downstream at a severely eroded bank and failed structure (10/23/08).

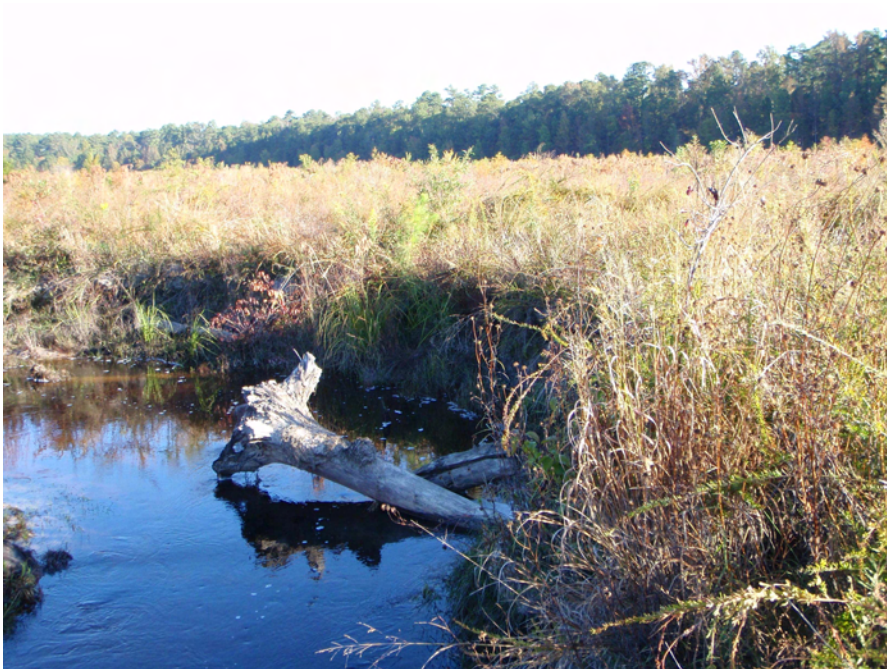
monitoring year 1 to Monitoring Year 2. The initial downcutting was most likely attributed to an undersized channel upstream. In addition, the upstream log cross-vane appears to have failed by not holding the grade of the bed during Year 1. XS7, which is located in the unstable downstream reach, provides evidence that this portion of the reach is actively degrading. The bed will most likely continue to downcut until a less erosive bed layer emerges in the profile to stop the incising. Two log cross-vanes, both upstream and downstream of the cross-section, have failed to hold grade and are contributing additionally to the active degradation of the stream bed.

Photo 2. Looking upstream at failed bank and structure, near headcut at Sta. 33+00 (10/23/08).

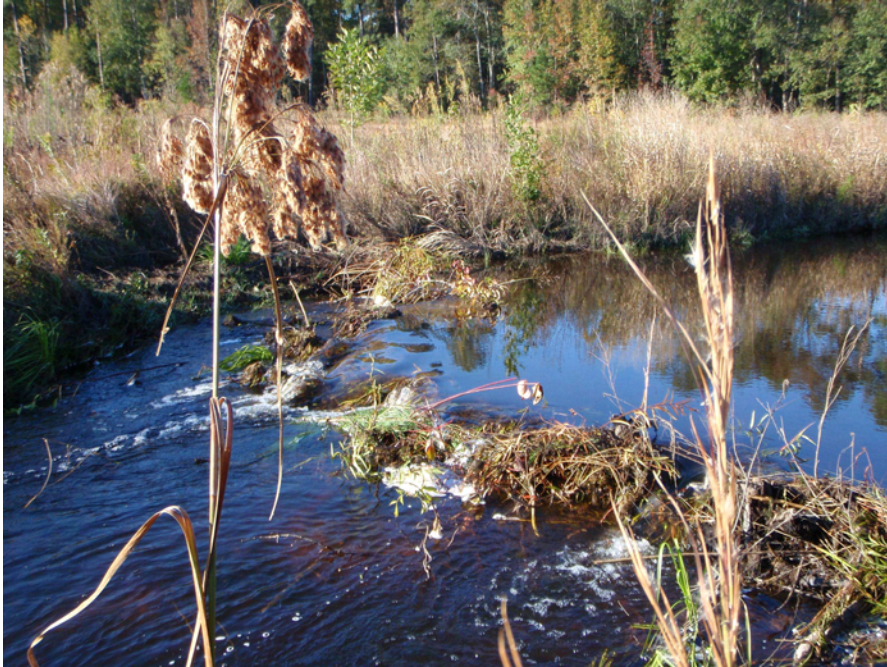
Minor problem areas such as bank scour and bare floodplains were found from Station 0+00 to Station 32+00 (Upper Reach) of the restoration reach (SPA Photo 4), but overall this area of the restoration appears to be stable (Appendix B.4, Photo 2). Normal water surface elevations are at or near the constructed bankfull, allowing the channel to access the floodplain under very small storm events, reducing shear stress in the channel. The areas immediately surrounding the channel were ponded near the channel banks. The beaver dam near Station 6+30 continues to cause problems such as scour and excessive sediment deposition. Minor scouring and sediment deposition was also observed around the two smaller beaver dams present at the time of the stream monitoring survey on August 12, 2008. The beaver dams were located at Stations 23+15 and 27+77. These are both shown on the longitudinal profiles and monitoring plan view; however, they were not present during the latest site visit in November of 2008. Significant storm events during the early fall most likely washed the dams downstream.

Photo 3. Beaver dam with scour on right bank (2/08/2008).

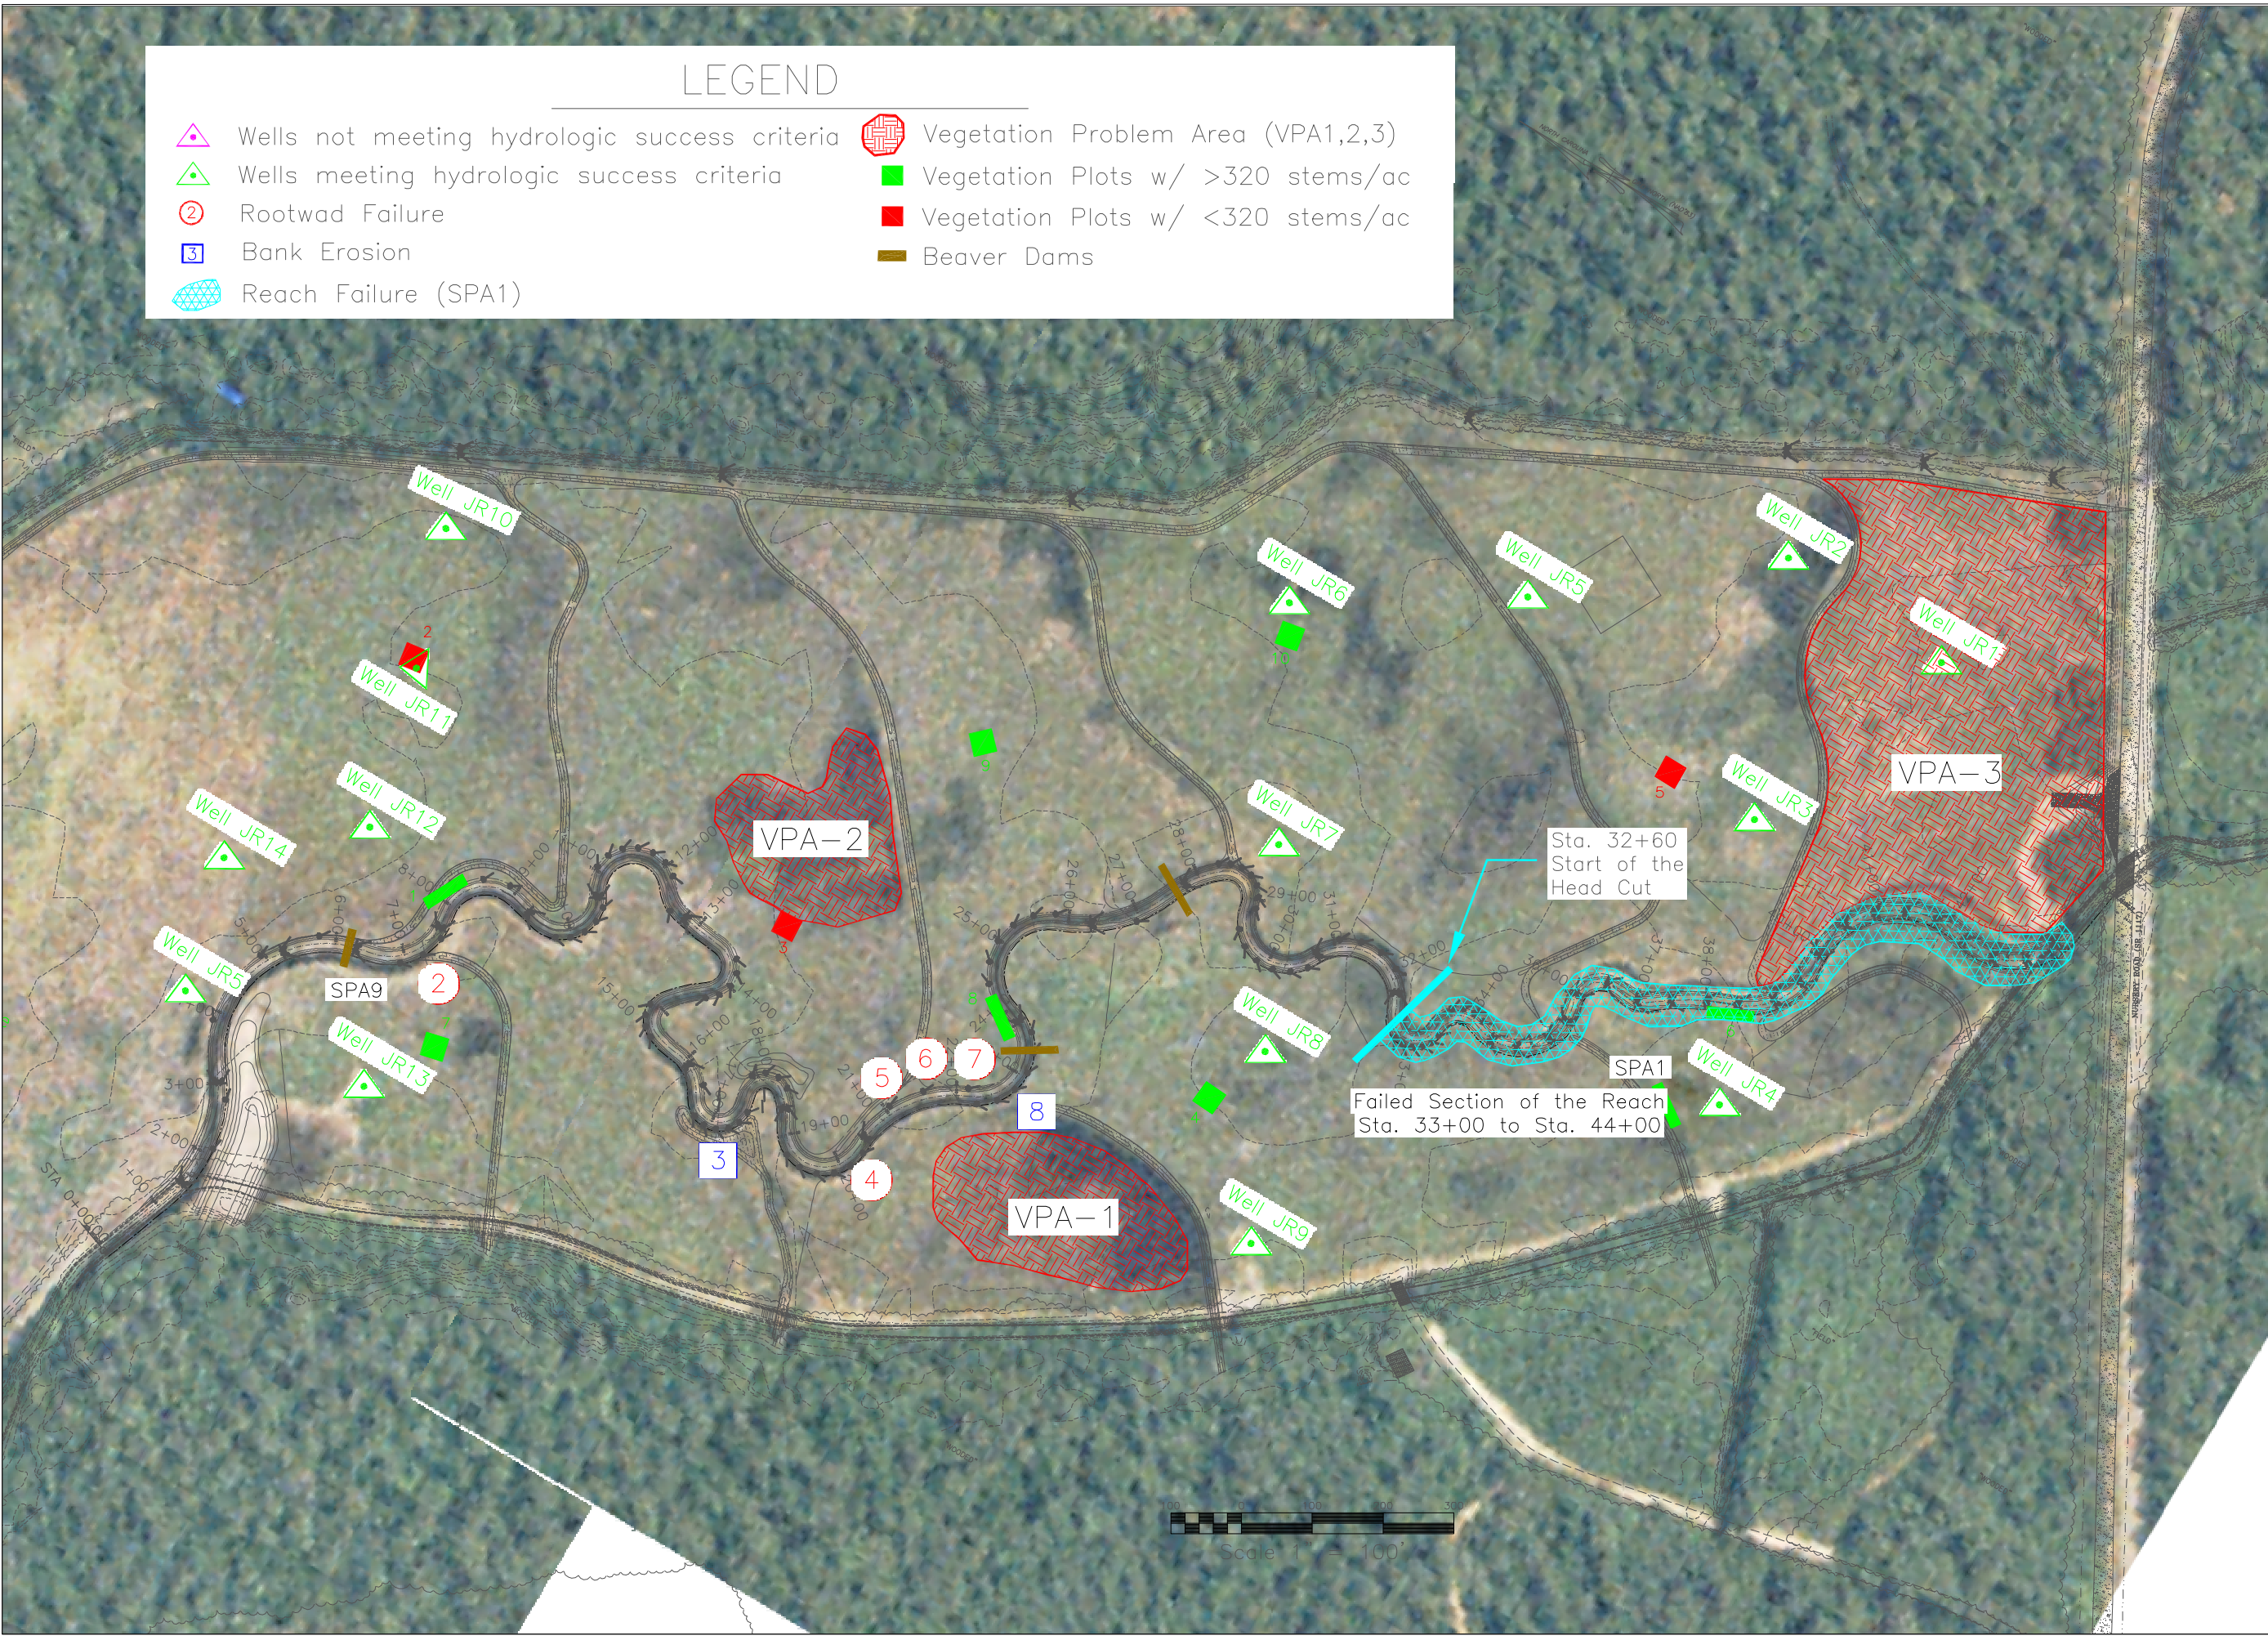
OVERHILLS
 STREAM RESTORATION
 Integrated Current Conditions Plan View
 APPENDIX D

In addition to the three failing vegetation plot sites, much of the same vegetation problem areas continue to exist onsite. These sites are referred to as VPA 1, 2, & 3 on the Integrated Current Condition Plan View located in Appendix D. In VPA 1 and 2, persistent flooding has occurred and has caused the majority of the planted woody vegetation to die (Photos 1 & 2 in Appendix A.2). Standing water continues to be present in VPA 1. VPA 3 is currently overrun with invasive species, primarily *Lespedeza* (Photo 3). *Lespedeza* continues to be a major problem on the project site. It is invading dry areas, especially on top of the berms onsite.

Rootwad Failure
-

Reach Failure (SPA1)
-

Beaver Dams
