OVERHILLS STREAM AND WETLAND
RESTORATION MONITORING REPORT (YEAR 5)

Harnett County, North Carolina

EEP Project No. 199

Status of Plan: Final
Submission Date: November 2011

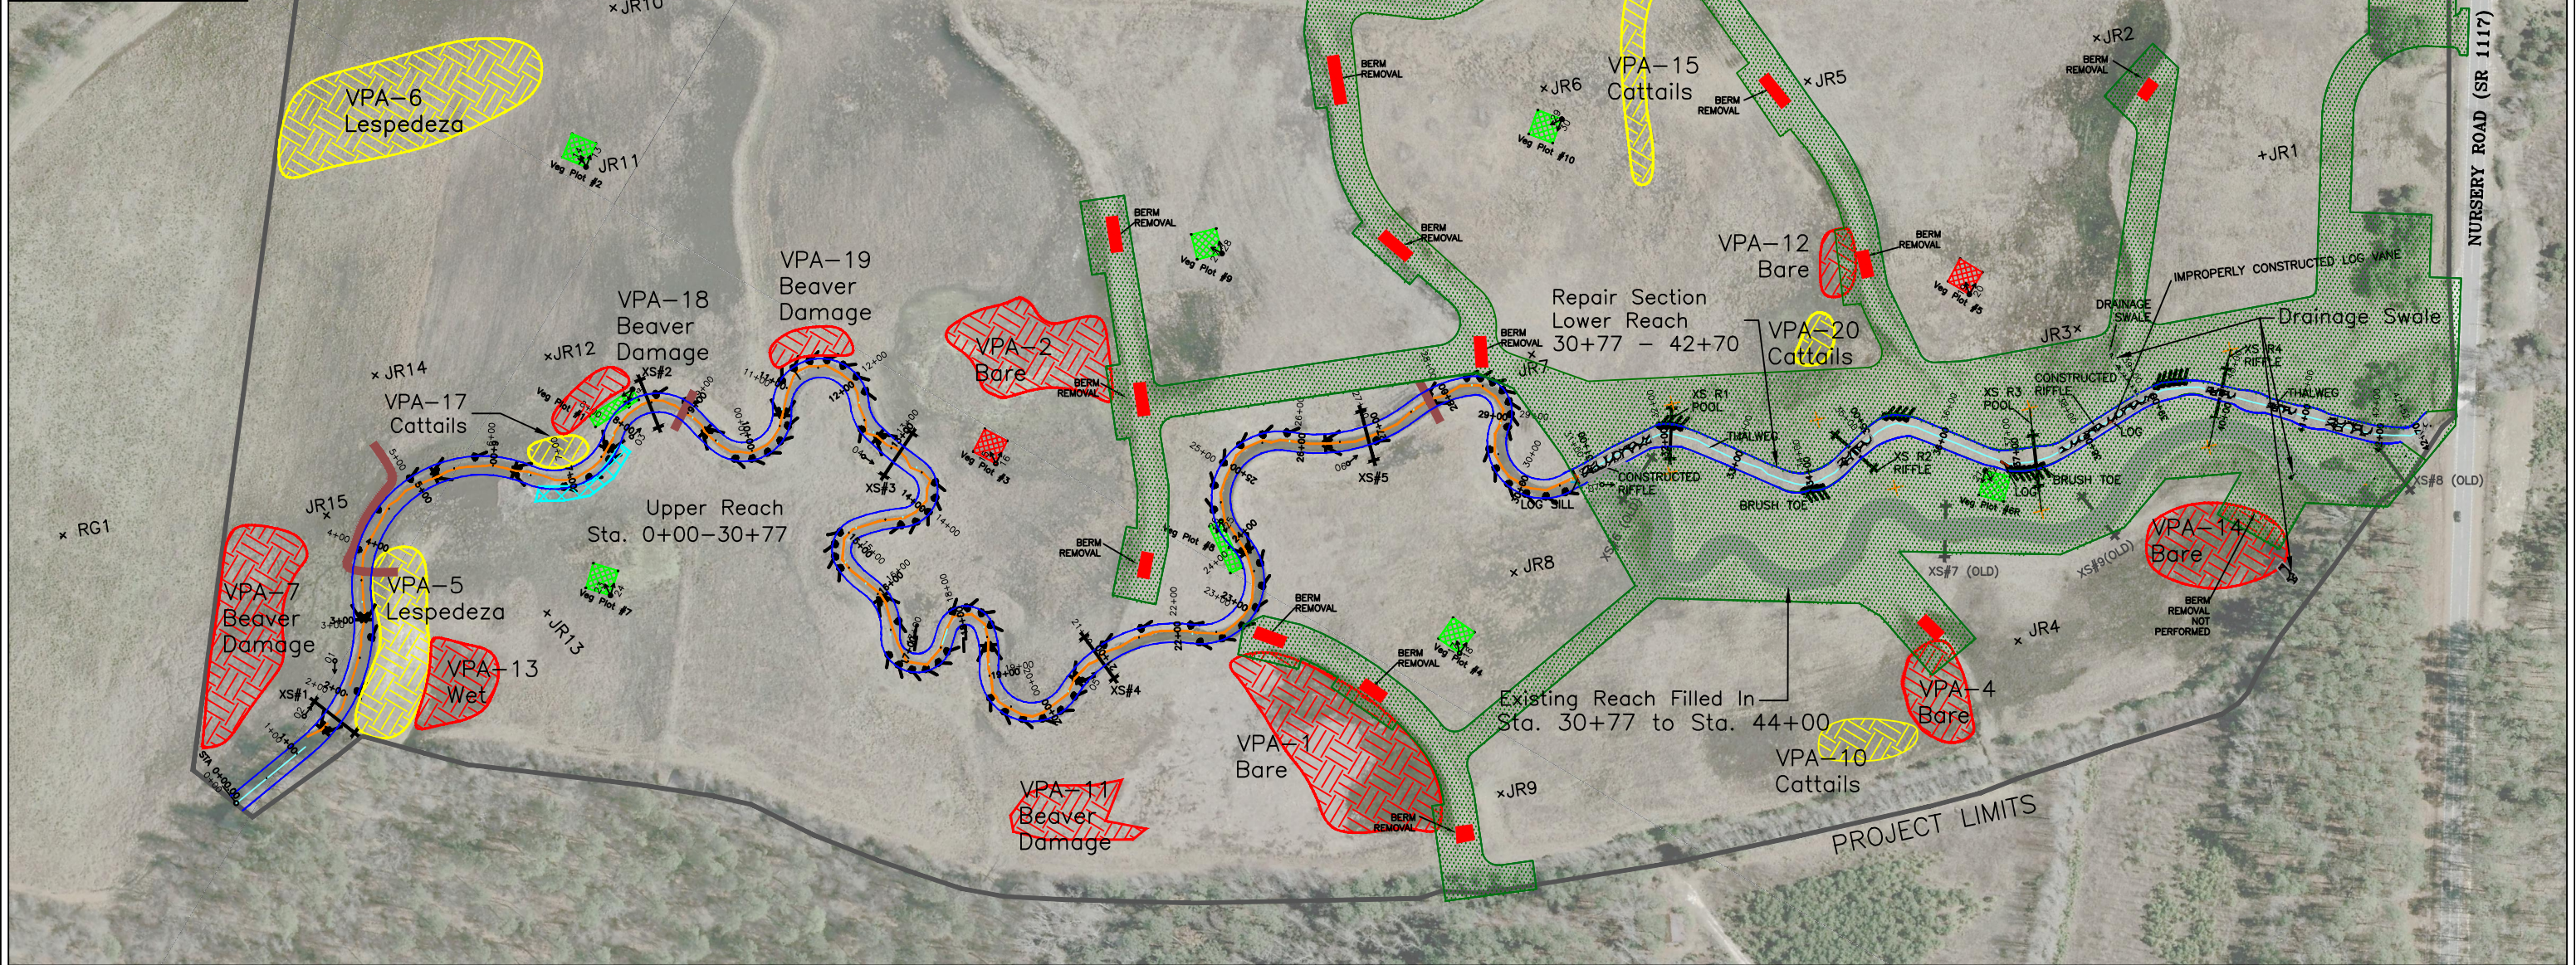
CURRENT STATUS PLAN VIEW

areas have been noticeably impacted by beaver foraging and are shown on the CCPV as VPA 7, 11, 18, and 19.

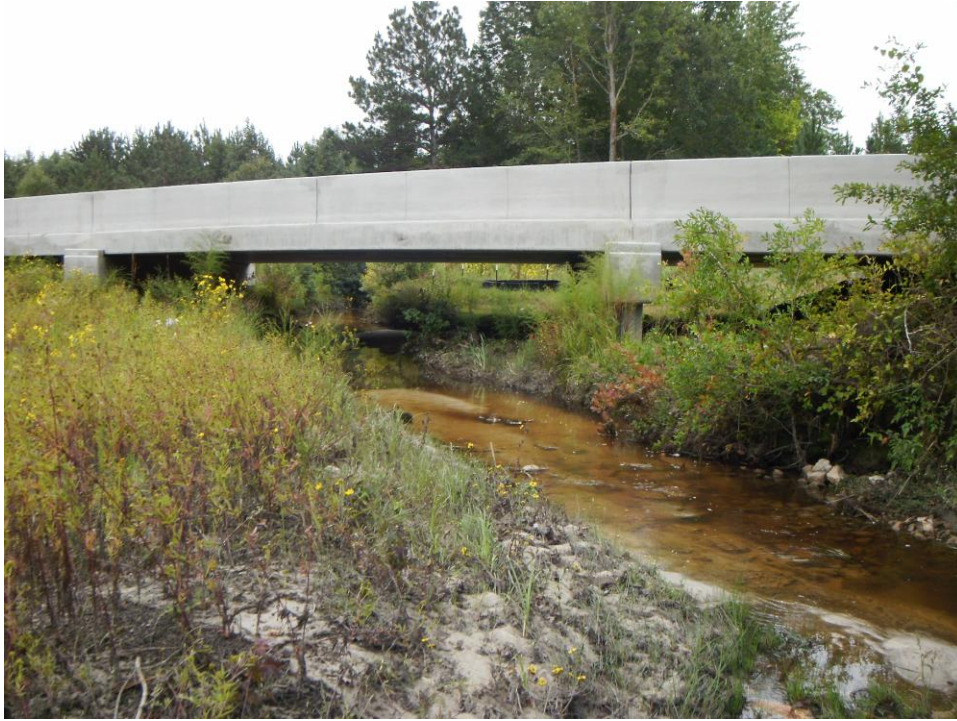
Photo 1 – Evidence of bankfull overflow near Station 42+00 – sediment on floodplain (9/21/11)

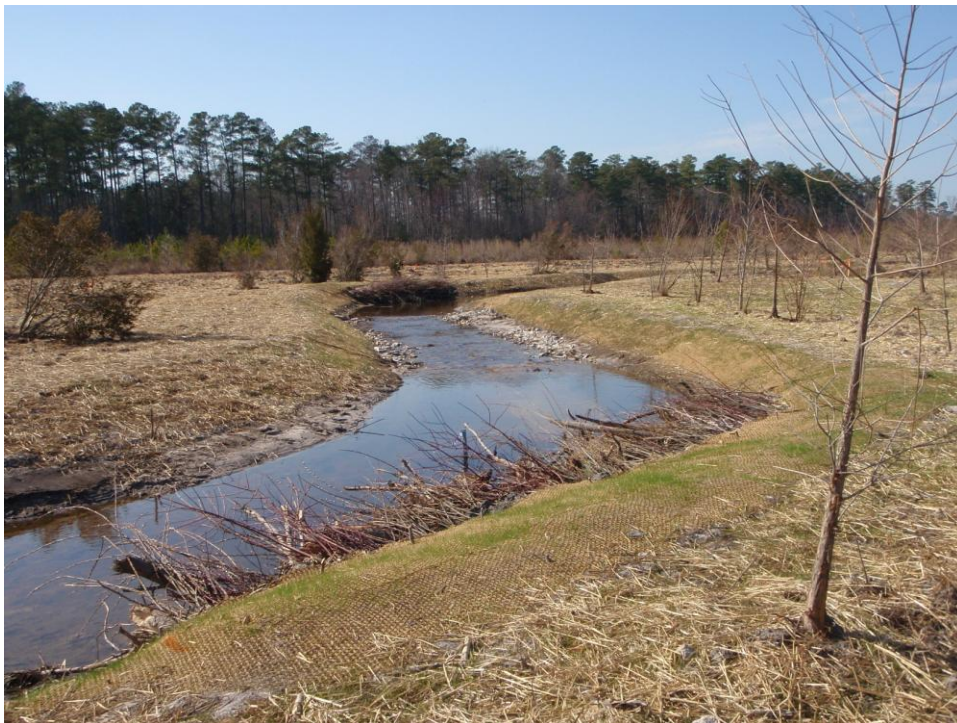
Photo 2 – Repaired reach looking upstream near Station 36+00 (2/23/11)

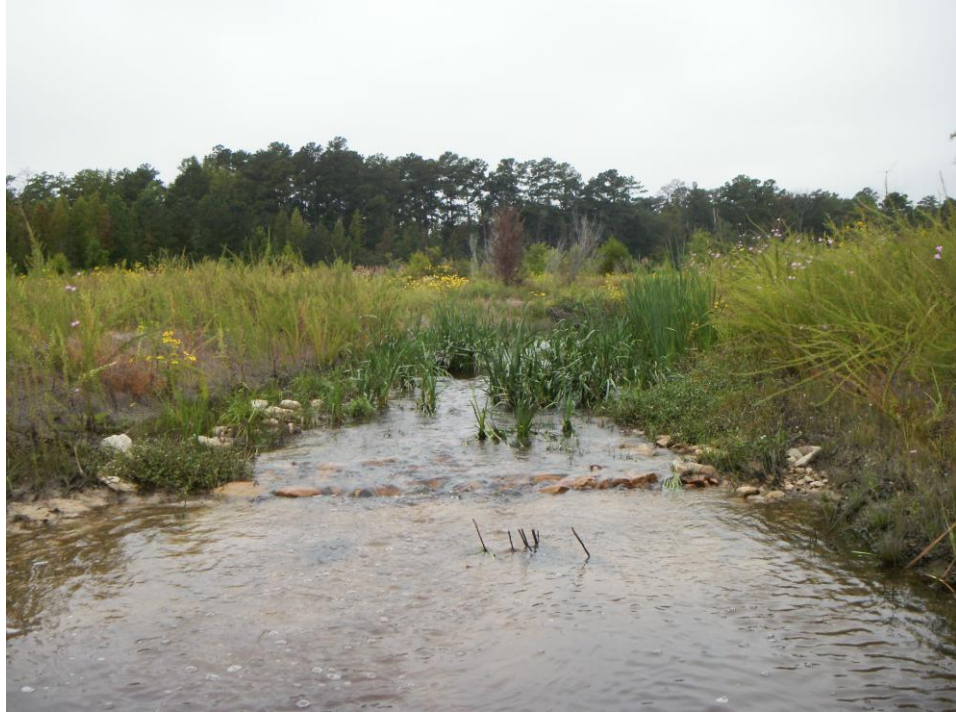
Photo 3. Repaired reach looking upstream near Station 35+50 (9/21/11)
