OVERHILLS STREAM AND WETLAND
RESTORATION MONITORING REPORT (YEAR 6)

Harnett County, North Carolina

EEP Project No. 199

Status of Plan: FINAL
Submission Date: November 2012

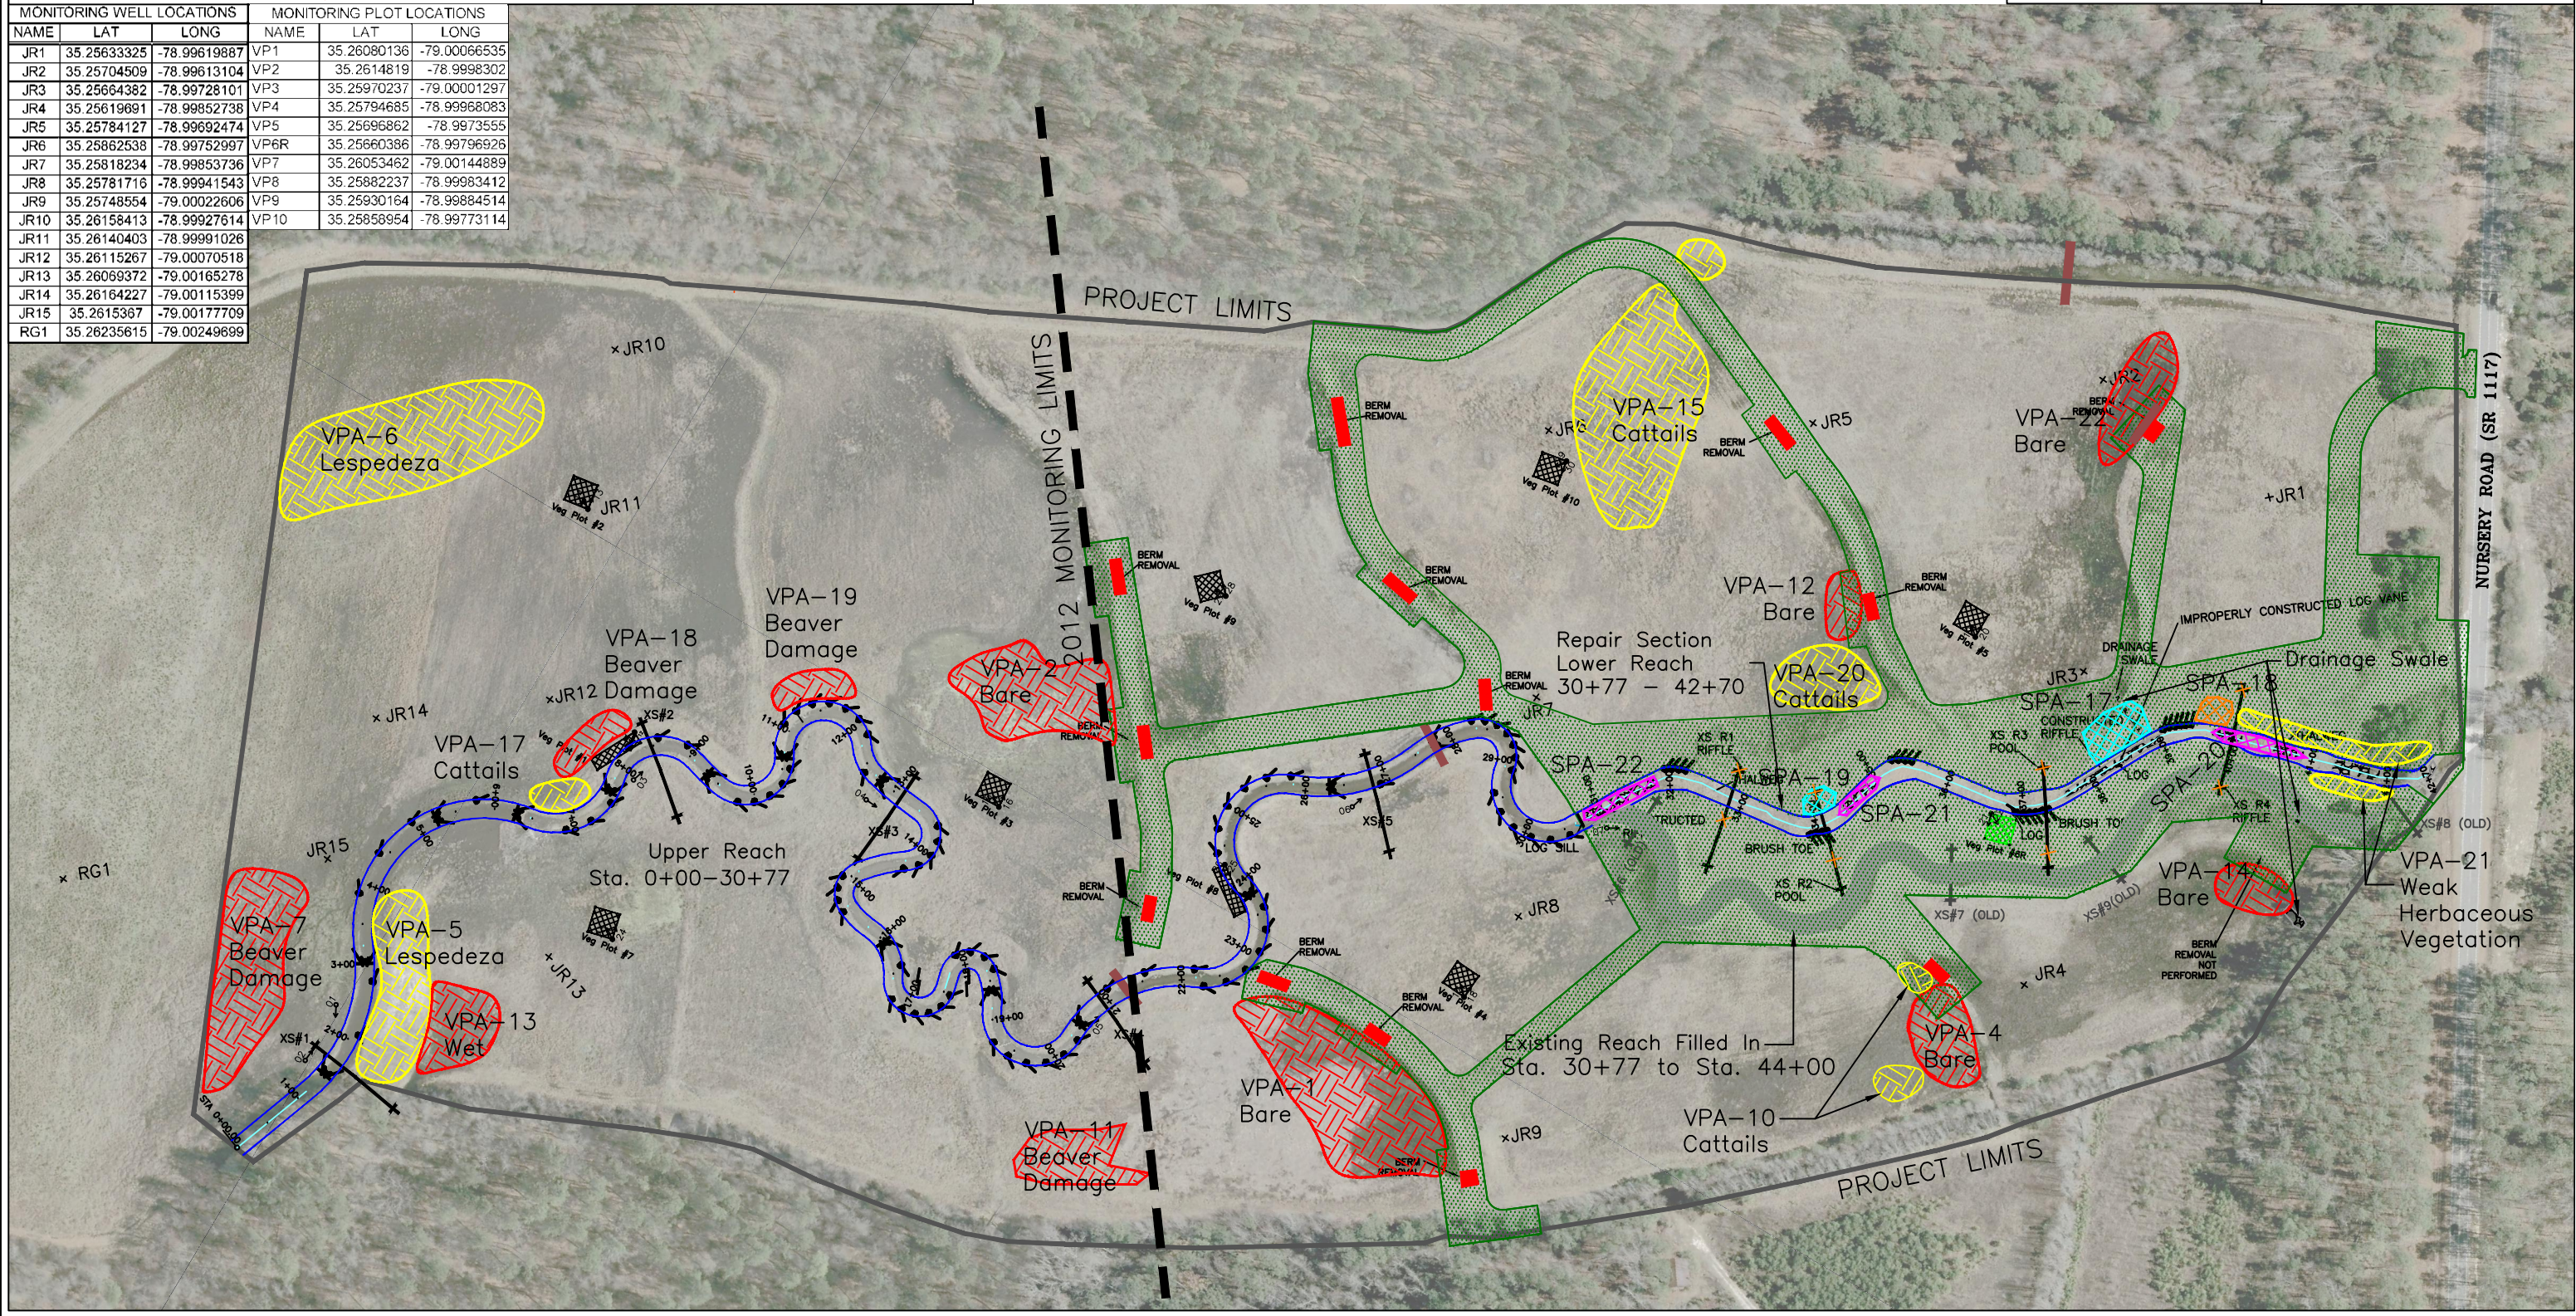
CURRENT STATUS PLAN VIEW

THIS MAP DEPICTS MY6 CONDITIONS AS OF 10/2012

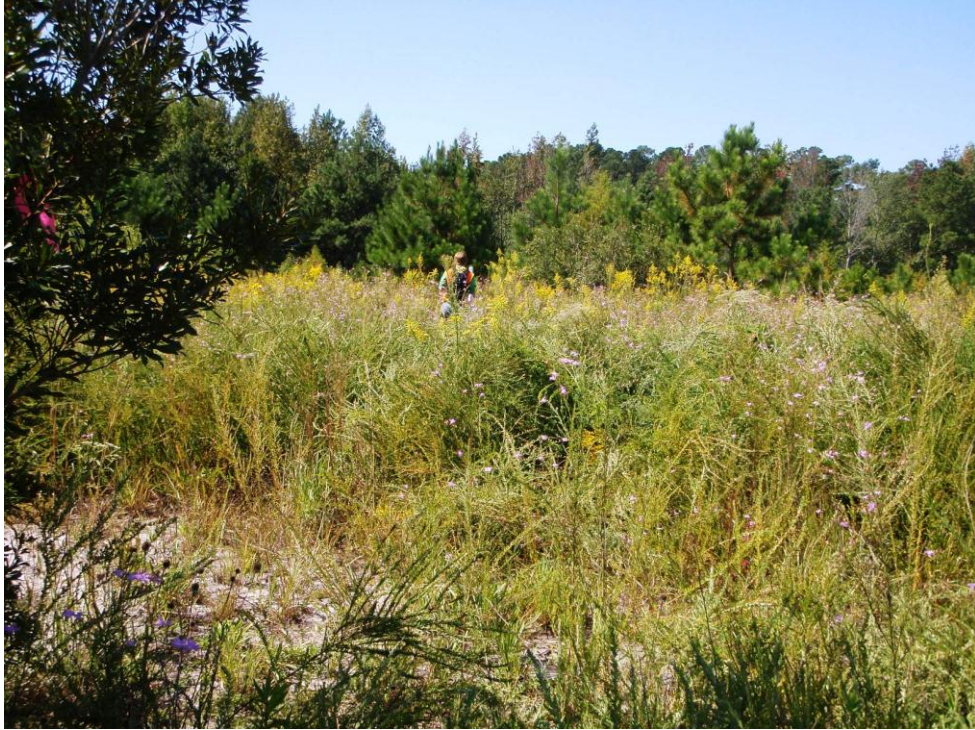
The Carolina Vegetation Survey (CVS) Level 2 methodology was utilized to sample vegetation in September 2012. One 100m² plot has been established along the right bank of the repair section of the Lower Reach. In the plot, two plot corners have been permanently located with conduit or rebar. Vegetation Plot 6 was moved in 2011 since it was a 5x20m streambank plot on the older failing section of stream. A new 10x10m plot, “6R”, was installed on the floodplain of the repaired reach. As per the mitigation plan, the vegetative success criteria are based on the US Army Corps of Engineers Stream Mitigation Guidelines (USACE, 2003). In the repair area, the vegetative success criteria will be the survival of 260 5-year old trees per acre for Monitoring Years 5 and 6, and the final Monitoring Year 7. Currently plot 6R is meeting success criteria with 445 stems per acre.

Photo Station 21 Vegetation Plot 6R looking northwest (9/25/12)

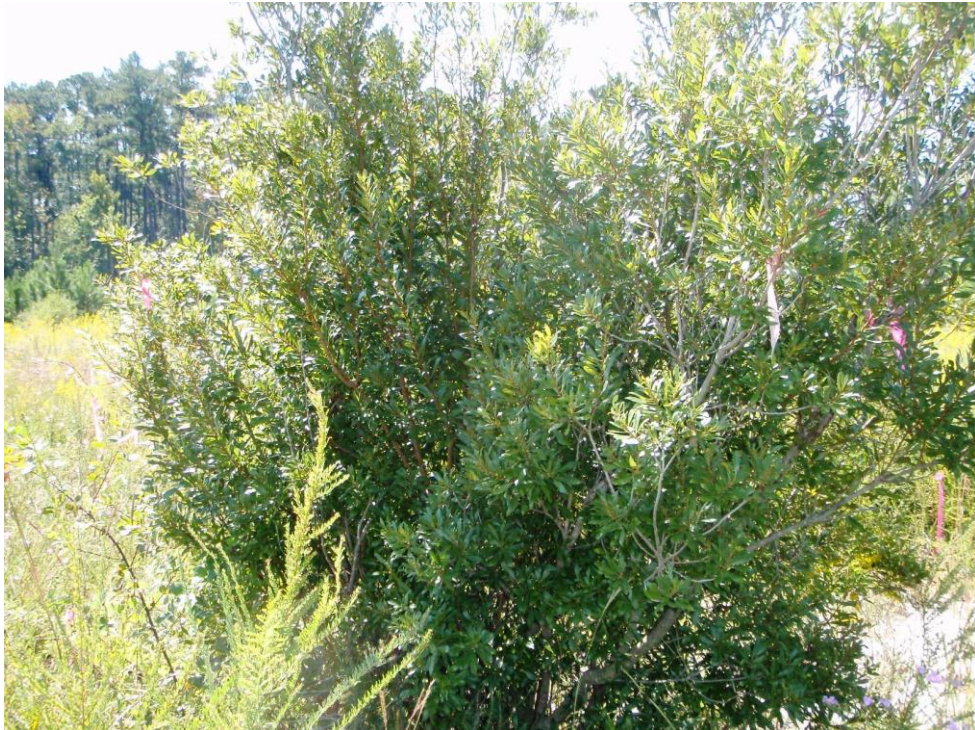
Photo Station 22 Vegetation Plot 6R looking north (9/25/12)

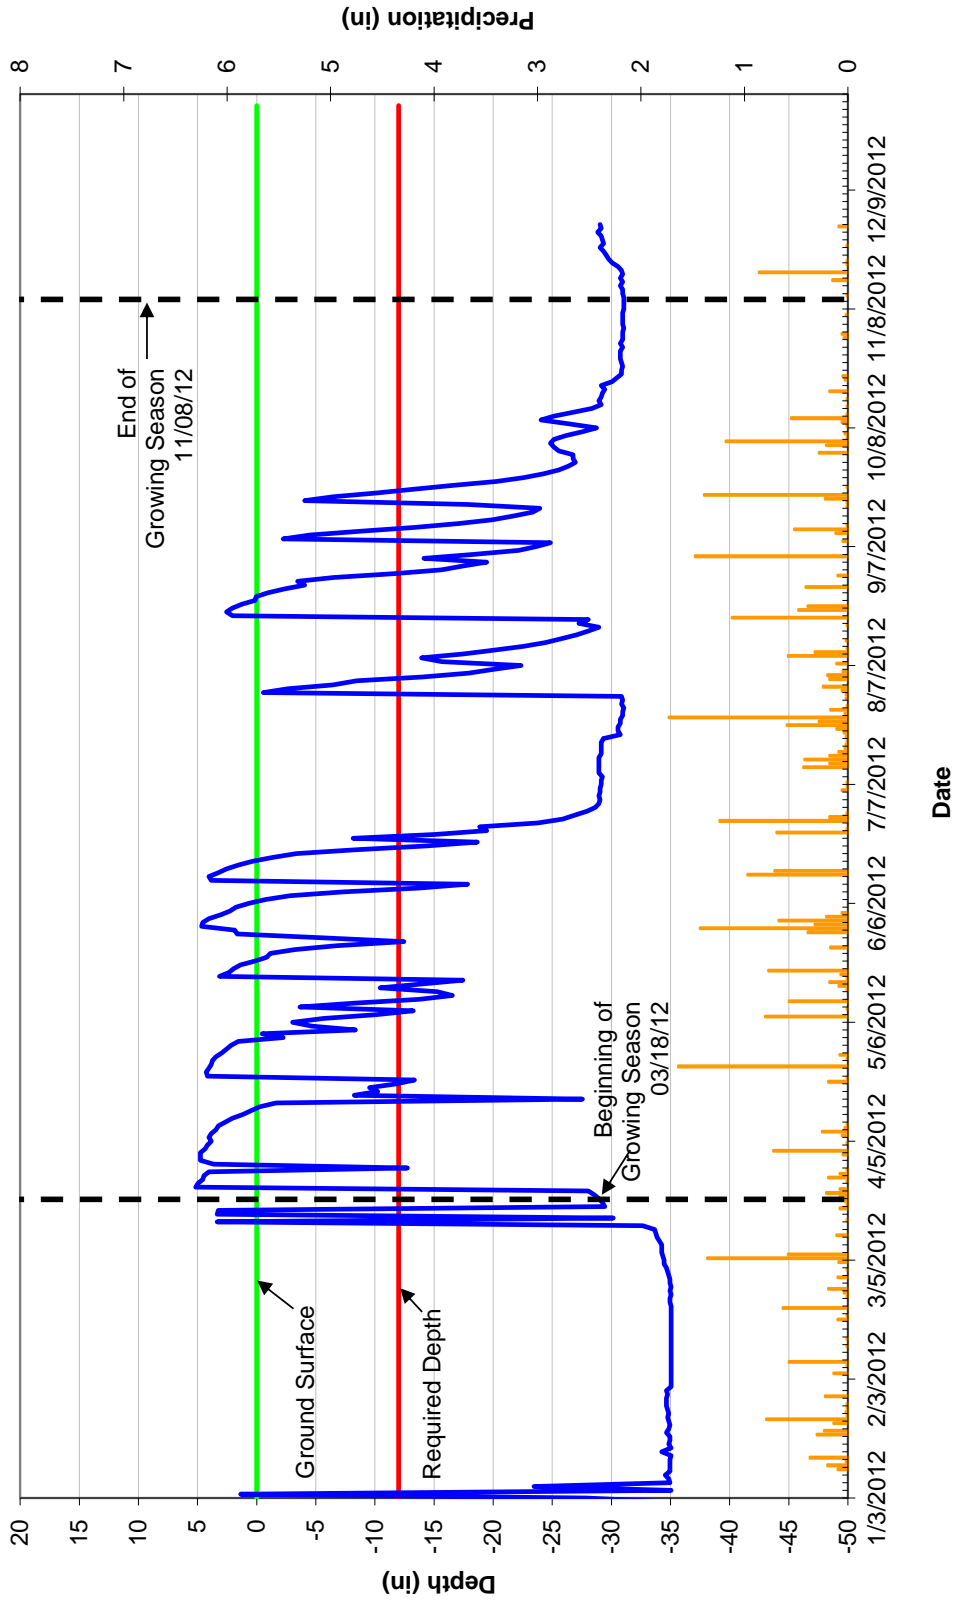
2012 Groundwater Data
Well JR-7 (SN: 000009BEBE36)

The floodplain immediately adjacent to the stream is drier than in past monitoring years, as shown in well JR-7 which did not meet the hydrology success criteria. However, areas of the floodplain further away from the channel continue to be inundated with water, especially between wells JR-2 and JR-3. The beavers have blocked the nearby breach in the berm (near well JR-2) and have reinforced the berm with sediment. The deepest water in this impounded area was over three feet deep. This beaver activity is directly corresponding to the excessive overland flow observed near STN 39+50, and overwhelming the constructed wetland outlet leading to bank erosion. Headcuts are occurring in areas where the inundated water reenters the stream channel from the side. These areas are located along the stream's left bank at Stations 34+00, 38+00 to 39+00, and 39+75. The CCPV shows beaver dam conditions as of 10/9/12. Continued beaver management will be beneficial to the stability of the site.

The reference well met the hydrology success criteria, with two periods of consecutive days of saturation within 12 inches of the ground surface during the growing season. The longest period, 92 days, comprises approximately 39% of the growing season. Additionally, eight of the nine groundwater monitoring wells currently monitored met the hydrology success criteria, with 6 of the wells being within 12 inches of the ground surface for more than 80% of the growing season. The remaining two wells met the success criteria for more than 45% of the growing season, further indication of the inundation present throughout the floodplain. The only well (JR-7) that did not meet the hydrology success criteria, experienced several

periods of saturation within 12 inches of the ground surface with the longest being 17 consecutive days. This well is the closest well to the stream channel and its hydroperiod may relate to the natural hydrological drainage associated with the stream. Monthly precipitation averages for 2012 fell between the 30th and 70th percentiles during the entire growing season.
