OVERHILLS STREAM AND WETLAND RESTORATION MONITORING REPORT (YEAR 7)

Harnett County, North Carolina

EEP Project No. 199

Monitoring Year 7
November 2013

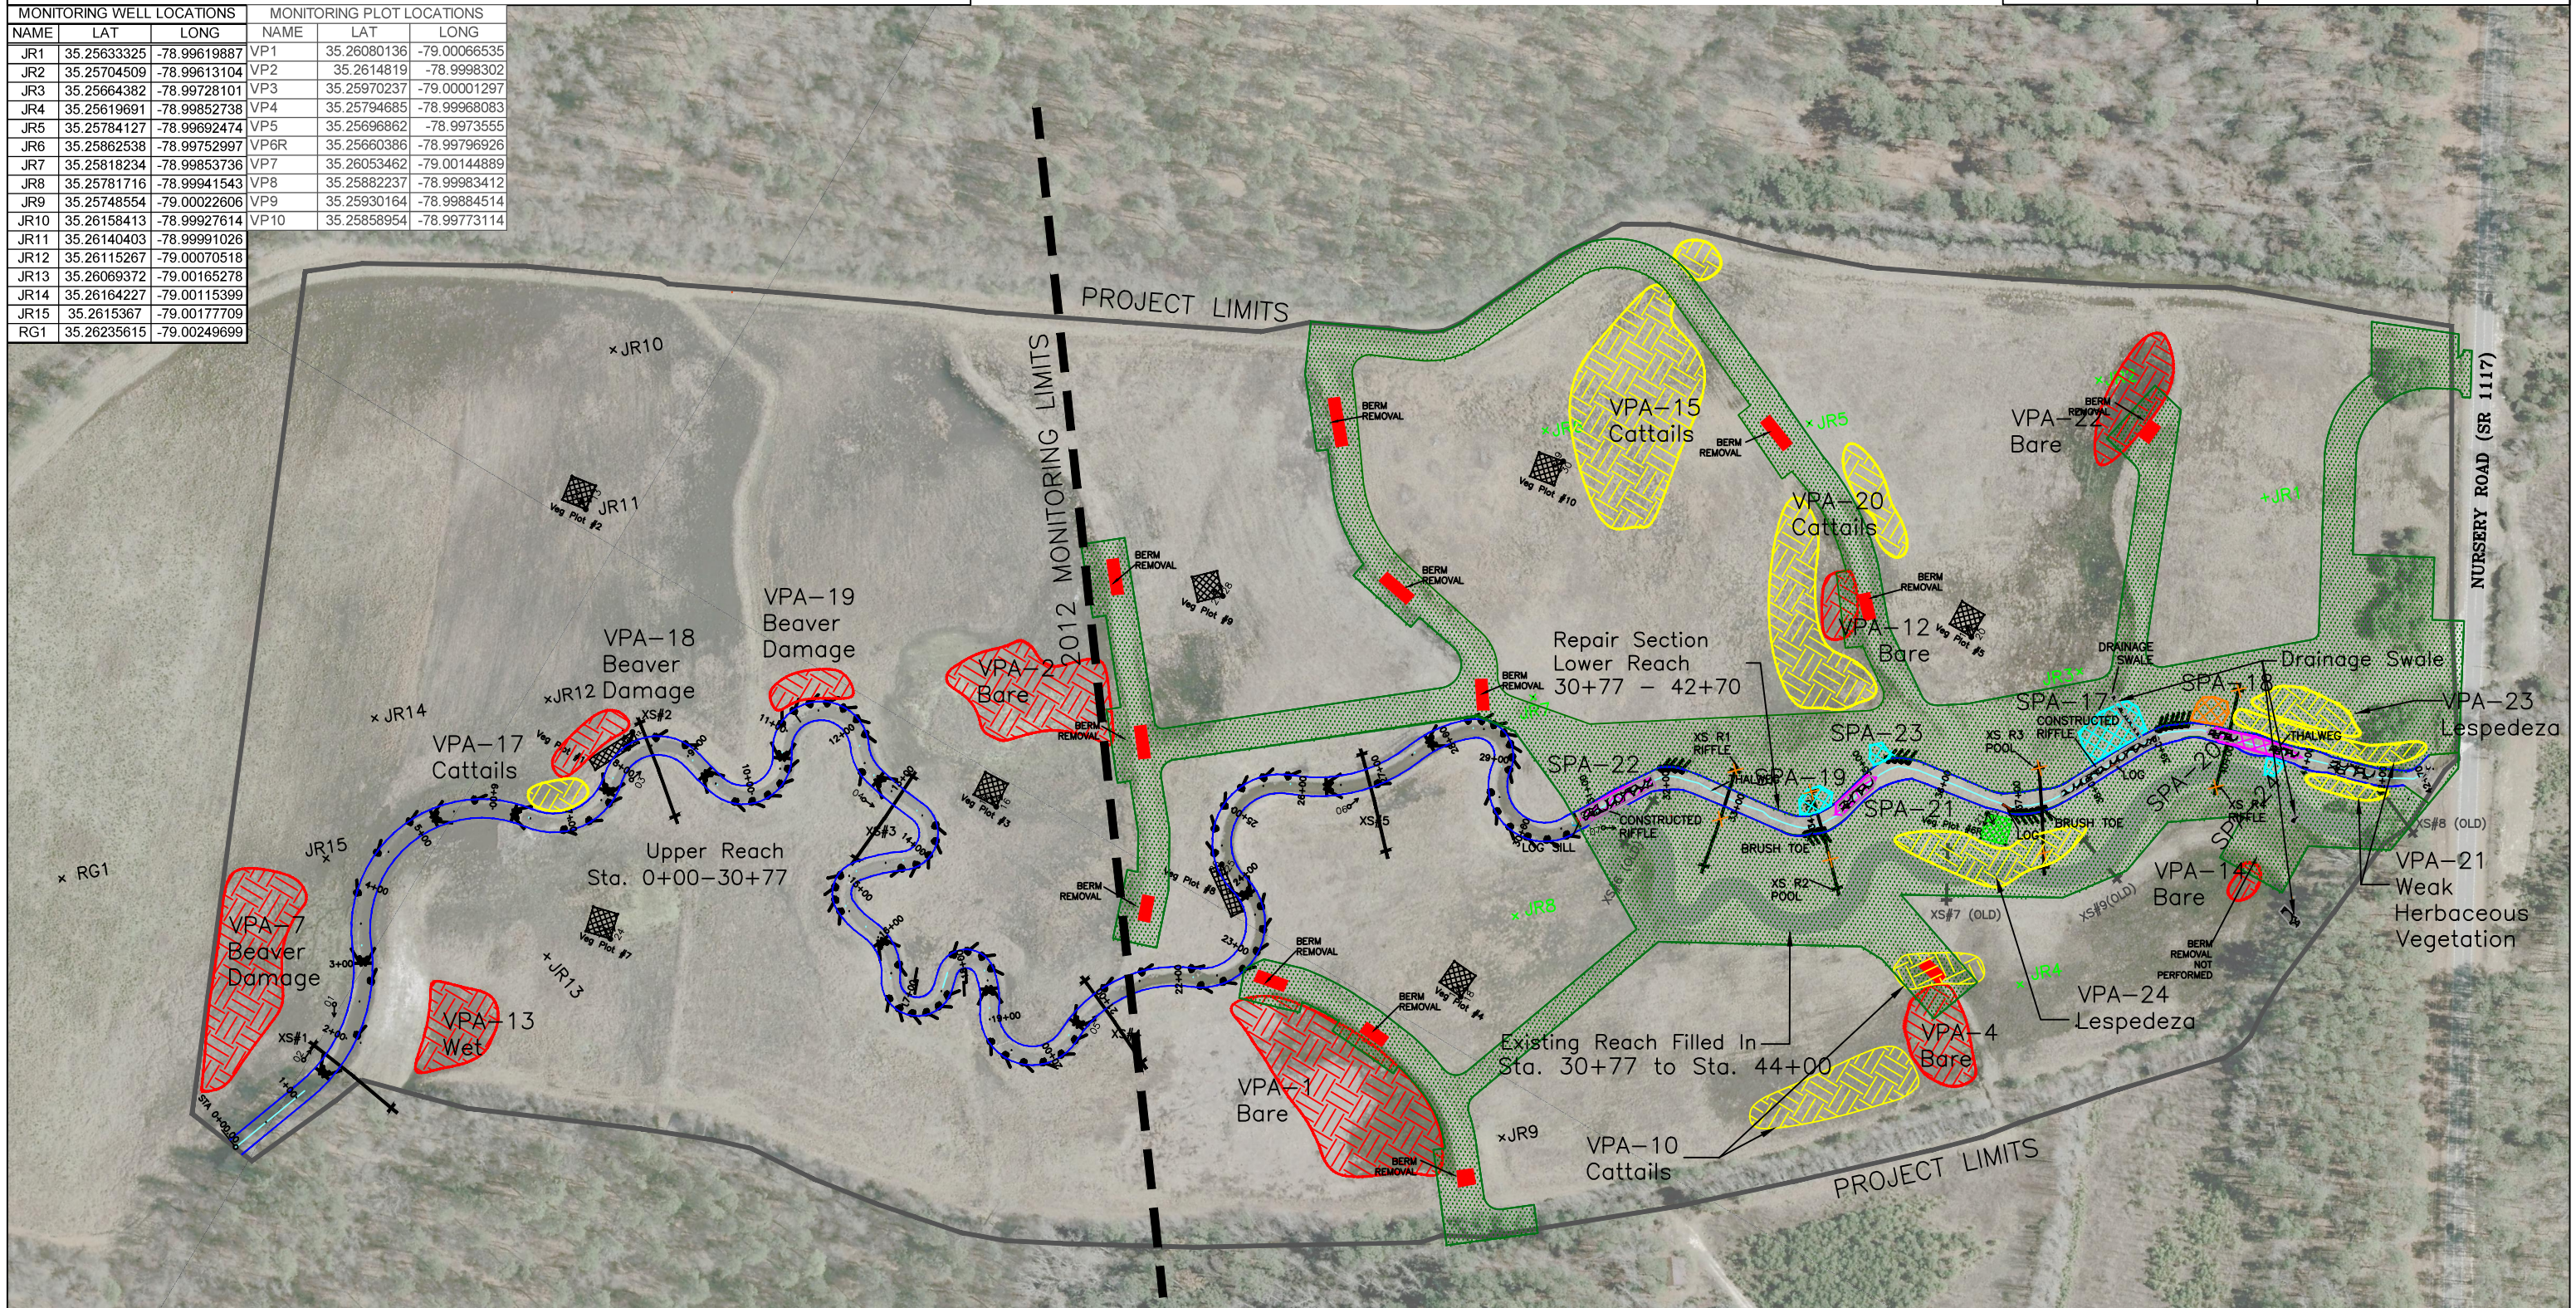
CURRENT CONDITION PLAN VIEW

Lespedeza is still present in some drier areas onsite, and has reestablished along the right bank and lower left bank in the newly repaired floodplain and has grown in area enough to be added to the CCPV as VPA 23 and 24. A few areas of *Typha* have also been observed onsite and are growing in size from previous assessments. Areas of *Typha* were observed near the wetter areas and are shown on the map as VPA 10, 15 and 20. VPA-10 and VPA-20 (*Typha*) have expanded. As previously noted, the remainder of the wetland is exhibiting excellent vegetation growth, particularly in the cypress trees.

The lower end of the repair reach continues to exhibit weak herbaceous vegetation growth on both the banks and lower floodplain (VPA-21). However, numerous viable bare root trees were found on the floodplain. Possible causes for the stunted herbaceous growth may include topsoil replacement or compaction during construction. This may be assisting in maintaining populations of *Lespedeza* in this area.

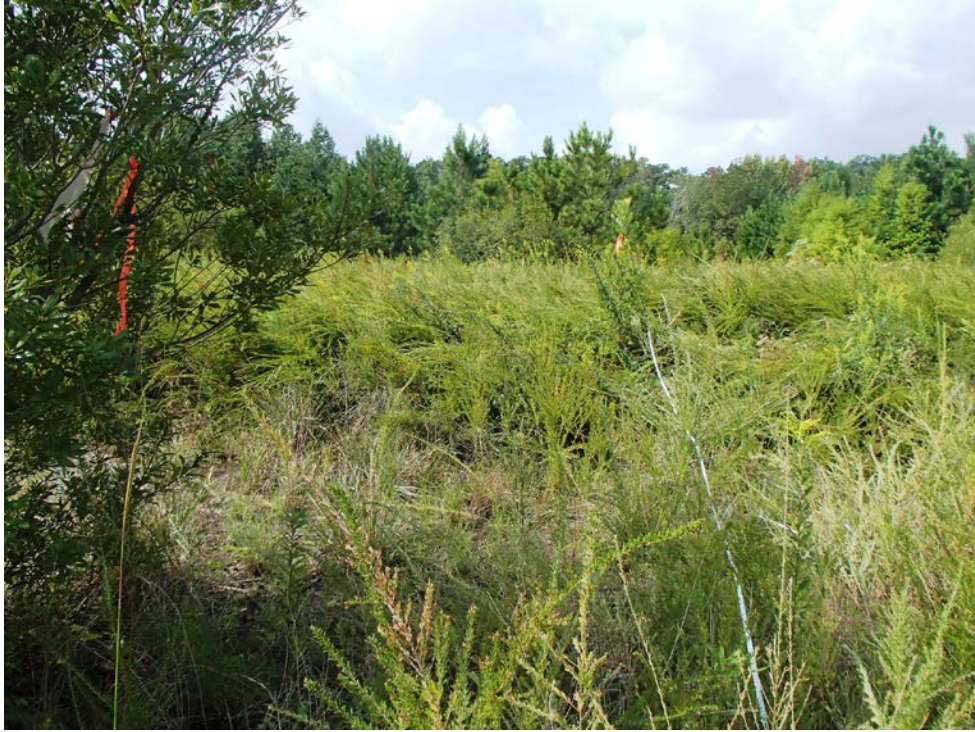
Photo Station 21 Vegetation Plot 6R looking northwest (9/16/13)

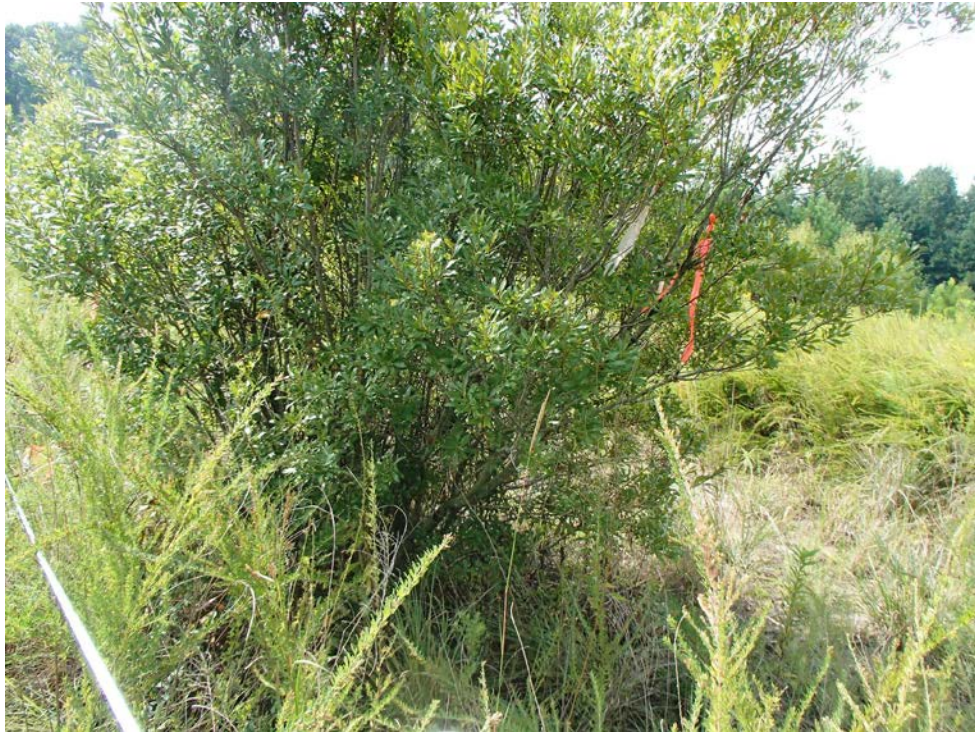
Photo Station 22 Vegetation Plot 6R looking north (9/16/13)

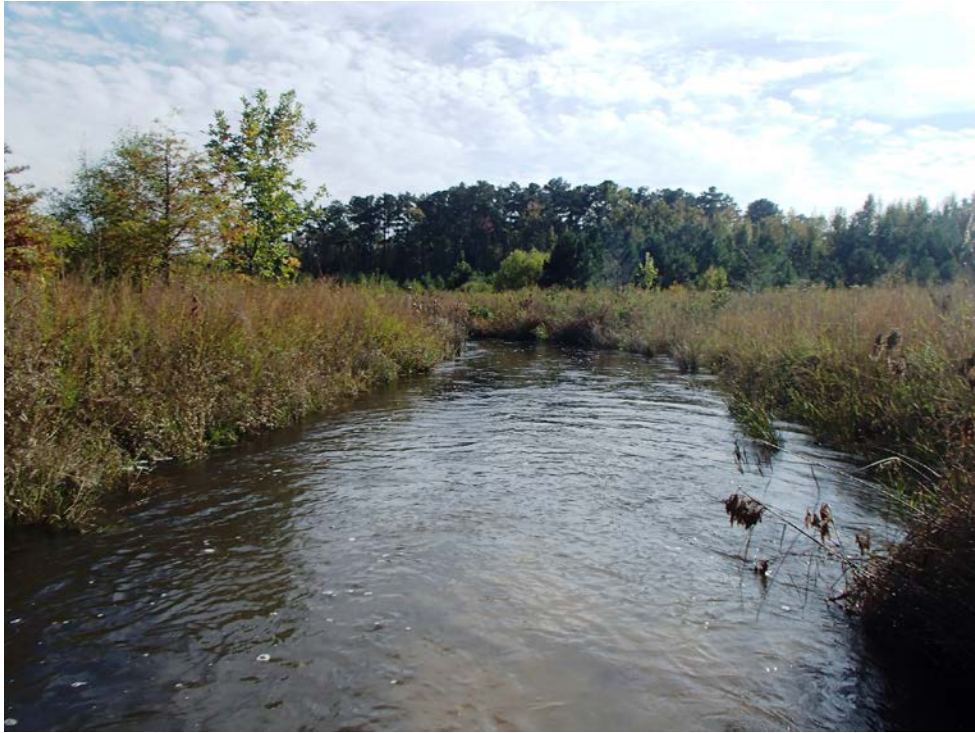
Photo Station 7 – Cross Section R1 – looking downstream (10/21/2013)

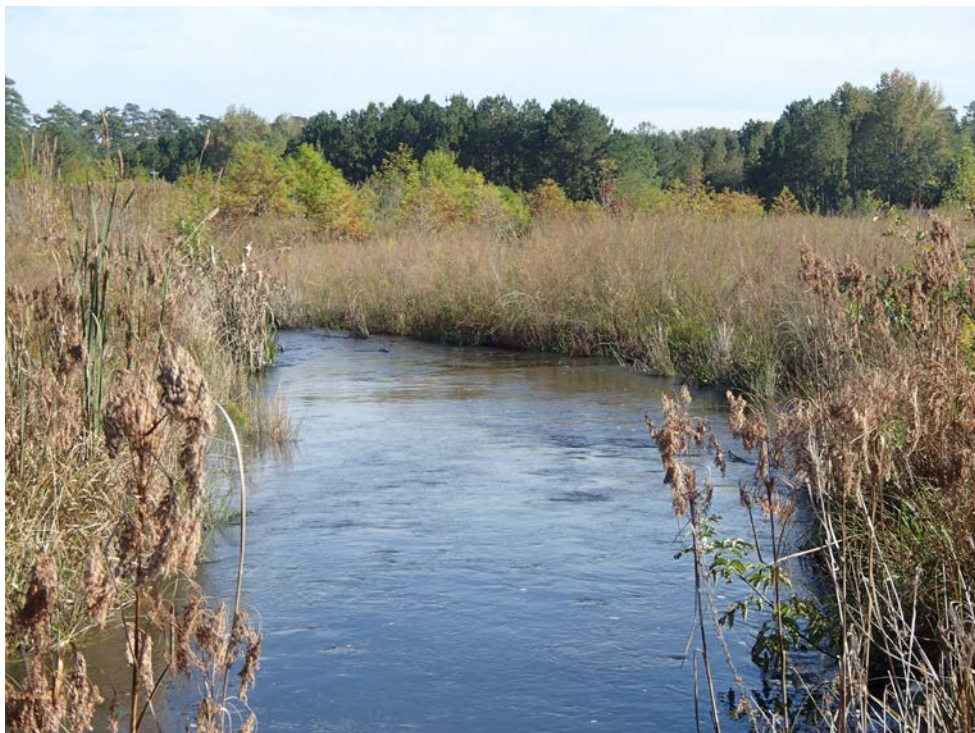
Photo Station 8 – Cross Section R2 – looking downstream (10/21/2013)

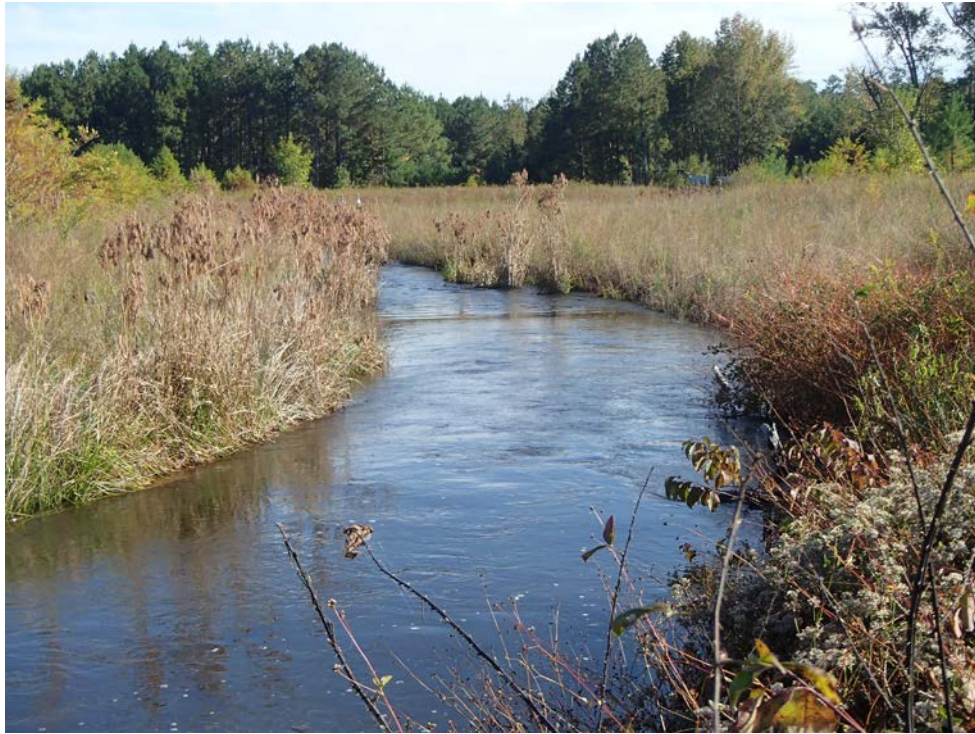
Photo Station 9 – Cross Section R3 – looking downstream (10/21/2013)

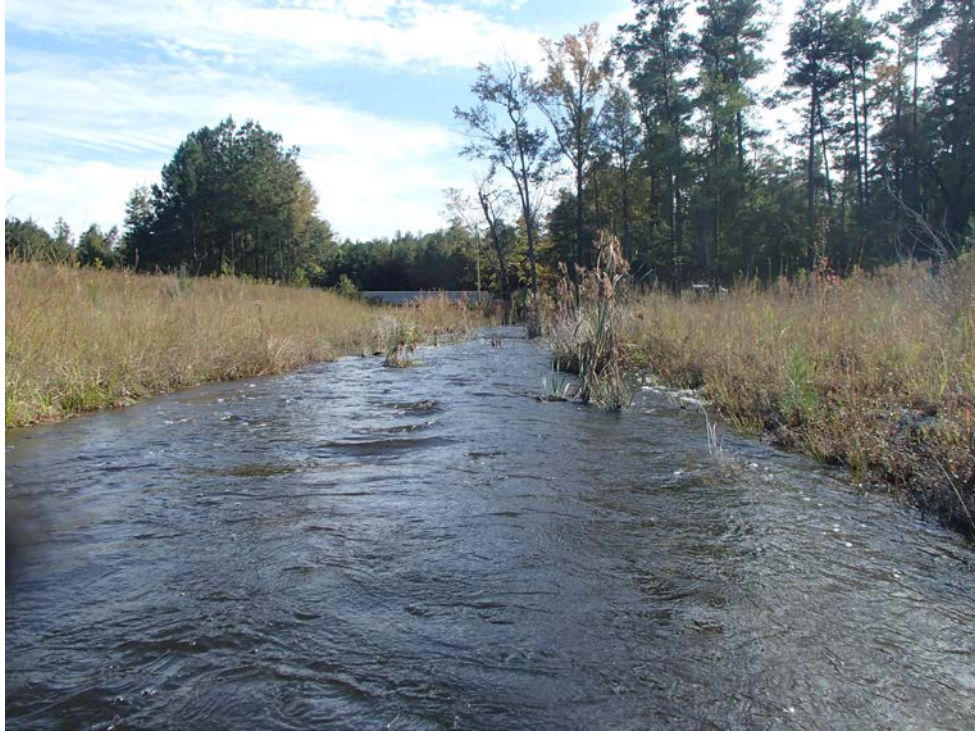
Photo Station 10 – Cross Section R4 – looking downstream (10/21/2013)

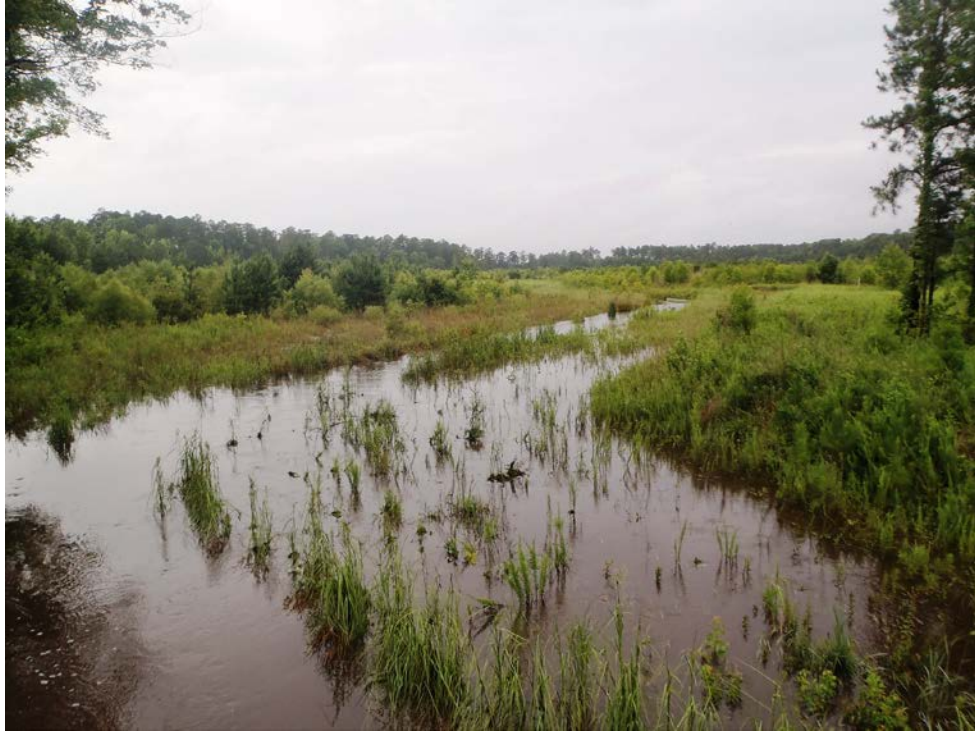
Photo S1 – Bankfull event looking upstream from the bridge on Nursery Road (7/2/2013)

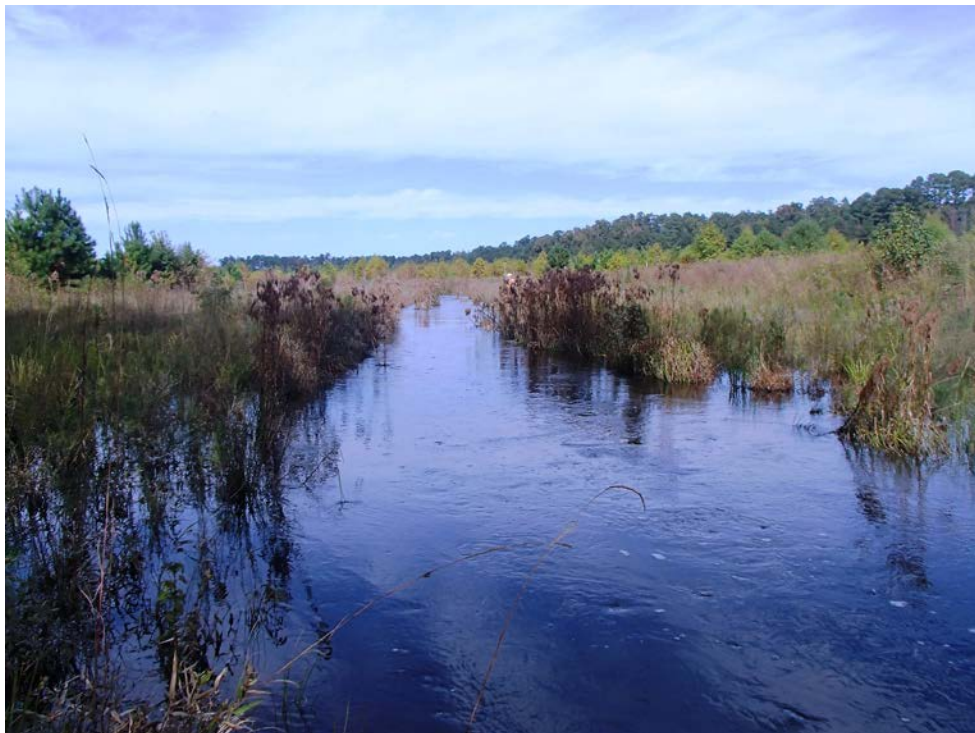
Photo S2 – Bankfull event looking upstream from the bridge on Nursery Road (10/21/2013)
