Annual Monitoring Report

Monitoring Year 3 of 5

Project Name: Junes Branch Stream Restoration

NCDMS Project No.: 95027

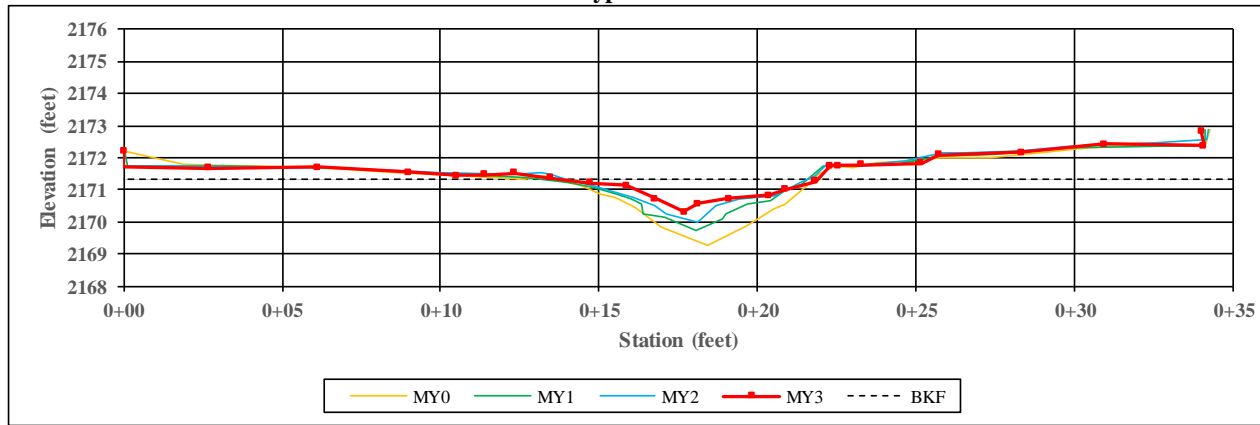
XS Number: 7
XS Type: Pool

Geomorphic data for MY3 was collected from August through December 2016. Summary tables, cross-section plots, and longitudinal profiles related to stream morphology are located in Appendix D. Significant changes in the cross-section data between MY2 and MY3 were limited to cross-sections 3, 6, 7, and 13 (Appendix B, Table 11a). Riffle cross-section 3, where downcutting of the channel was evident in MY1 has begun to stabilize, however the maximum water depth still increased by 0.2 feet from MY2 to MY3. Deposits of fine material and increased vegetation caused the formation of an inner berm on the left descending bank of cross-section 6, decreasing bankfull width, maximum depth and cross-sectional area by 1.7 feet, 0.2 foot, and 1.3 feet, respectively. Deposits of finer material in pools led to a significant decrease in maximum pool depth at cross-sections 7 and 13 over the last two monitoring years.

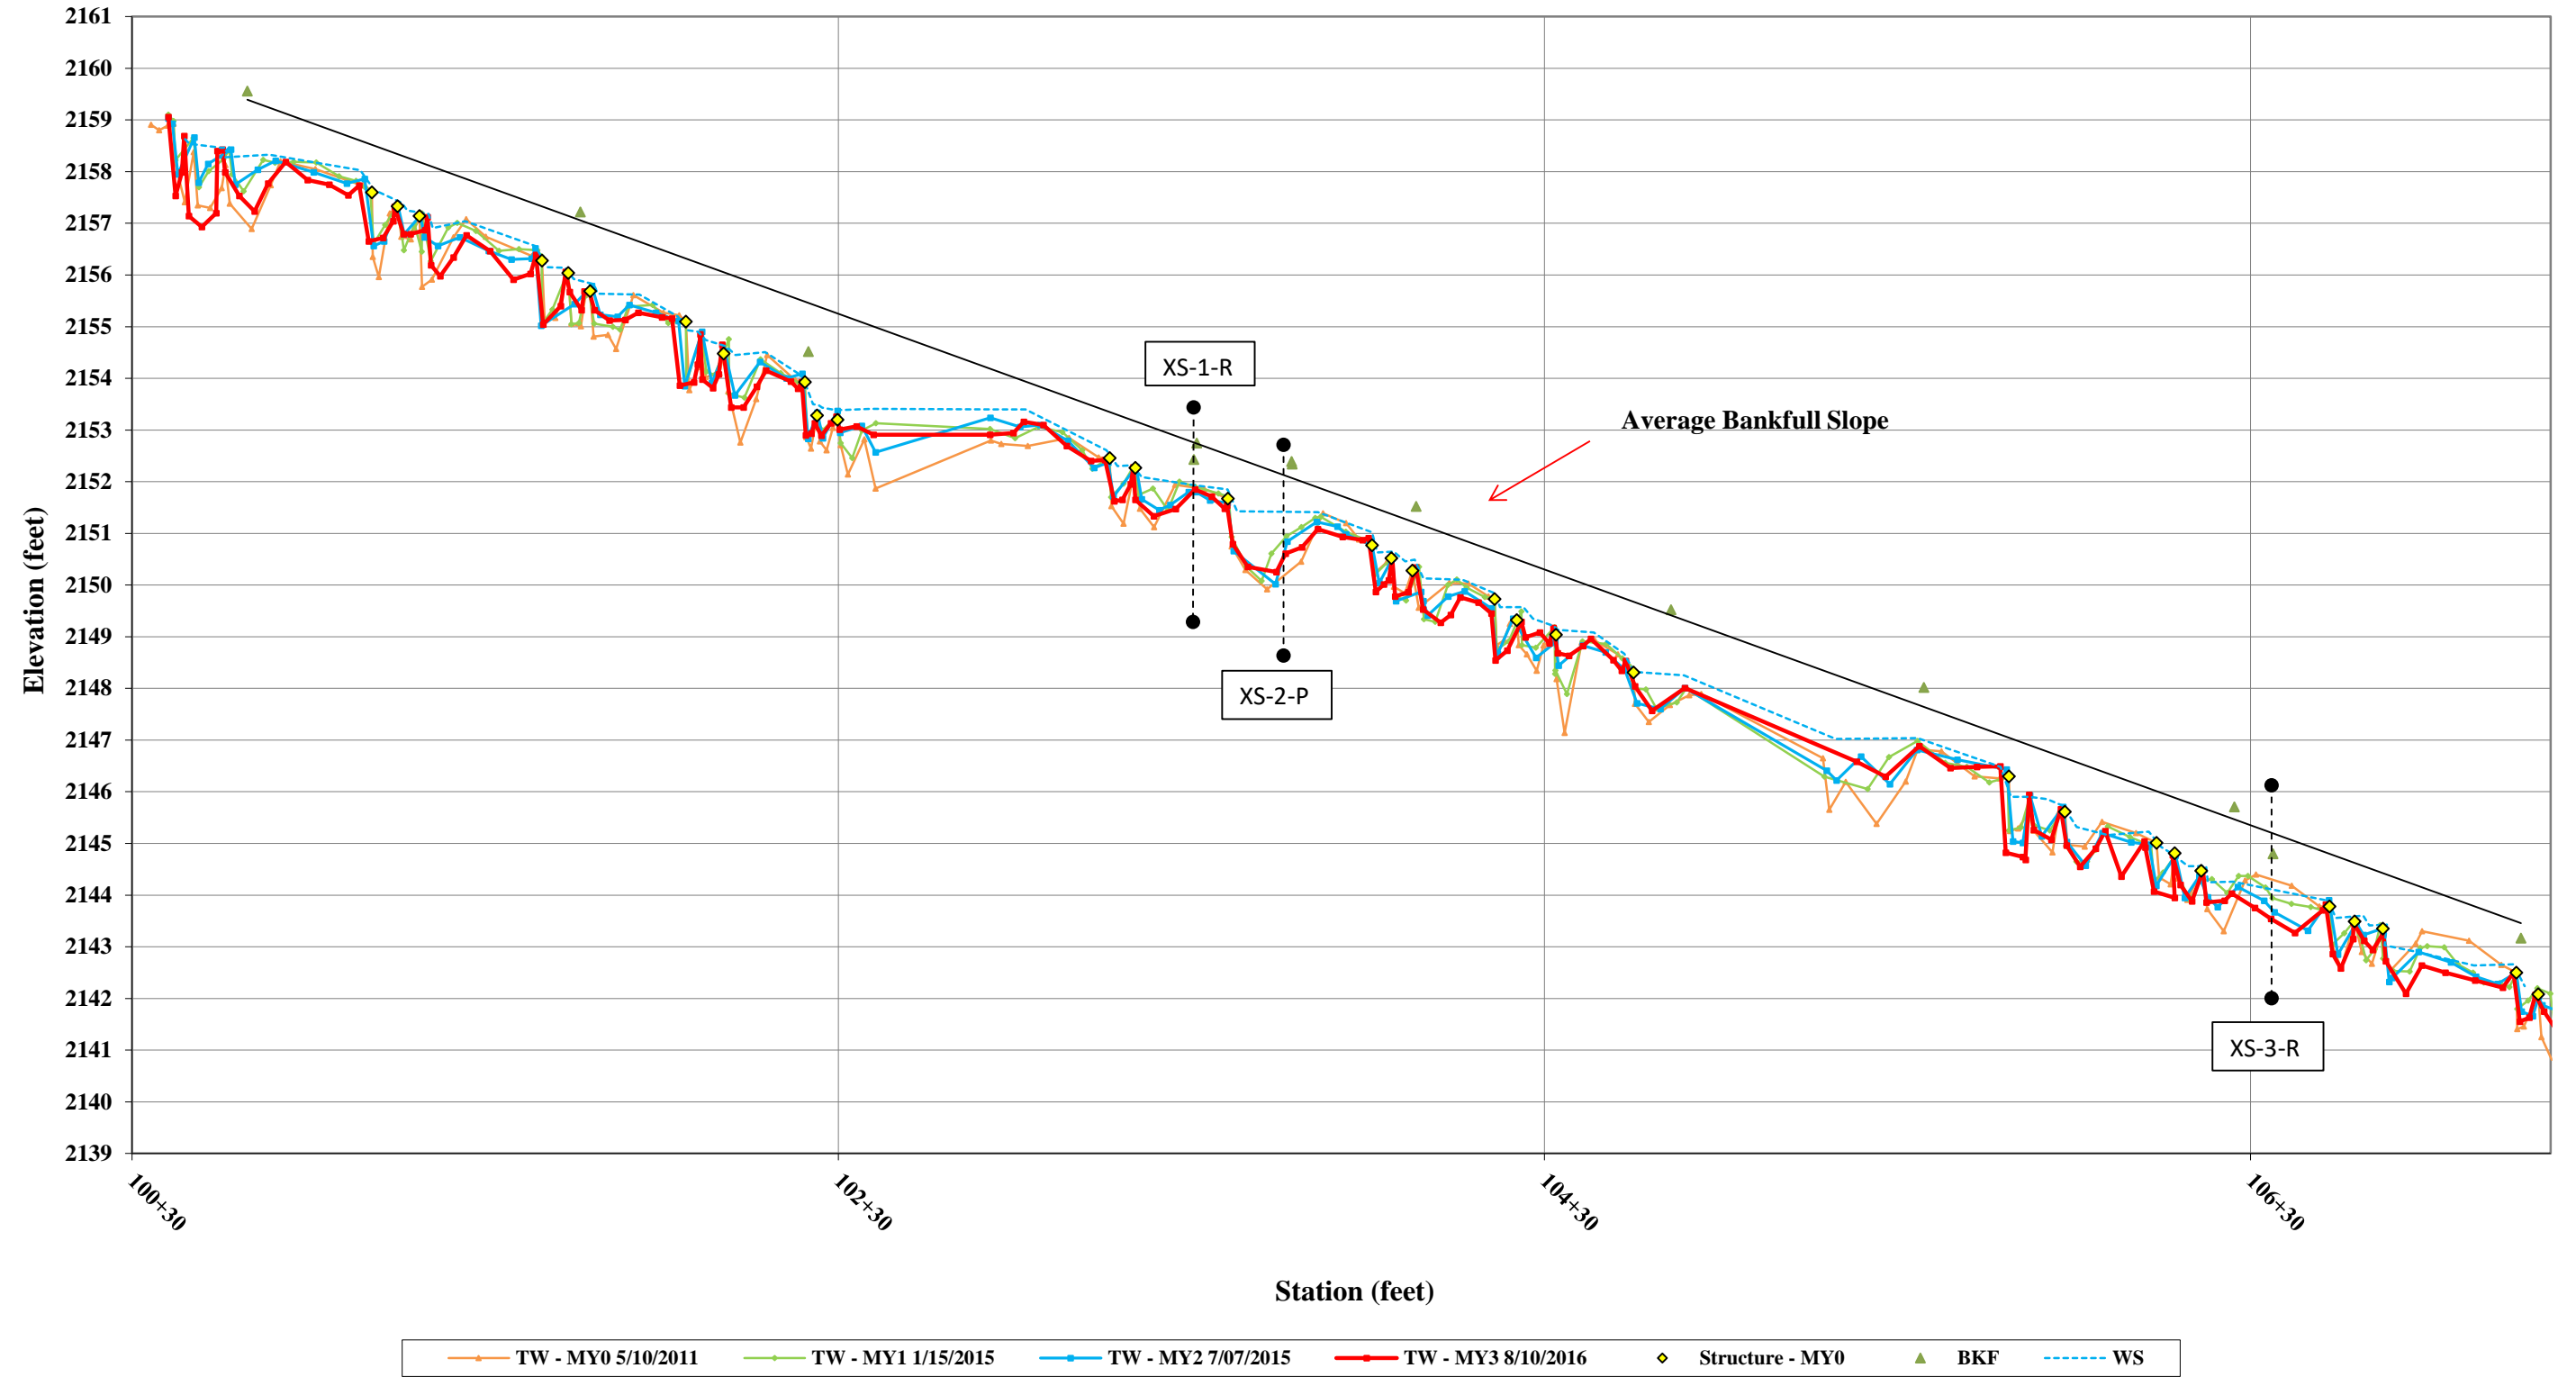
**Bumgarner Branch I
Longitudinal Profile
Staioning 100+37 to 107+27**

Generally, longitudinal profile data (Appendix B, Table 11b) indicated relatively little change in riffle and pool dimensions between MY2 and MY3. Bumgarner Branch I showed a decrease in riffle length of 2.0 feet, from 17.5 feet to 15.5 feet, and a decrease in pool maximum depth of 0.4 foot to 1.9 feet. An increase in sediment deposition has caused a slight flattening of the riffle slope from 0.028 (ft/ft) to 0.022 (ft/ft). Bumgarner Branch II dimensions remained relatively similar to the MY2 dimensions; however, pool maximum depths have decreased by 0.3 foot to 2.2 feet. The upper end of Junes Branch saw an influx of fine sediment flattening the riffle profiles and filling in some of the pools. No other major

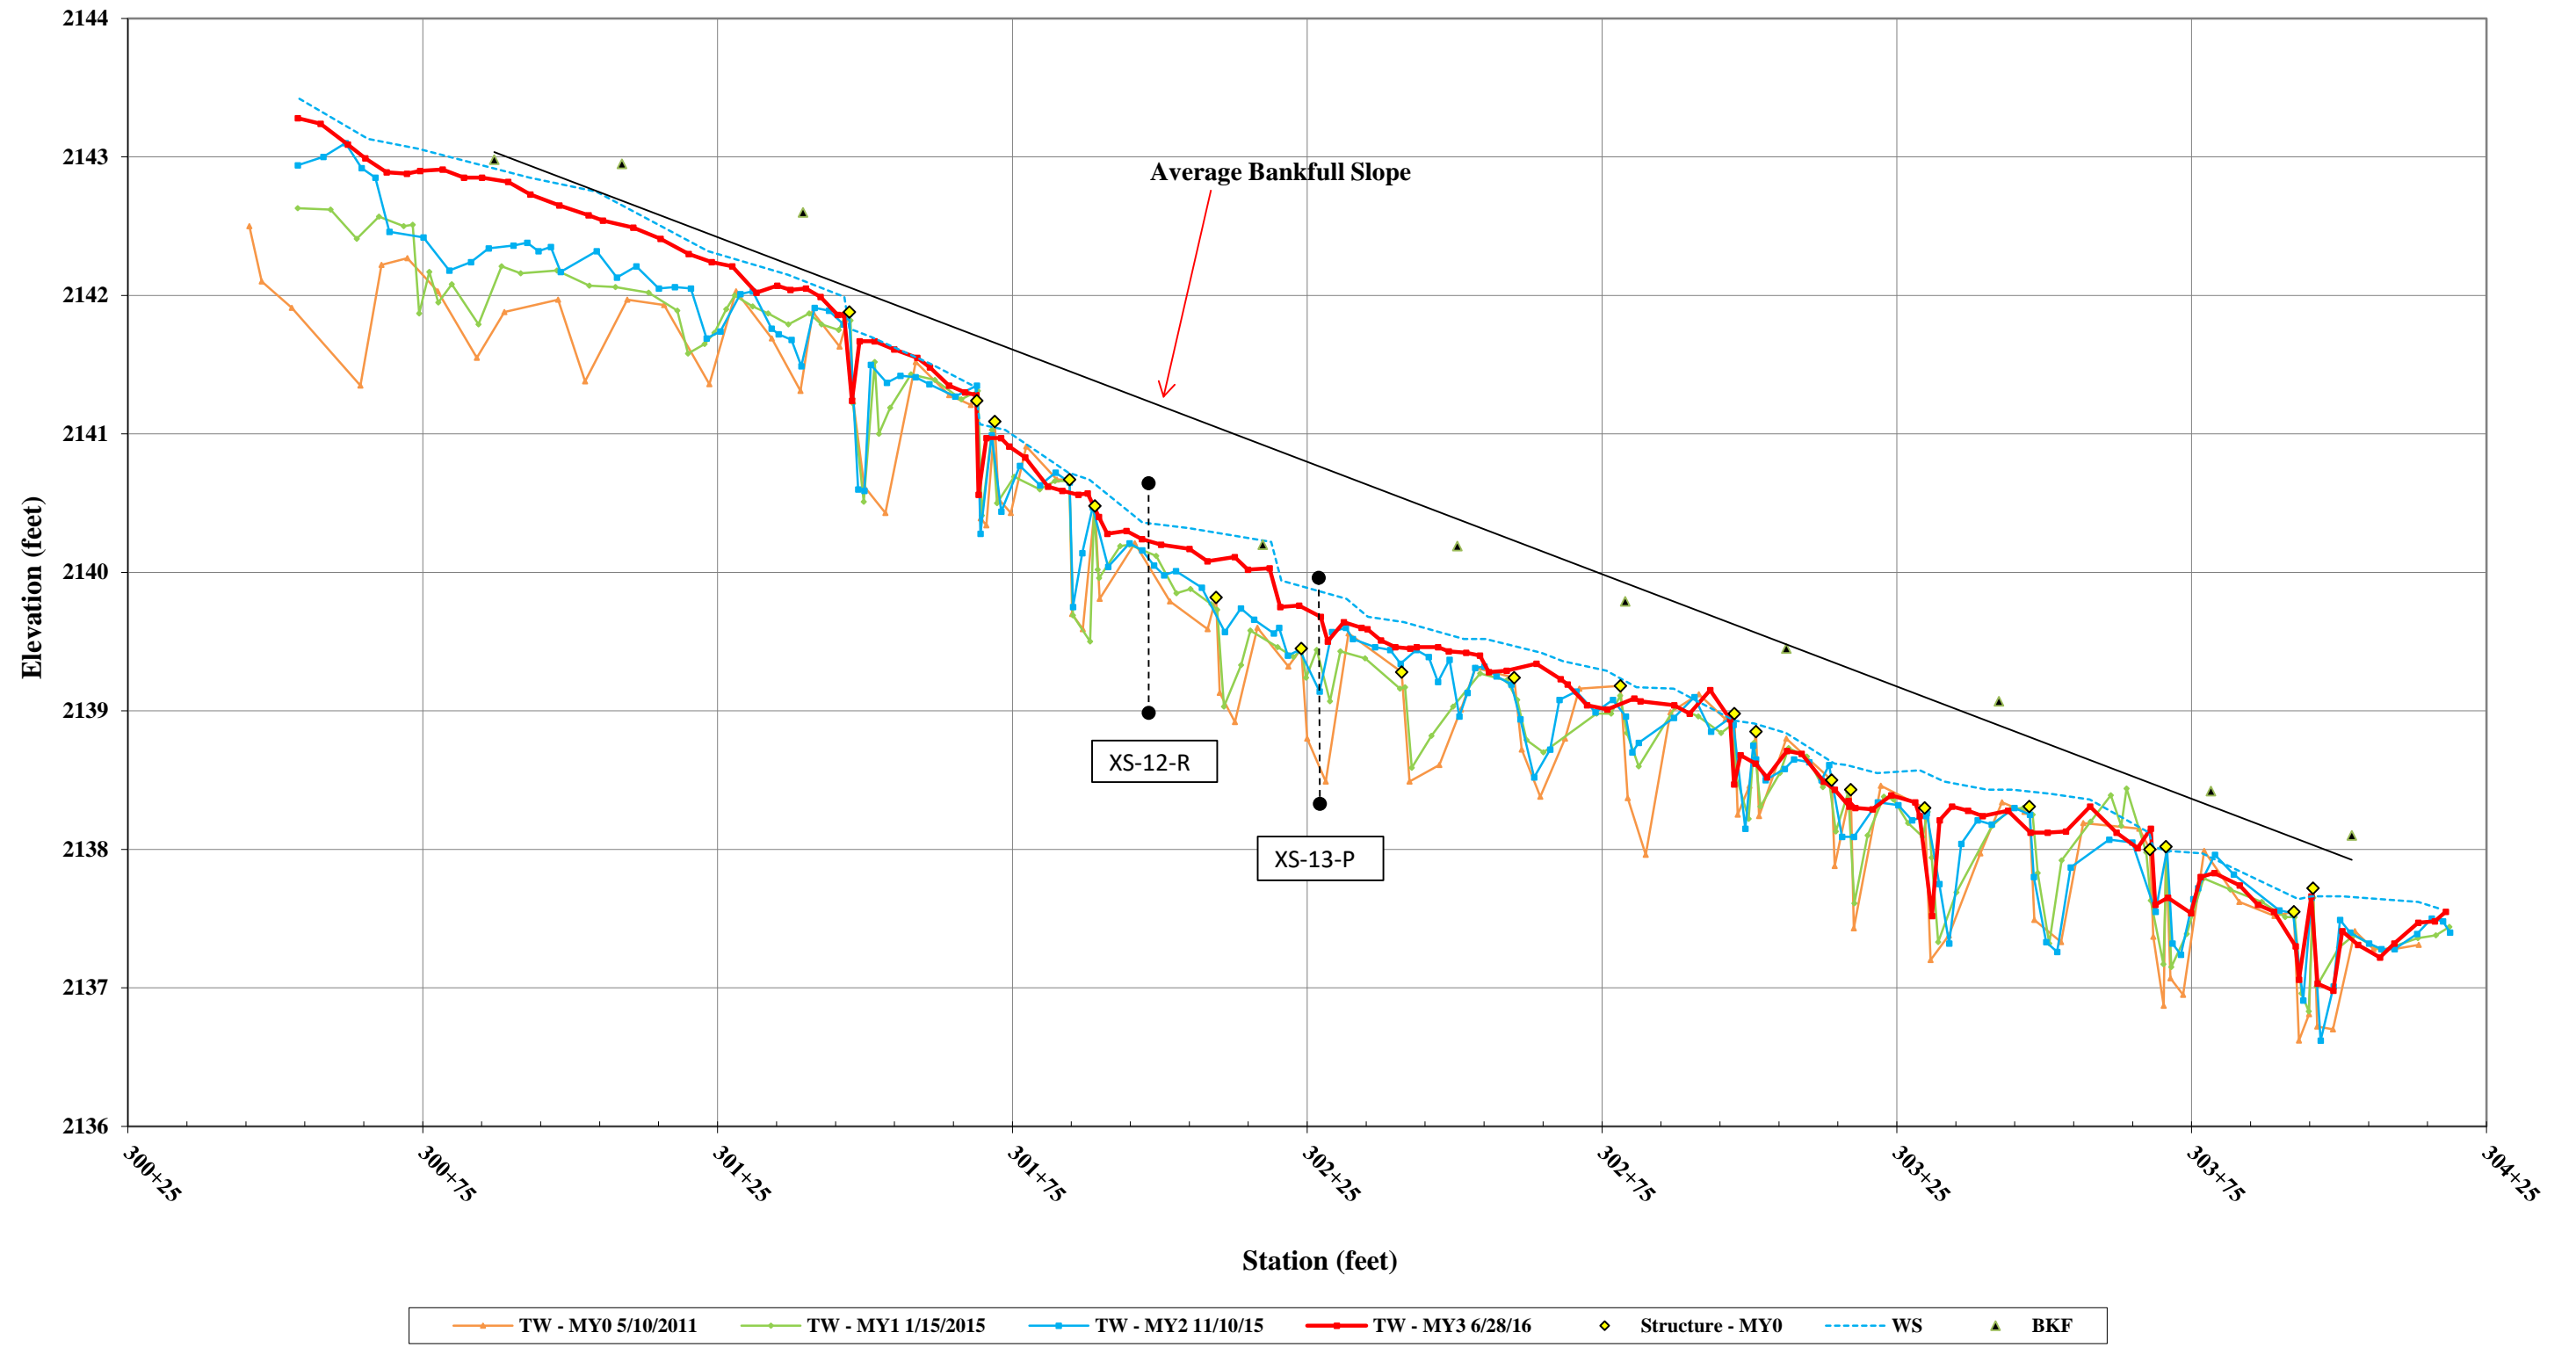
**Hidgon Branch
Longitudinal Profile
Staioning 300+46 to 304+22**

changes were noted in the Junes Branch profile. Increased vegetation and drought conditions at the Site has led to deposition of fine sediment within Higdon Branch. Pool maximum depths have decreased from 1.4 feet to 1.0 foot between MY2 and MY3. This influx of sediment also caused a flattening of the water surface slope from 0.0184 (ft/ft) to 0.0162 (ft/ft). Aggradation within the upper portion of Higdon Branch has transitioned approximately the first 100 feet of stream to a linear wetland. This area still maintains hydrologic function, but riffle/ pool features have become difficult to decipher. Considering the drought conditions this year, RES will monitor this area during MY4 site visits to determine if any remedial work is warranted. Doris Branch also displayed a decrease in pool maximum depth from 1.2 feet to 0.9 foot between MY2 and MY3. As with Higdon Branch, aggradation can be seen throughout the Doris Branch reach, especially in pools. RES will also monitor this area during MY4 to determine if any remedial work is warranted. Assessment of recent aerial imagery within the watershed does not identify any off-site sediment sources affecting Junes Branch, Higdon Branch, or Doris Branch. However, it is expected that the unstable streams located upstream of the Site are contributing a considerable amount of sediment to the project. Considering the easements' close proximity to the road, runoff from the Fairview Road is another expected cause of sedimentation within the reaches. Especially the upper portions of Junes Branch and Higdon Branch.
