Annual Monitoring Report

Monitoring Year 4 of 5

Project Name: Junes Branch Stream Restoration

NCDMS Project No.: 95027

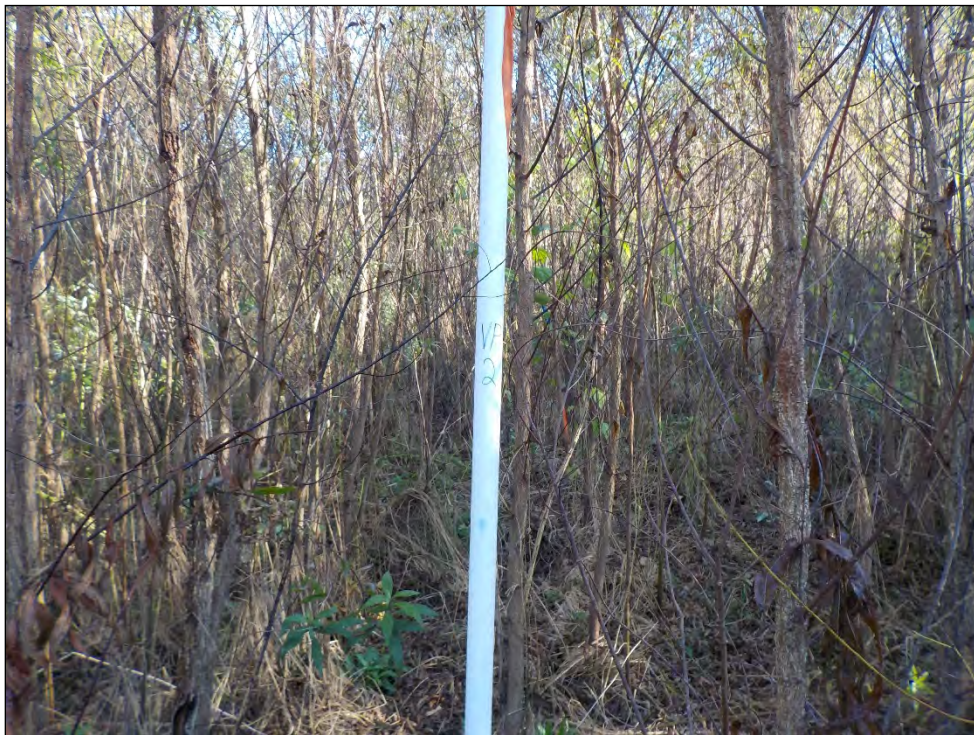
Junes Branch - Vegetation Monitoring Plot 2
October 5, 2017

Monitoring of eight permanent vegetation plots was completed during October 2017. Summary tables and photographs associated with MY4 monitoring can be found in **Appendix C**. With the exception of Plot 2, MY4 monitoring data indicates that all vegetation monitoring plots met the MY4 interim success criteria of 260 planted stems per acre. Low planted stem densities at Plot 2 can be attributed to thick herbaceous vegetation and a large density of recruited black willows (*Salix nigra*) outcompeting the planted stems. While vegetation Plot 2 is not meeting success criteria for planted stems, with recruits, the stem density 8,498 stems/ acre, far exceeding the MY4 interim success criteria of 260 stems per acre. Eleven species were documented in the plots as volunteers: red maple (*Acer rubrum*), hazel alder (*Alnus serrulata*), river birch (*Betula nigra*), shagbark hickory (*Carya ovata*), silky dogwood (*Cornus amomum*), flowering dogwood (*Cornus florida*), green ash (*Fraxinus pennsylvanica*), tulip poplar (*Liriodendron tulipifera*), sycamore *Platanus occidentalis*), black cherry (*Prunus serotina*), and black willow (*Salix nigra*). Planted stem densities among the plots ranged from 162 to 1,012 planted stems per acre with a mean of 622 stems per acre across all plots. When volunteer stems are included, densities ranged between 688 and 8,498 total stems per acre with a mean of 2,327 stems per acre across all plots. The estimated average plot tree height was 223 cm (7.3 ft). No invasive species were observed in the easement in MY4. RES will continue to monitor for invasive species and will treat them as needed in the upcoming monitoring year.

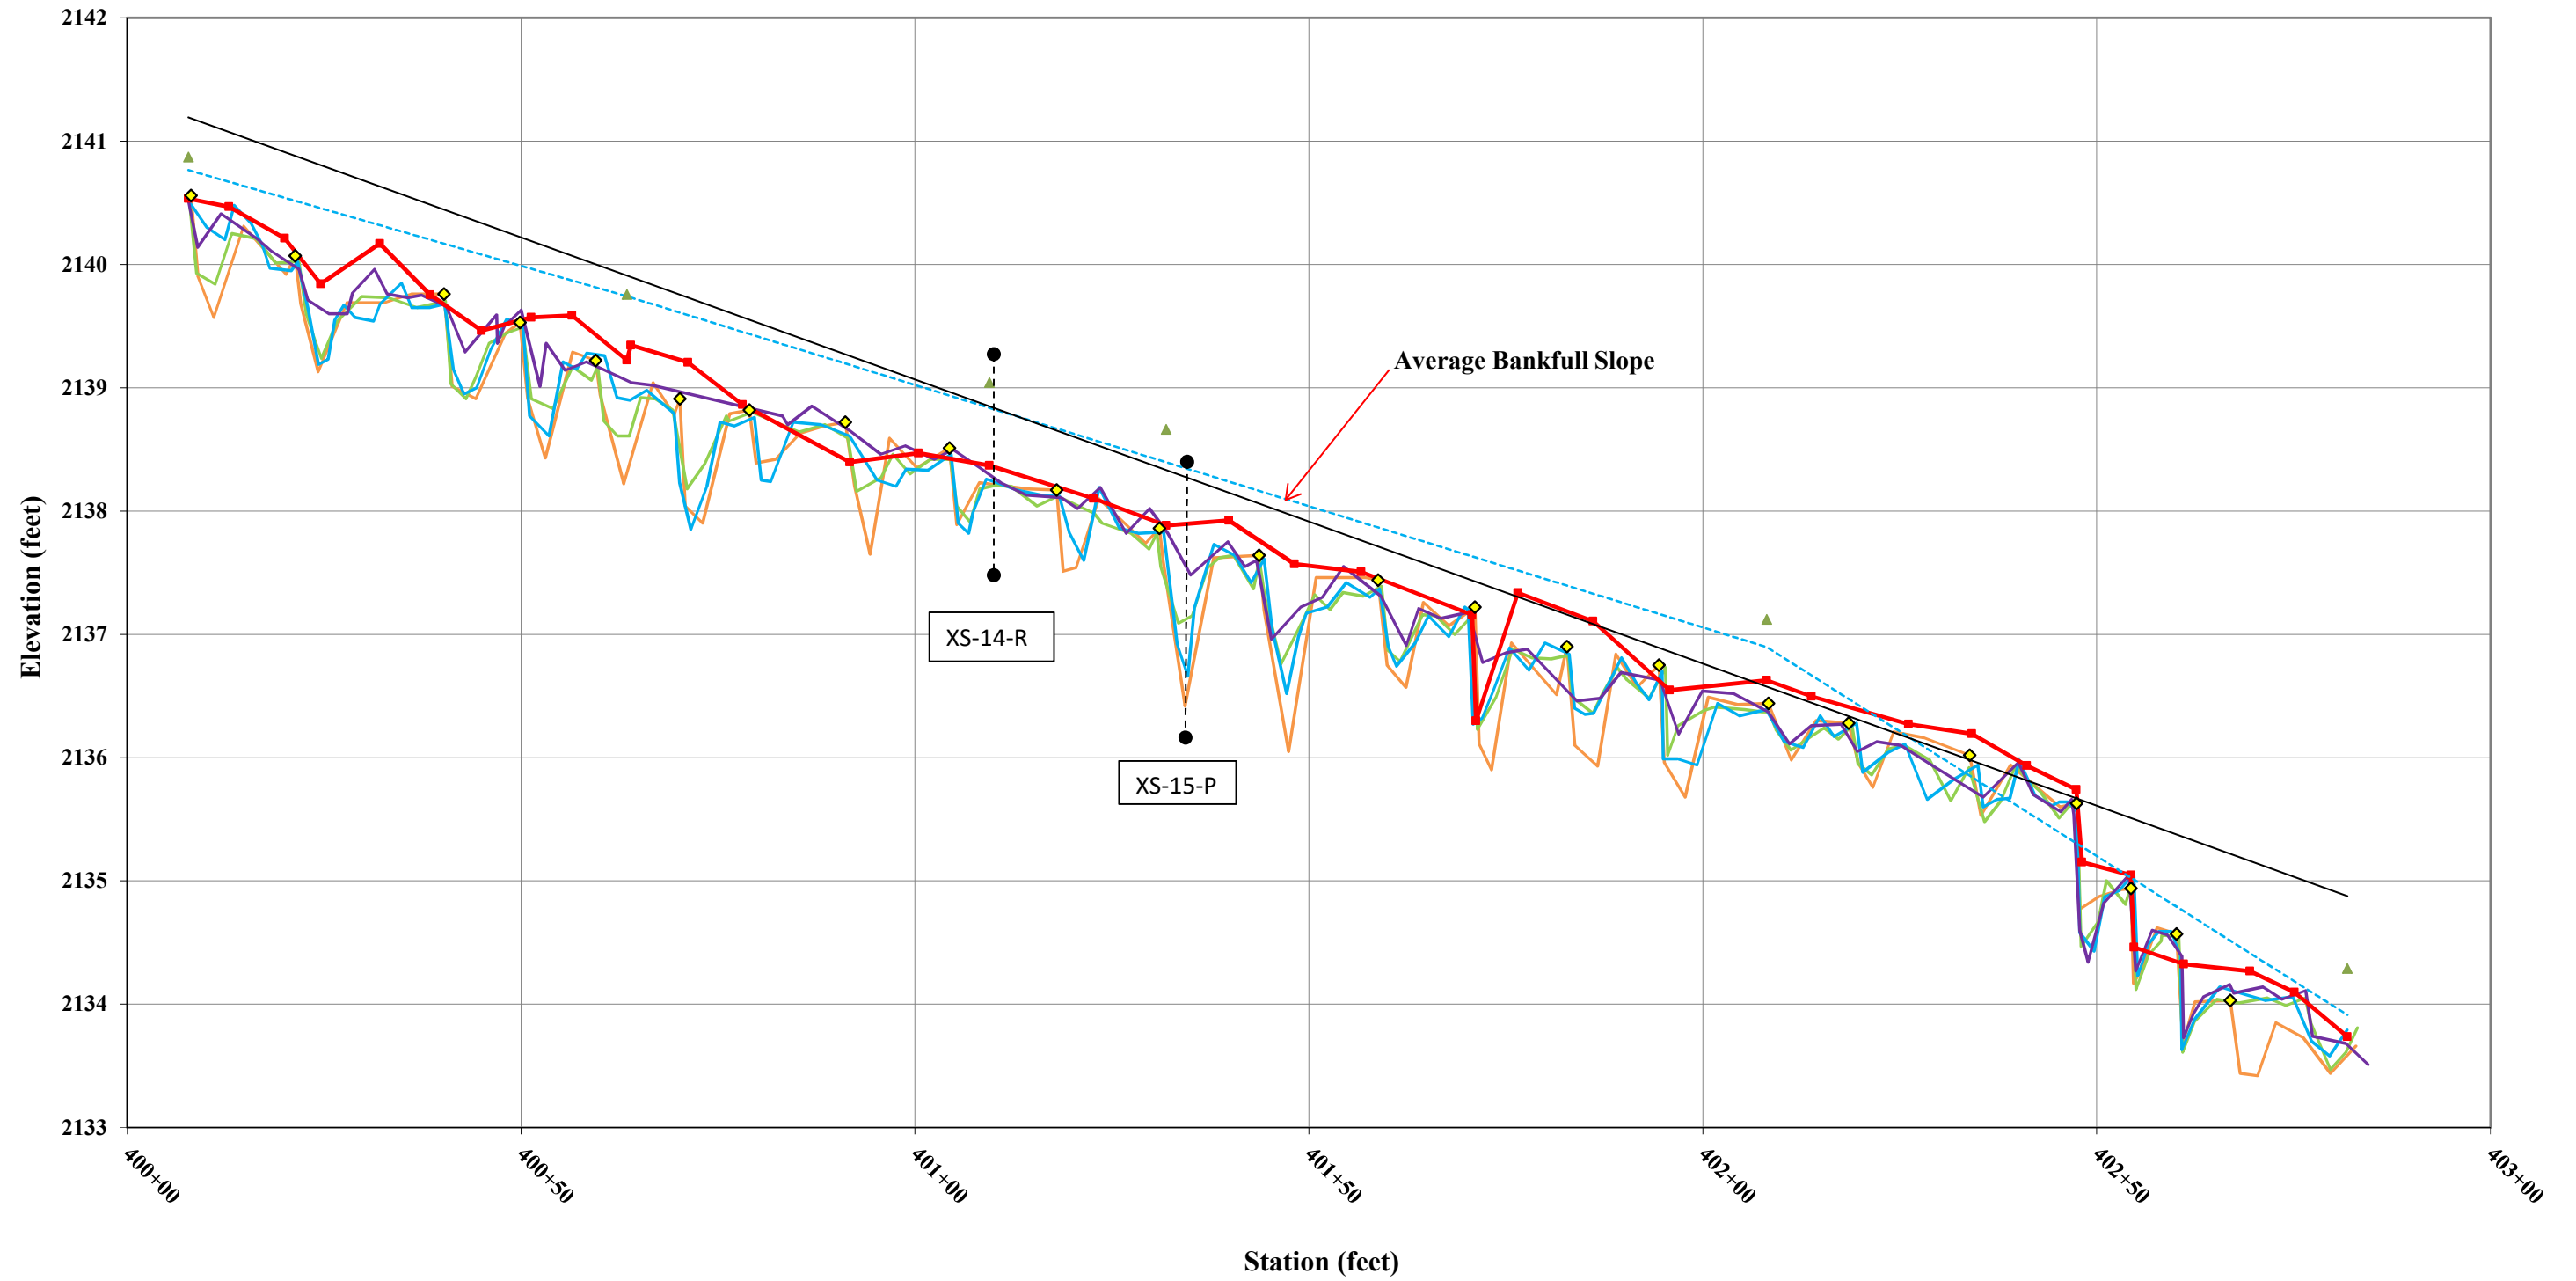
**Doris Branch
Longitudinal Profile
Staioning 400+00 to 402+82**

General: The MY4 cross section and longitudinal profile data shows significant aggradation on Higdon Branch and Doris Branch. This aggradation has increased on both reaches since MY3. Junes Branch also shows areas of increased aggradation in MY4. In the report text, please add additional discussion regarding the aggradation on these reaches.

- Sediment accumulation was observed in Doris Branch and distinct channel features are absent along much of the reach.
- No specific maintenance was requested by the IRT.
- Todd T. stated the system appeared to be more of a linear wetland seep.
- Mac H. and David B. both observed that some aquatic function was still provided by the restoration.
- Mac H. commented that a reduced credit ratio, such as 2:1, may be warranted.
- David B. and Paul W. both stated the pre-construction condition was a shallow ditch/swale through a disturbed old field with groundwater flow.
- Based on monitoring data the reach appears to have spring fed perennial flow, but limited watershed size and is lacking channel-forming flow events.
- IRT members did not request any specific remedial actions and recommended a final decision on crediting be made after additional monitoring.

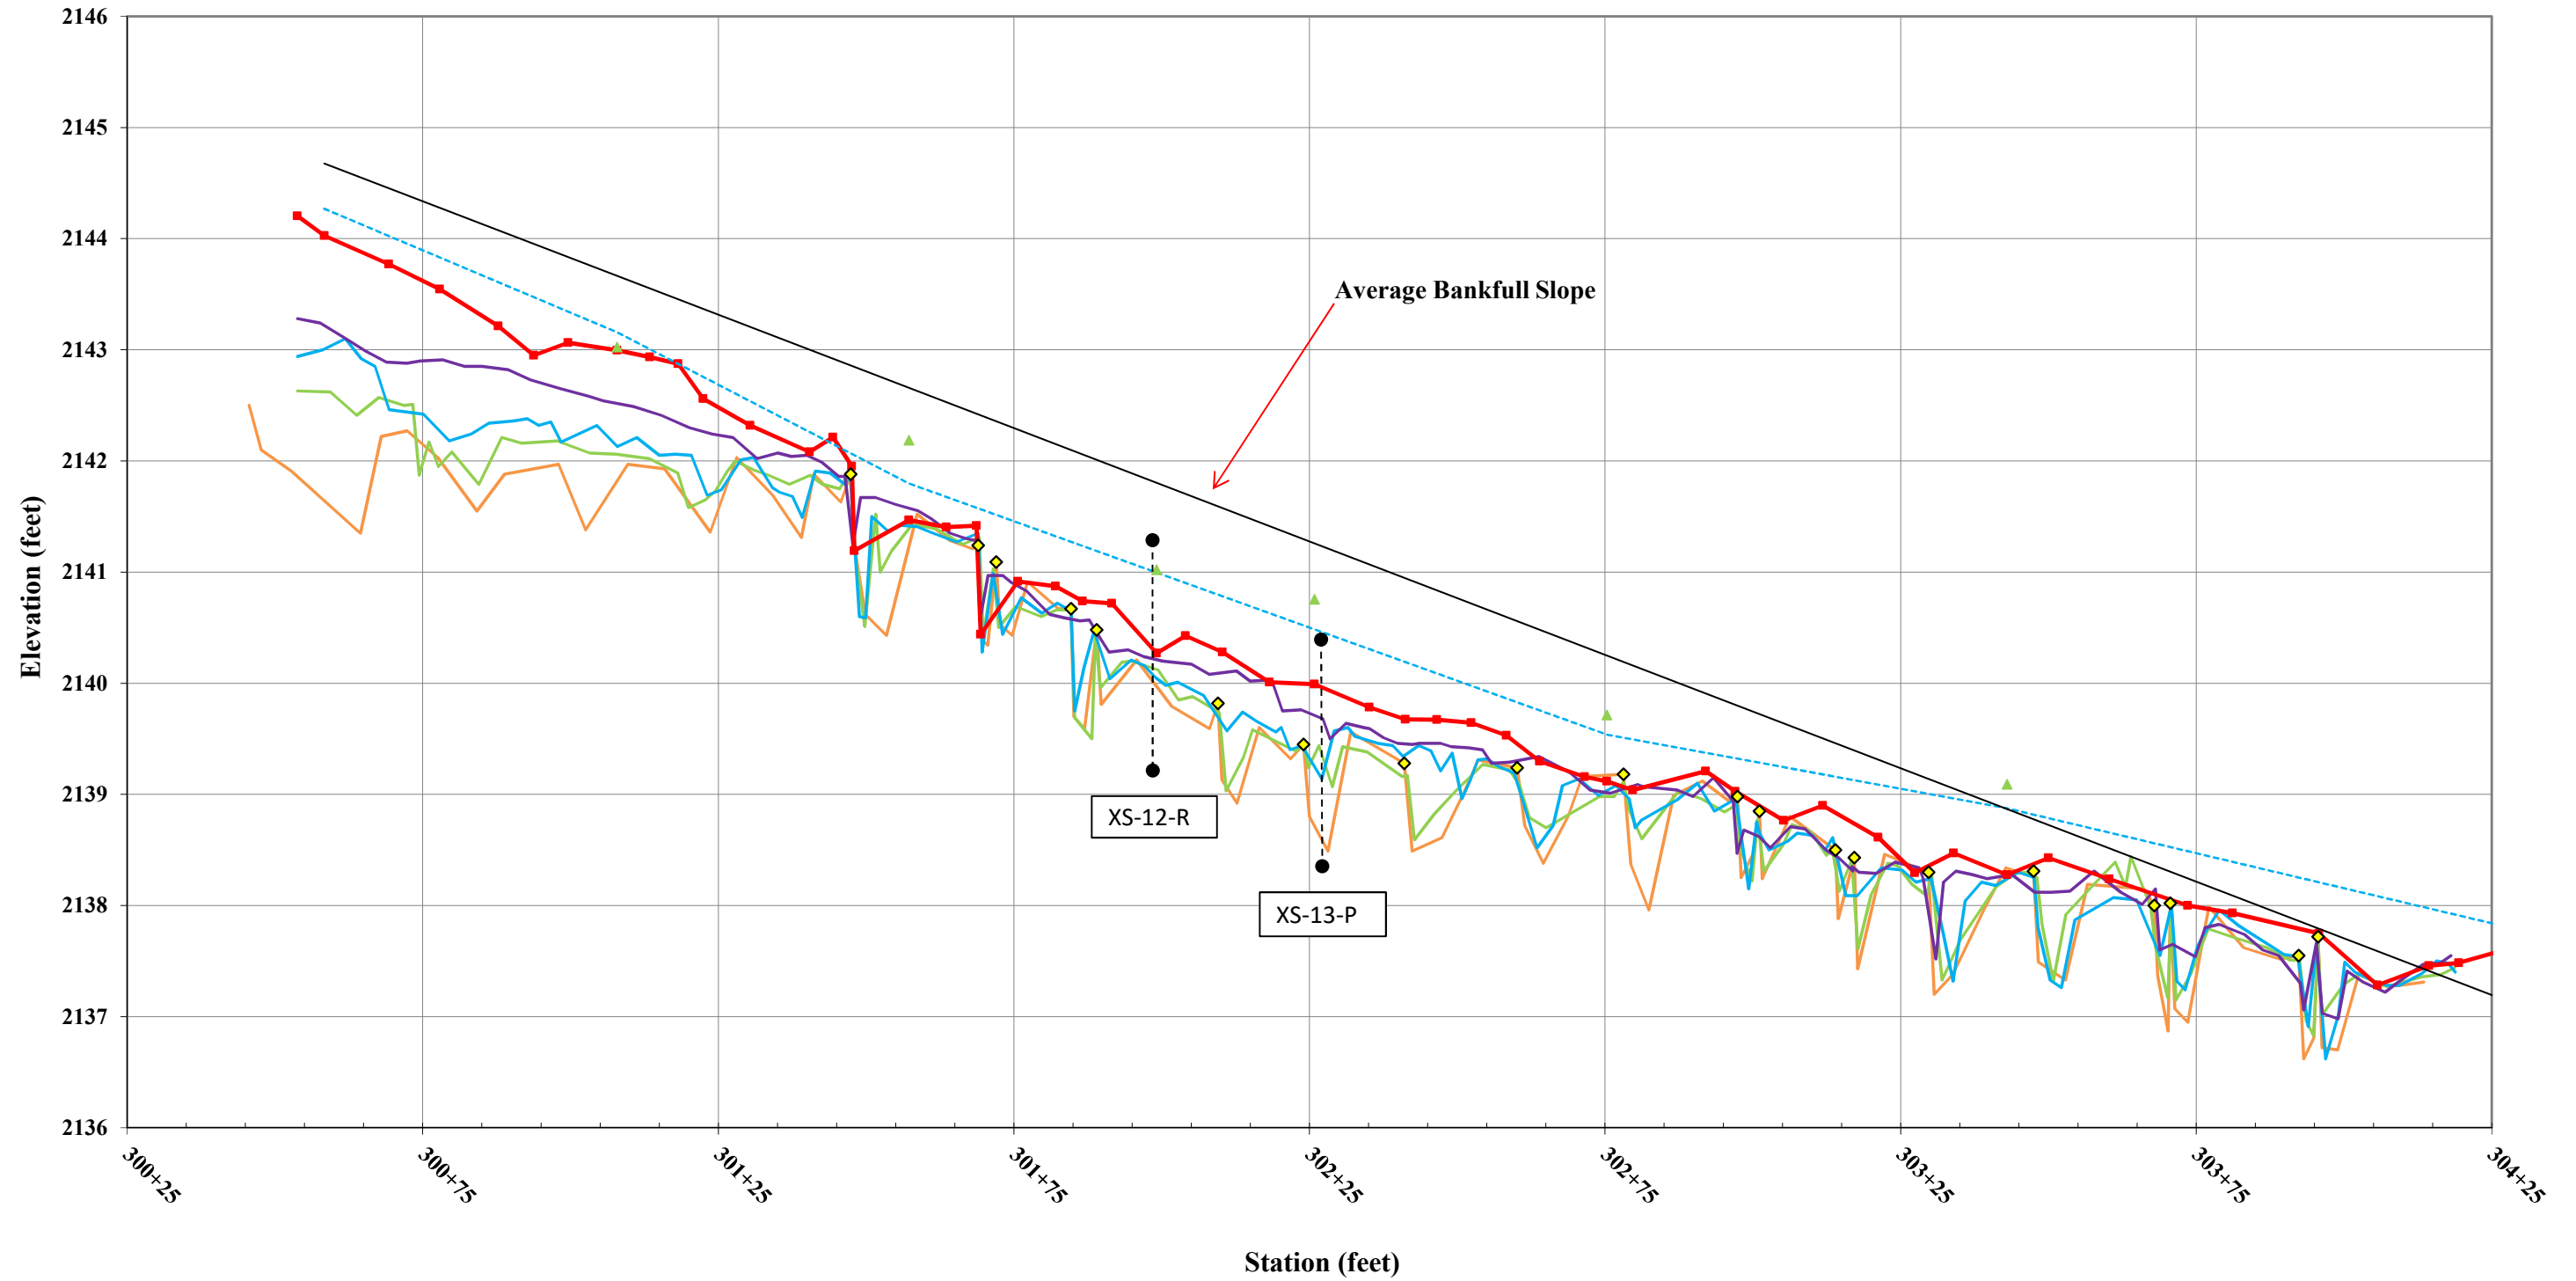
**Hidgon Branch
Longitudinal Profile
Staioning 300+46 to 304+22**

- Sediment accumulation was noted in Higdon Branch, but a defined channel was present.
- No maintenance, remedial actions, or credit deductions were requested by the IRT.
