Annual Monitoring Report

Monitoring Year 5 of 5

Project Name: Junes Branch Stream Restoration

Jackson County, NC

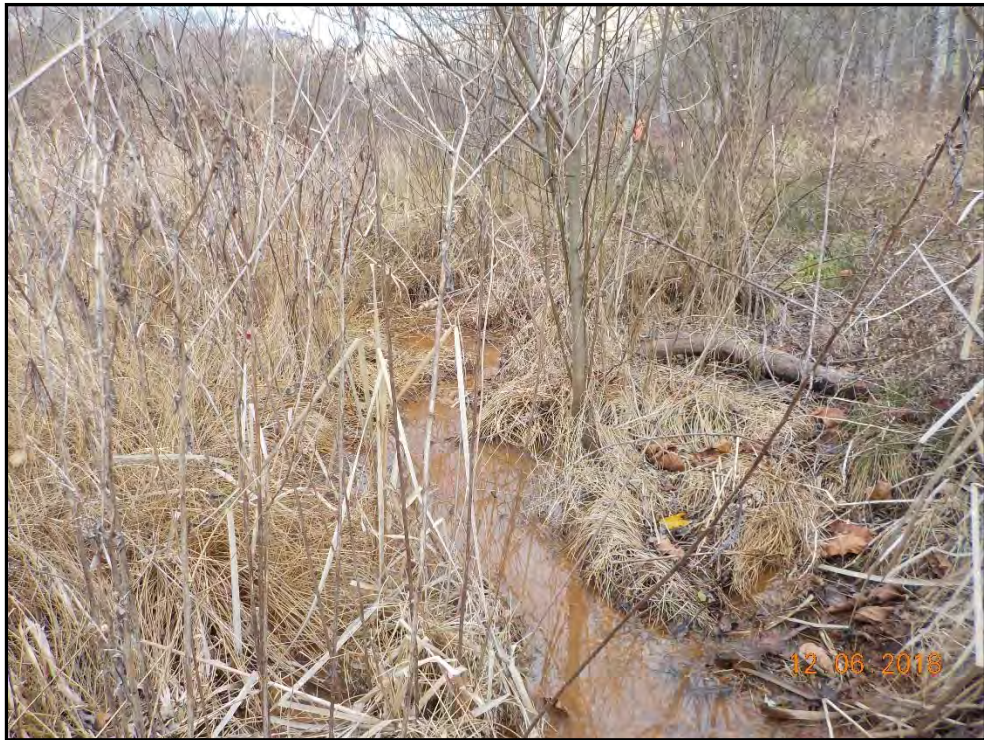
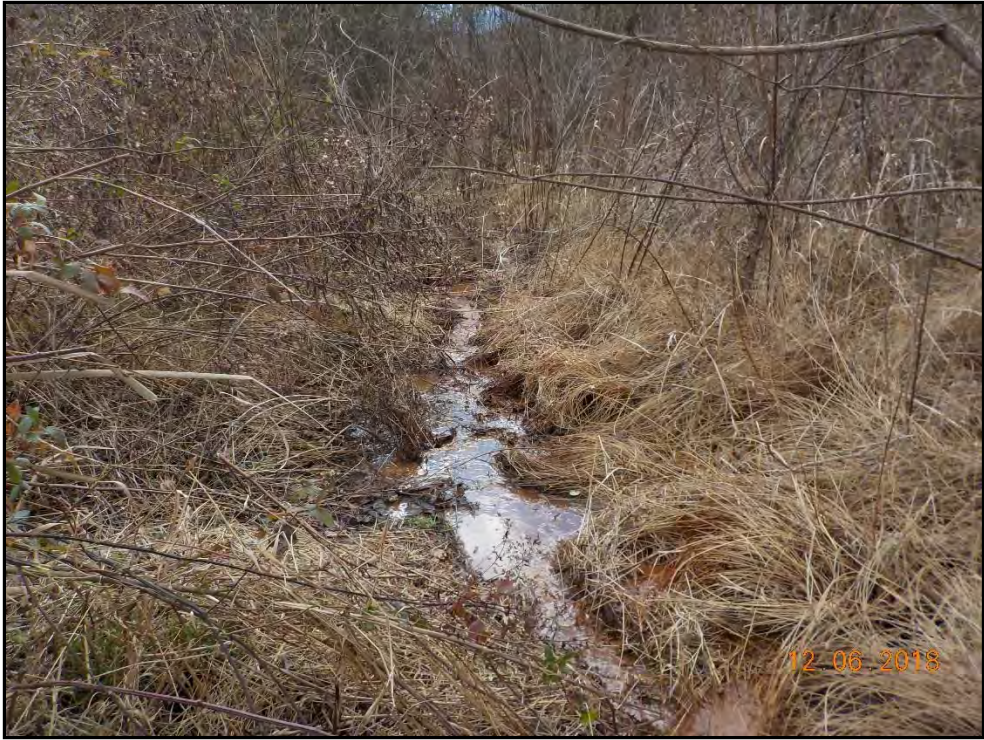
Doris Branch – General Conditions

[The aggradation issue on Doris Branch and Higdon Branch has stabilized in MY5 and has improved in some areas especially when compared to MY3 and MY4. Despite an increase in bed elevation, both reaches still maintain riffles and pools. Based on this data, RES proposes credits be released in full for these two reaches.](#)

In April of 2017, RES and the IRT met to discuss the sediment aggradation noted on Doris Branch and Higdon Branch. On Higdon Branch, the IRT agreed there was sediment aggradation but a defined channel was present. No maintenance, remedial actions or credit deductions were requested. On Doris Branch, however, the sedimentation had diminished the distinct channel features. The IRT requested no specific maintenance and recommended a final decision on crediting be made after additional monitoring. The IRT also noticed that overall Junes Branch has a high sediment load but concluded that it appeared to be maintaining appropriate geomorphology. The meeting summary is documented in **Appendix F**. The sediment aggradation was observed again on these reaches at the end of MY4. In July 2018, RES performed light maintenance on Higdon and Doris Branch by treating the vegetation in the channels with aquatic safe herbicide and mechanically removing the dead vegetation from the channels. The goal is by removing the vegetation in the channels, the trapped sediment will be free to move down the system.

- Sediment accumulation was observed in Doris Branch and distinct channel features are absent along much of the reach.
- No specific maintenance was requested by the IRT.
- Todd T. stated the system appeared to be more of a linear wetland seep.
- Mac H. and David B. both observed that some aquatic function was still provided by the restoration.
- Mac H. commented that a reduced credit ratio, such as 2:1, may be warranted.
- David B. and Paul W. both stated the pre-construction condition was a shallow ditch/swale through a disturbed old field with groundwater flow.
- Based on monitoring data the reach appears to have spring fed perennial flow, but limited watershed size and is lacking channel-forming flow events.
- IRT members did not request any specific remedial actions and recommended a final decision on crediting be made after additional monitoring.

[RES plans to add containerized trees to both banks of Doris and Higdon Branch before the start of the growing season in 2019. This has been added to the report.](#)

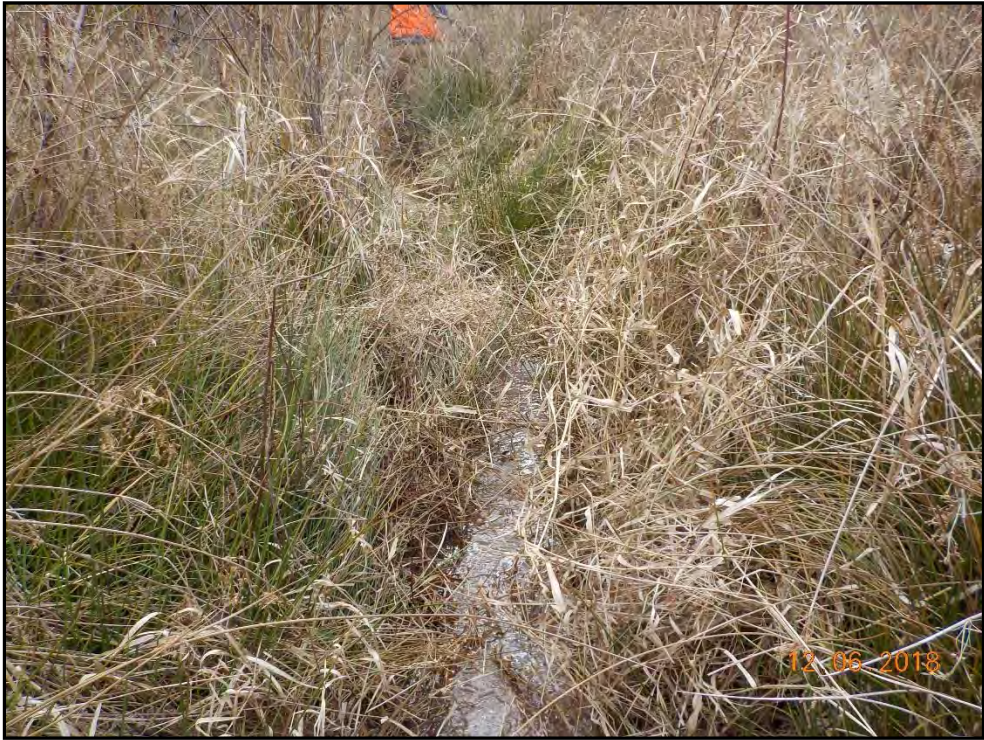
Higdon Branch – General Conditions

- Sediment accumulation was noted in Higdon Branch, but a defined channel was present.
- No maintenance, remedial actions, or credit deductions were requested by the IRT.

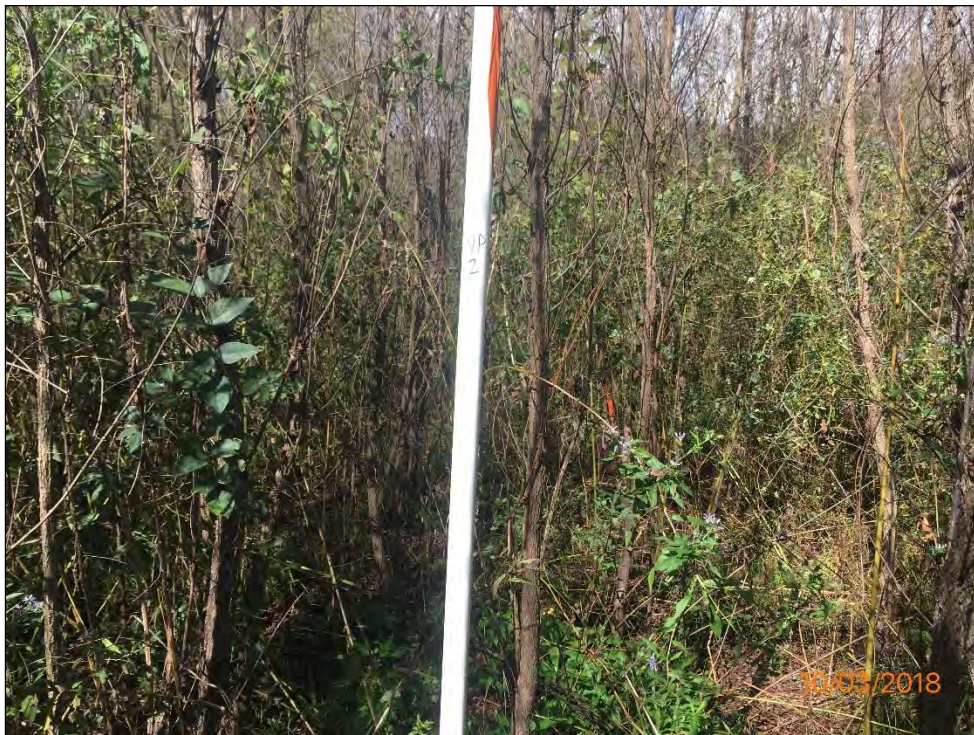
Junes Branch - Vegetation Monitoring Plot 2

Monitoring of eight permanent vegetation plots was completed during October 2018. Summary tables and photographs associated with MY5 monitoring can be found in **Appendix C**. With the exception of Plot 2, MY5 monitoring data indicates that all vegetation monitoring plots met the MY5 interim success criteria of 260 planted stems per acre. Low planted stem densities at Plot 2 can be attributed to a large density of recruited black willows (*Salix nigra*) outcompeting the planted stems; however, the surviving five trees in Plot 2 average eight feet tall. While Plot 2 is not meeting interim success criteria for planted stems, with recruits, the stem density is 18,413 stems/ acre, far exceeding the MY5 interim success criteria of 260 stems per acre. Six species were documented in the plots as volunteers. Planted stem densities among the plots ranged from 202 to 850 planted stems per acre with a mean of 531 stems per acre across all plots. When volunteer stems are included, densities ranged between 567 and 18,413 total stems per acre with a mean of 3,278 stems per acre across all plots. The estimated average stem height was 7.7 feet. No invasive species were observed in the easement in MY5. An invasive species treatment, however, was conducted in July 2018 along the edge of the easement where invasive species were beginning to grow back towards the easement area.

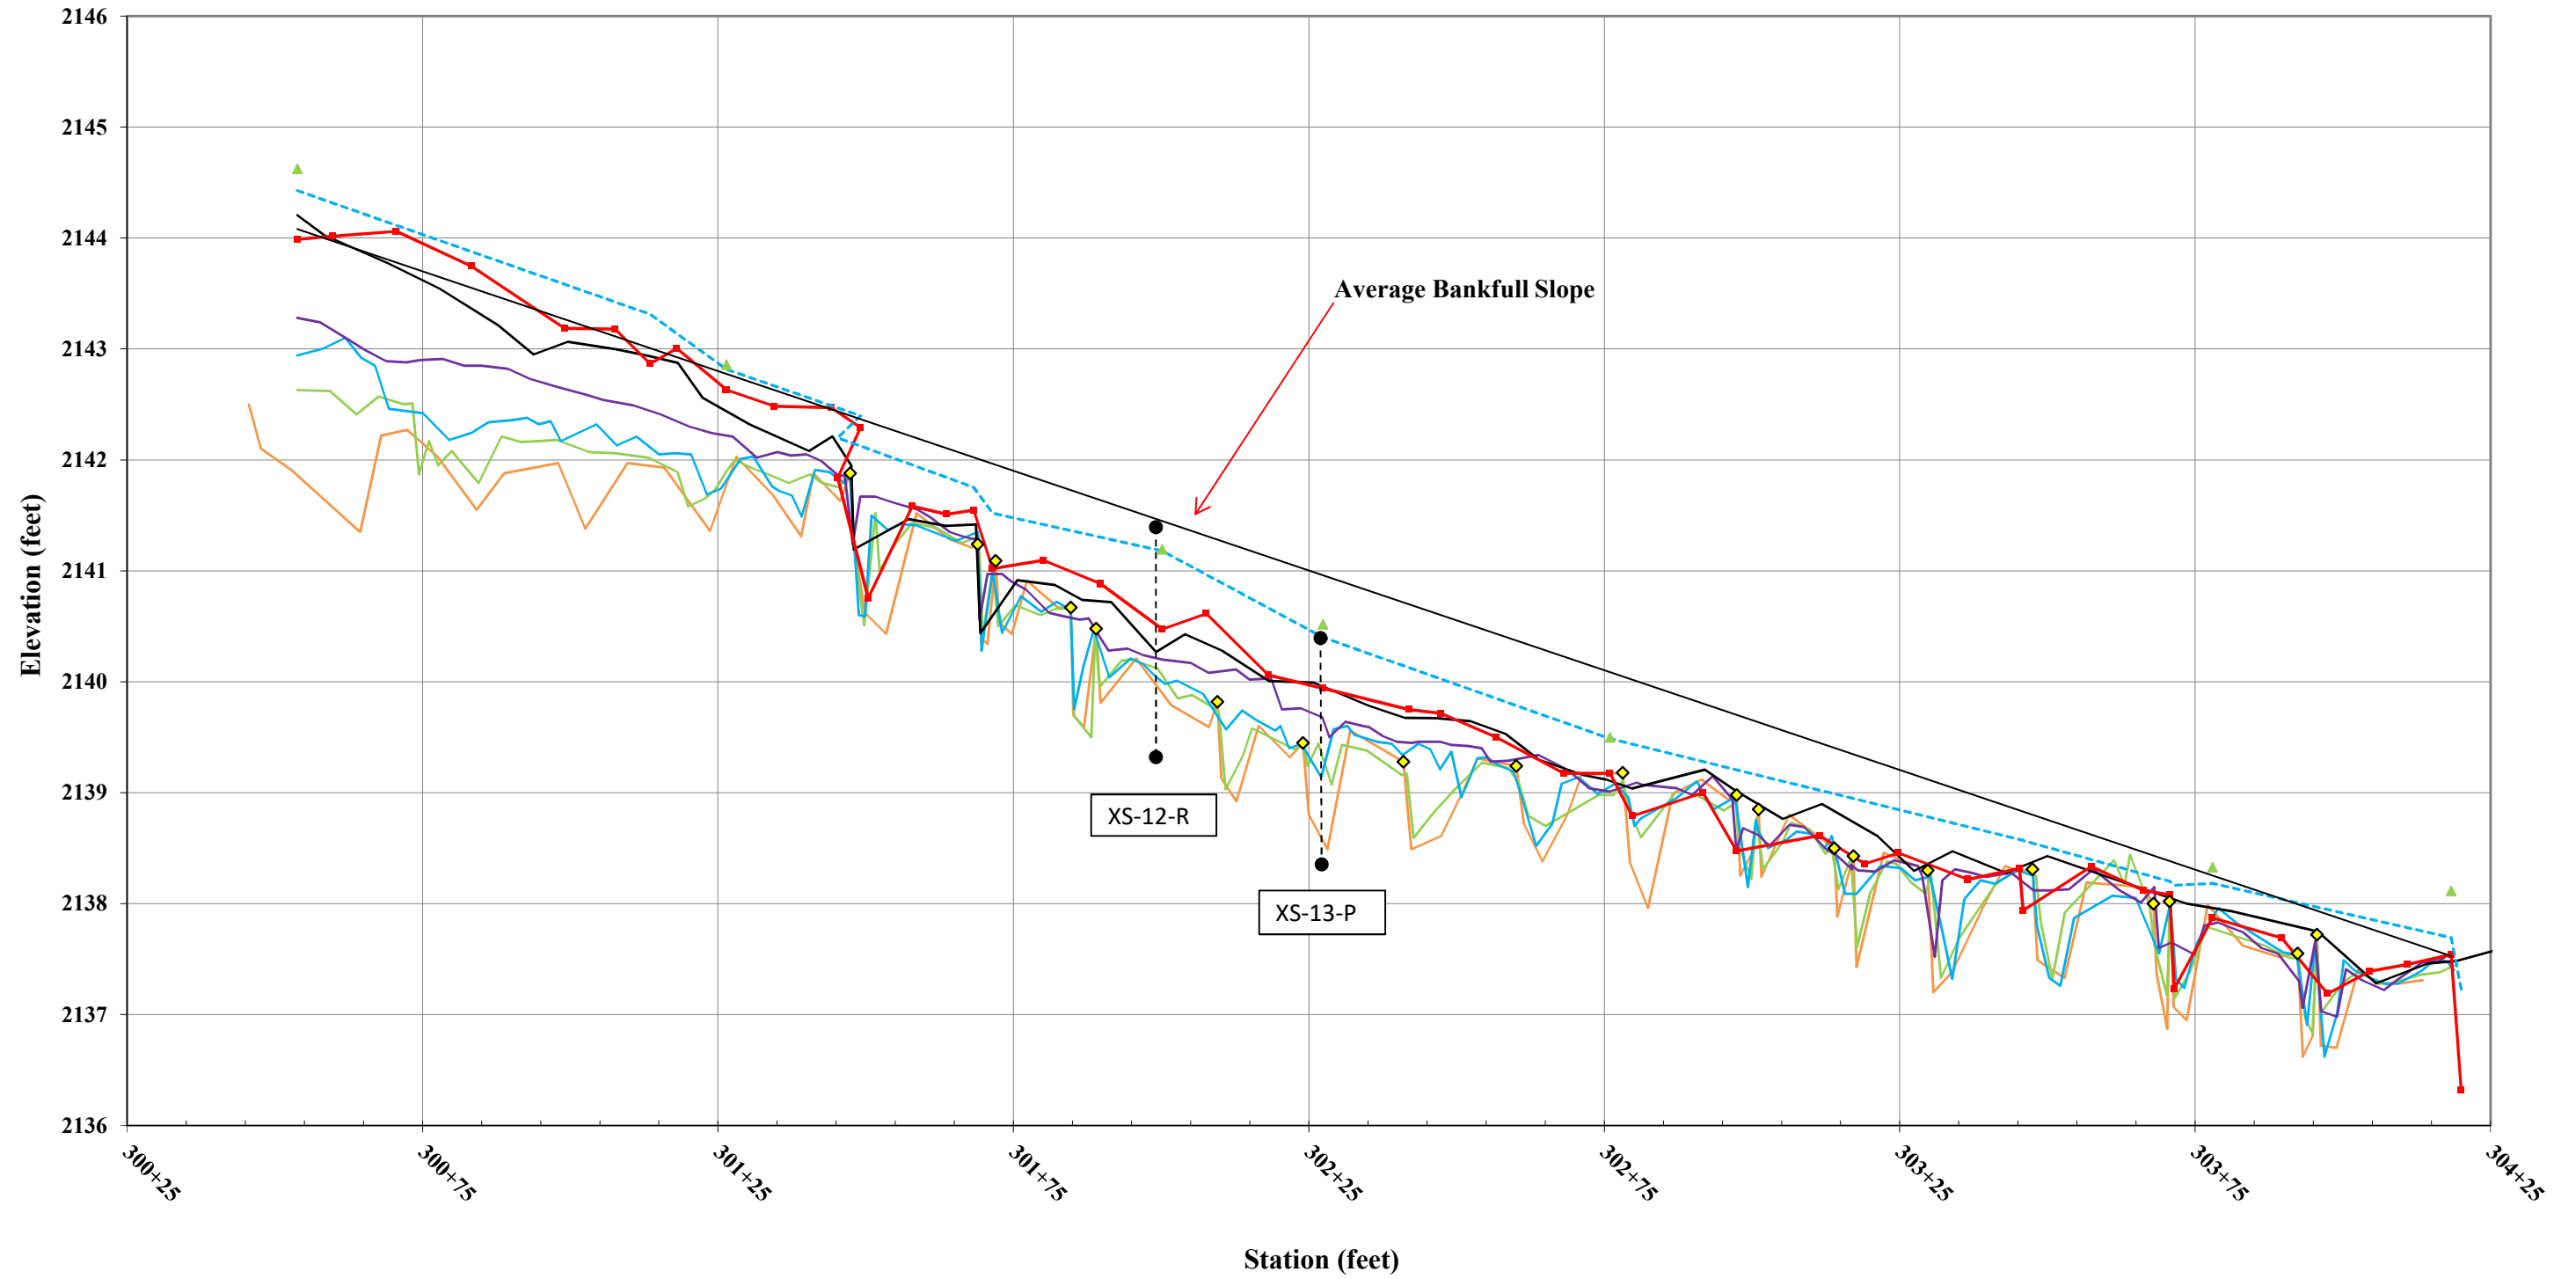
**Hidgon Branch
Longitudinal Profile
Staioning 300+46 to 304+22**

Table 5 (Doris Branch and Higdon Branch): The table currently indicates that both reaches are 100% stable and performing as intended. The cross sections and longitudinal profiles indicate aggradation on both reaches over the monitoring term. Please review, confirm the assessment and update the report if necessary.
