**Juniper Bay Wetland Mitigation Site
Robeson County, NC**

**2007 Annual Monitoring Report
Year 2 of 5**

NCEEP Project Number 201

Date: February 2008

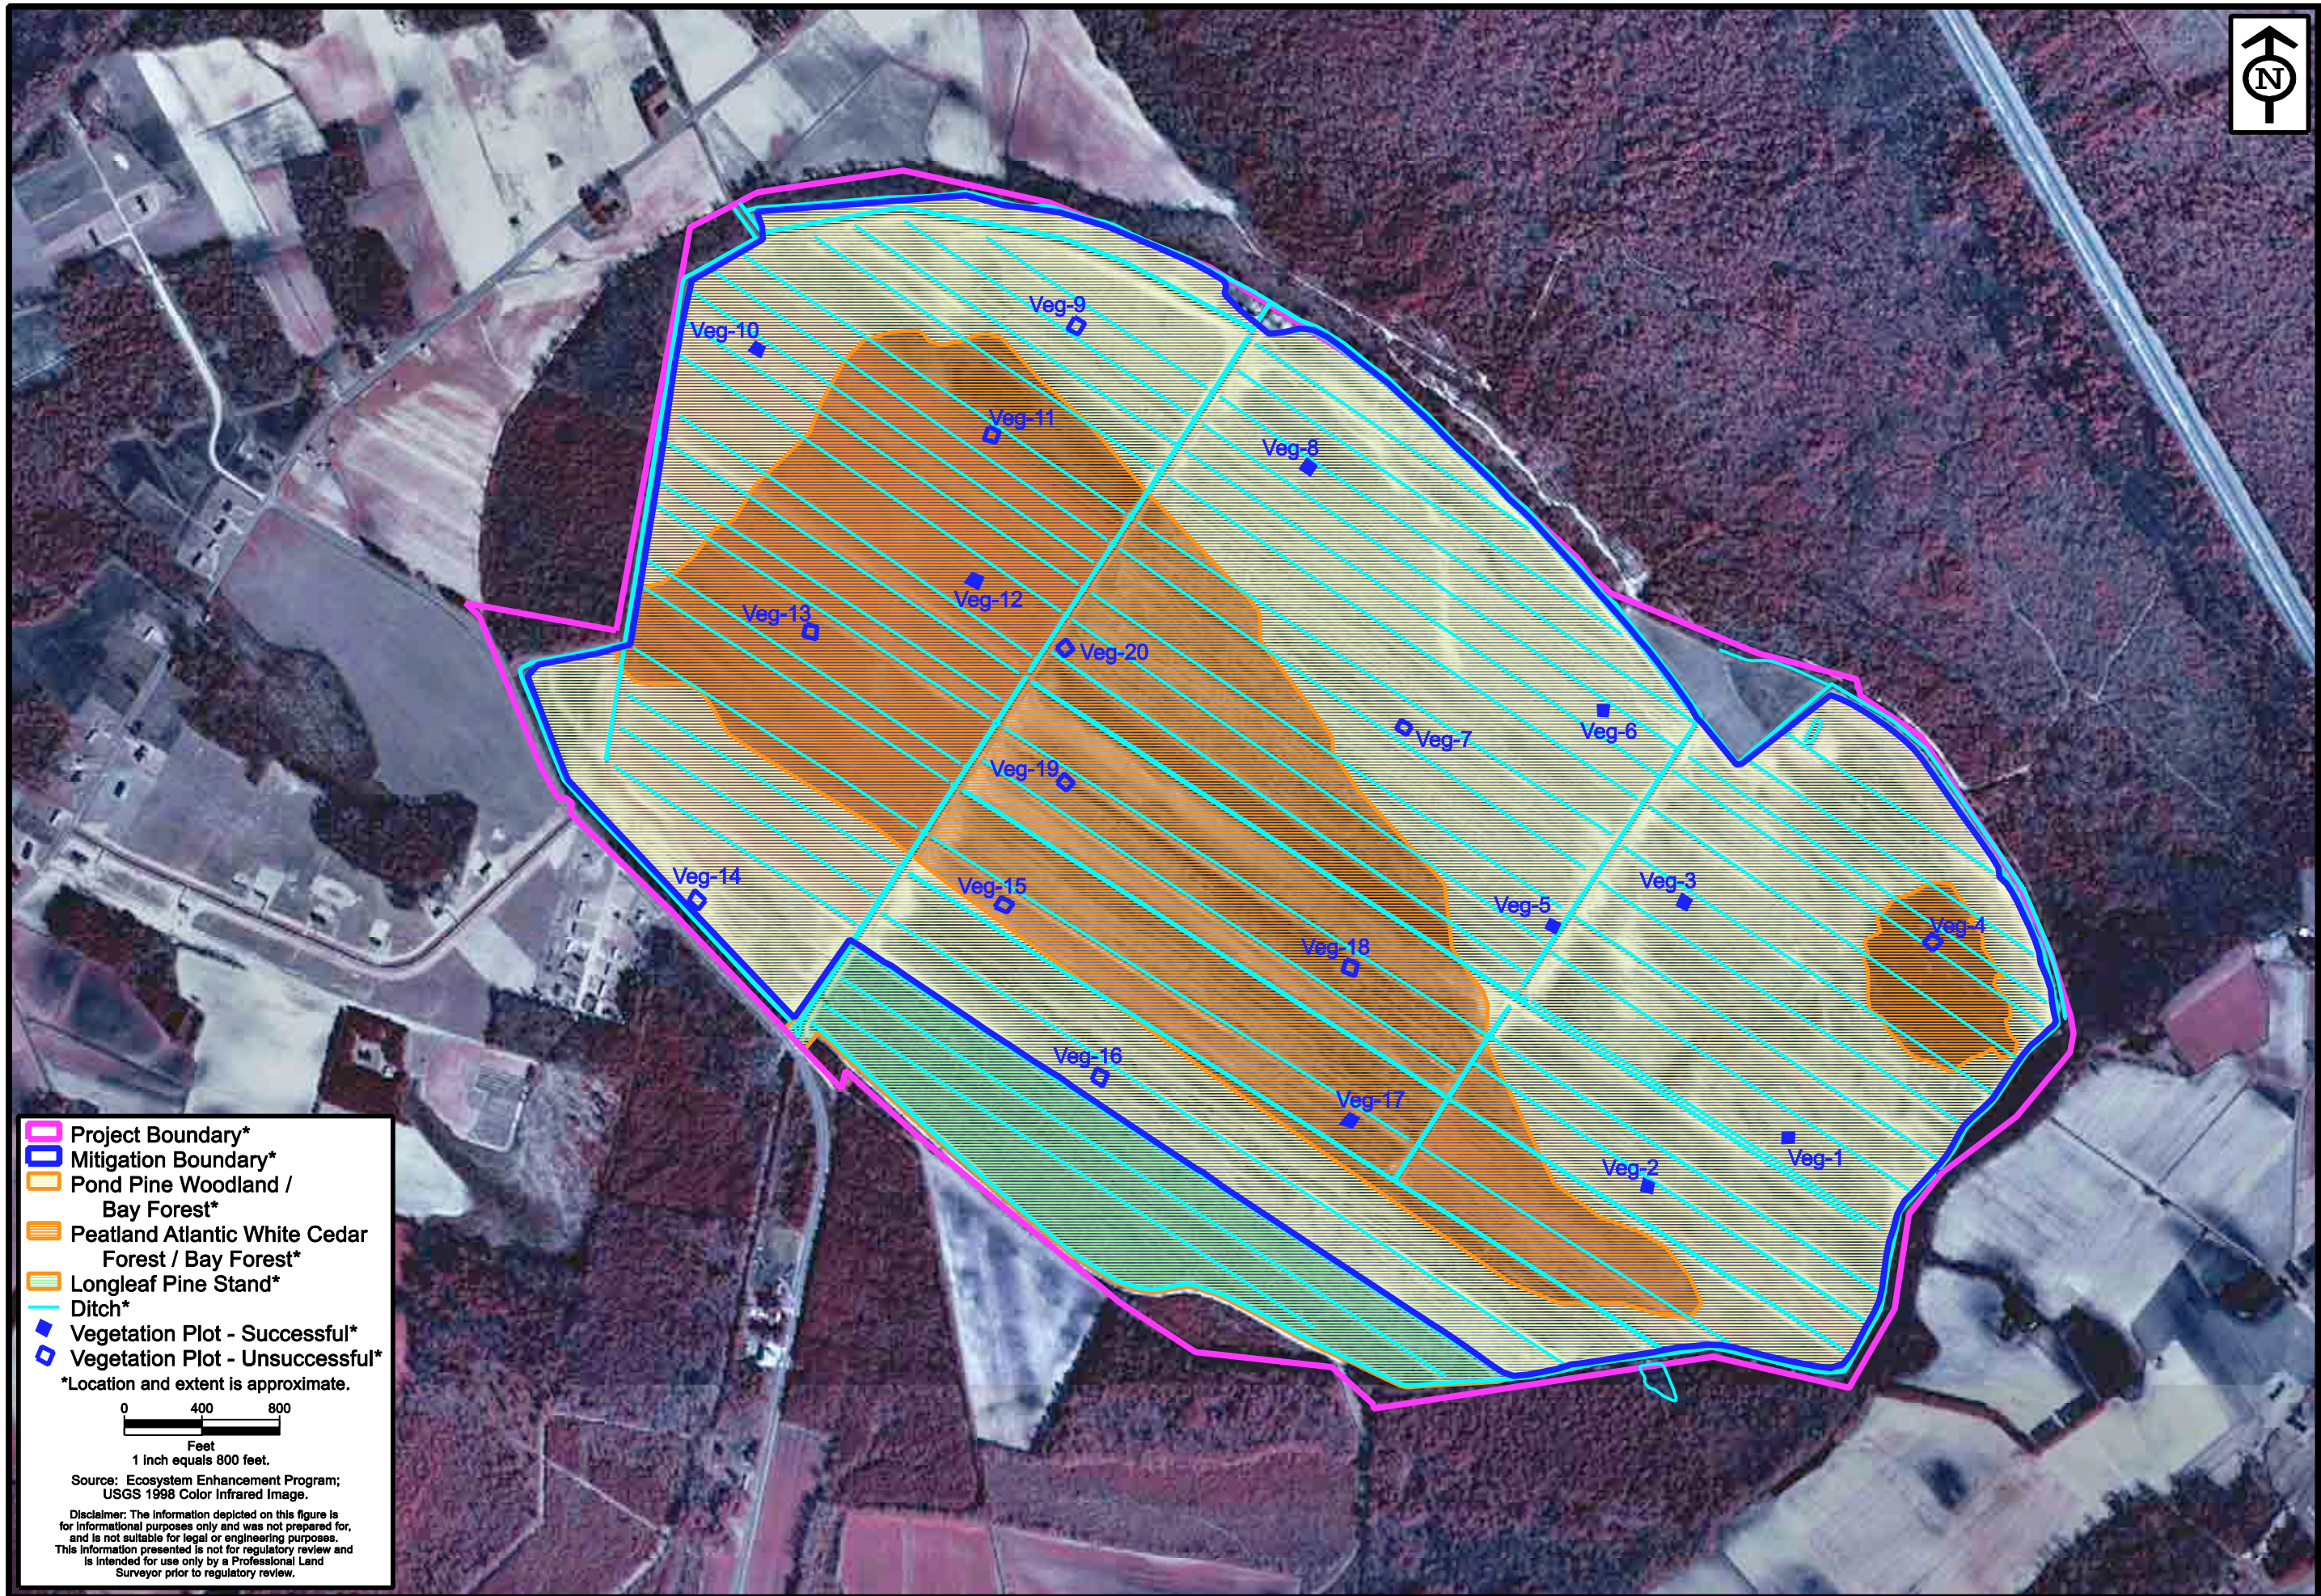
Project: ER07008.00
 Date: Nov 2007
 Drwn/Chkd: KT/GT
 Figure: 3a

Table 6. Vegetative Problem Areas			
Feature/Issue	Plot	Probable Cause	Photo #
Leaf scorch	1	Drought conditions	VPA 1
Human trampled with high mortality	5	Area potentially driven/walked through	VPA 2
Vine strangulation and herbaceous competition	15	Vine and herbaceous growth is overtopping stems	VPA-3
High water levels	20	Plot submerged with water depth exceeding 16".	VPA 4

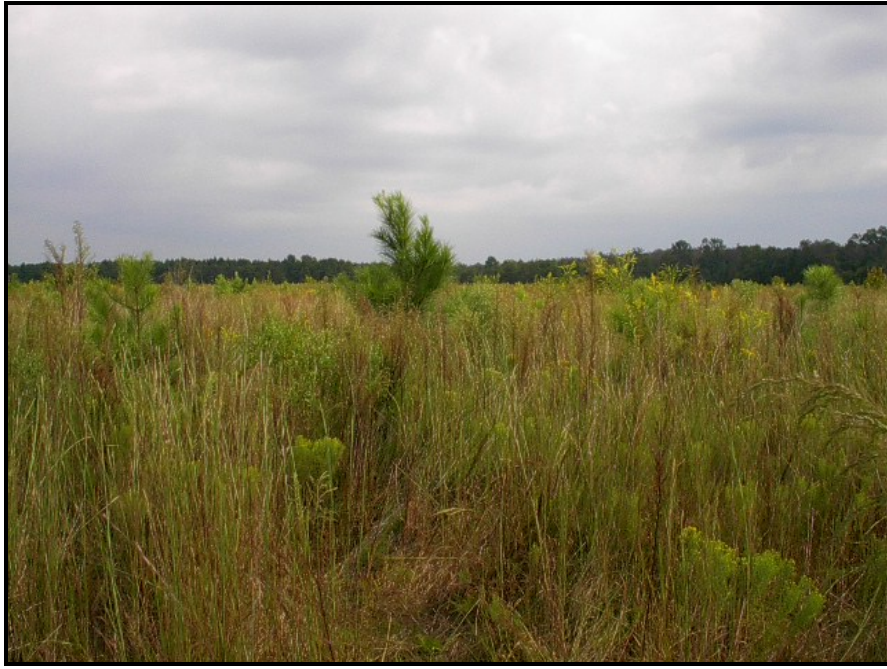
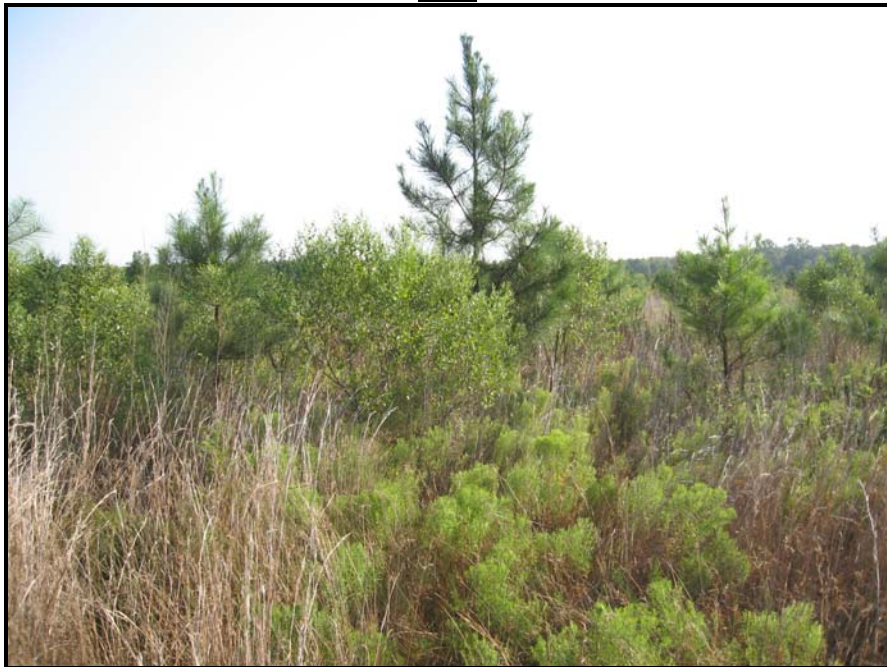
PLOT 1

The effects of drought conditions late in the growing season were observed in multiple plots, primarily in the form of leaf scorch. Low vigor scores were attributed to the drought conditions for multiple plots. It is unknown what effects the drought will have upon the survival rates of stems for the 2008 monitoring event.

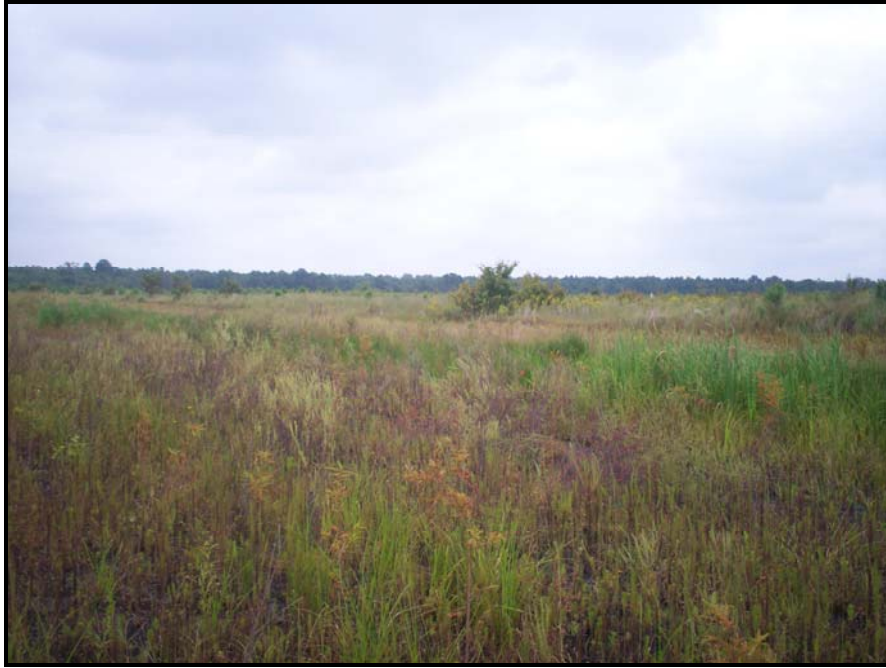
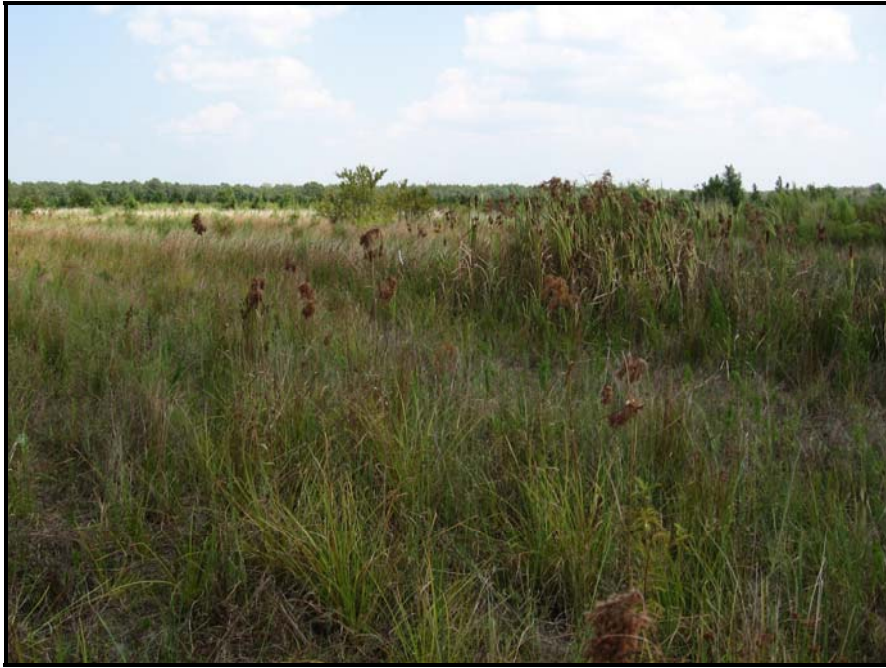
PLOT 5

Plot 5, although successful in meeting the 320 stems/acre criterion, experienced significant loss of stems. Twenty of the 42 stems were recorded as missing during the 2007 monitoring event. The bald cypress stems were the only species which survived. All swamp tupelo (8), overcup oak (5), and swamp red bay (7) stems were missing from the plot. Plot 5 is located on the edge of one of the graded southwest to northeast ditches. It appears that low water levels due to drought conditions late in the growing season have enabled all-terrain vehicular (ATV) traffic to travel through this area causing the high stem missing rate. The vehicular traffic through this plot has been resolved by flagging the perimeter and instructing others on-site to avoid this area.

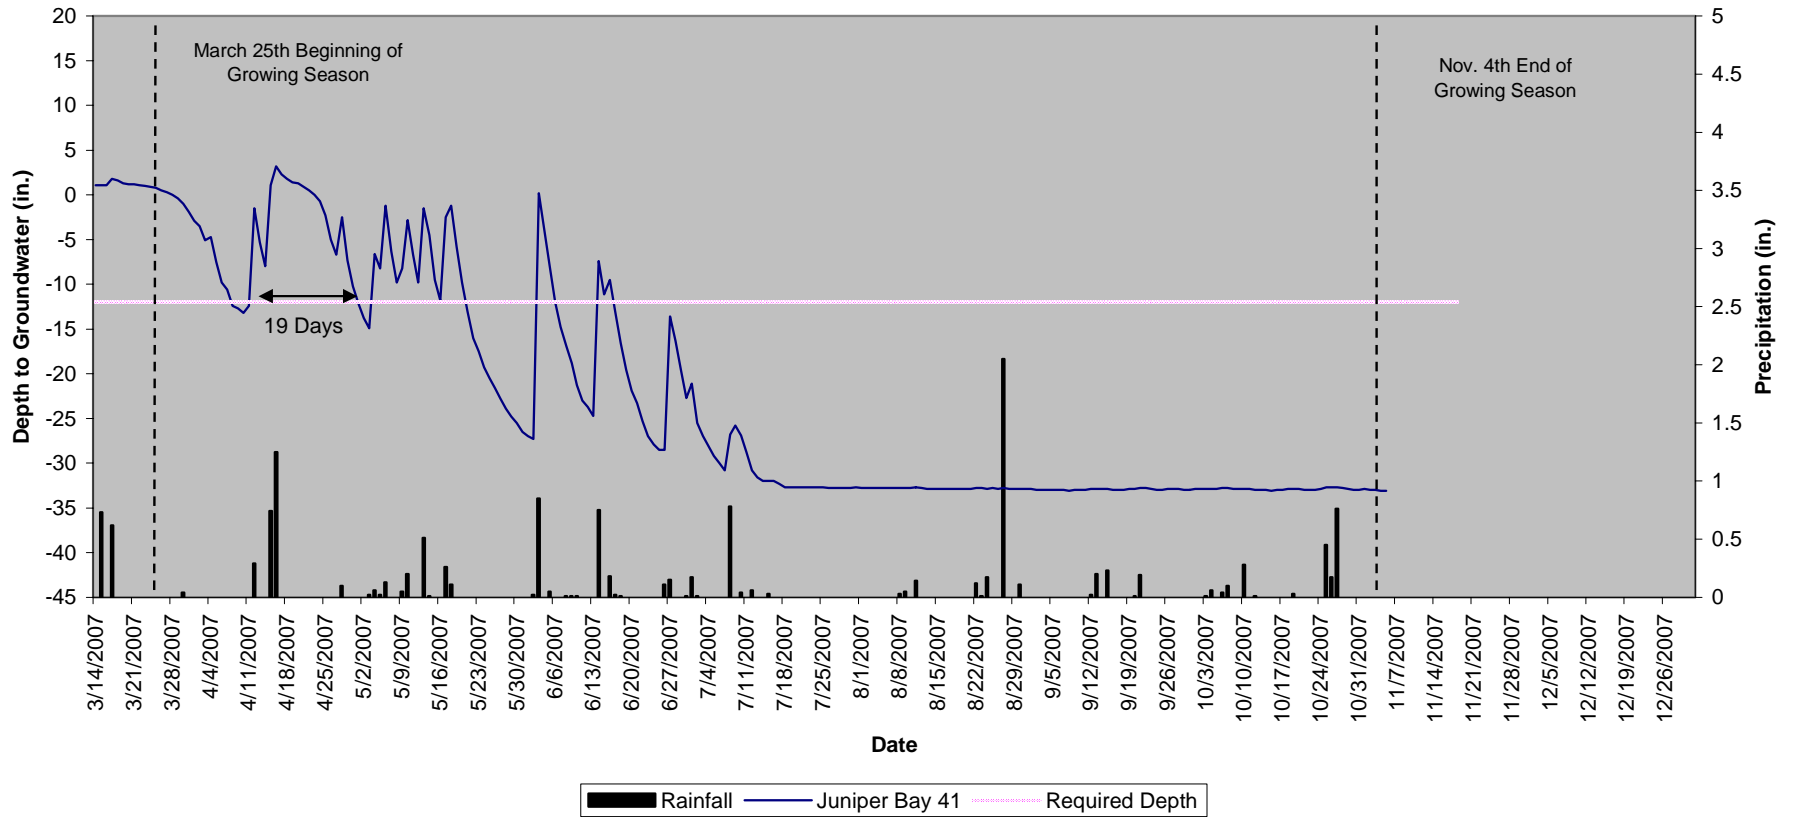
Juniper Bay
41
40" Groundwater

Of the 17 remaining gauges in the Pond Pine Woodland/ Bay Forest community; 16 (94.1%) met the hydrological success criterion. Gauge GW-41 did not meet the hydrologic success criterion. The soils within this community type are sandy with higher infiltration rates than those in the Peatland Atlantic White Cedar Forest/ Bay Forest community. The hydrograph

for GW-41 reflects the high infiltration rate for these soils in that the water levels tend to peak after a rain event but quickly drop within days of the event.
