**Juniper Bay Wetland Mitigation Site
Robeson County, NC**

**2008 Annual Monitoring Report
Year 3 of 5**

NCEEP Project Number 201

Date: February 2009

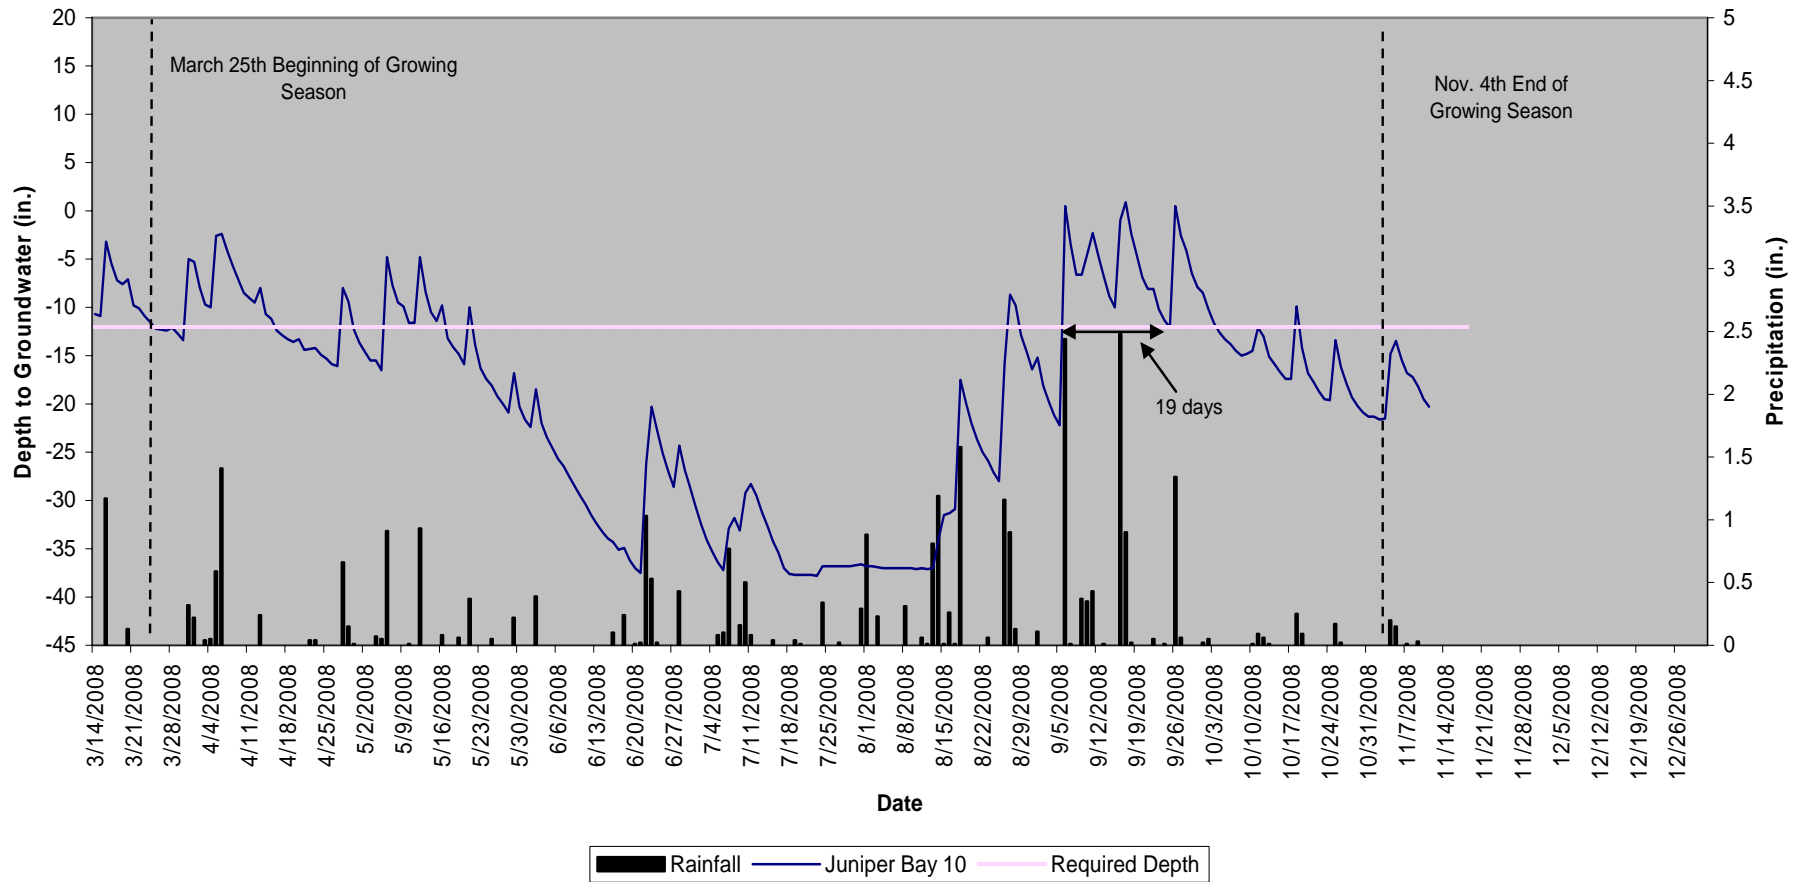
Juniper Bay
10
40" Groundwater

Of the 17 remaining gauges in the Pond Pine Woodland/ Bay Forest community; 15 (88.2%) met the hydrological success criterion. Gauges GW-10 and GW-34 did not meet the hydrologic success criterion. The soils within this community type are sandy with higher infiltration rates than those in the Peatland Atlantic White Cedar Forest/ Bay Forest community. The hydrographs for GW-10 and GW-34 reflect the high infiltration rate for these soils. Water levels peak after a rain event and quickly drop within days of the event preventing the necessary consecutive day saturation of the soil.

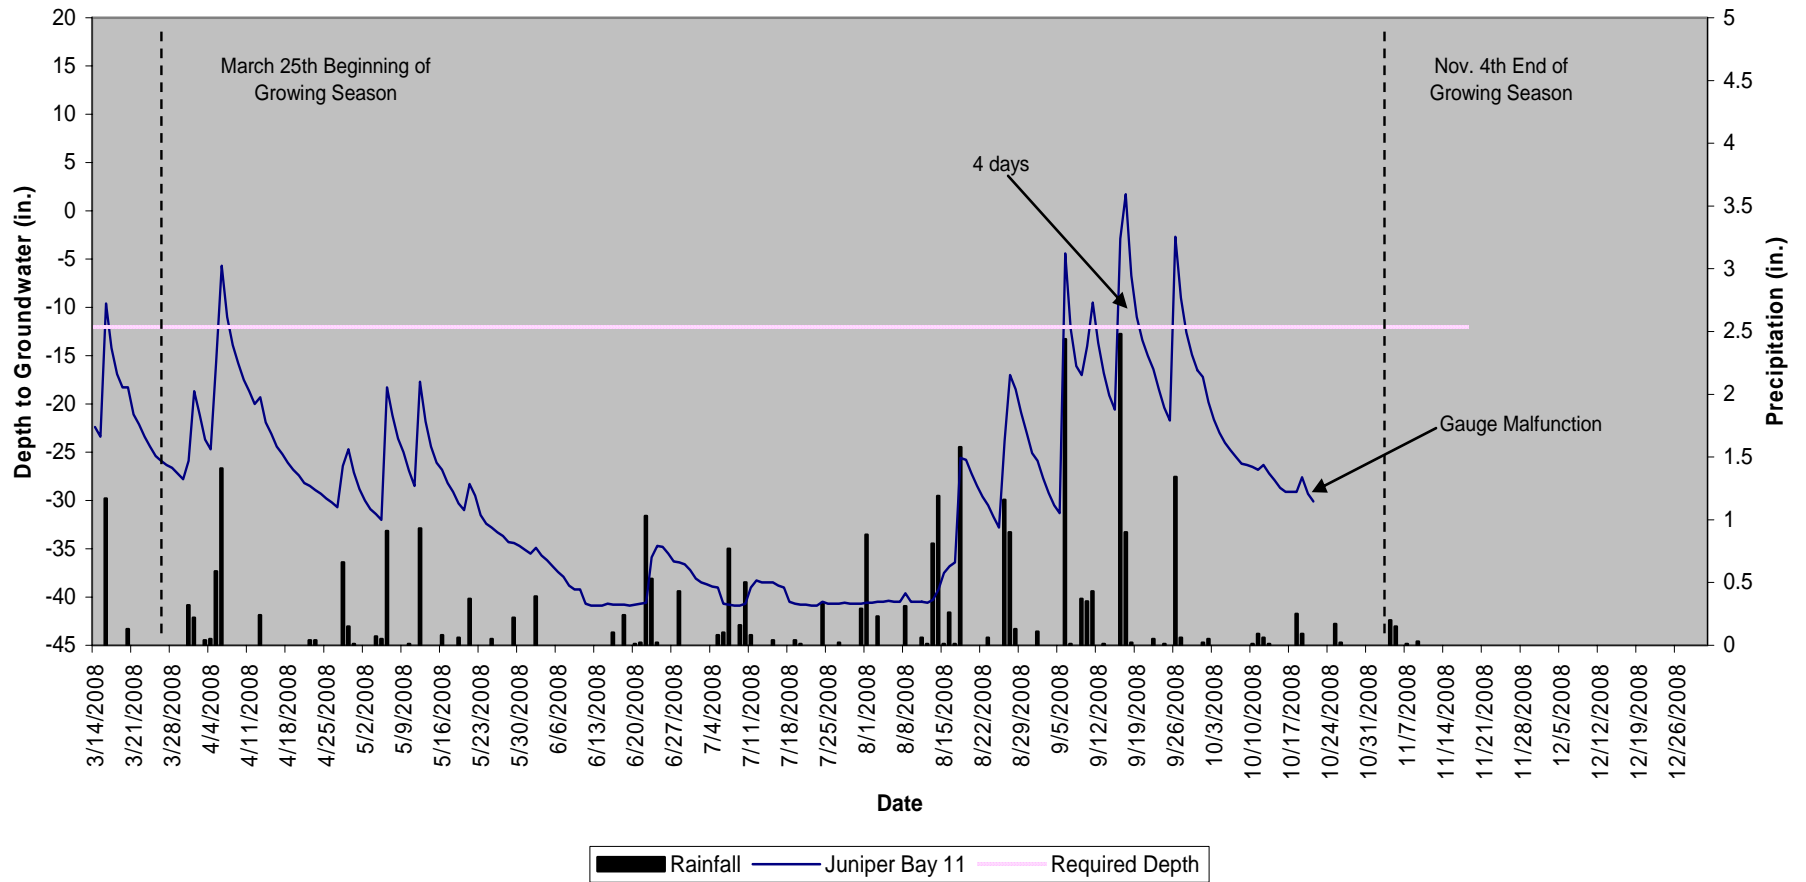
Juniper Bay
11
40" Groundwater

Gauges GW-3, GW-11, GW-12, GW-28, GW-33, and GW-42 malfunctioned for short periods of the growing season and were replaced. Gauges GW-3, GW-28, and GW-42 met the hydrologic success criterion regardless of the periods of missing data. The missing data for GW-42 did not affect the longest consecutive hydroperiod. Gauges GW-11 and GW-33 did not meet the hydrologic success criterion. The missing data from GW-11 and GW-33 was extrapolated by examining the periods before and after the missing data along with the hydrologic data of the gauges adjacent to the malfunctioning gauges. Using this extrapolated data, it can be assumed that GW-11 and GW-33 would not have met the hydrologic success criterion. GW-3 recorded 72 consecutive days of jurisdictional hydrology after one initial data gap. Using adjacent data points to extrapolate missing data, it can be assumed that GW-3 would have met the jurisdictional hydrology criterion for 79 consecutive days or 35.1% of the growing season. Gauge GW-12 recorded 12 consecutive days of jurisdictional hydrology after one data gap. Using adjacent data points to extrapolate the missing data, it can be assumed that GW-12 would have made jurisdictional hydrology for 30 consecutive days or 13.3% of the growing season.
