**AS-BUILT REPORT
BUSHY BRANCH AT KENTWOOD PARK
RALEIGH, NORTH CAROLINA**

**North Carolina Ecosystem Enhancement Program
Raleigh, North Carolina**

**EcoScience Corporation
1101 Haynes Street, Suite 101
Raleigh, North Carolina 27604**

February 2005

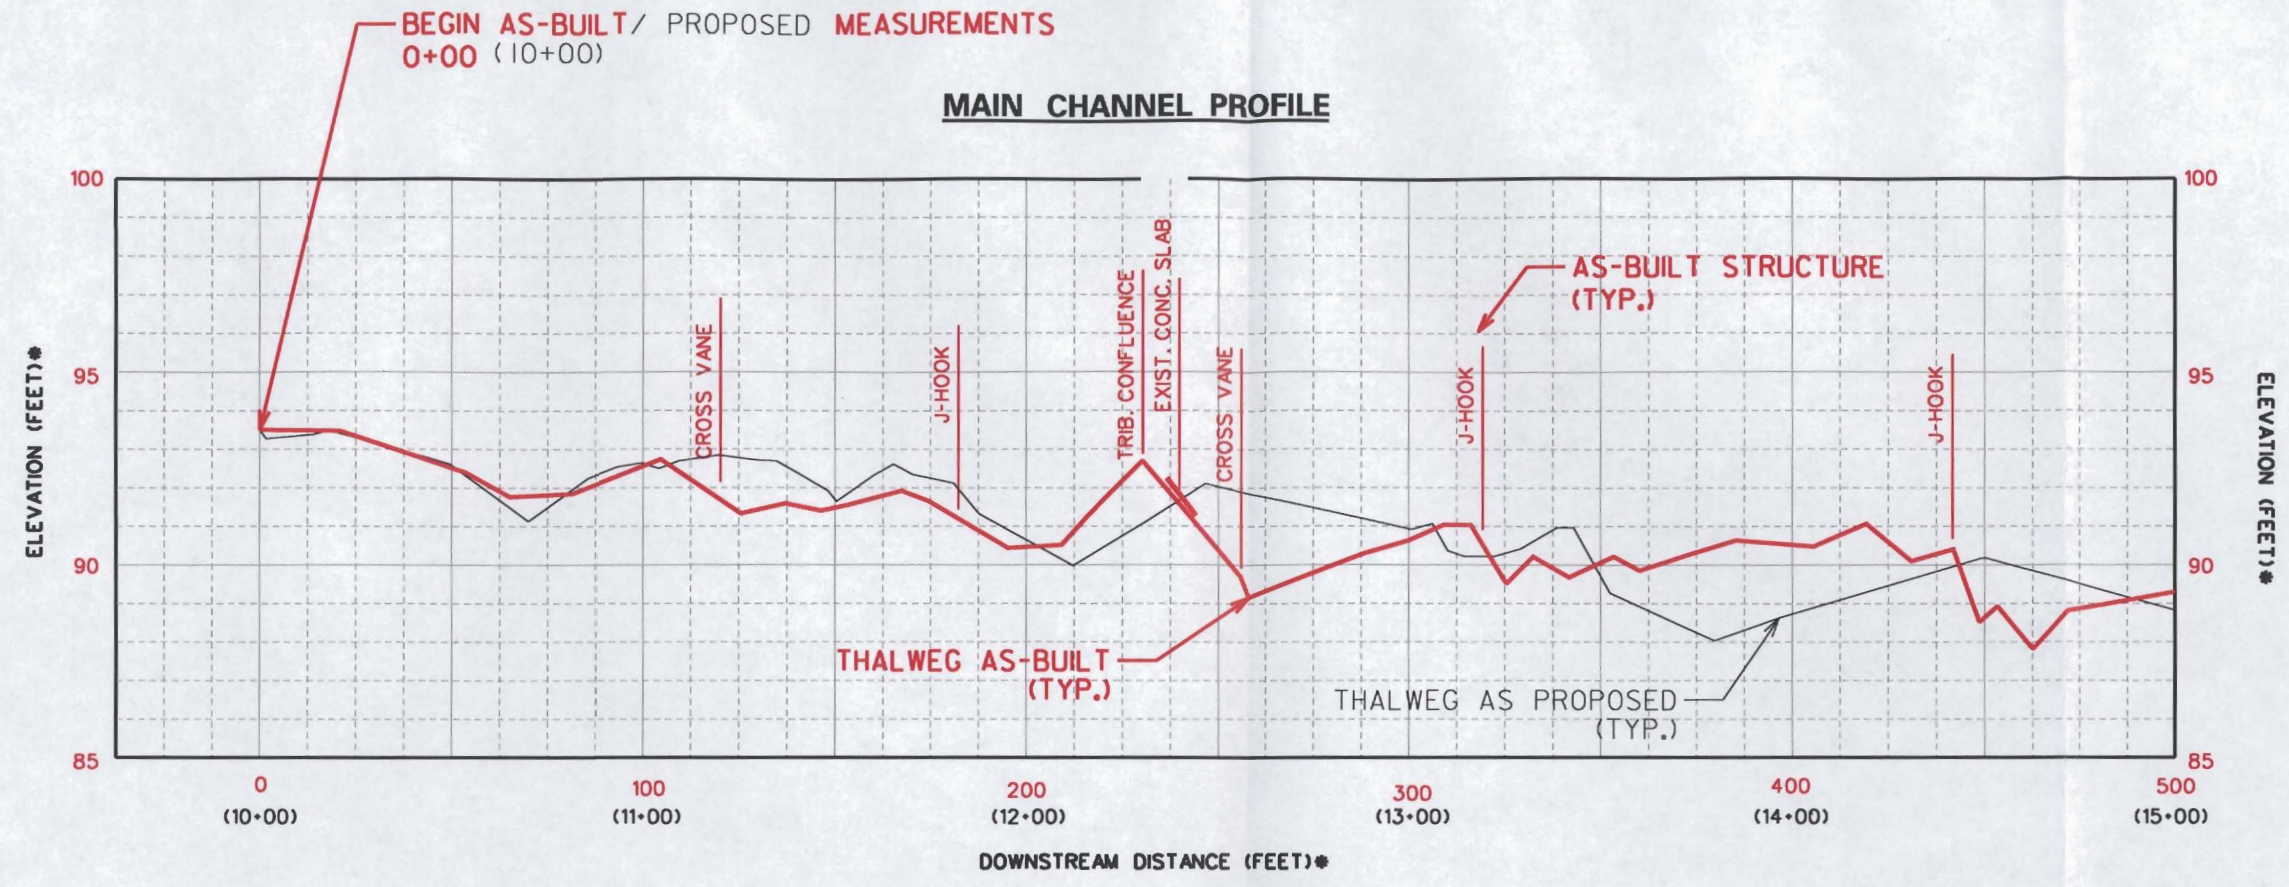
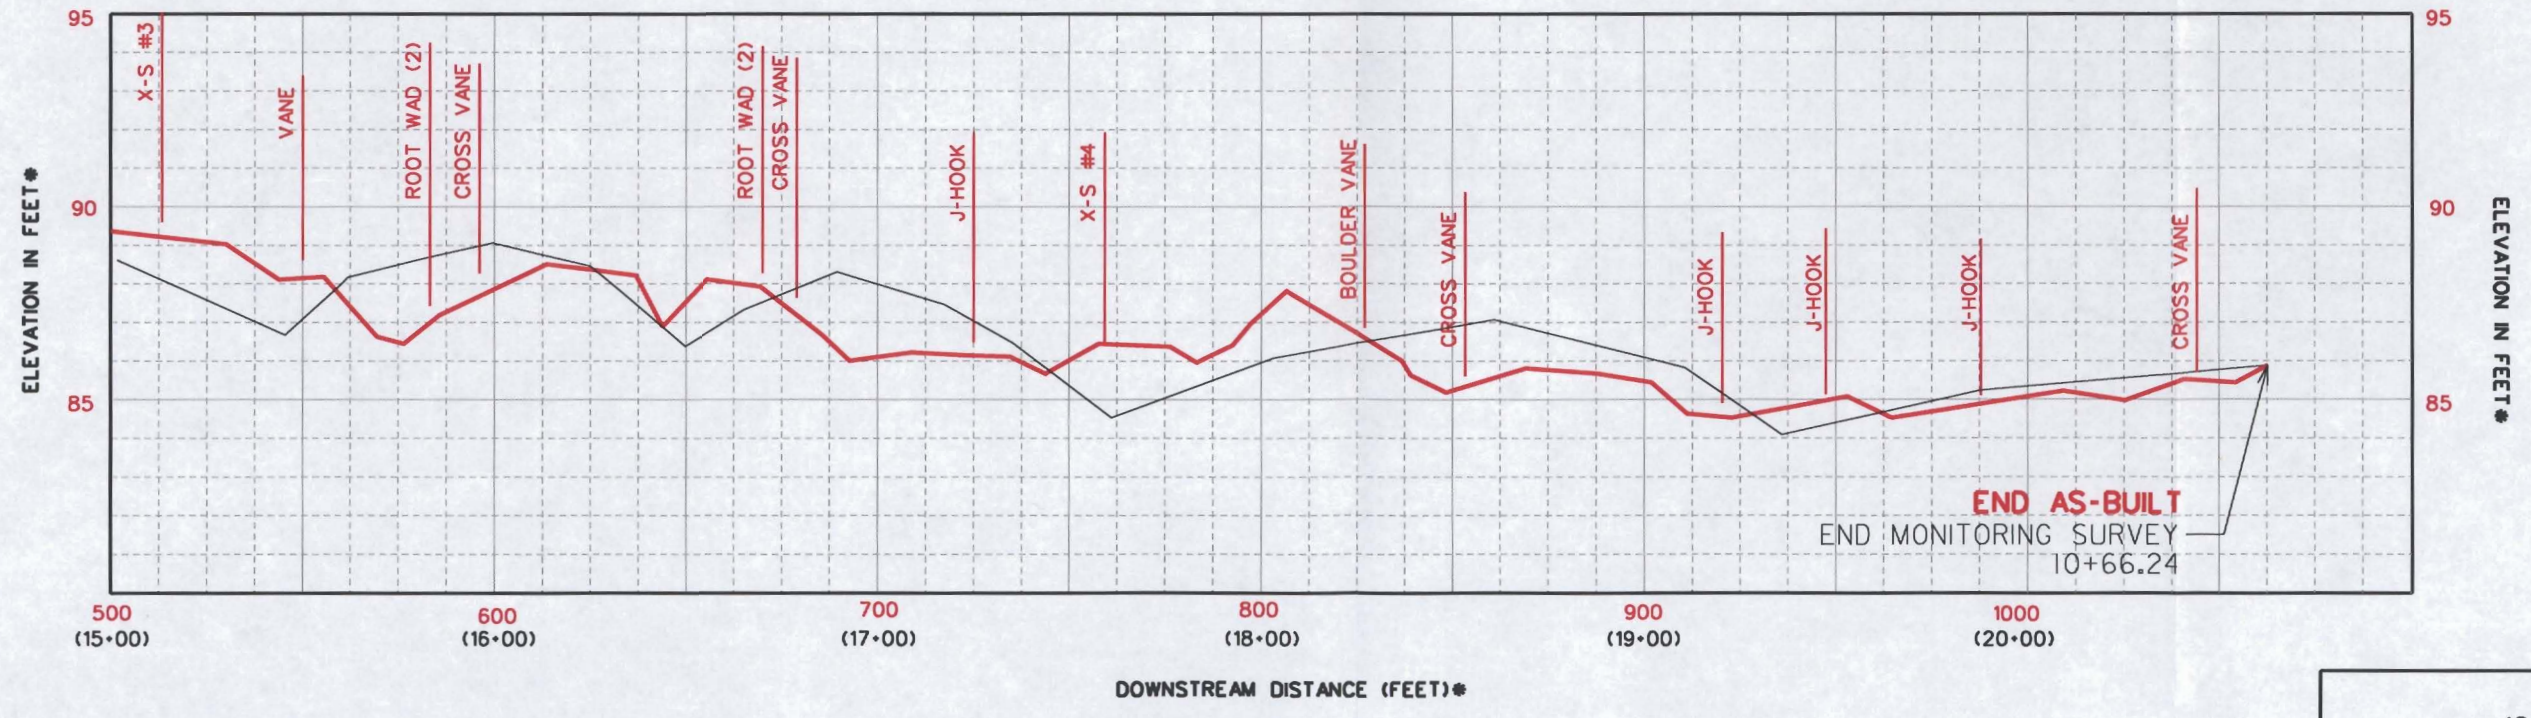
FIGURE
2

*NOTE:
AS-BUILT PROFILE BASED ON CURRENT THALWEG LOCATION WHICH HAS MIGRATED IN SOME PLACES, DUE TO NATURAL STREAM PROCESSES, SINCE CONSTRUCTION IN 2002.

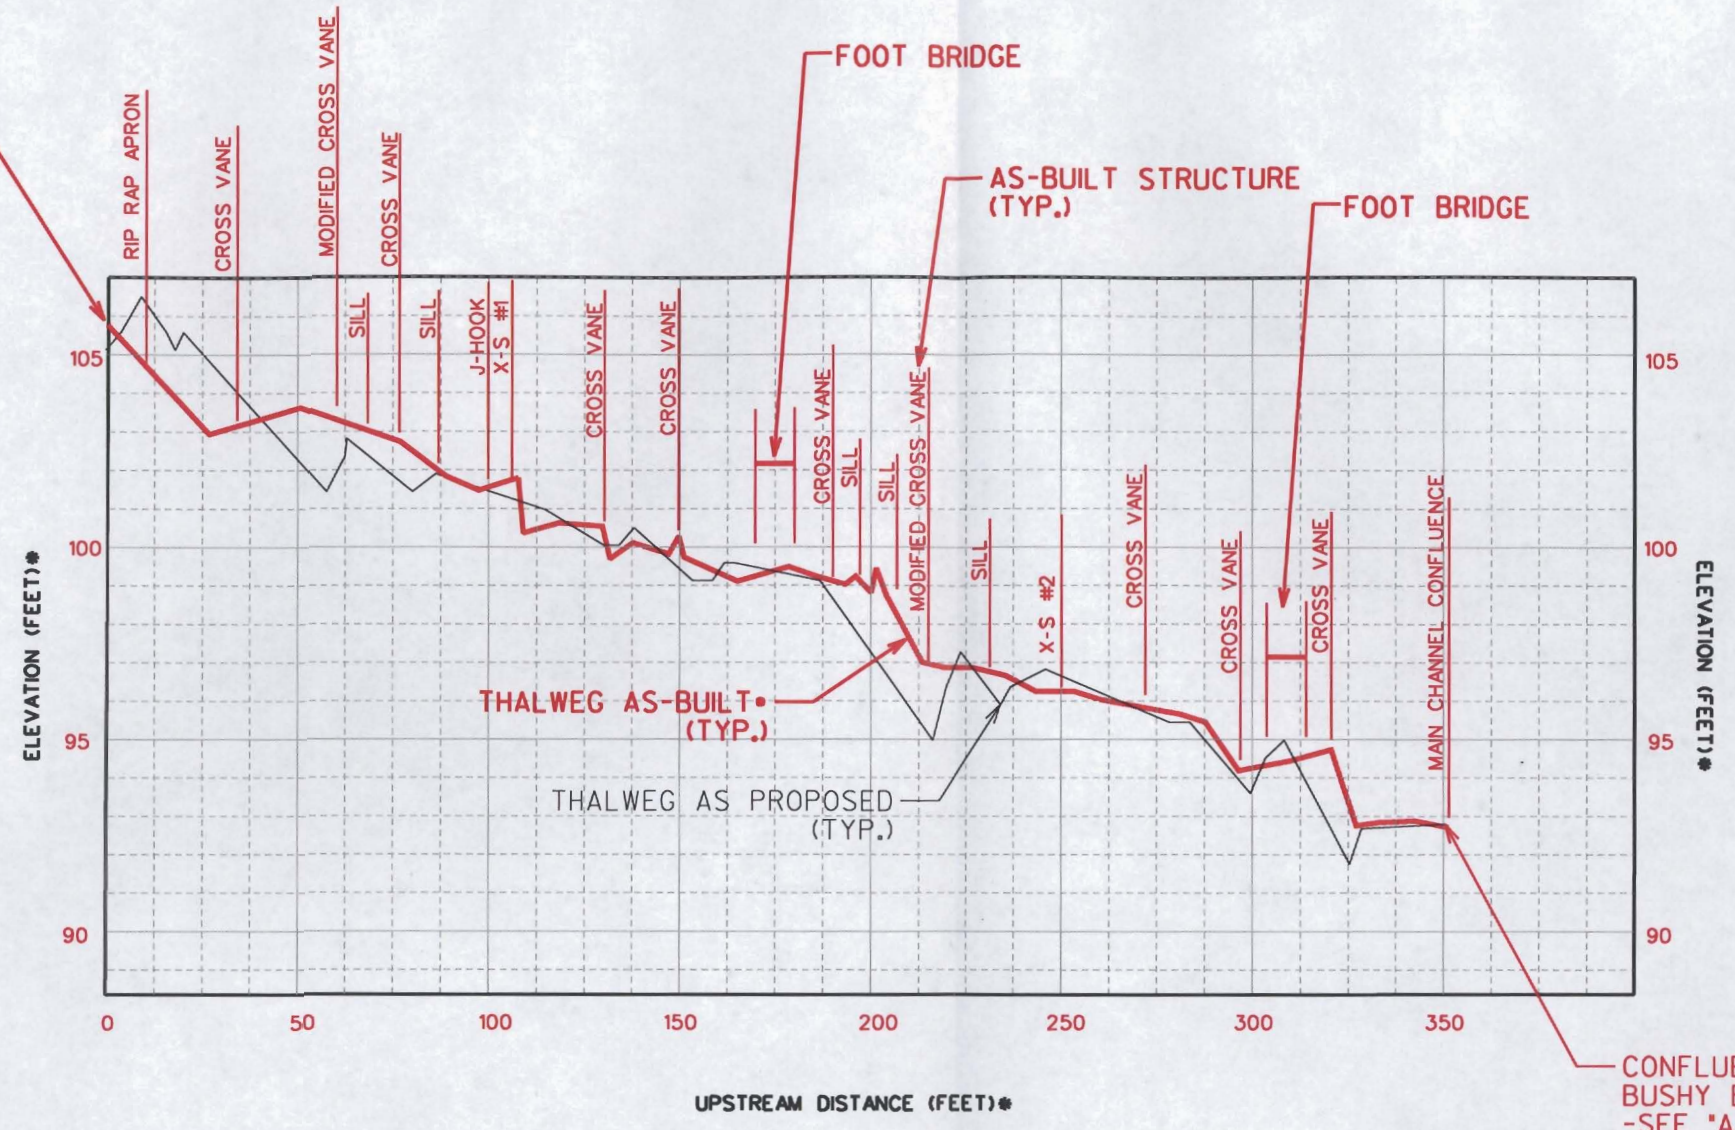
AS-BUILT PROFILE BASED ON CURRENT THALWEG LOCATION WHICH HAS MIGRATED IN SOME PLACES, DUE TO NATURAL STREAM PROCESSES, SINCE CONSTRUCTION IN 2002.

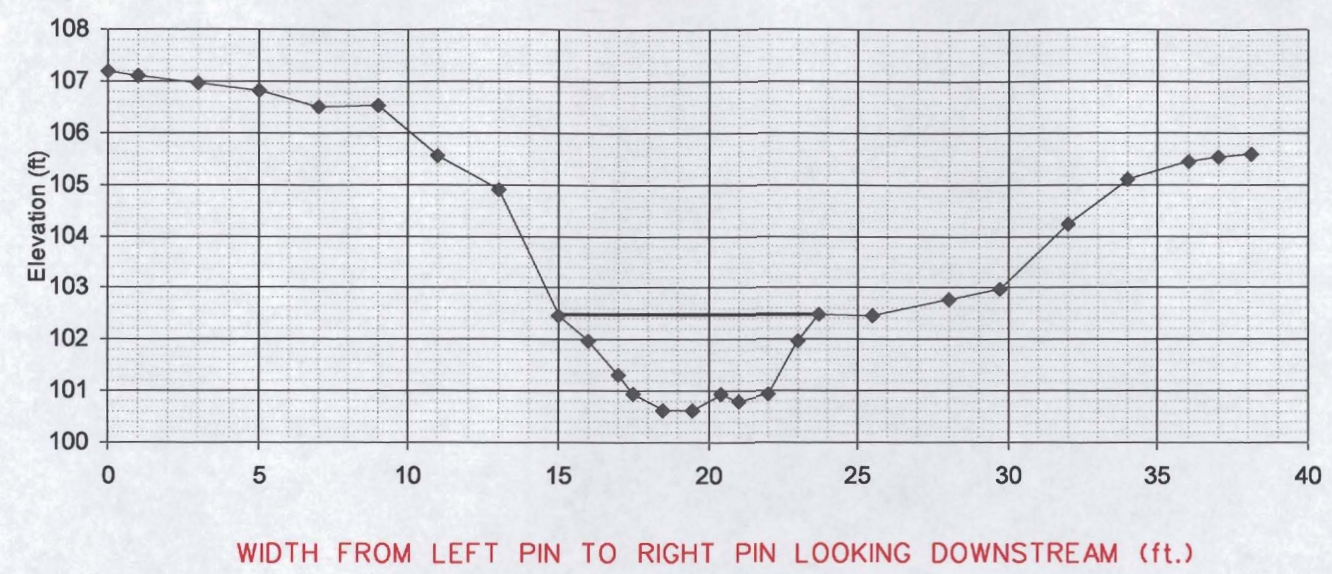
CROSS SECTION 1
UT to Bushy Branch
POOL

Cross Section 1 is located in a pool just upstream of the vegetation monitoring plot on the UT. In this section of stream, the channel was modified with additional cross vane and rock sill structures as shown on the as-built plan. These structures were designed to create bed form features for habitat, as well as to stabilize the channel bed. The banks were stabilized with vegetation.

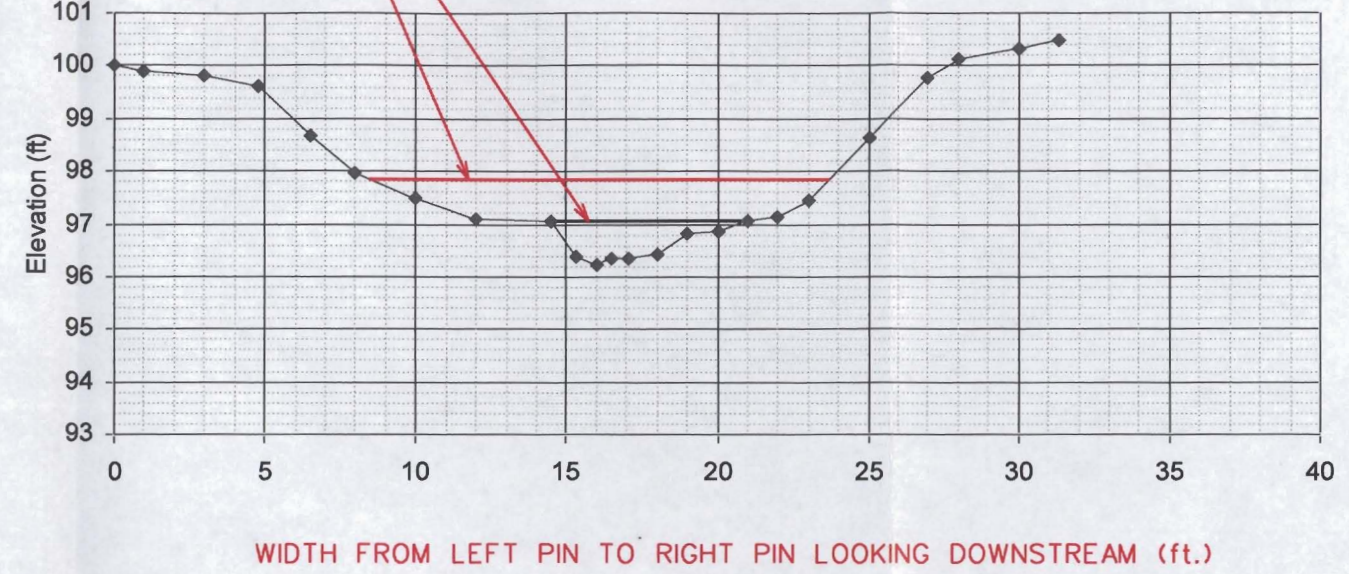
CROSS SECTION 2
UT to Bushy Branch
RIFFLE

Cross Section 2 is located in a riffle on the UT nearly halfway between the two walking bridges. In this portion of the UT, the benches adjacent to the channel are more defined though the overall width of the channel remains consistent. Work in this area includes the addition of cross vane structures for bed stability and grading of the banks to form a floodplain bench. Vegetation was planted throughout the floodplain in order to stabilize the banks.

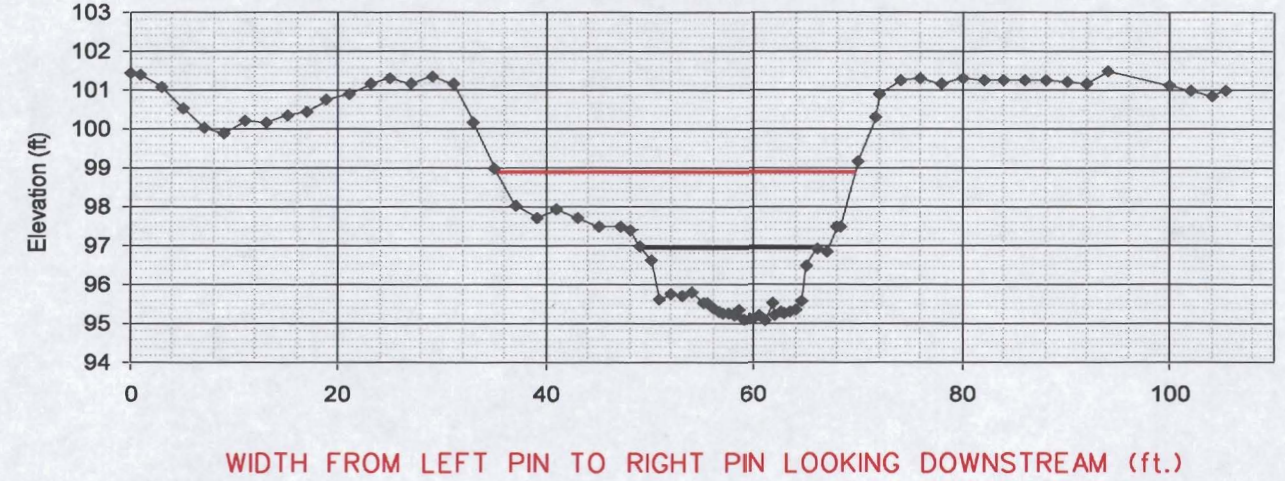
CROSS SECTION 3
Bushy Branch
RIFFLE

Cross Section 3 is located in a riffle on Bushy Branch. In this section, a bench was created in order to allow the stream to overbank in higher flows. Structures were installed to create bed form features for habitat and to stabilize the channel bed.

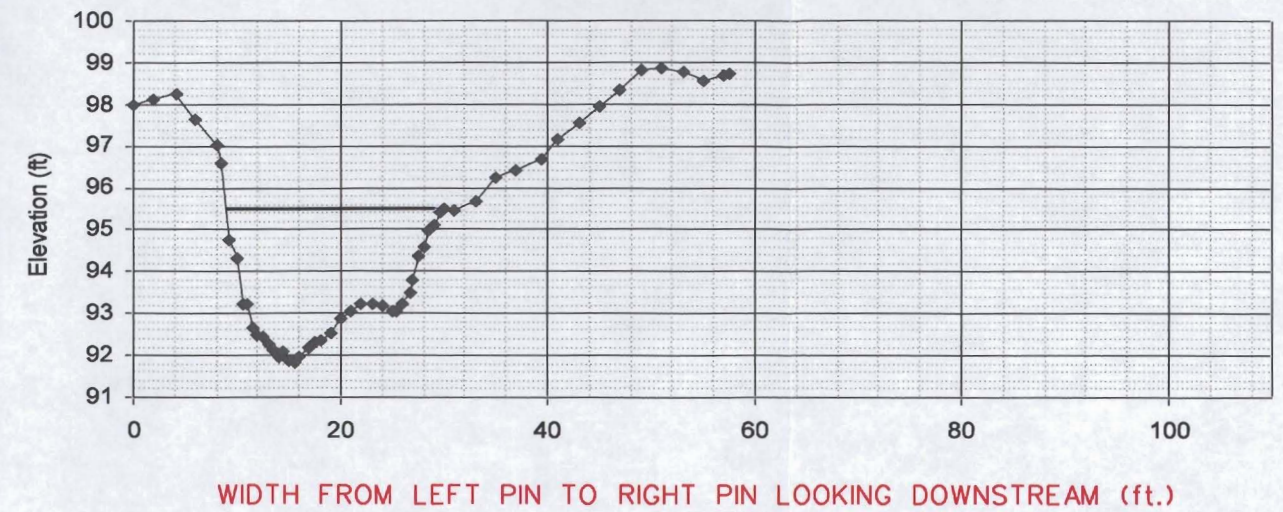
CROSS SECTION 4
Bushy Branch
POOL

Cross Section 4 is located in a pool within the newly located channel near the bottom of the Site. This area was selected as a representative pool cross section for the restored reach of Bushy Branch. No bankfull bench was created in this area, and the formation of a sediment bar is evident on the inside of the meander bend. In this area structures were placed to create bed form features for habitat and to stabilize the channel bed.

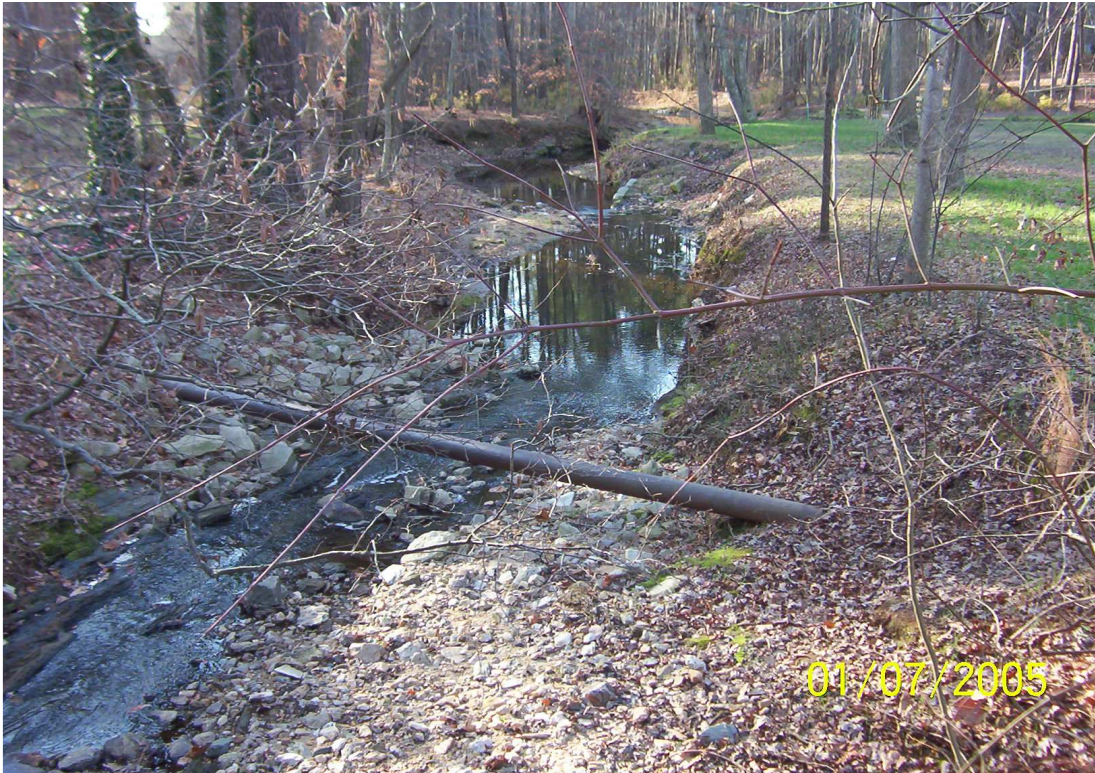
- Photo Location #1: Taken at the top of the box culvert at Kaplan Drive looking downstream on Bushy Branch.
- Photo Location #2: J-hook structure just upstream of the UT confluence, on the east bank. Photos were taken looking upstream and downstream at this location.

Photo Location 1: Standing on Kaplan Road Looking downstream.

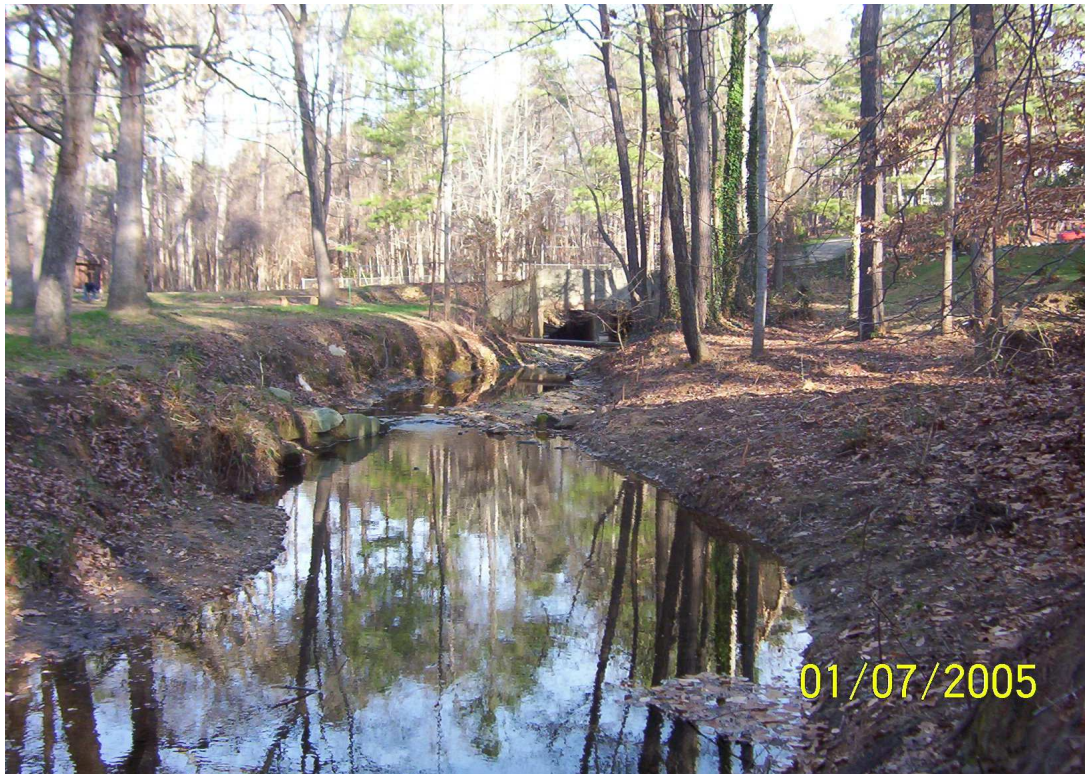
Photo Location 2: at J-hook upstream of confluence, looking upstream toward culvert.

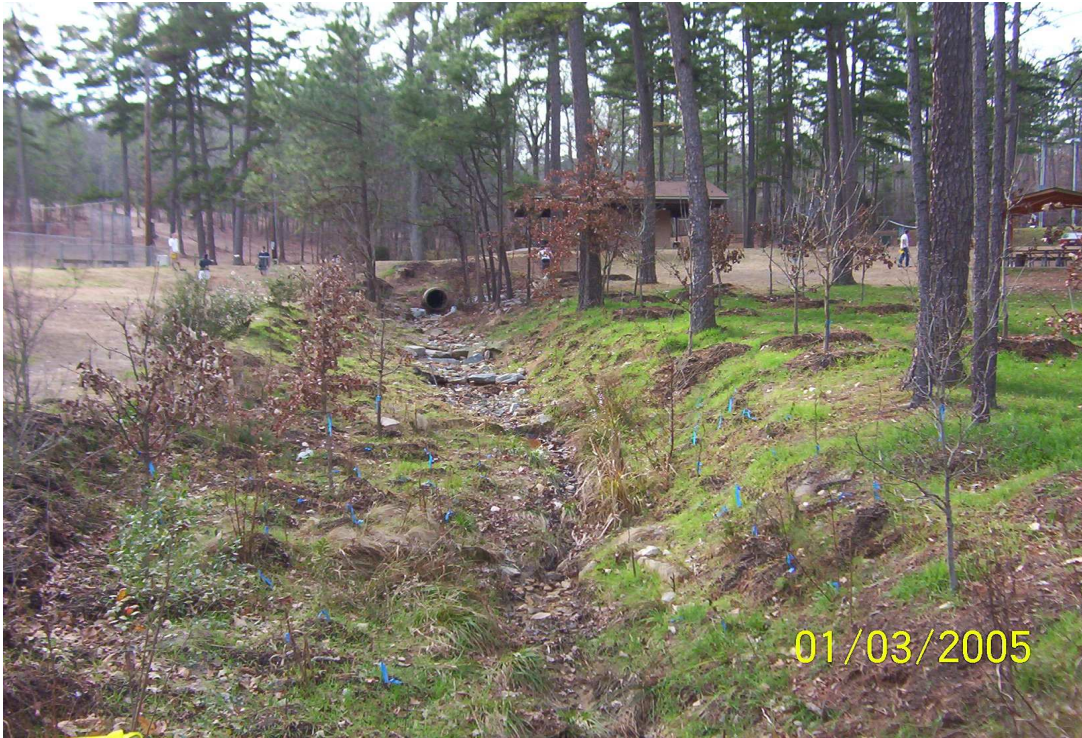
- Photo Location #3: Standing on upstream pedestrian bridge on UT. Upstream picture shows vegetation plot and cross-section 1. Downstream picture shows several structures and cross-section 2.

Photo Location 3: Standing on pedestrian bridge over UT looking upstream

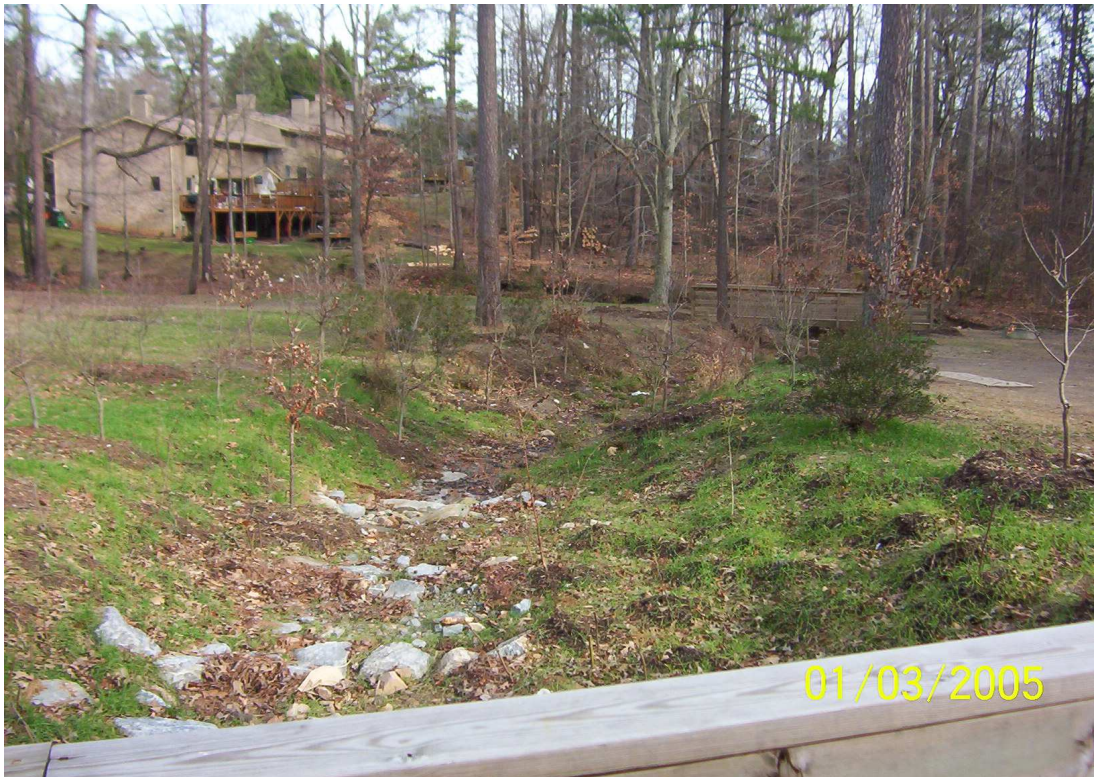
Photo Location 3: Standing on pedestrian bridge over UT looking downstream.

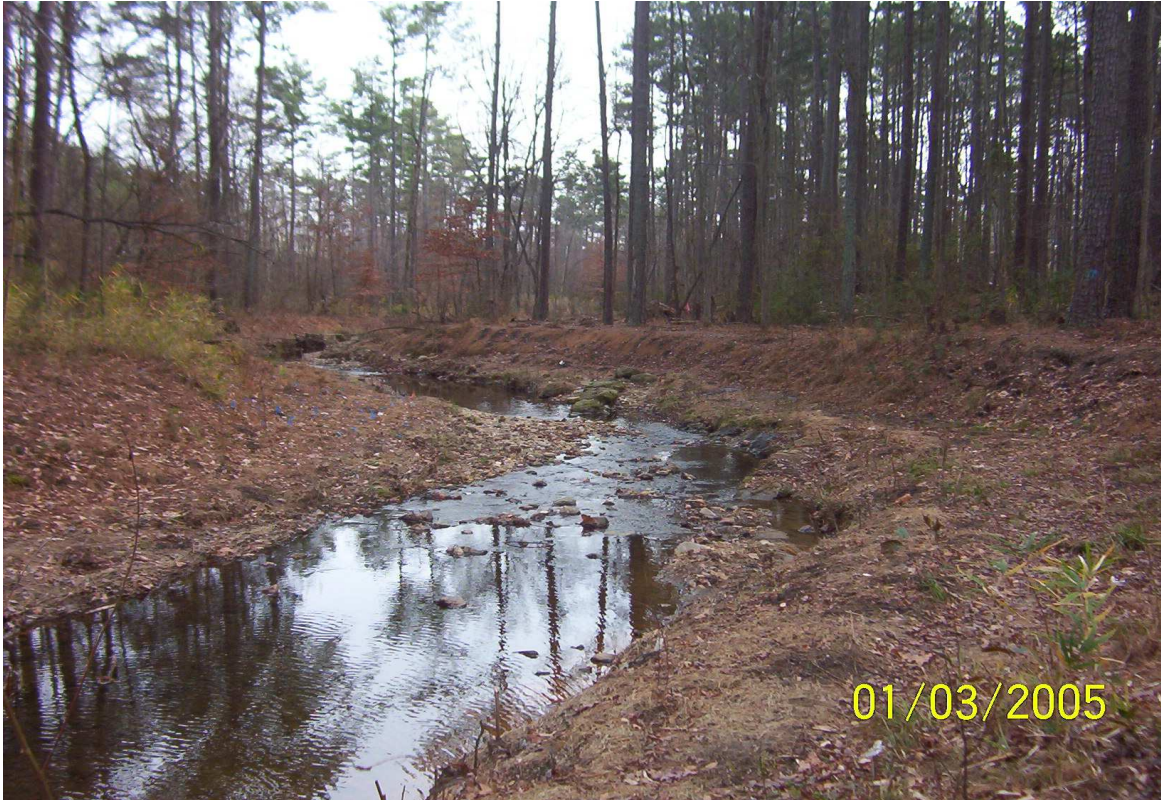
Photo Location 4: Looking downstream toward Vegetation Plot 2 and Cross Section 3

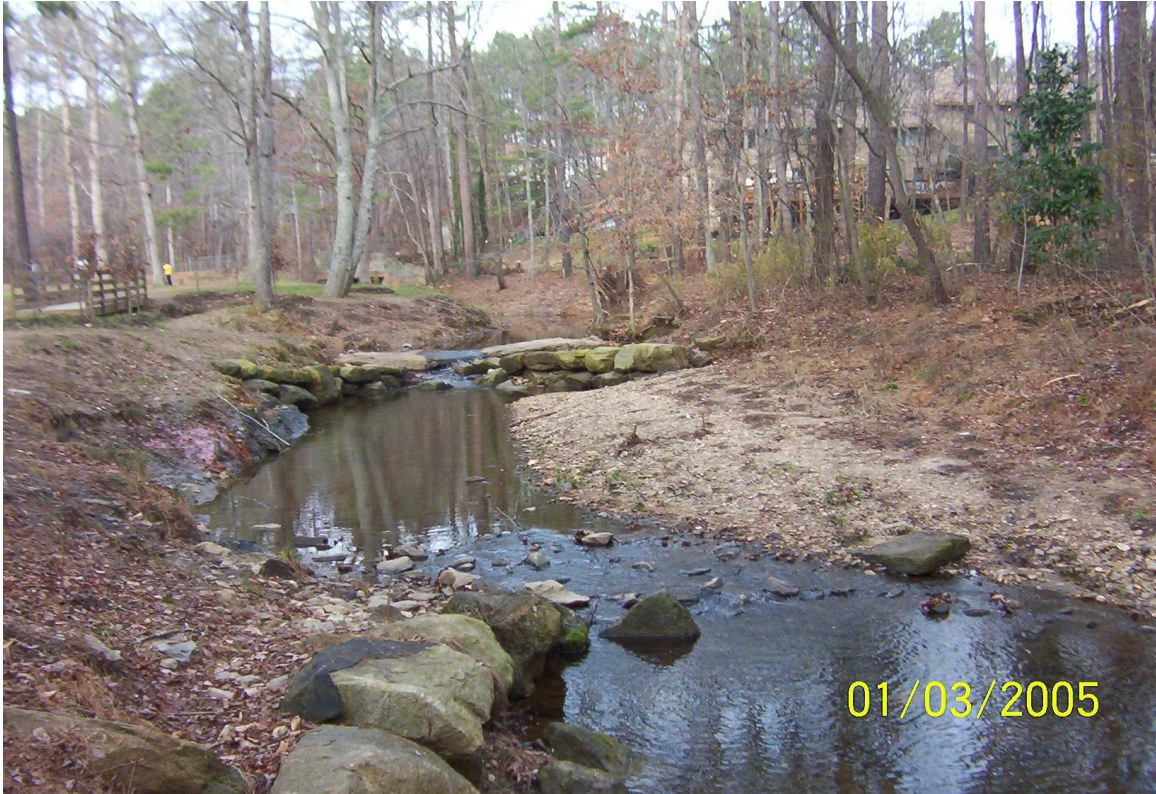
Photo Location 4: Looking upstream toward a J-hook, a cross vane, and the confluence.

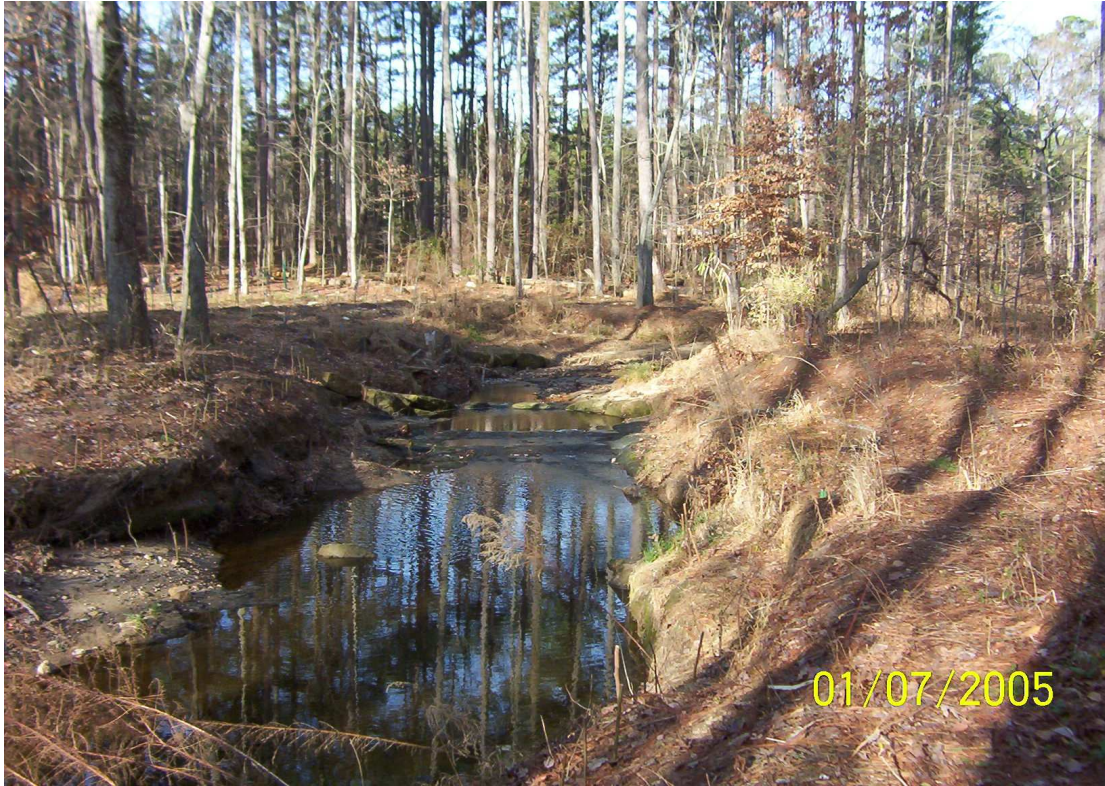
Photo Location 5: At cross section 4 looking upstream toward cross vane and root wads.

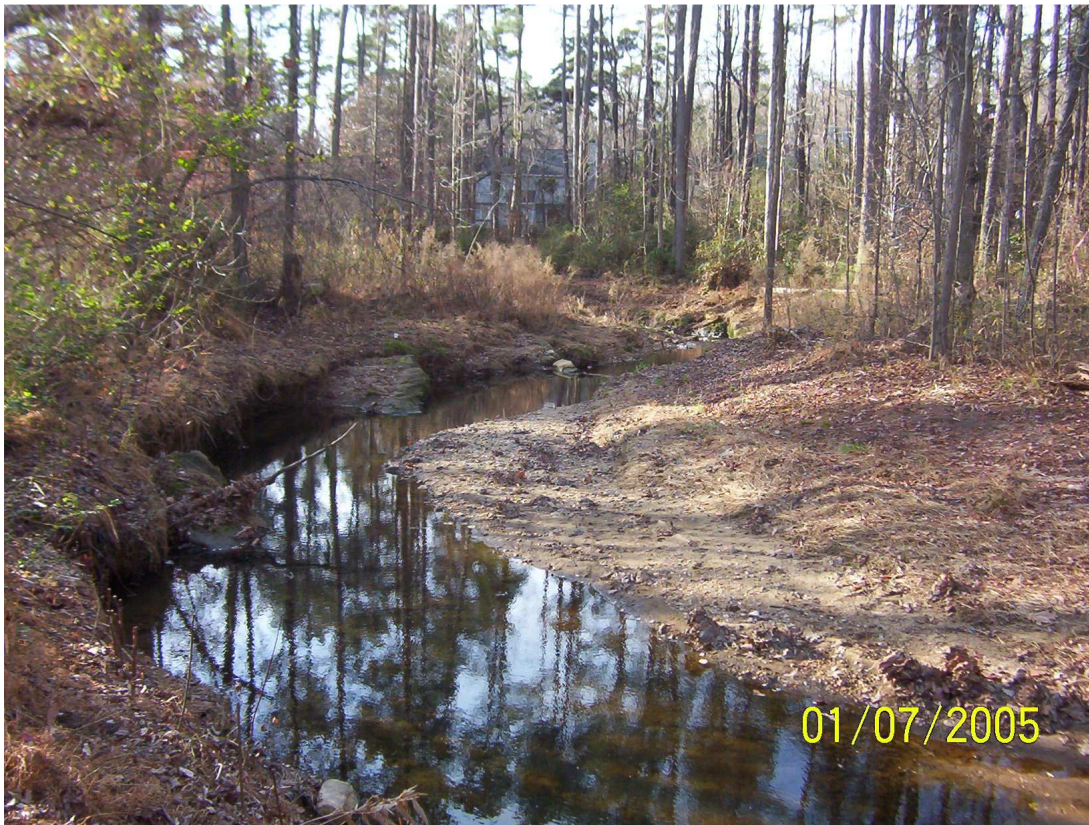
Photo Location 5: At cross section 4 looking downstream toward vane and cross vane.

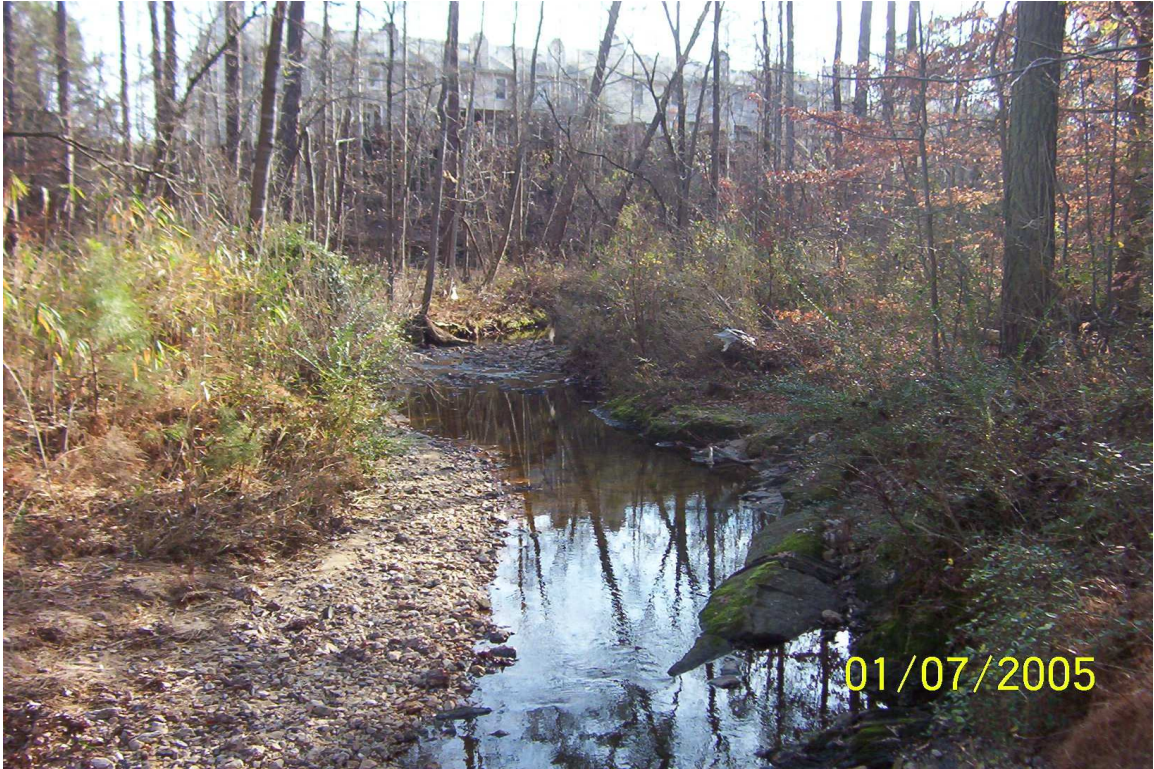
- Photo Location #6: Standing on the west bank at most downstream boulder vane. Downstream photo shows last cross vane as it ties into the existing stream. Upstream photo shows several structures looking toward cross-section 4.

Photo Location 6: West bank at most downstream vane looking toward final cross vane.

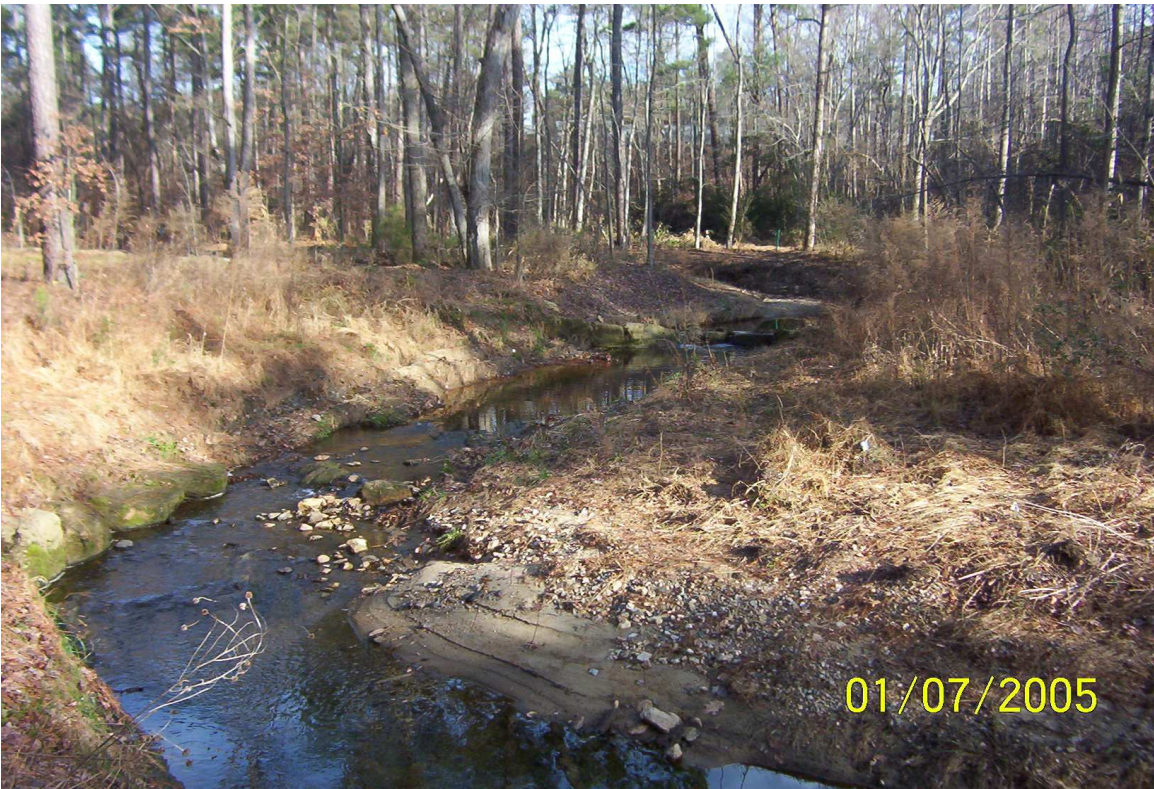
Photo Location 6: At most downstream vane looking upstream toward cross vane and cross-section 4.
