**Kentwood Park (Bushy Branch) Stream
Restoration Monitoring Report
EEP Project # 205
Monitoring Year – 01
2005**

Appendix A2: Vegetative Problem Area Plan View
 Kentwood Park, Wake County, EEP Project Number 205 - MY01

Appendix B1: Stream Problem Area Plan View
 Kentwood Park, Wake County, EEP Project Number 205 - MY01

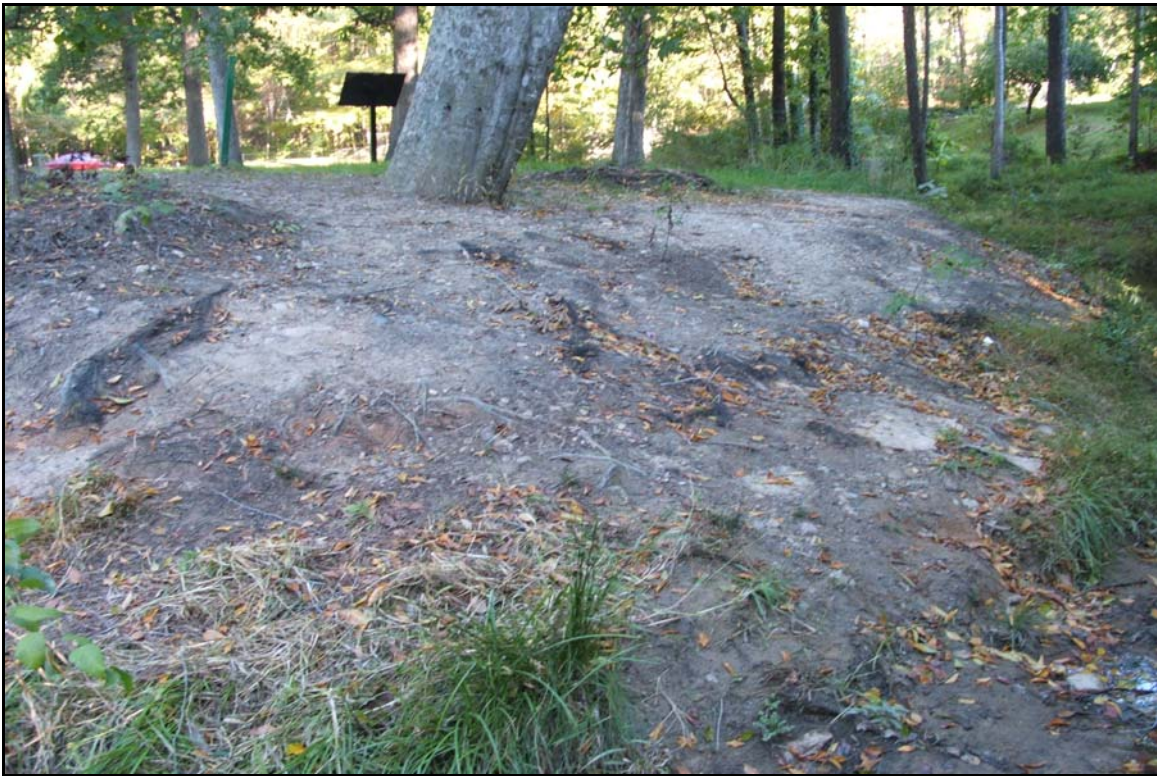
VP1 – Bare terrace occurs near the confluence of Bushy Branch and the UT. Photo taken near station 12+00. 10/27/05 - MY 01

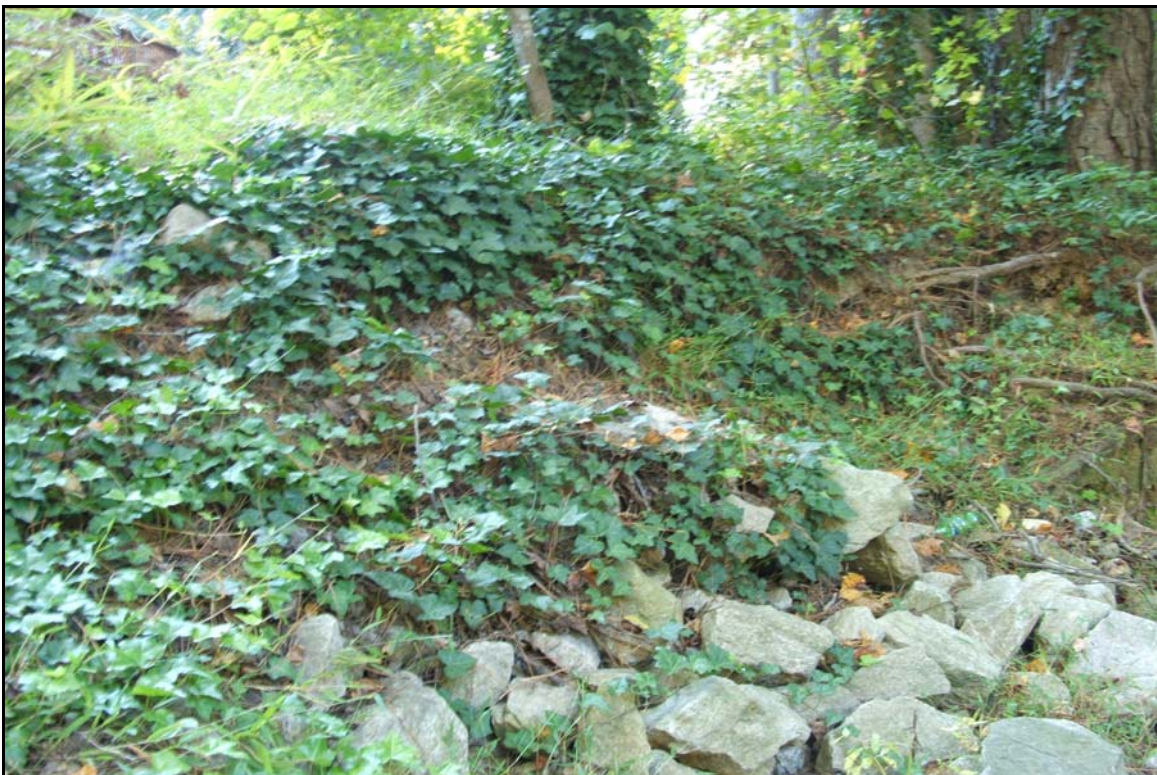
VP2 – English ivy (*Hedera helix*) on stream bank. Photo taken near station 10+25. 10/27/05 - MY 01

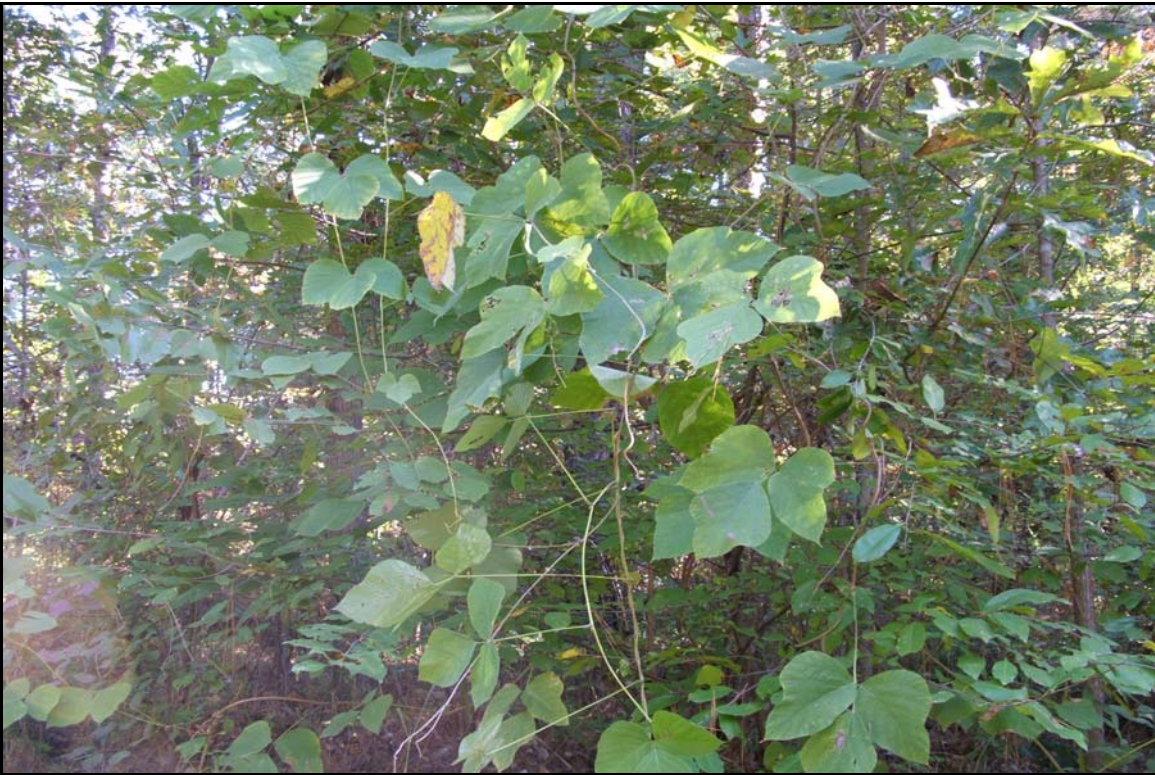
VP3 – Kudzu (*Pueraria lobata*) on tree along stream bank. Photo taken near station 16+25. 10/27/05 - MY 01

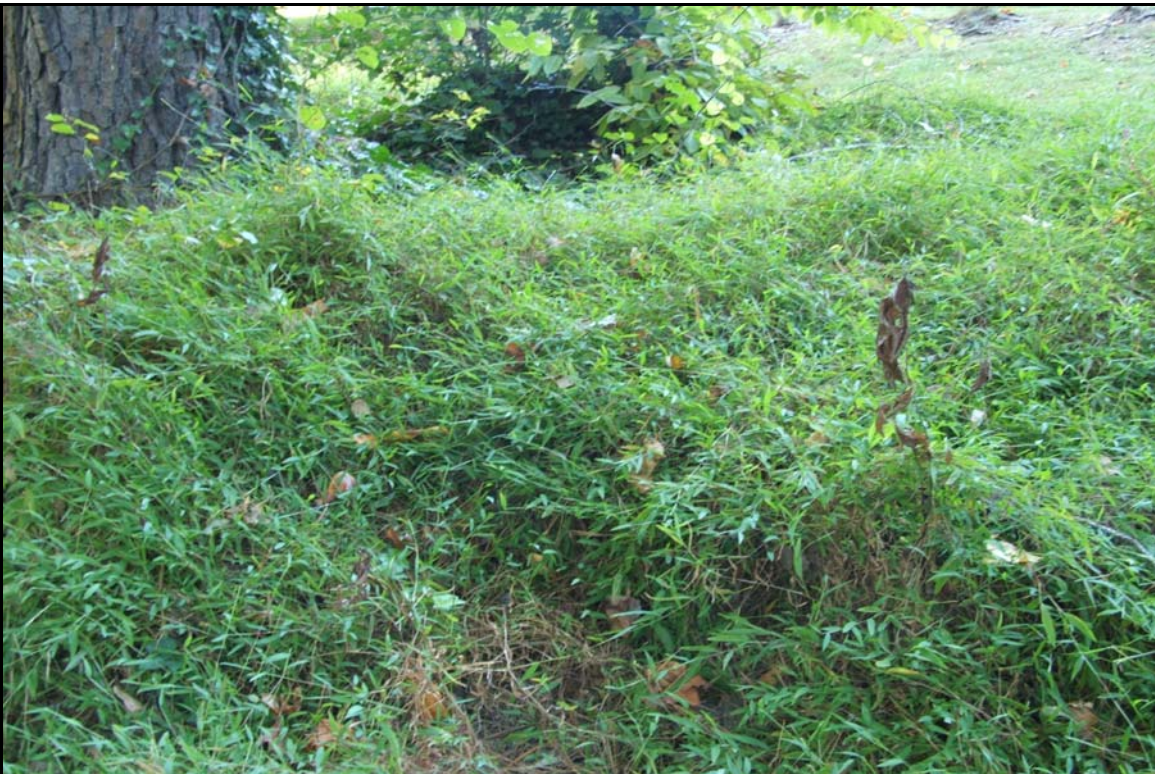
VP4 – Microstegium (*Microstegium vimineum*) covering stream bank. Photo taken near station 10+75. 10/27/05 - MY 01

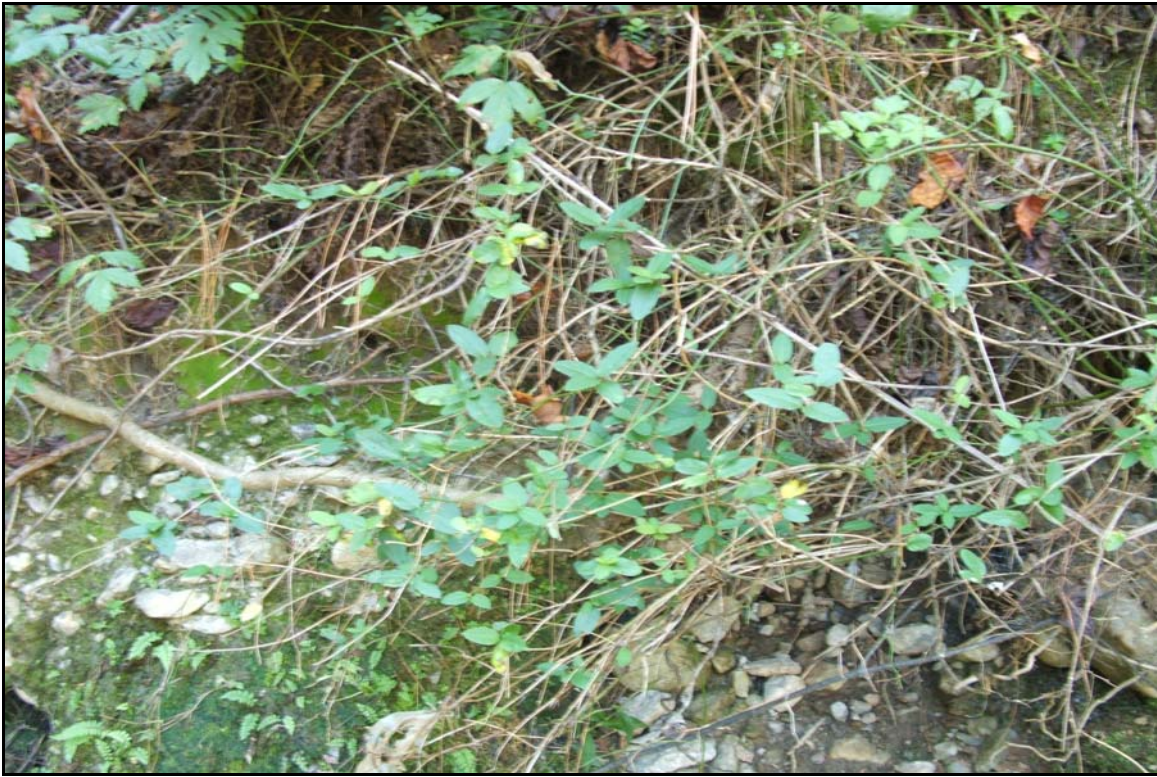
VP5 – Japanese honeysuckle (*Lonicera japonica*) covering stream bank. Photo taken near station 19+60. 10/27/05 - MY 01

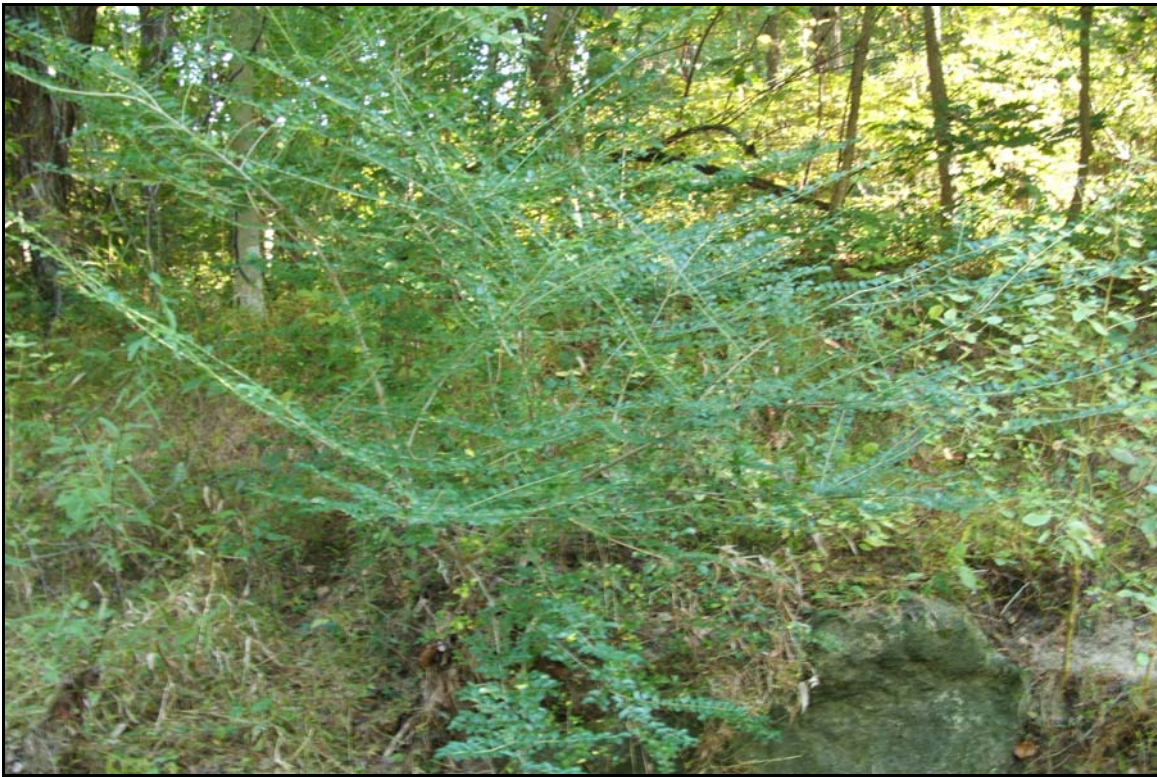
VP6 – Chinese privet (*Ligustrum sinense*) on stream bank. Photo taken near station 15+40. 10/27/05 - MY 01

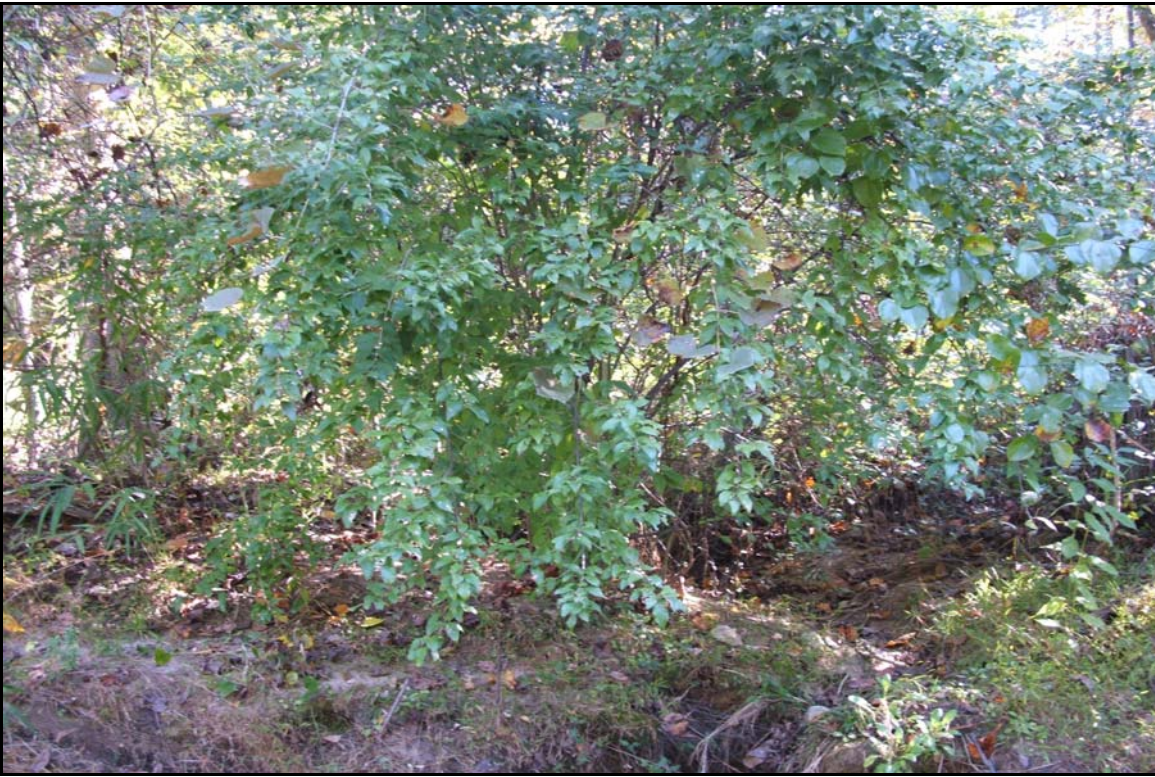
VP7 – Russian olive (*Elaeagnus angustifolia*) on stream bank. Photo taken near station 17+75. 10/27/05 - MY 01

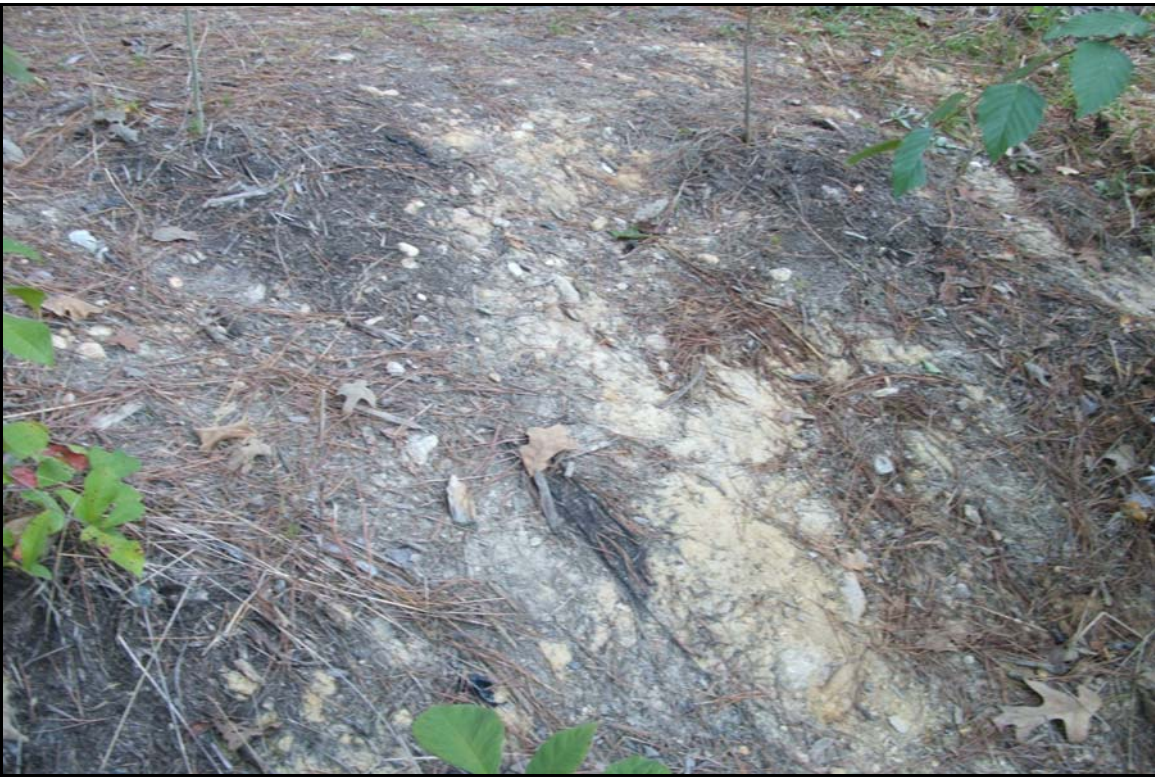
VP8 – Breakdown of geogrid stabilization, with bare subsoil exposed on stream bank. Photo taken near station 00+30. 10/27/05 - MY 01

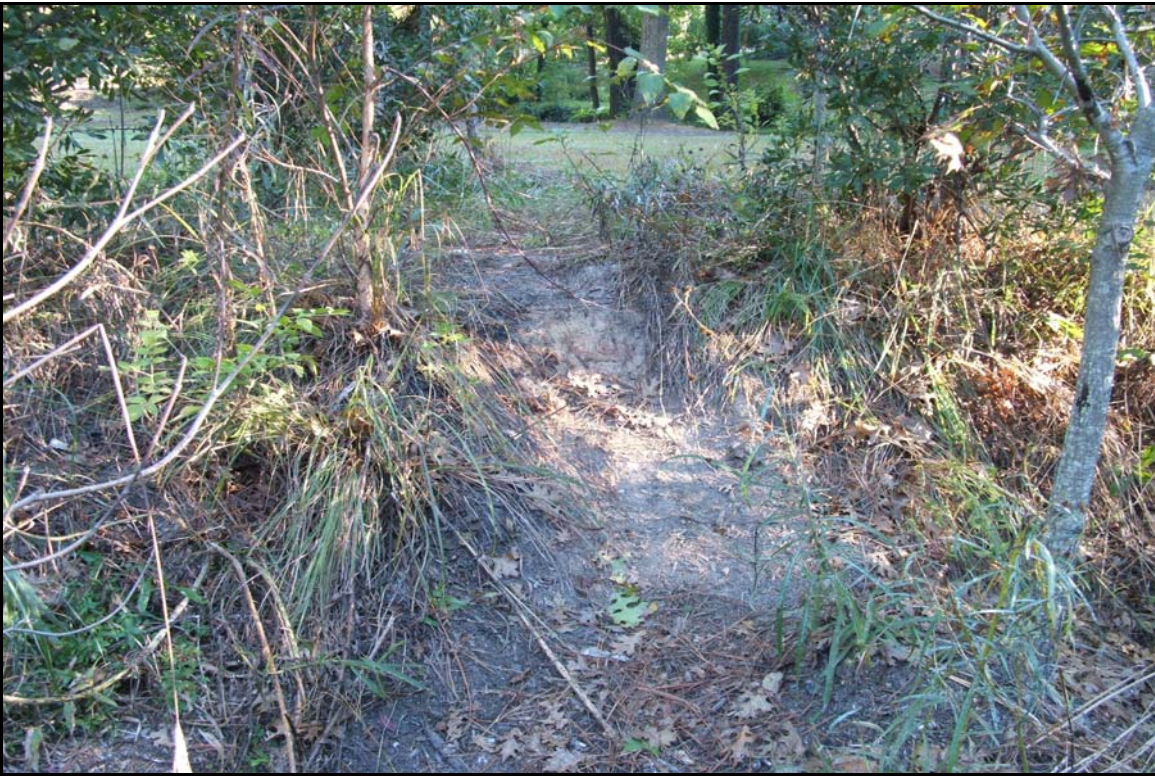
VP9 – Path worn into stream bank from people access and crossing the stream. Photo taken near station 02+60.
10/27/05 - MY 01

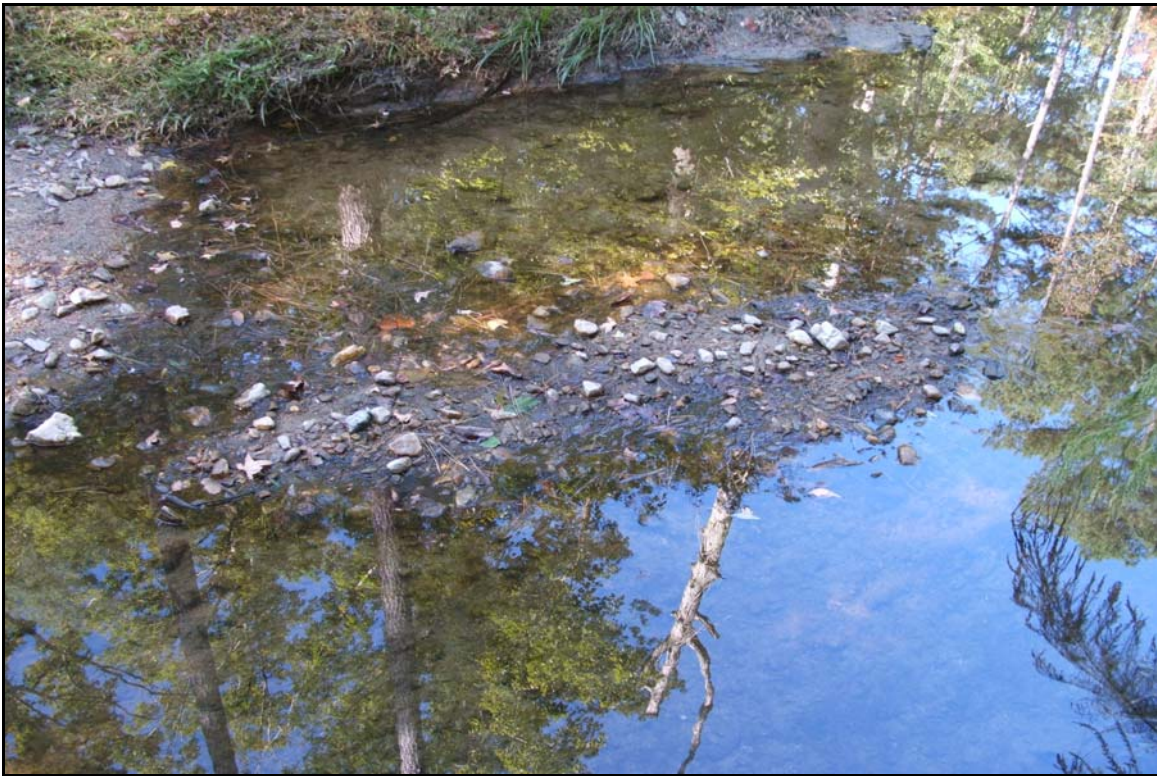
SP1 – Mid-channel bar forming. Photo taken near station 16+70. 10/27/05 - MY 01

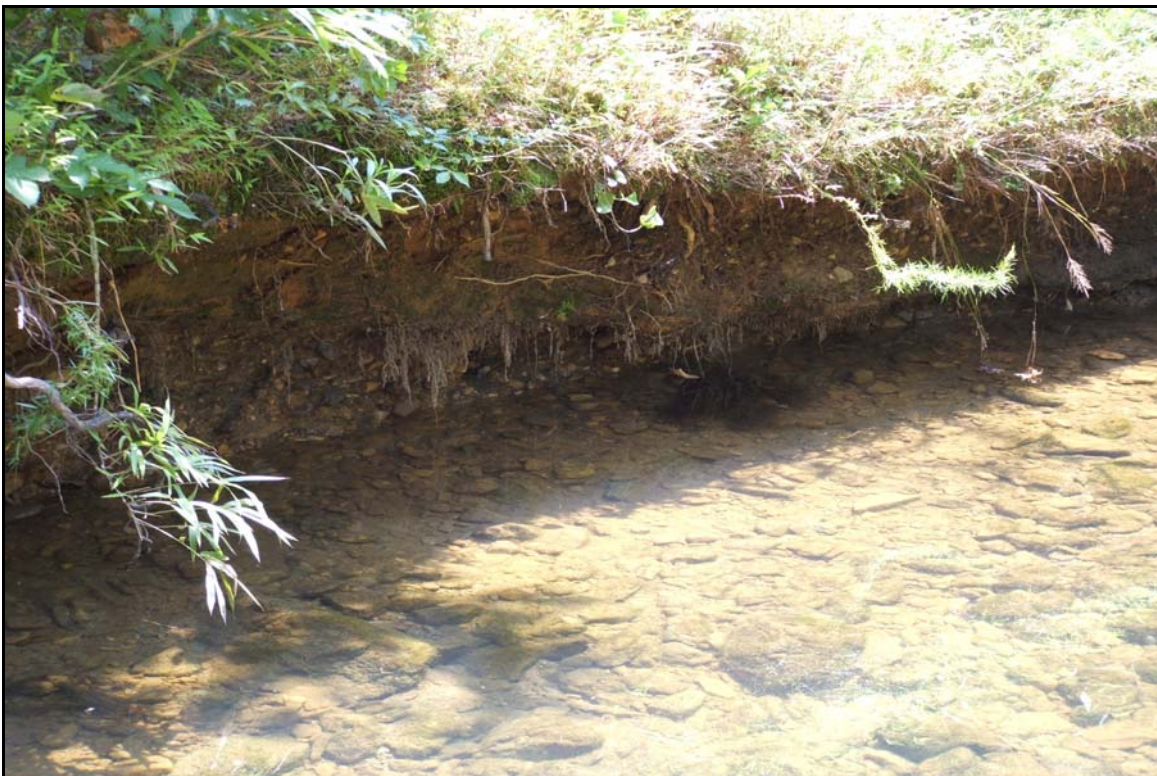
SP2 – Bank erosion. Photo taken near station 18+00. 10/27/05 - MY 01

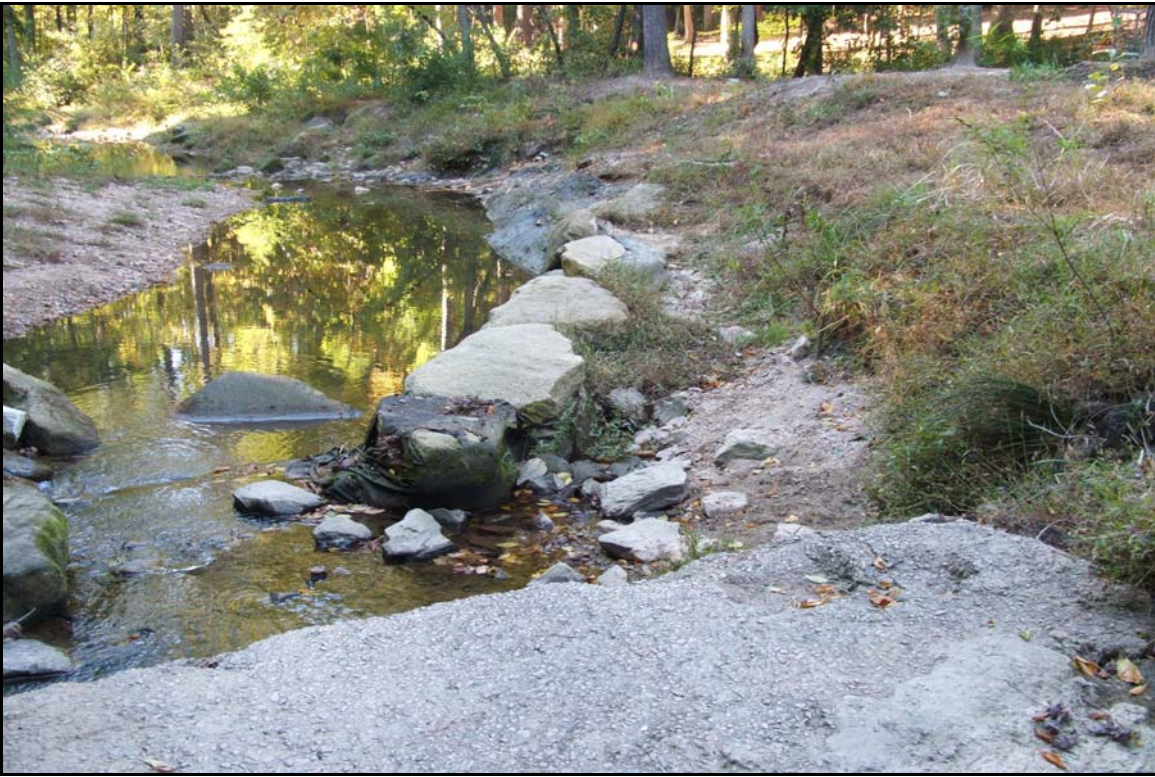
SP3 – Back arm scour on right arm of cross vane. Photo taken near station 12+60. 10/27/05 - MY 01

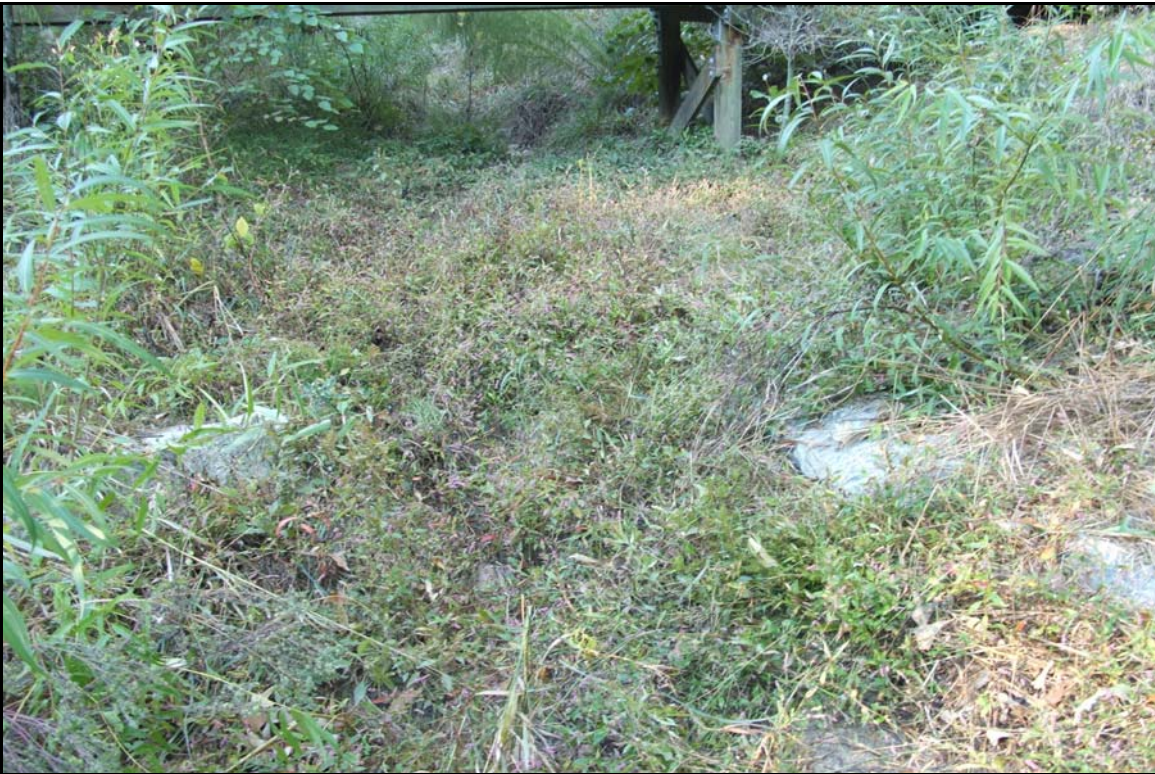
SP4 – Bed aggradation and weedy growth in channel. Photo taken near station 02+00. 10/27/05 - MY 01

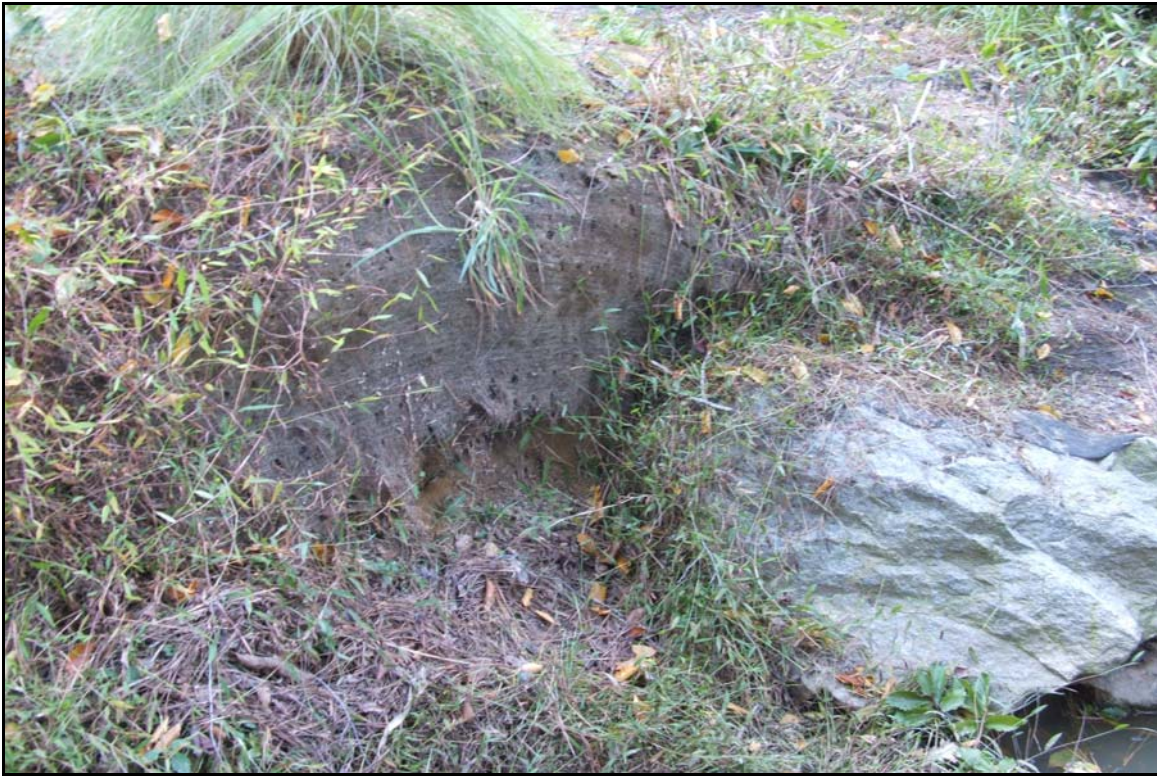
SP5 – Unstable, steep bank on UT to Bushy Creek, near confluence with Busy Creek. Photo taken near station 03+30. 10/27/05 - MY 01

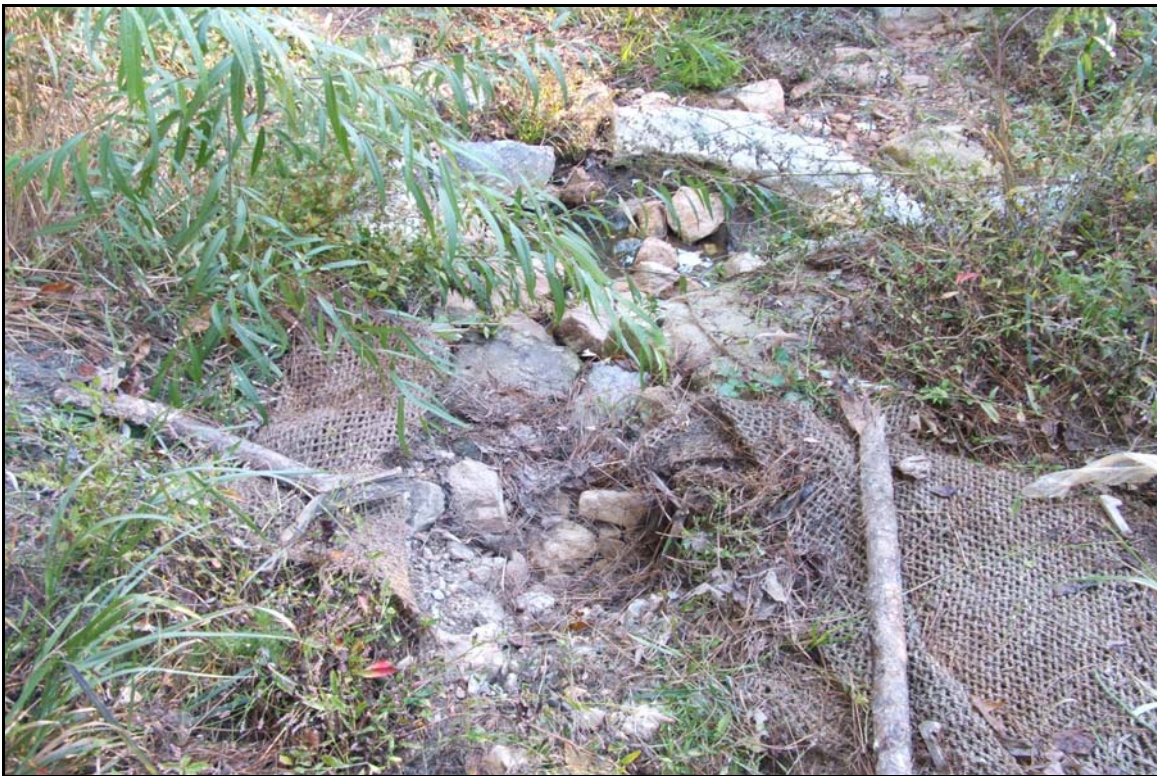
SP6 – Hole degrading on upstream side of cross vane. Photo taken near station 02+25. 10/27/05 - MY 01
