**Kentwood Park (Bushy Branch) Stream
Restoration Monitoring Report
EEP Project # 205
Monitoring Year – 02
2006**

January 2007

KENTWOOD PARK (BUSHY BRANCH)
MONITORING PLAN VIEW
WAKE COUNTY
EEP PROJECT NUMBER 205 - MY02

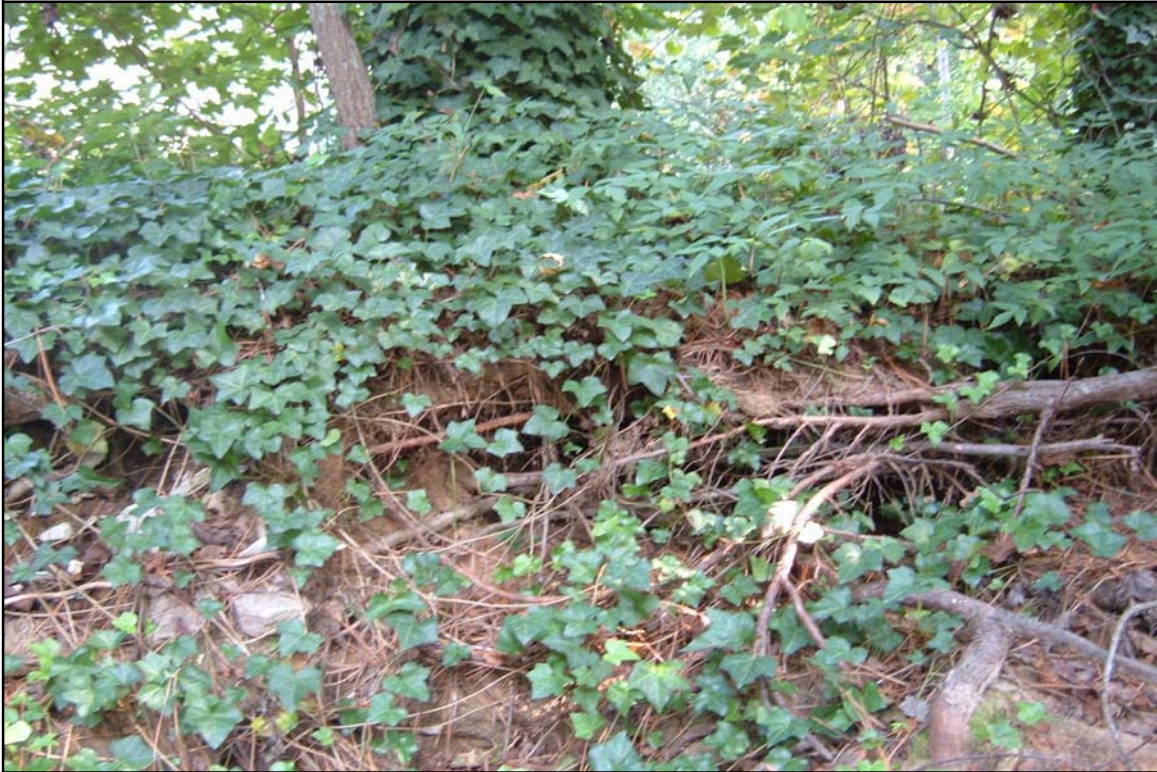
Table A3a. Vegetative Problem Areas			
Project Number and Name: 205 – Kentwood Park (Bushy Branch)			
Segment/Reach: Bushy Branch (1,070 ft.)			
Feature/Issue	Station # / Range	Probable Cause	Photo #
Bare Terrace	10+50 - 11+10	Foot traffic from disc golf course	
	11+50 - 12+00	Foot traffic from disc golf course	
Invasive/Exotic Population	10+00 - 10+50	English Ivy: encroachment from outside project	VP1
	16+00 - 16+75 and 19+25 - 19+75	Kudzu: unknown	VP2
	Scattered Throughout	Mimosa: outside seed source	VP2
	Heavy Throughout	Microstegium: previously established	VP3
	Scattered Throughout	Japanese honeysuckle: previously established	
	Scattered Throughout	Chinese privet: previously established	
	Scattered Throughout	Thorny olive: previously established	VP4

VP1 – English ivy (*Hedera helix*) on stream bank. Photo taken near station 10+25. 10/5/06 - MY 02

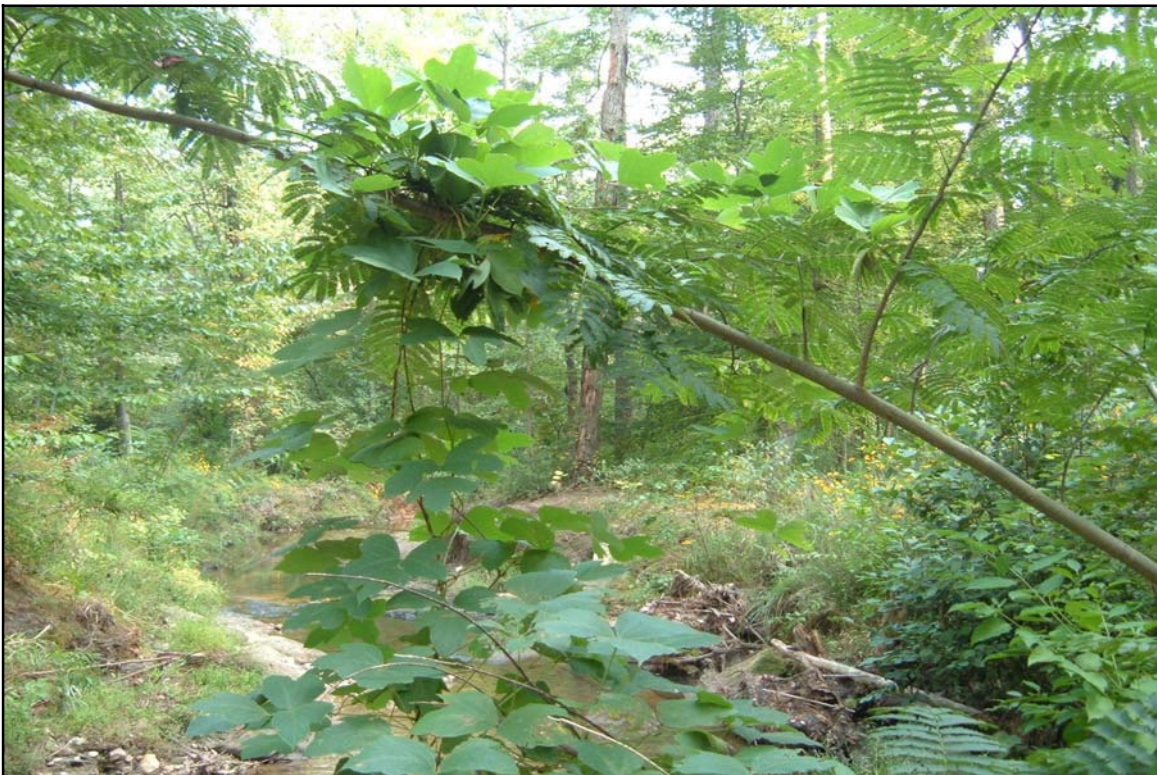
VP2 – Kudzu (*Pueraria lobata*) on mimosa (*Albizia julibrissin*) along stream bank. Photo taken near station 16+75. 10/5/06 - MY 02

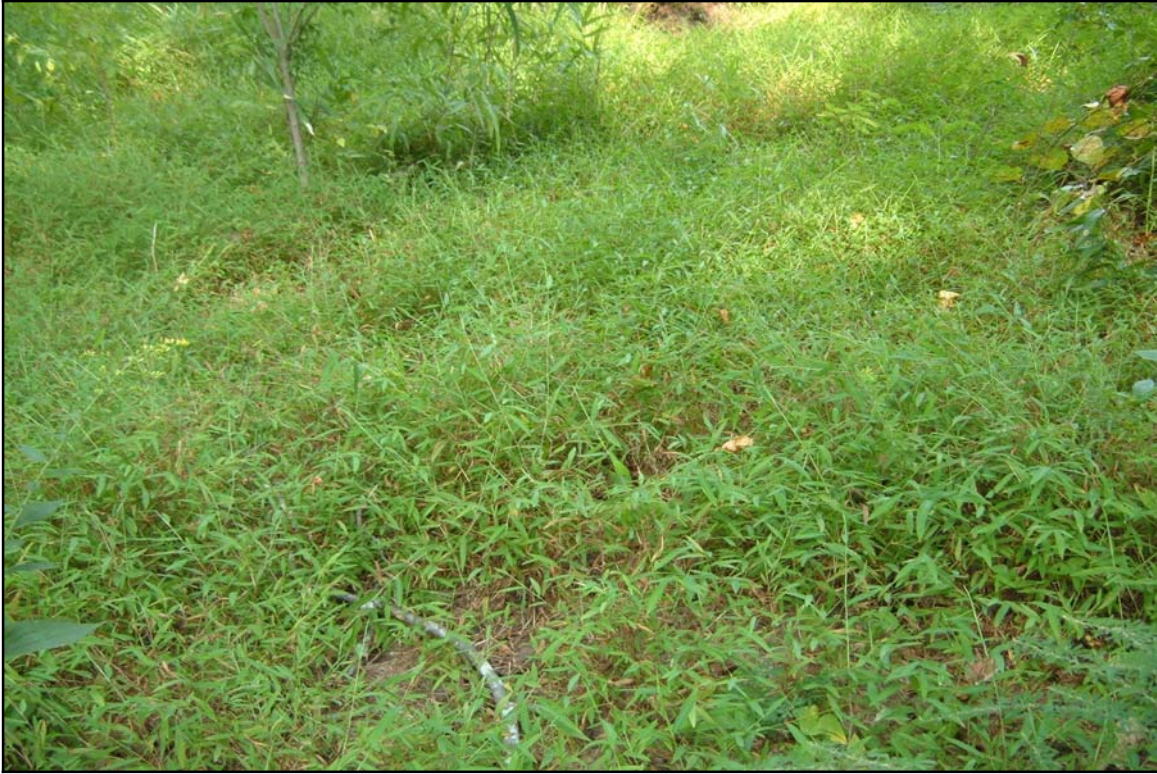
VP3 – *Microstegium* (*Microstegium vimineum*) covering stream bank. Photo taken near station 11+15. 10/5/06 - MY 02

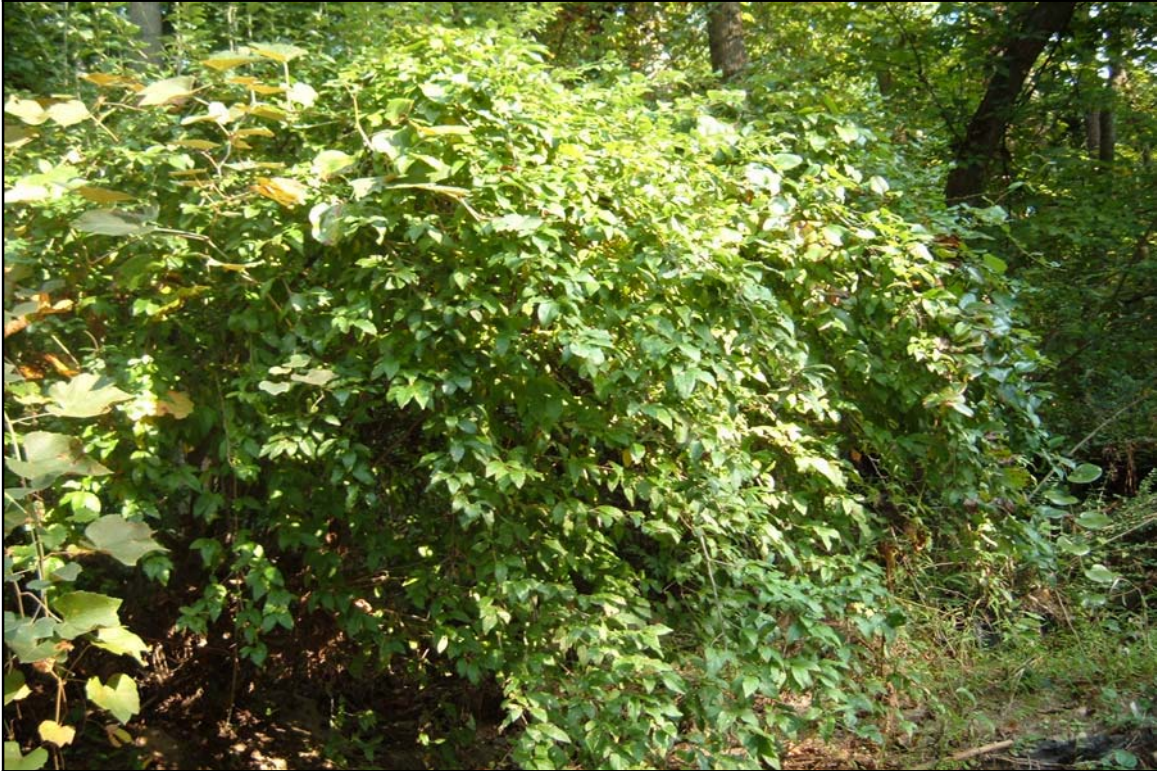
VP4 – Thorny olive (*Elaeagnus pungens*) on stream bank. Photo taken near station 17+75. 10/5/06 - MY 02

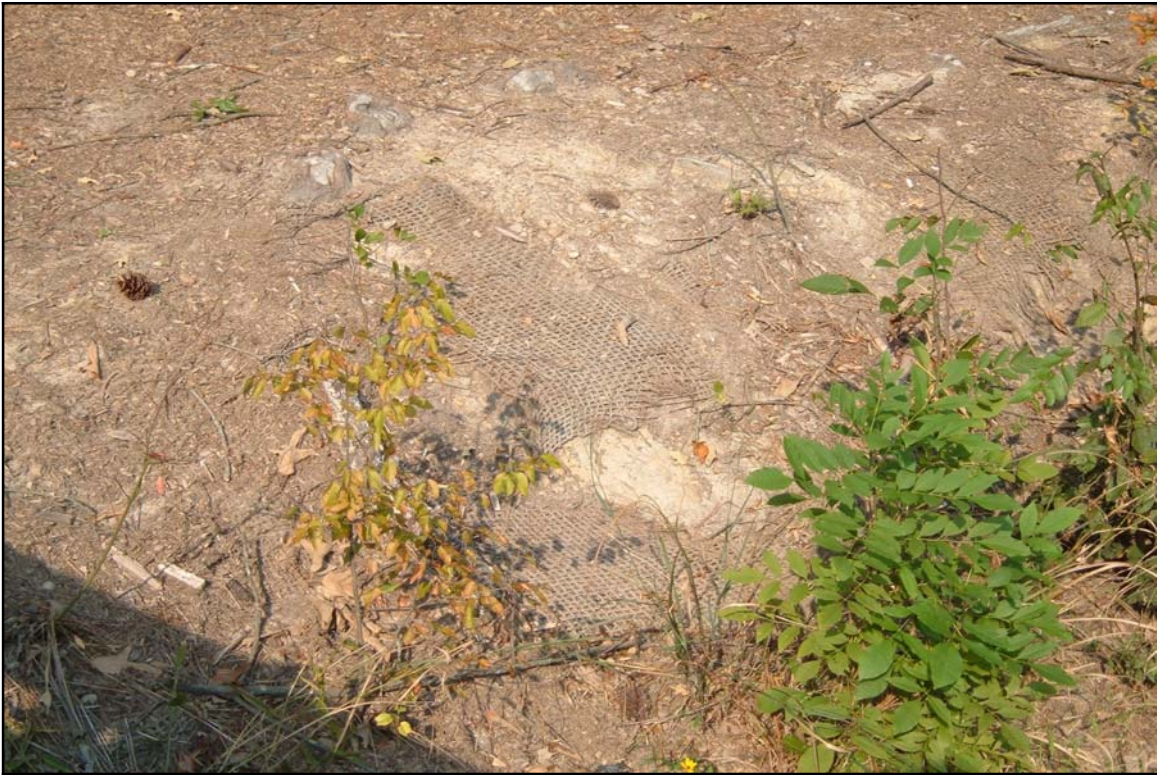
VP5 – Breakdown of coir matting, with bare subsoil exposed on stream bank. Photo taken near station 03+40.
10/5/06 - MY 02

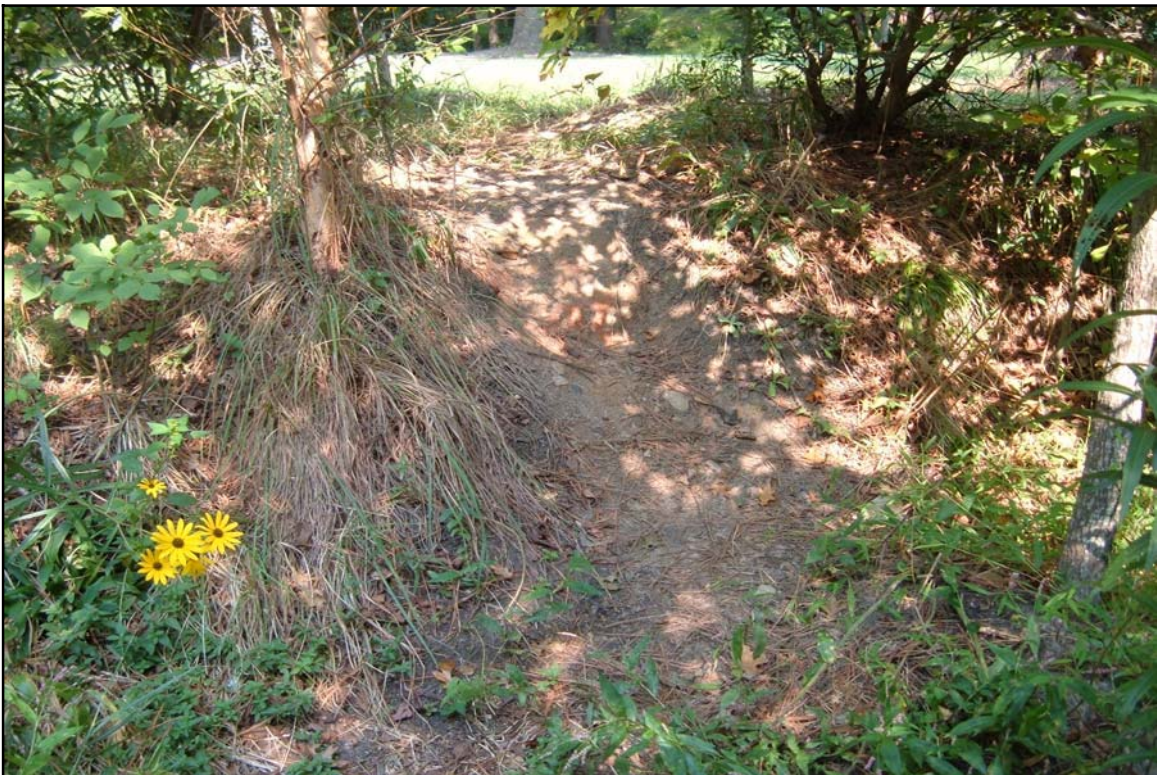
VP6 – Path worn into stream bank from pedestrian access to the stream. Photo taken near station 02+70.
10/5/06 - MY 02

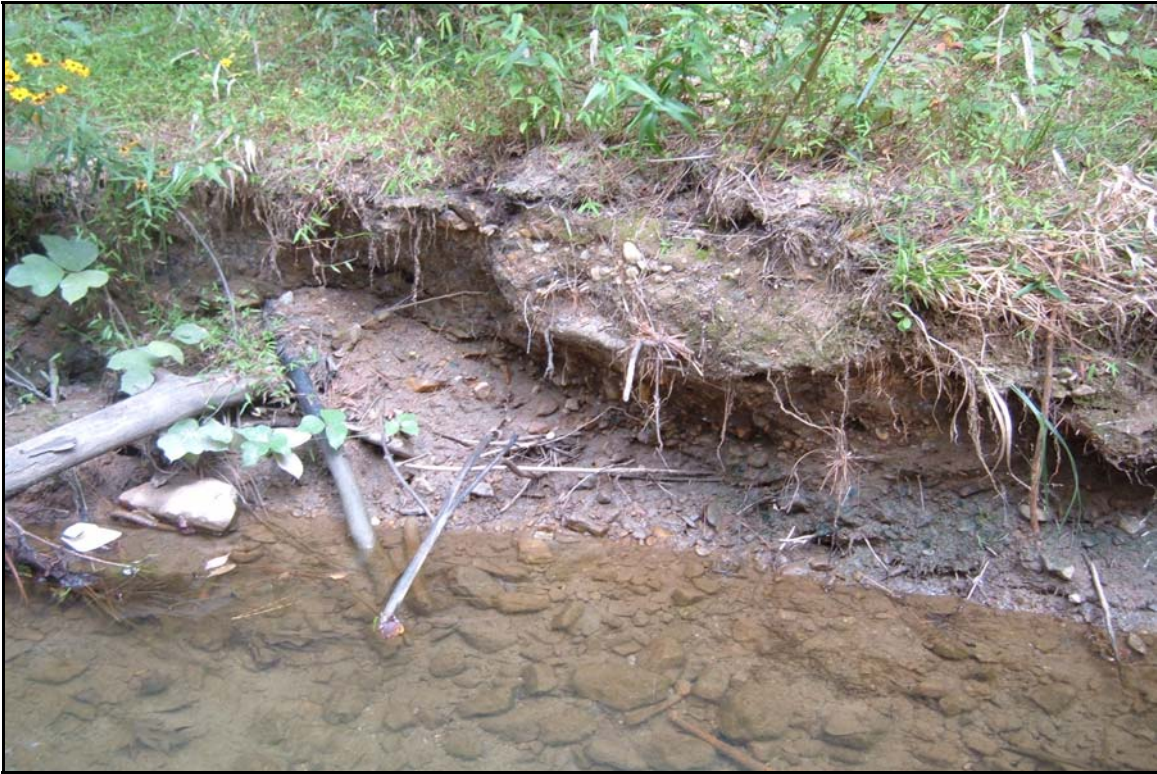
SP1 – Bank erosion. Photo taken near station 15+65 on left bank. 10/5/06 - MY 02

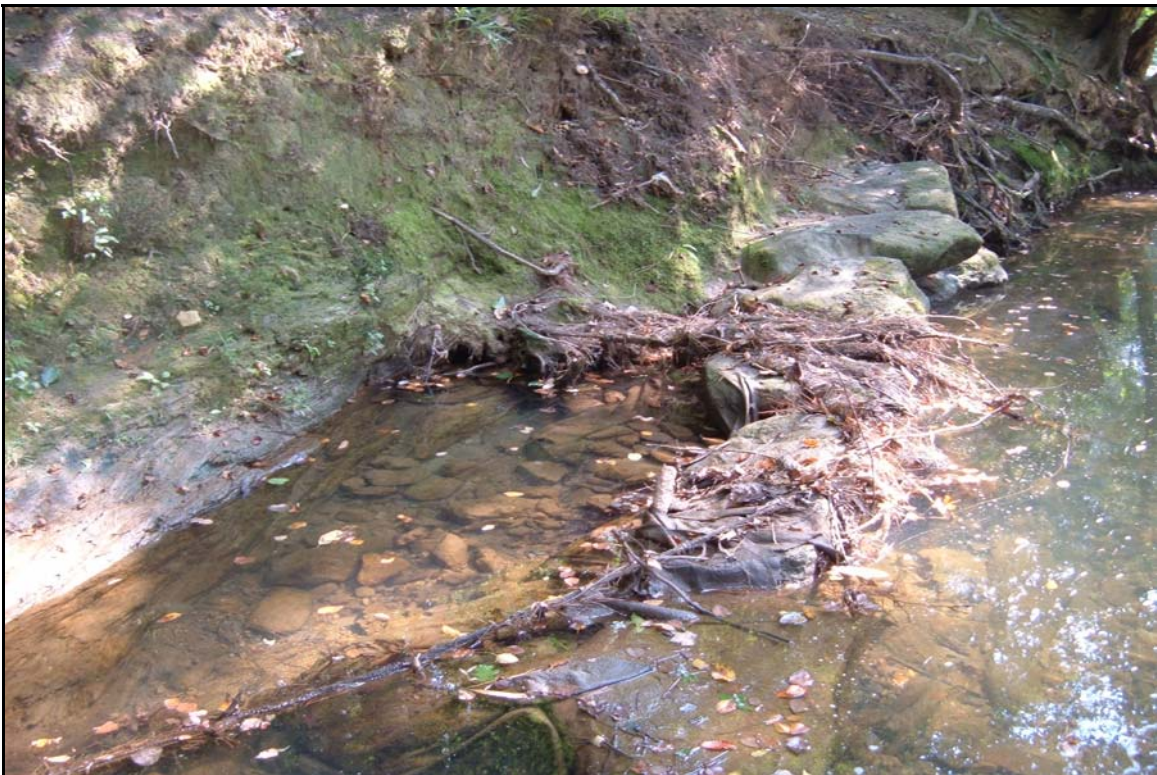
SP2 – Back arm scour on arm of j-hook. Photo taken near station 11+75. 10/5/06 - MY 02

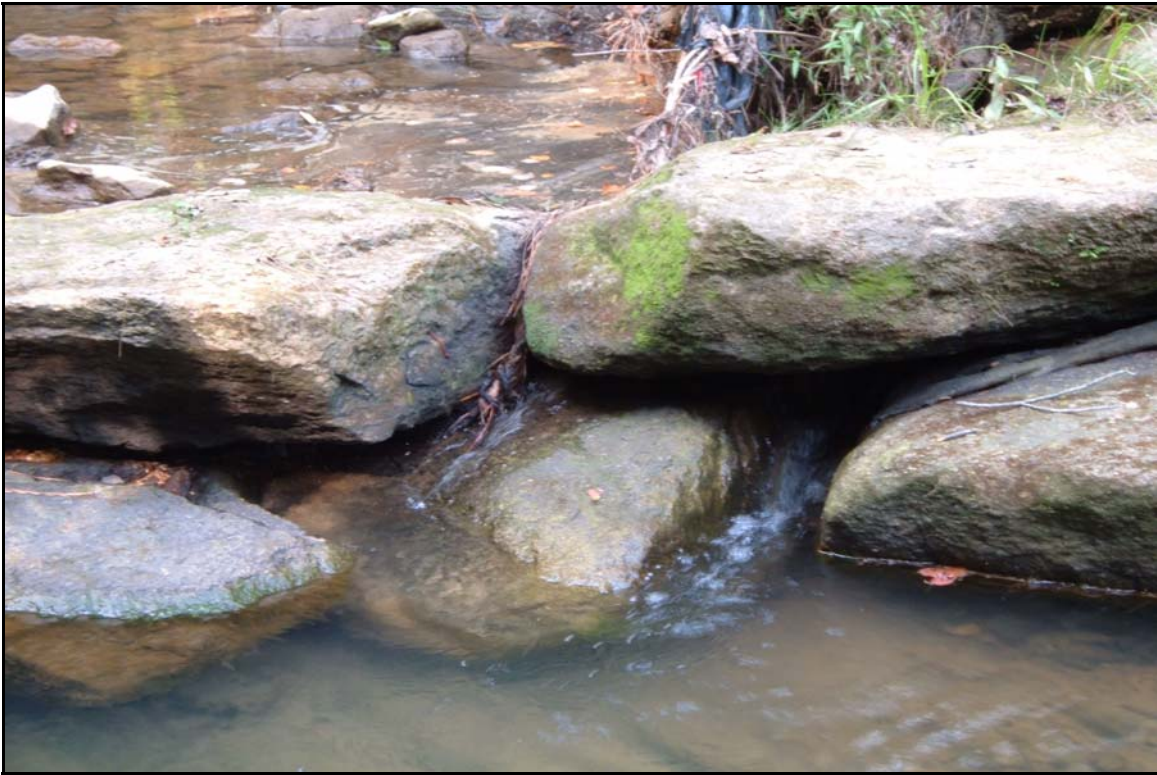
Table B1a. Stream Problem Areas			
Project Number and Name: 205 – Kentwood Park (Bushy Branch)			
Segment/Reach: Bushy Branch (1,070 ft.)			
Feature Issue	Station numbers	Suspected Cause	Photo #
Aggradation/Bar Formation	16+30 - 16+60	unknown	
Bed Degradation	14+00 - 14+60	unknown	
	18+00 - 18+60	unknown	
Bank Scour	10+50-11+20	unknown	SP1
	11+30-11+50	unknown	
	11+60-12+50	unknown	
	12+75-13+00	scour from misdirected cross vane	
	15+50-15+65	unknown	
	16+00-16+30	unknown	
	16+80-17+25	unknown	
	17+50-18+30	unknown	
Engineered Structures - back or arm scour	11+75	unknown	SP2
	12+60	improper placement	
	13+10	poorly backfilled vane arm	
	18+00	unknown	
	18+30	unknown	
	19+40	poorly backfilled vane arm	
Engineered Structures – piping	16+00	poor fabric installation	SP3
Root Wads - scour	16+00	unknown	SP4

SP3 – Piping through boulders in cross vane. Photo taken near station 16+00. 10/5/06 - MY 02

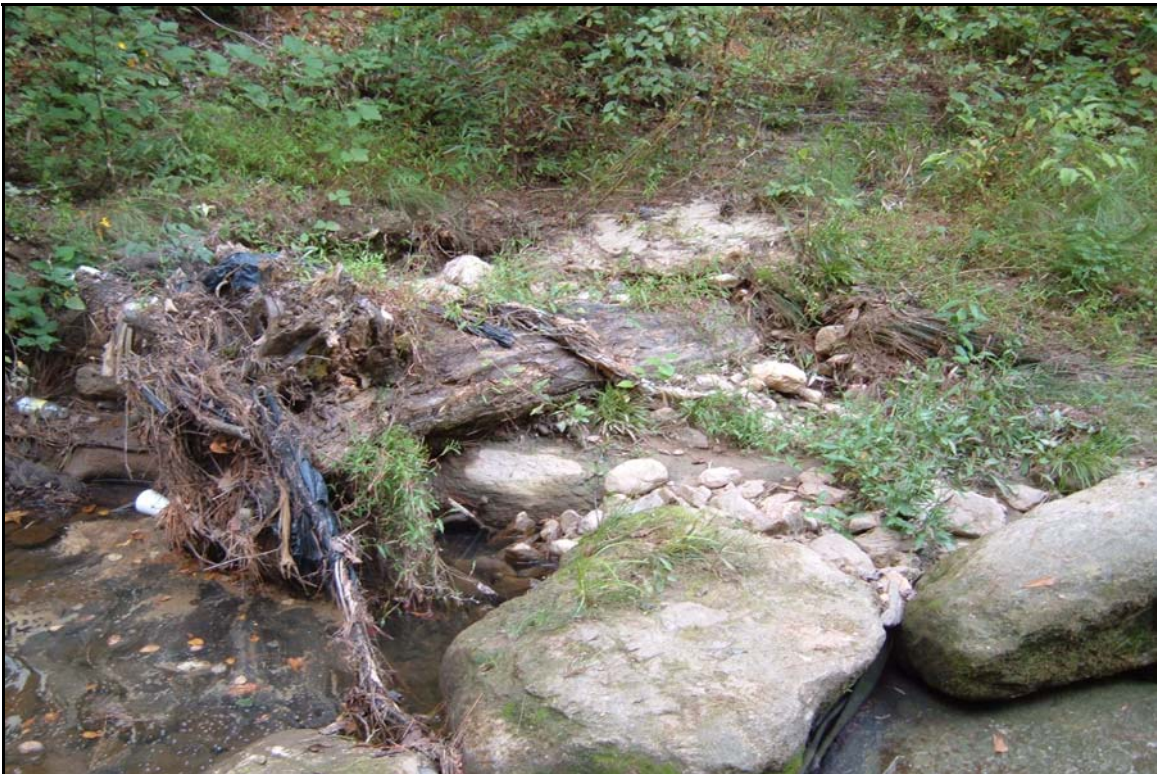
SP4 – Scour behind root wads. Photo taken near station 16+00. 10/5/06 - MY 02

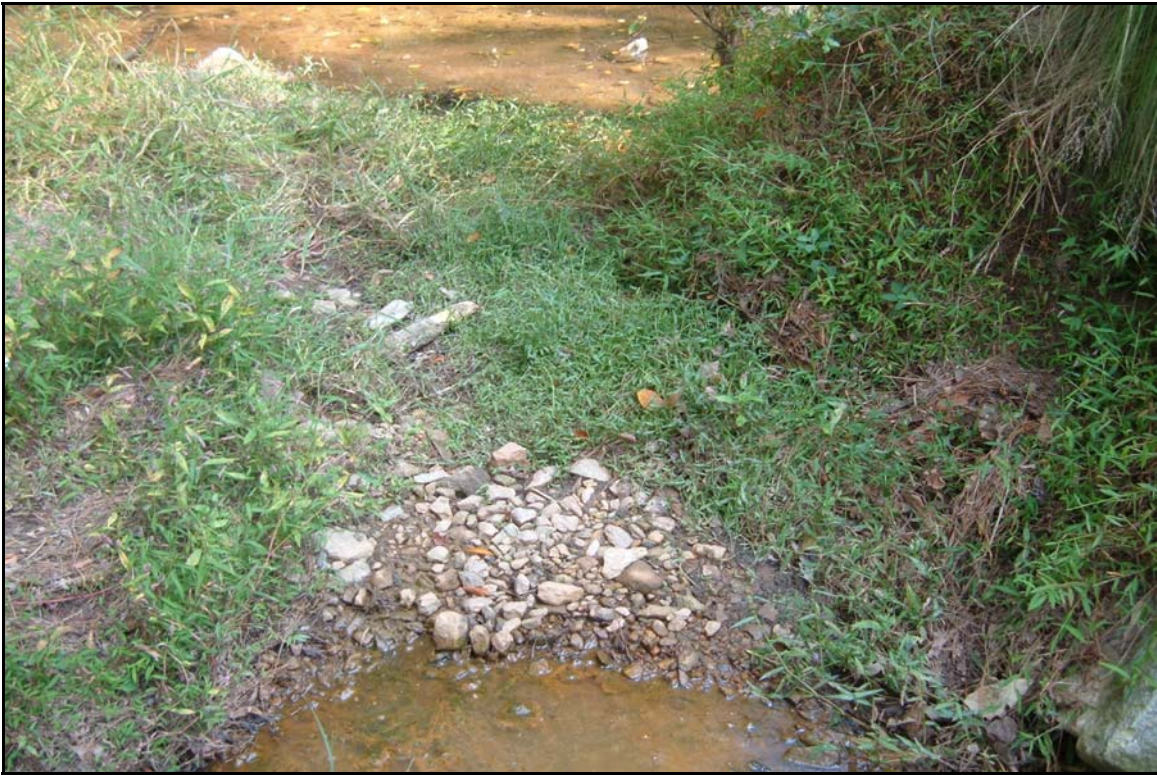
SP5 – Bed aggradation and weedy growth in channel near confluence of UT to Bushy Branch and Bushy Branch. Photo taken near station 03+40. 10/5/06 - MY 02

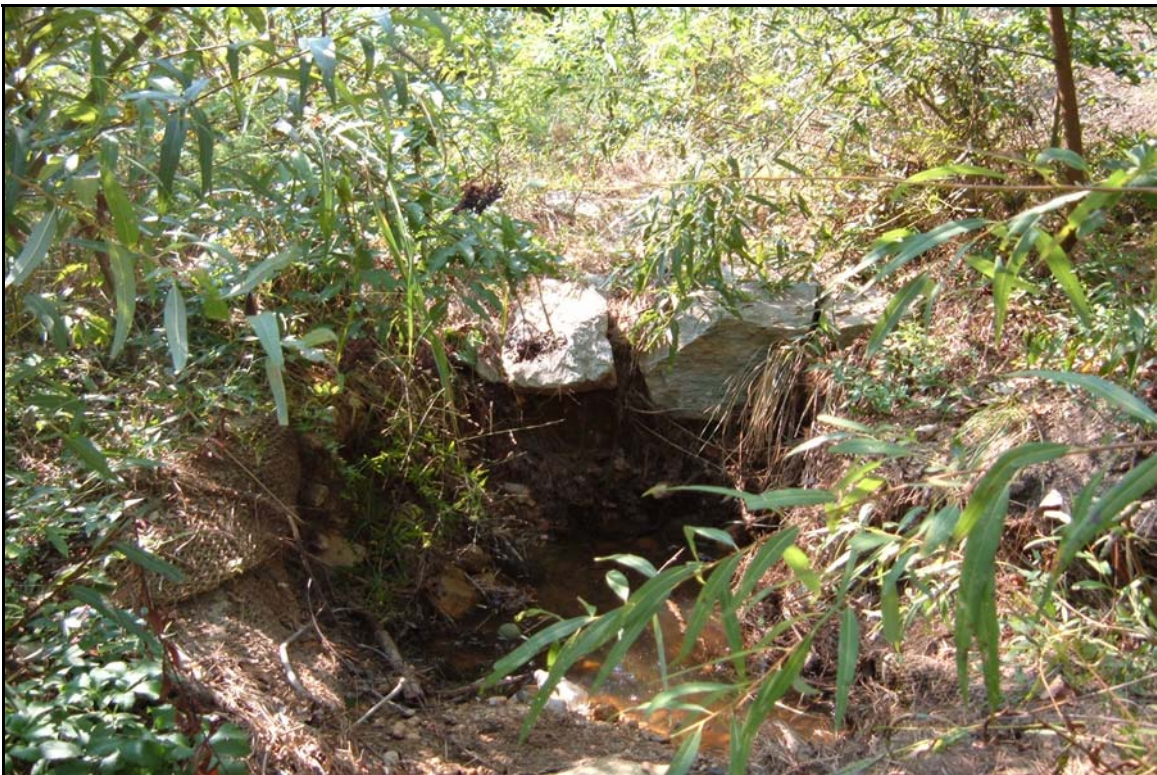
Table B1b. Stream Problem Areas			
Project Number and Name: 205 – Kentwood Park (Bushy Branch)			
Segment/Reach: UT to Bushy Branch (350 ft.)			
Feature Issue	Station numbers	Suspected Cause	Photo #
Aggradation/Bar Formation	01+80 - 02+00	herbaceous vegetation accumulating soil	SP5
	03+30 - 03+40	herbaceous vegetation accumulating soil	
Bed Degradation	02+25	unstable soils downstream of sill damaged by large storm event	SP6

SP6 – Bed degrading on downstream side of rock sill. Photo taken near station 02+25. 10/5/06 - MY 02
