**Kentwood Park (Bushy Branch)  
Stream Restoration Monitoring Report  
EEP Project # 205  
Monitoring Year – 03  
2007**

**February 2008**

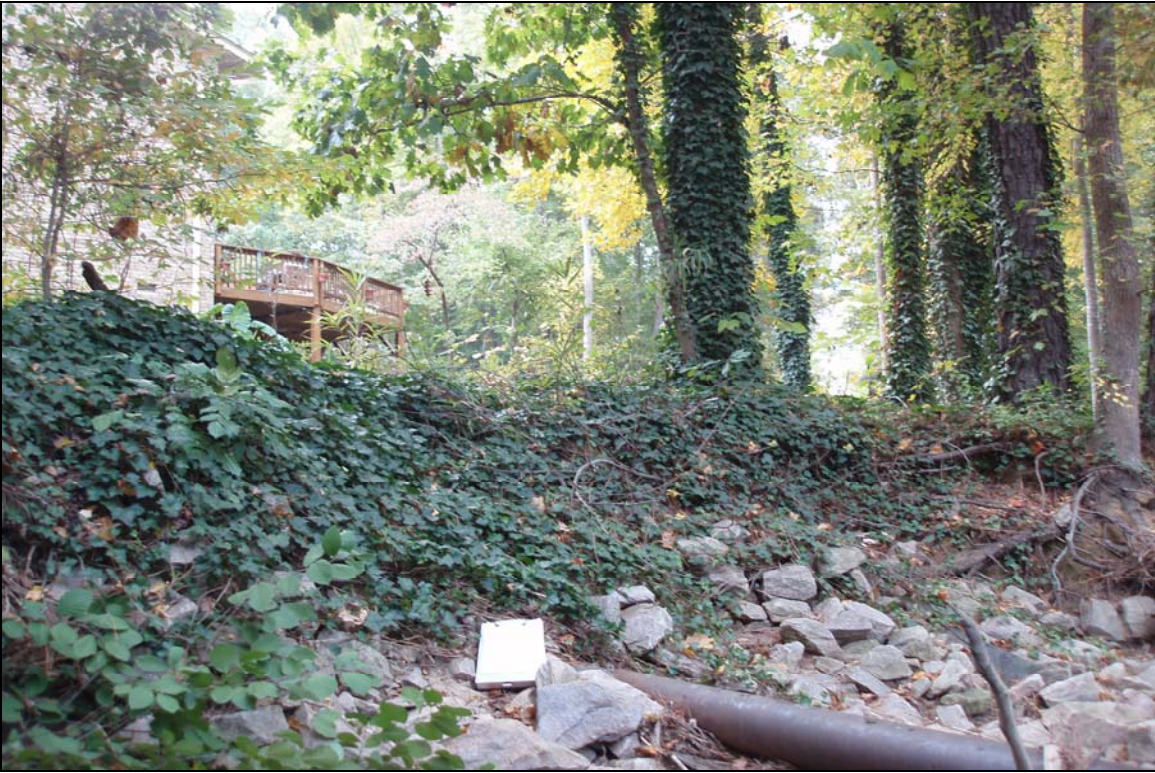
VP1 - English ivy (*Hedera helix*) on stream bank. Photo taken near Station 10+25. 11/12/07 - MY 03

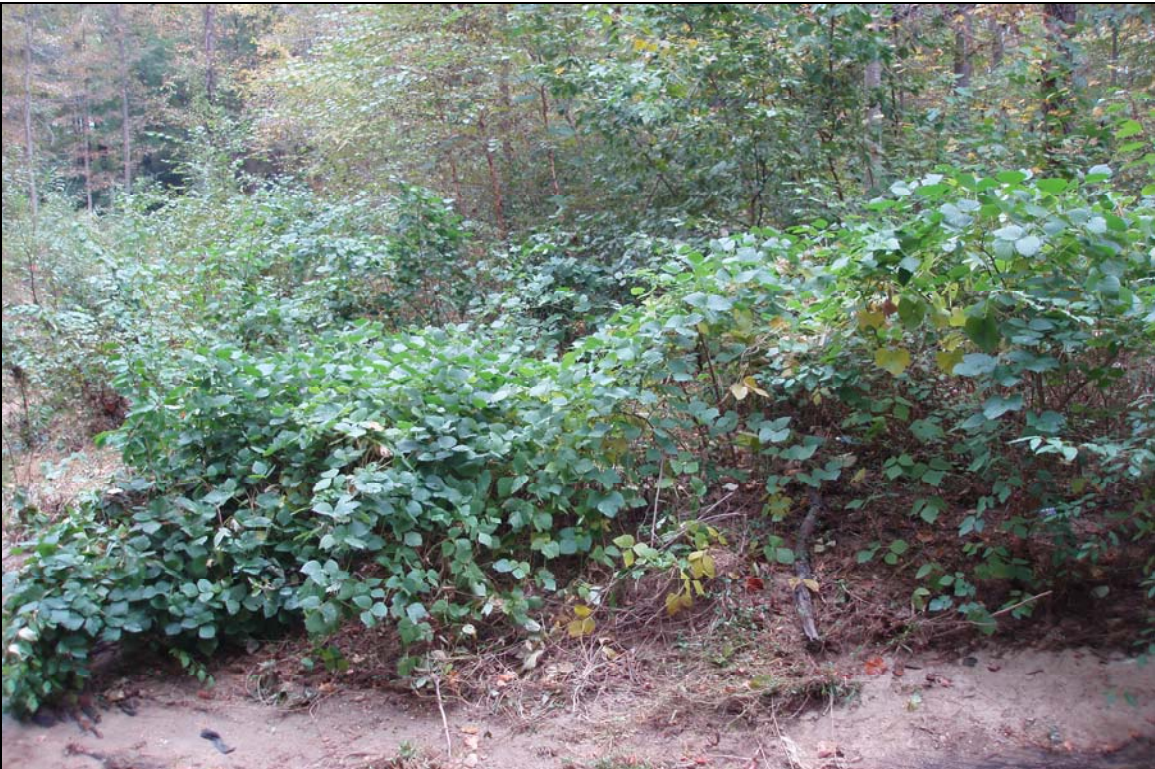
VP2 - Kudzu (*Pueraria lobata*) along stream bank. Photo taken near Station 19+50. 11/12/07 - MY 03

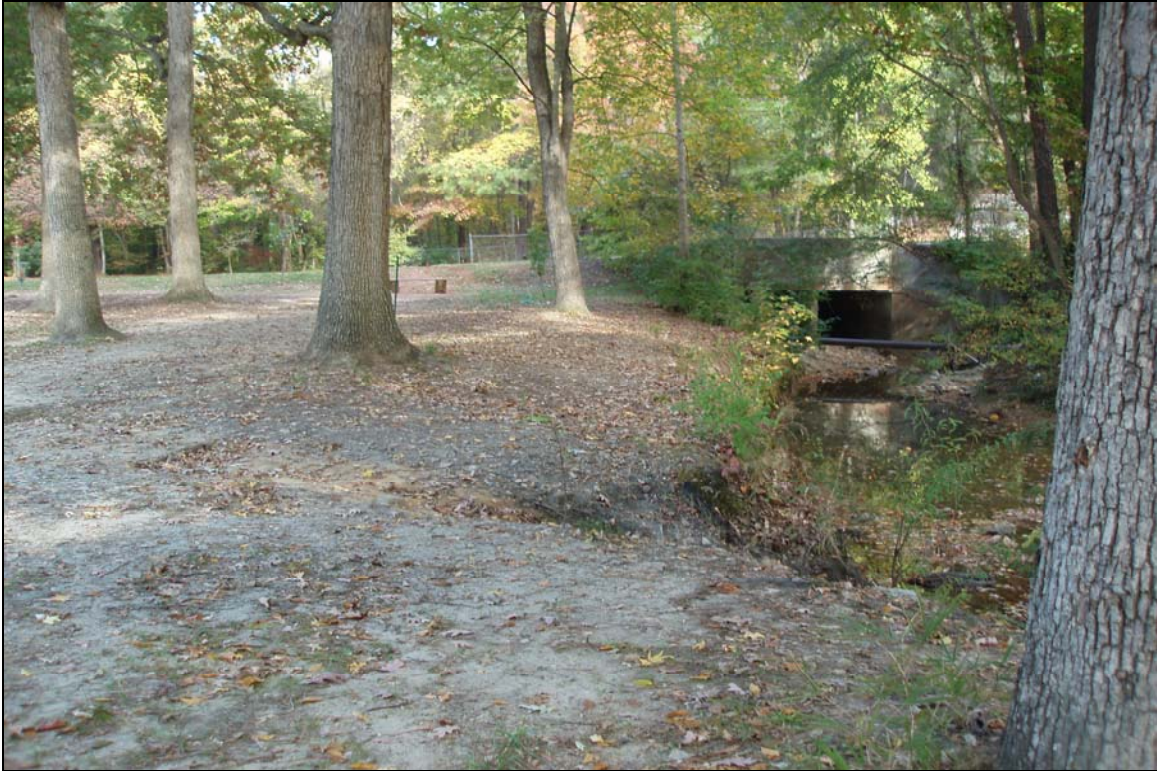
VP3 - Bare terrace that is void of herbaceous vegetation. Photo taken near Station 11+25. 11/12/07 - MY 03

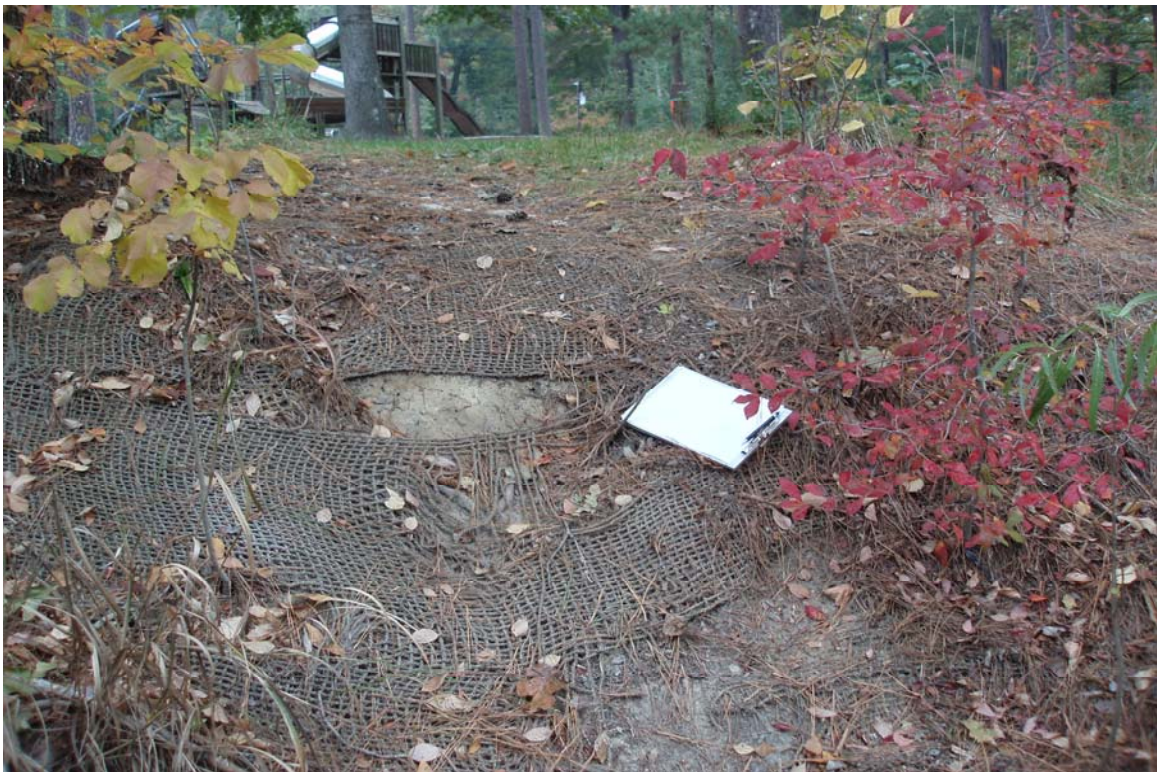
VP4 - Breakdown of coir matting with bare subsoil exposed on stream bank. Photo taken near Station 02+00. 11/12/07 - MY 03

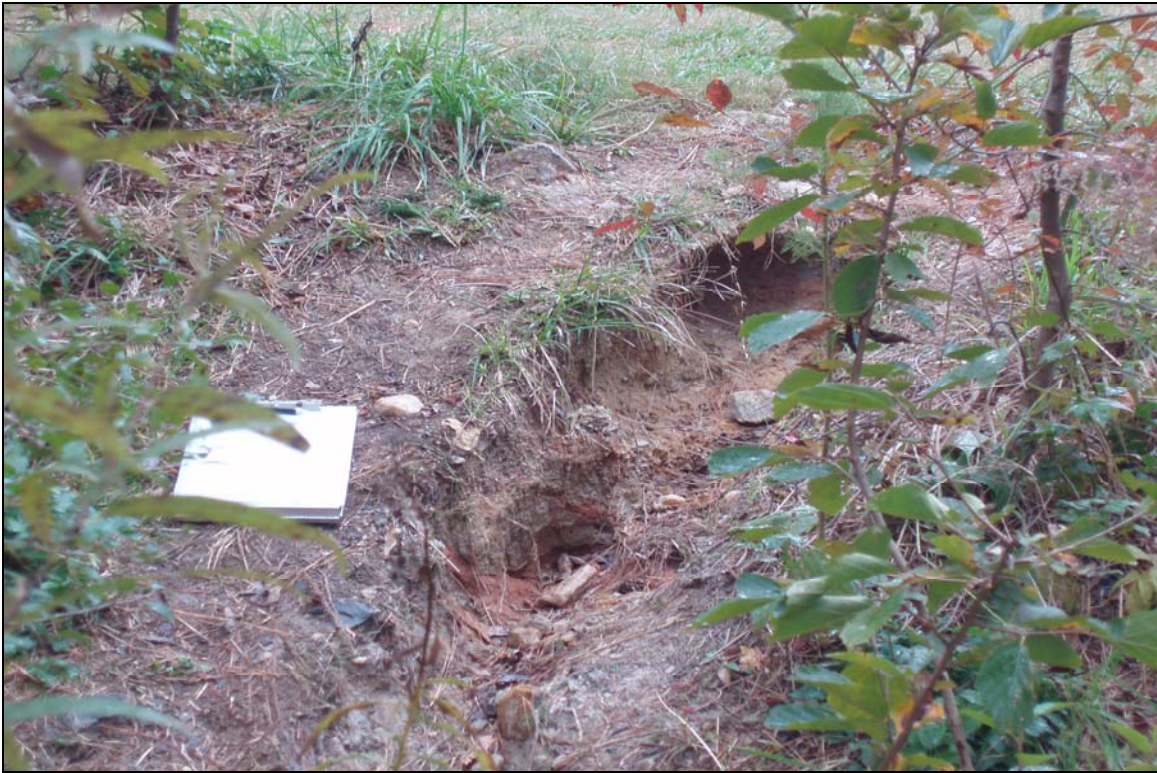
VP5 - Erosion from path worn into stream bank from pedestrian access to the stream. Photo taken near Station 01+00. 11/12/07 - MY 03

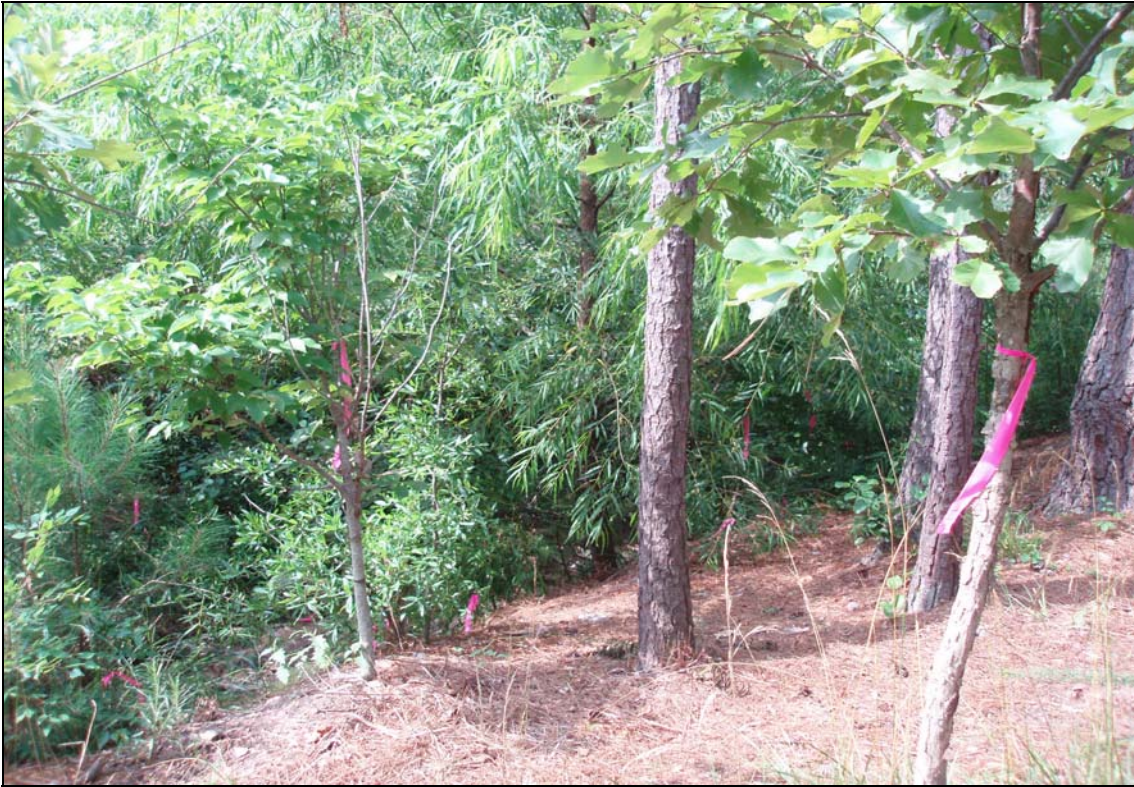
- The *Euonymus americana* mortality can be attributed to the high foot traffic from the disc golf course or browsing in Vegetation Plot 1. Many paths cross through plot 1 and many plants (planted and unplanted) have been trampled.

- The decrease in *Lindera benzoin* in Plot 1 during Monitoring Year 03, could be attributed the heavy foot traffic through the plot or browsing pressure. The direct cause could not be determined, because the plant was missing.

Vegetation Plot 1 Photo – Taken looking south from the north corner. 7/13/07 - MY 03

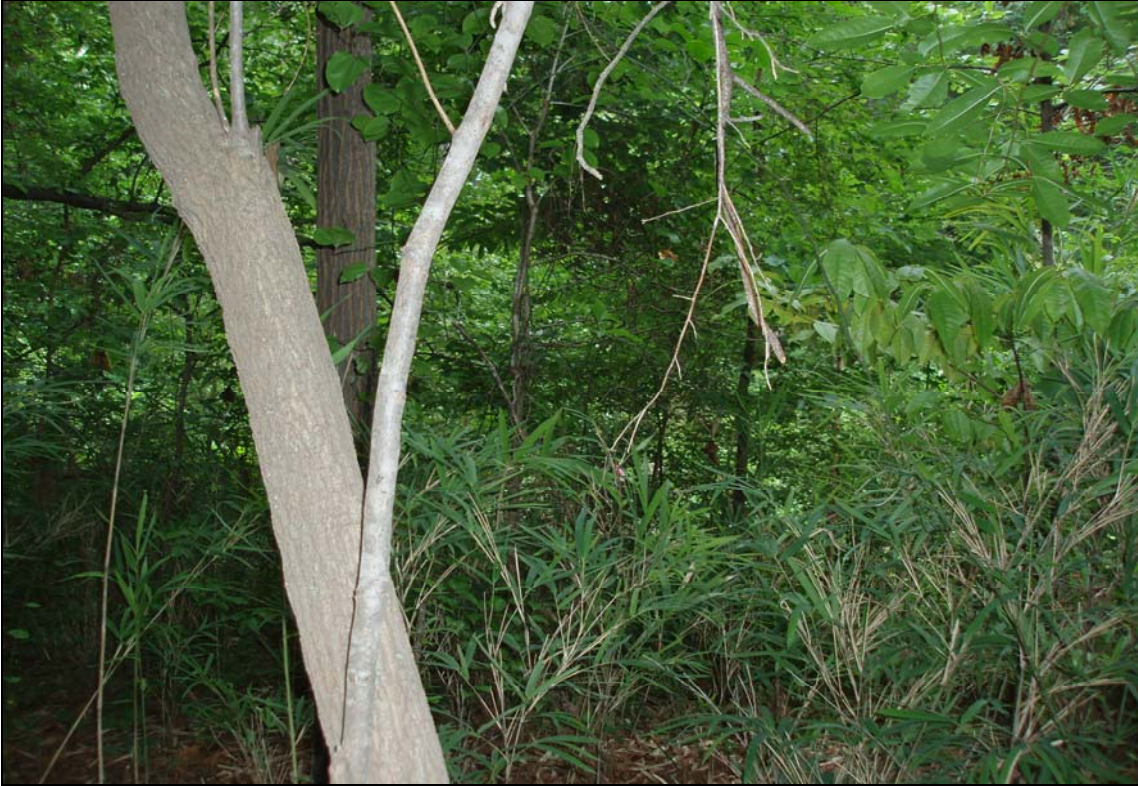
- One *Cornus amomum* and one *Sambucus canadensis* were not found in Vegetation Plot 2. As stated in previous reports, this vegetation plot is located on a bankfull bench and is subject to frequent flooding, which may have caused the plants to become.

Vegetation Plot 2 Photo – Taken looking south from the north corner. 7/13/07 - MY 03

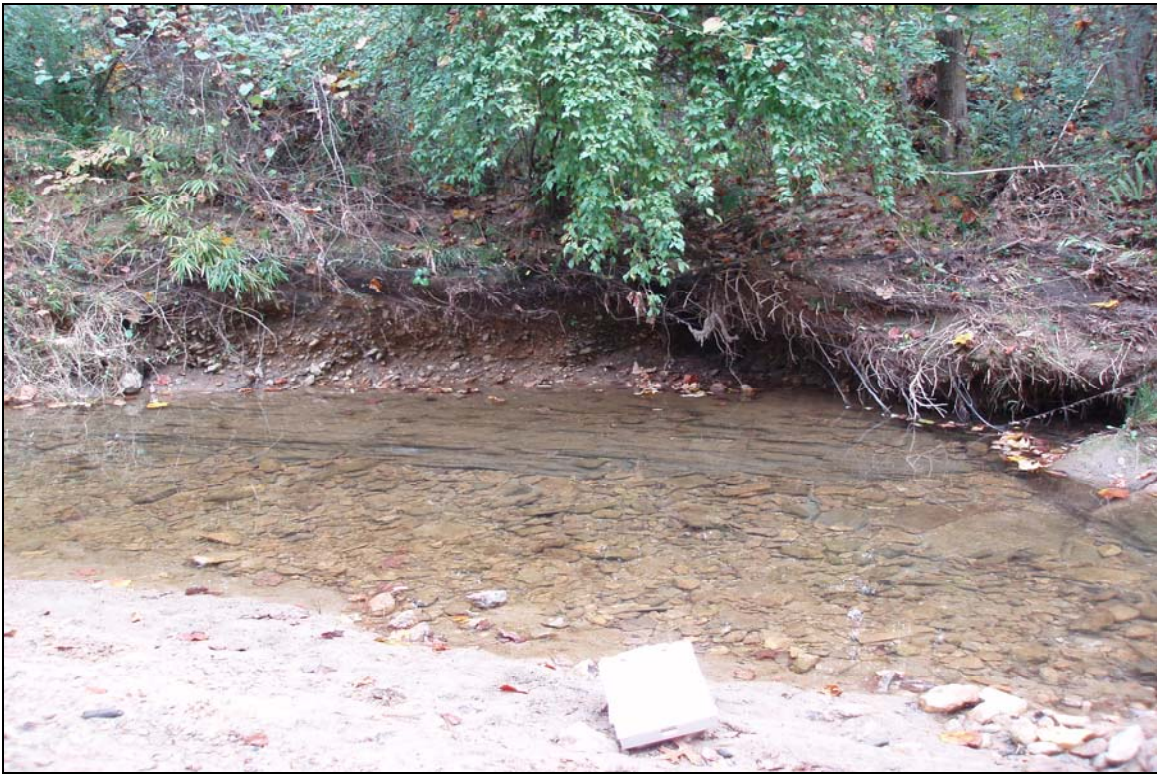
SP1 - Bank erosion. Photo taken near Station 17+95 on left bank. 11/12/07 - MY 03

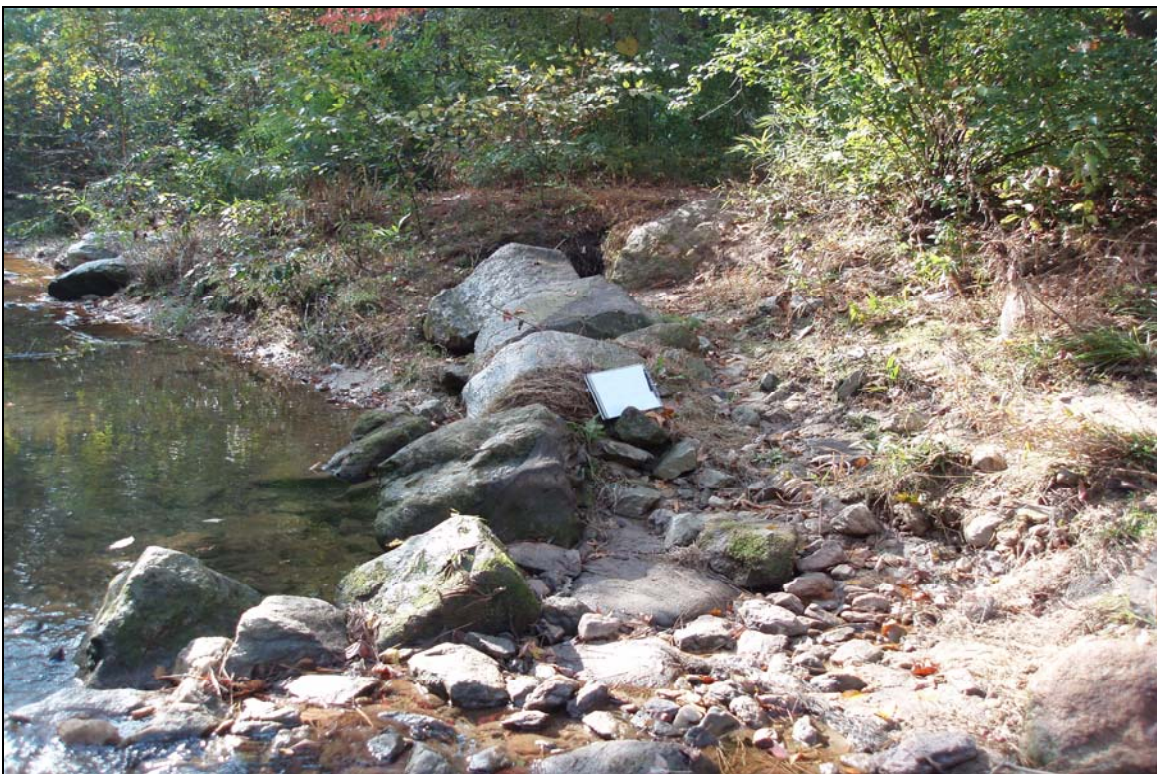
SP2 - Back arm scour on arm of J-hook. Photo taken near Station 13+50. 11/12/07 - MY 03

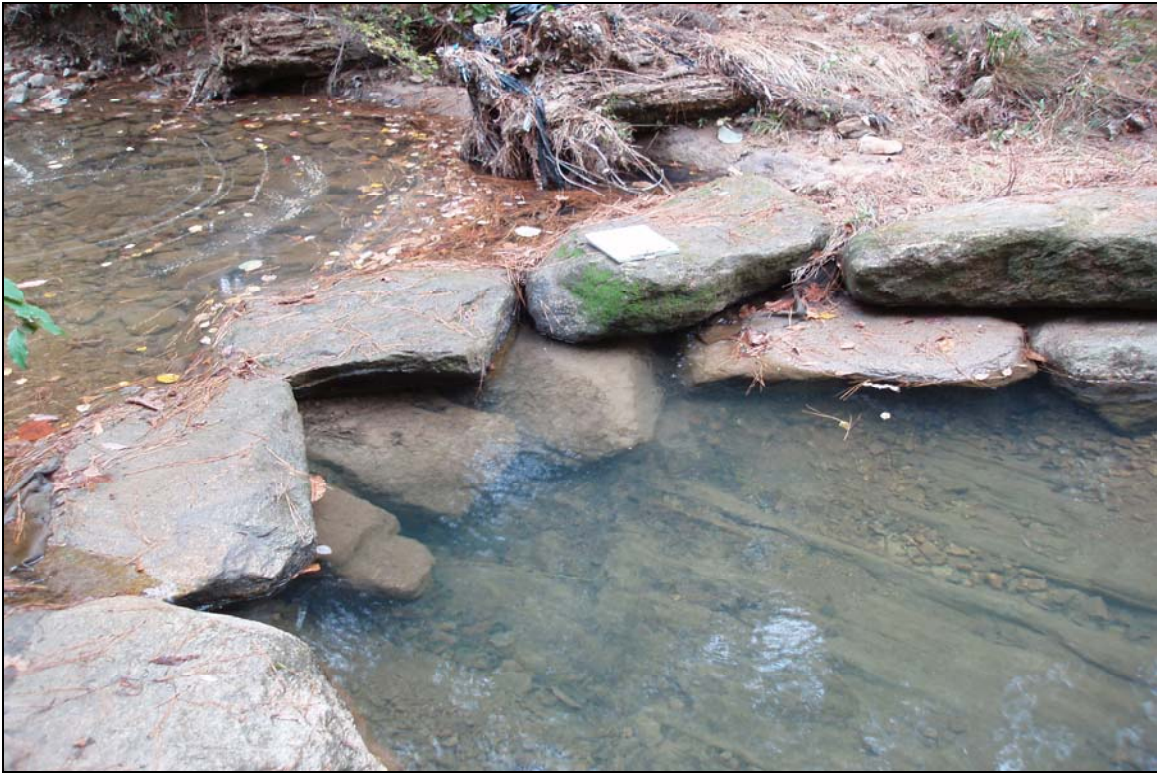
SP3 - Piping through boulders in cross vane. Photo taken near Station 16+00. 11/12/07 - MY 03

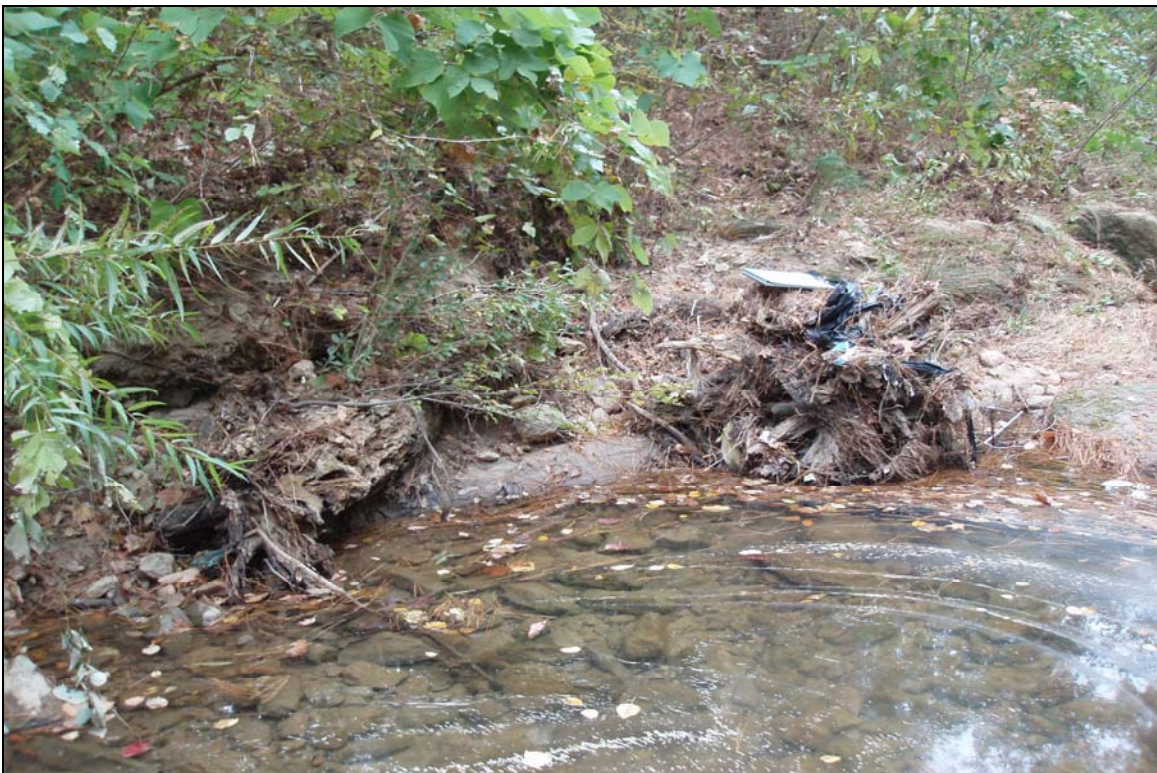
SP4 - Scour behind root wads. Photo taken near Station 16+00. 11/12/07 - MY 03

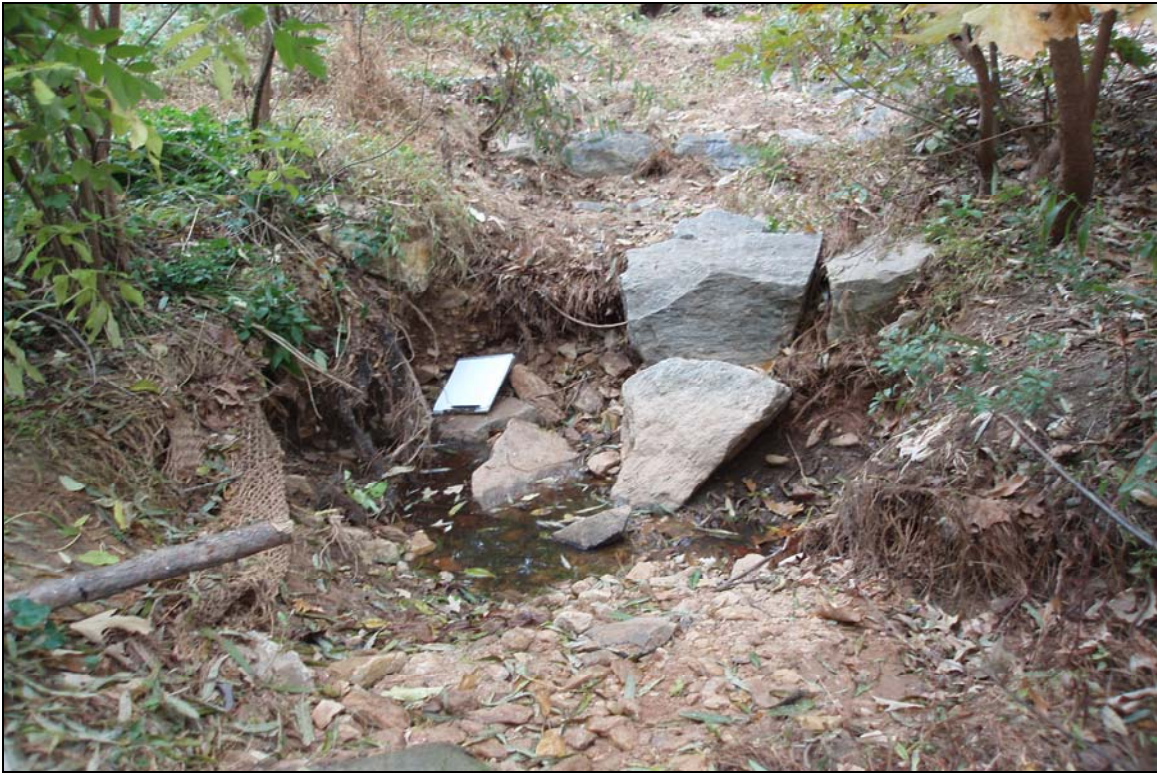
SP5 - Head stones of cross vane fallen into pool with headcutting. Photo taken near Station 2+20. 11/12/07 - MY 03
