**Kentwood Park (Bushy Branch)  
Stream Restoration Monitoring Report  
EEP Project # 205  
Monitoring Year – 04  
2008**

**March 2009**

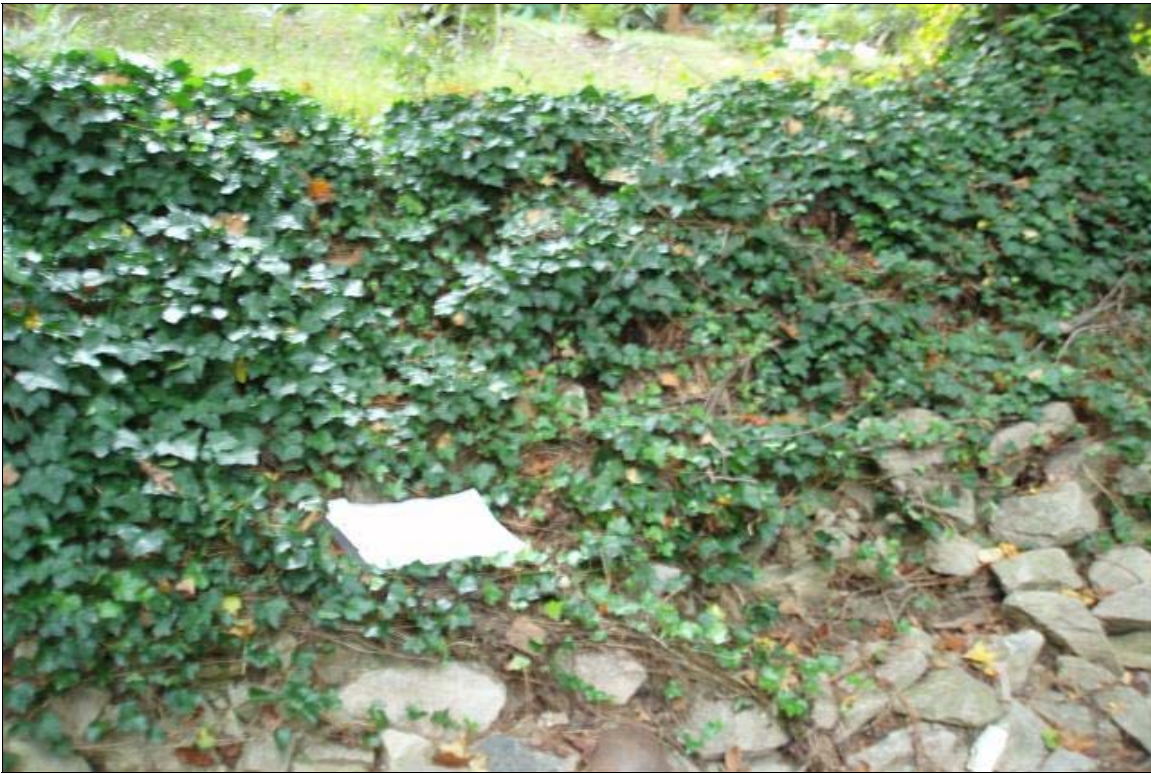
VP1 - English ivy (*Hedera helix*) on stream bank. Photo taken near Station 10+25. 10/27/08 - MY 04

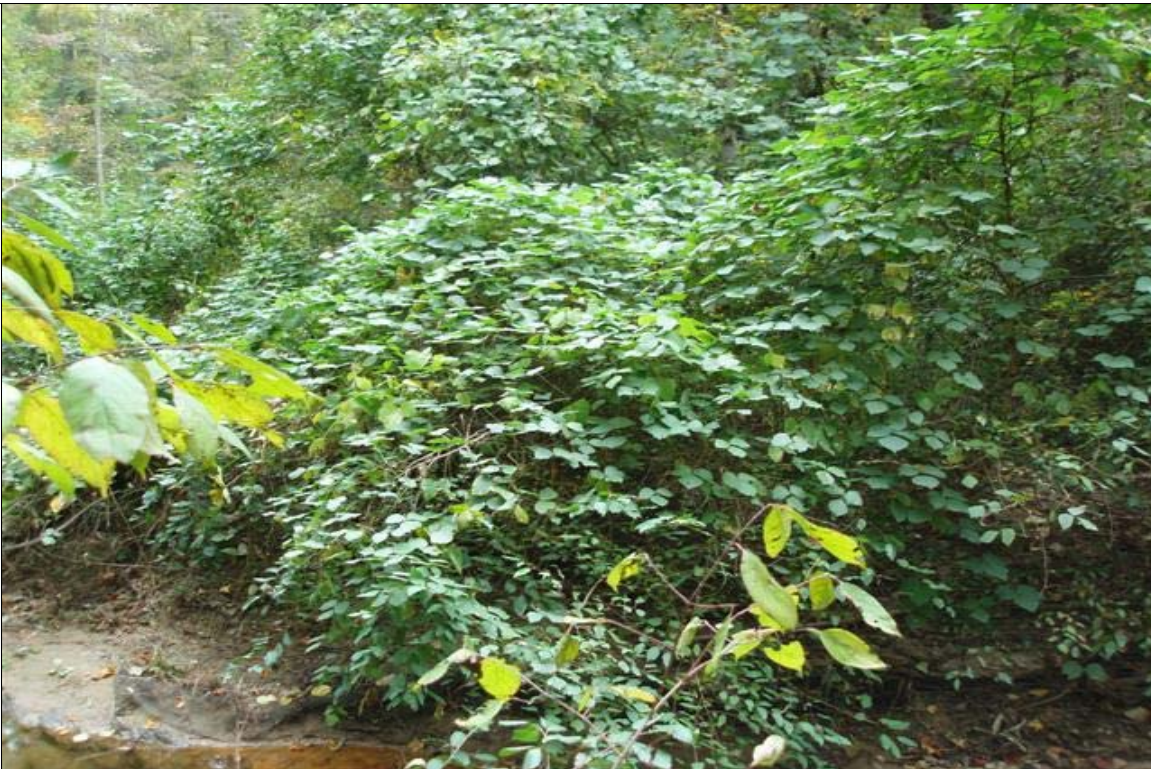
VP2 - Kudzu (*Pueraria montana*) along stream bank. Photo taken near Station 19+50. 10/27/08 - MY 04

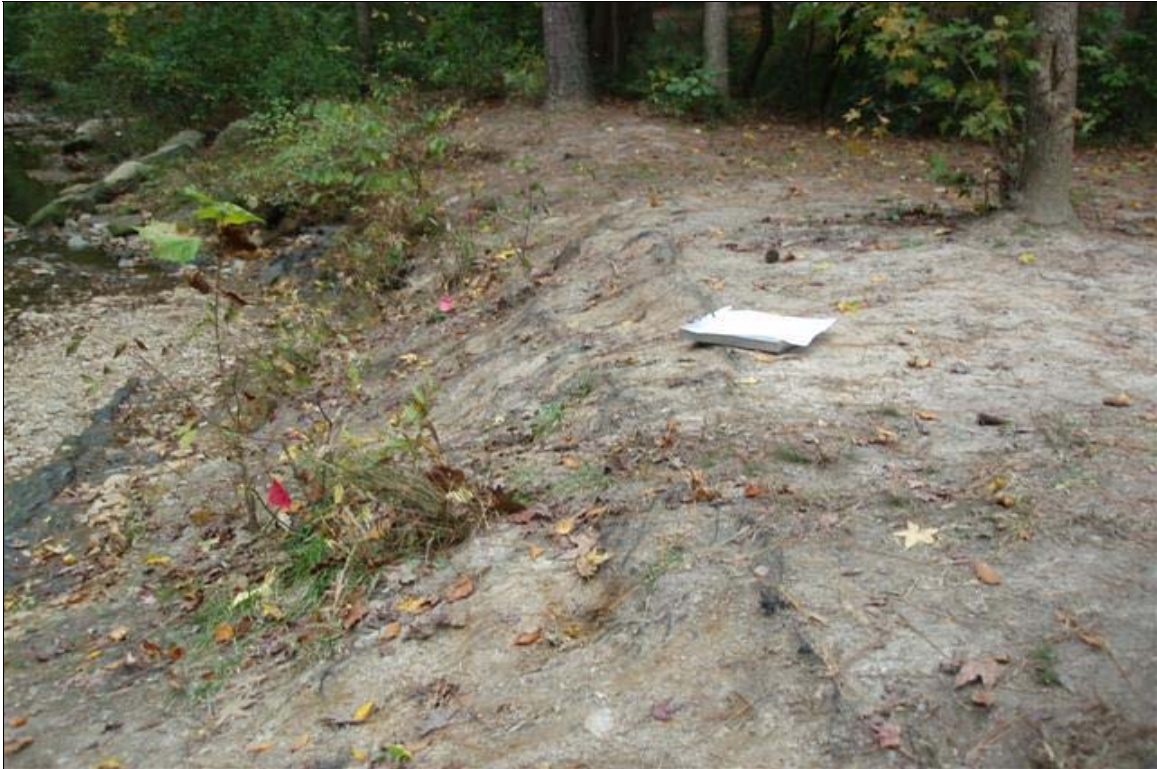
VP3 - Bare terrace that is devoid of herbaceous vegetation. Photo taken near Station 12+80. 10/27/08 - MY 04

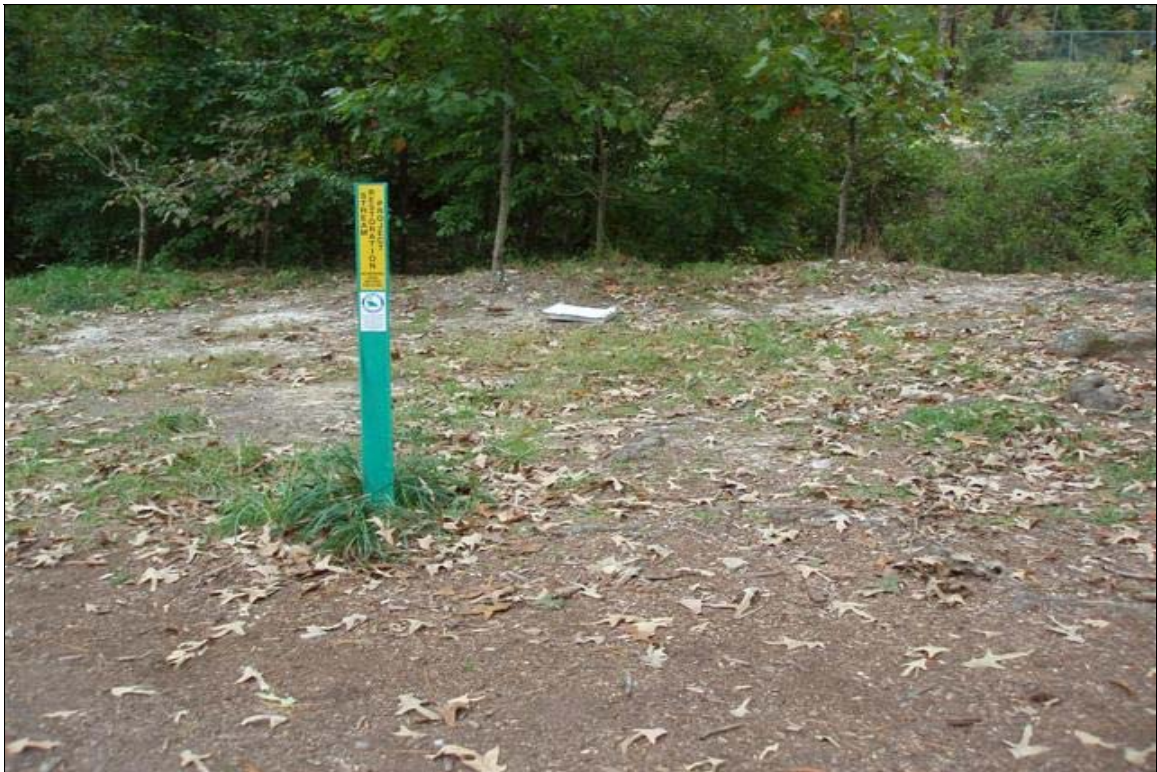
VP4 – Easement area mowed and worn by pedestrian traffic. Photo taken near Station 02+50. 10/27/08 - MY 04

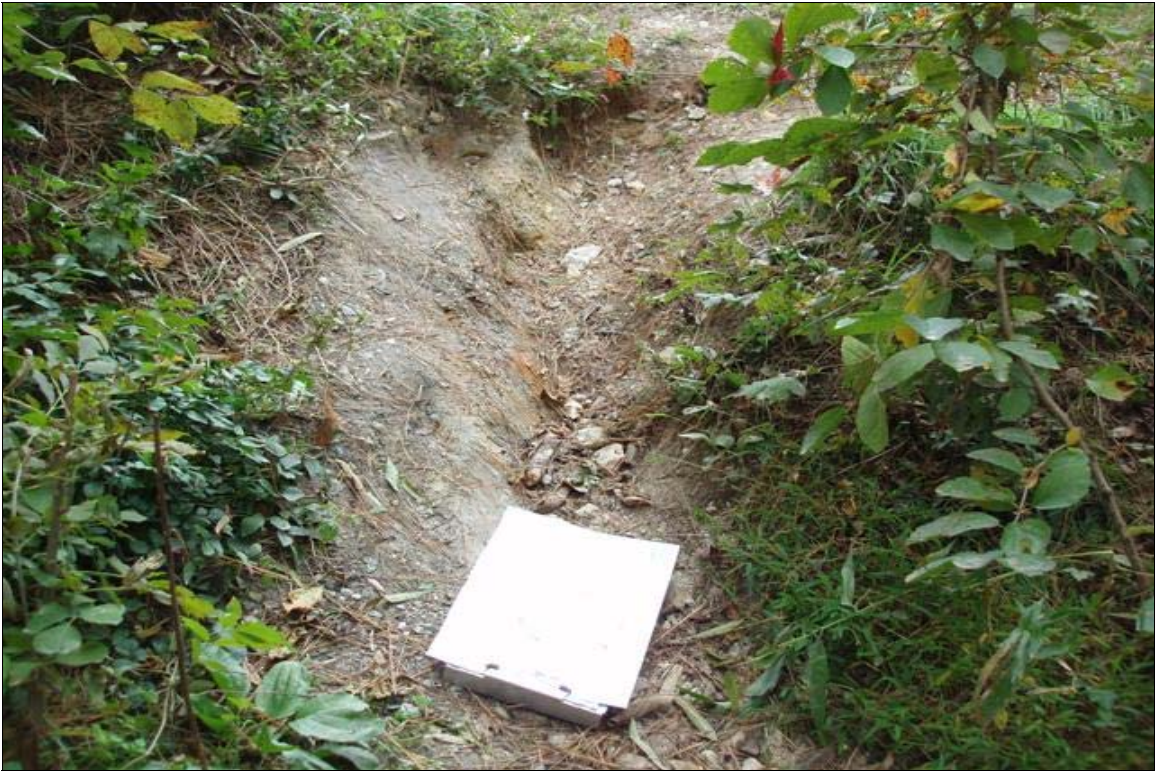
VP5 - Erosion from path worn into stream bank from pedestrian access to the stream. Photo taken near Station 01+00. 10/27/08 - MY 04

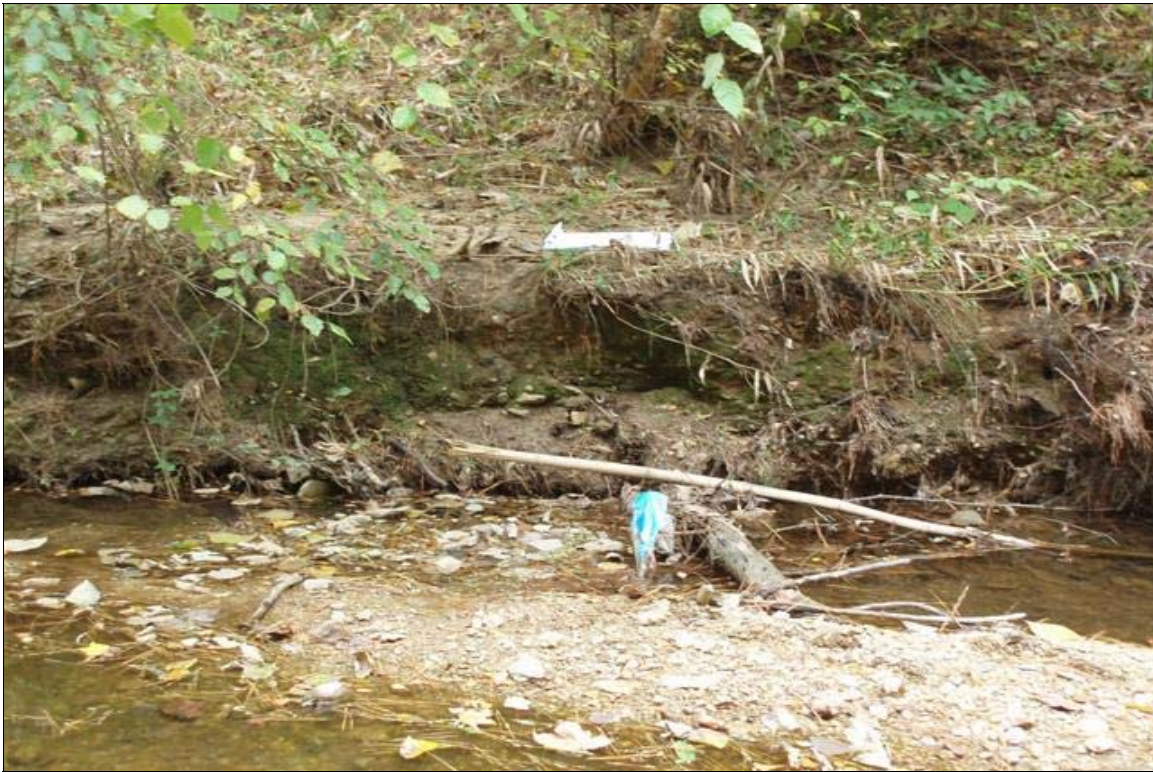
SP1 - Bank erosion. Photo taken near Station 17+80 on left bank. 10/28/08 - MY 04

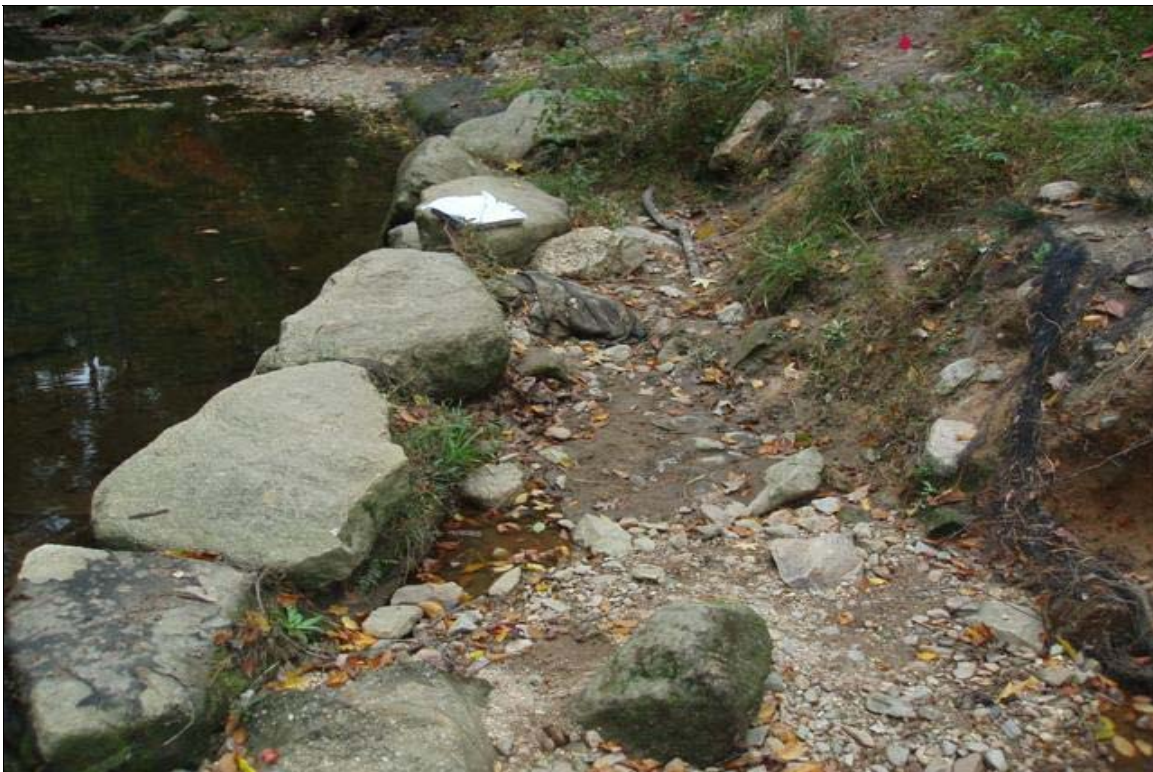
SP2 - Back arm scour on arm of cross vane. Photo taken near Station 12+60. 10/28/08 - MY 04

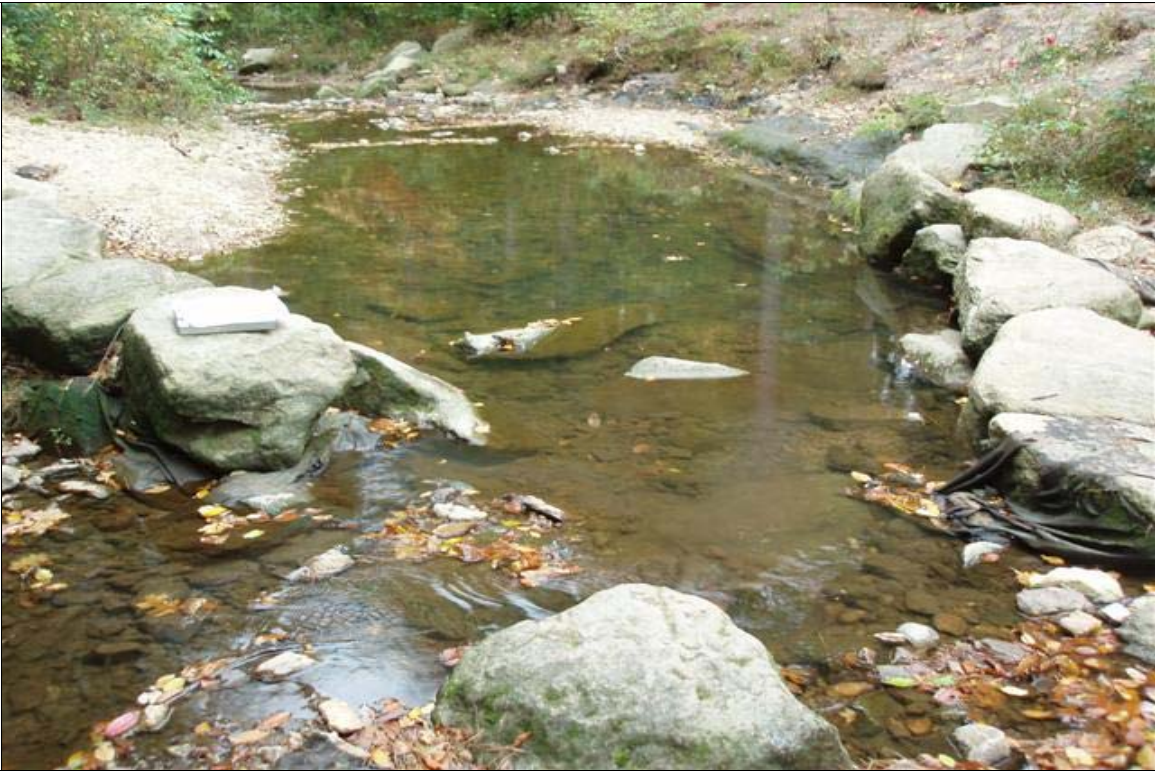
SP3 - Failed cross vane in main stem. Photo taken near Station 12+60. 10/28/08 - MY 04

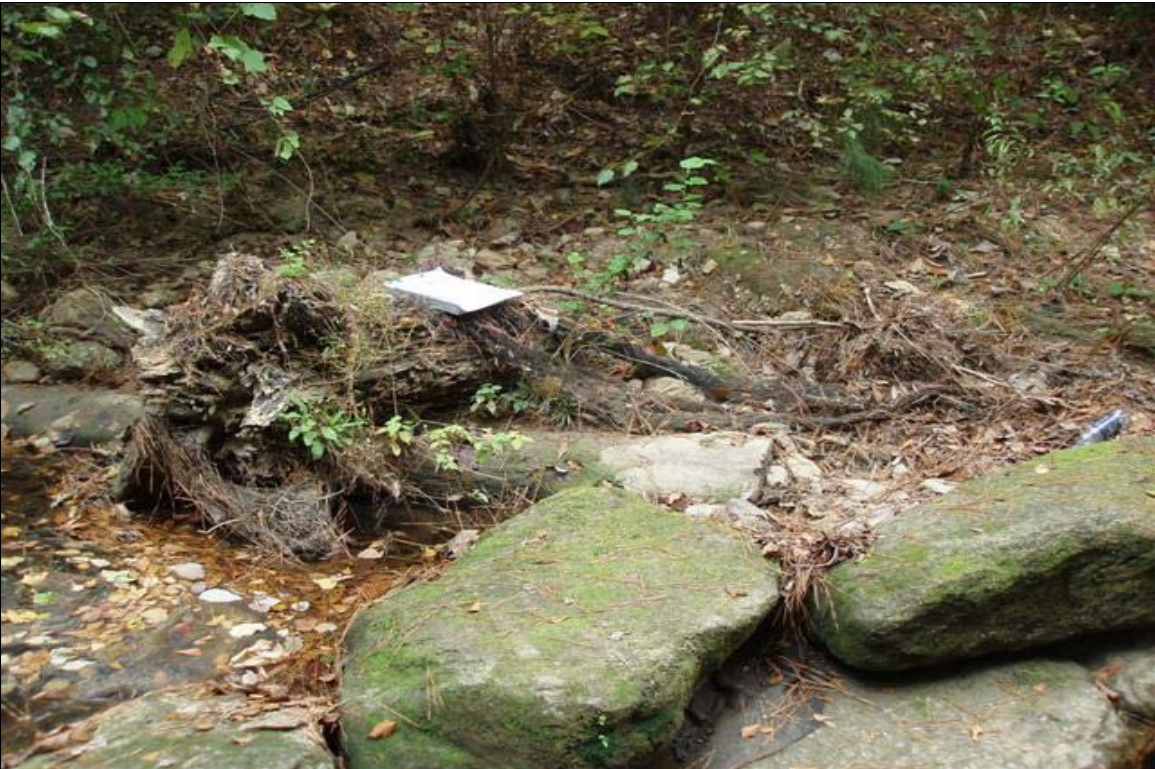
SP4 - Scour behind failed root wads. Photo taken near Station 16+00. 10/28/08 - MY 04

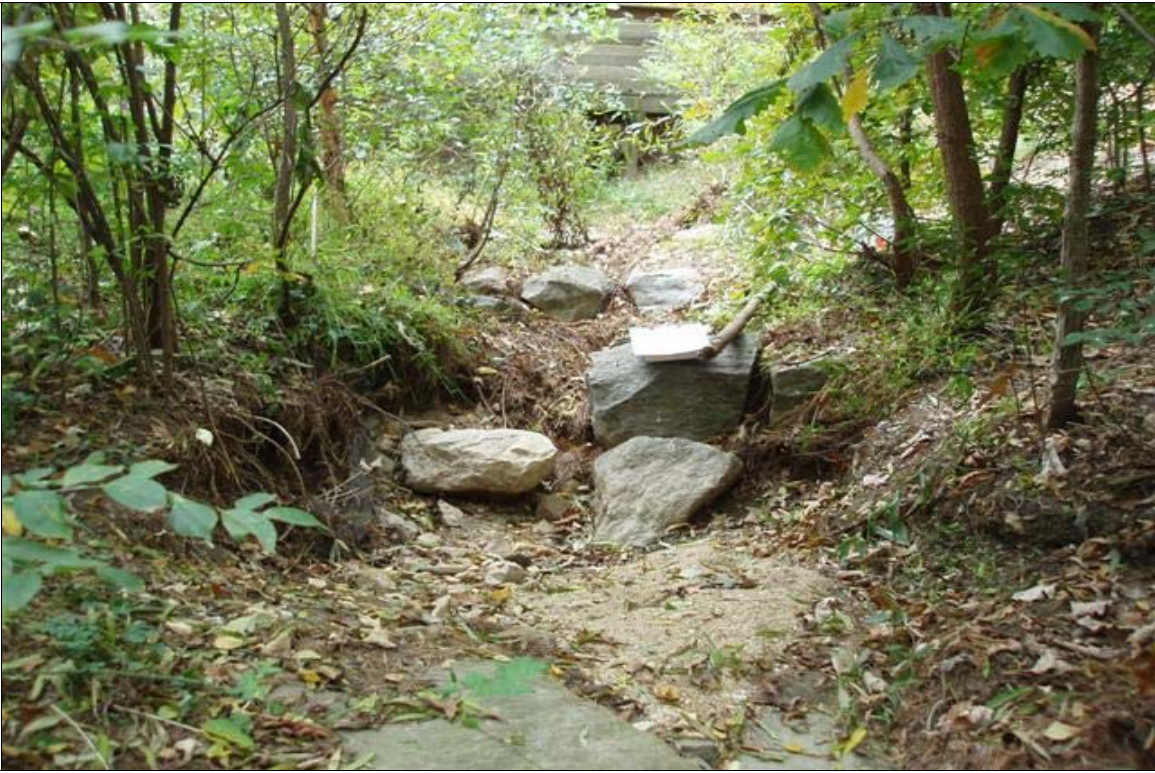
SP5 - Header stones of cross vane that have fallen into the pool; the stream is headcutting up from this point. Photo taken near Station 02+20. 10/28/08 - MY 04

A repair assessment is recommended to investigate stabilizing and rebuilding the structure that has been affected by the headcut on UT to Bushy Creek. If left unstabilized, this vertical instability could continue to migrate upstream, affecting additional structures. Additional repair assessment is also recommended at the cross vane that has failed at Station 12+60. There is a pipe protected by concrete immediately upstream of this structure, which will control vertical instability, but further bank erosion could continue to take place in this location.

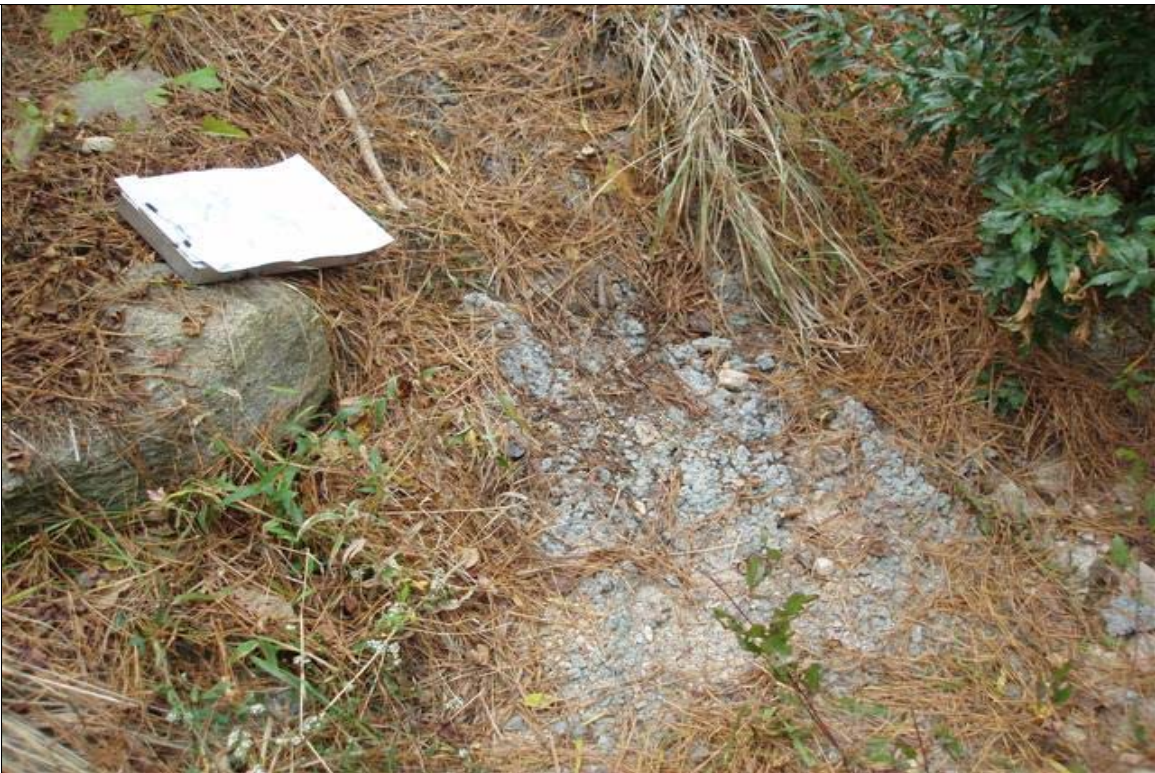
the bank and bed near Station 01+15 and the other is the outlet from a black drain pipe that has been put into the bank near Station 01+00. These issues are most likely related to the adjacent playground equipment that was replaced earlier this summer.

SP6 – Cement discarded on bank and bed of tributary. Photo taken near Station 01+15. 10/28/08 - MY 04
