**Kentwood Park (Bushy Branch)  
Stream Restoration Monitoring Report  
EEP Project # 205  
Monitoring Year – 05  
2009**

**December 2009**

**TABLE OF CONTENTS**

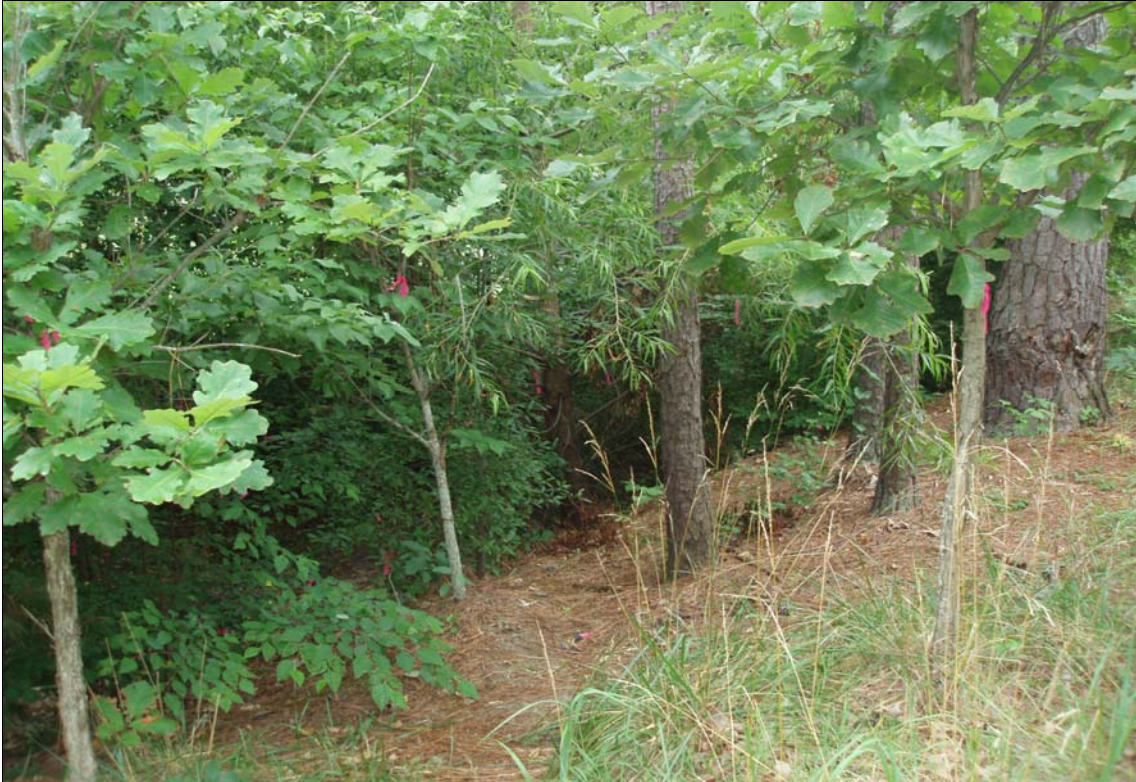
Vegetation Plot 1 Photo – Taken looking south from the northern corner. 7/9/09 - MY 05

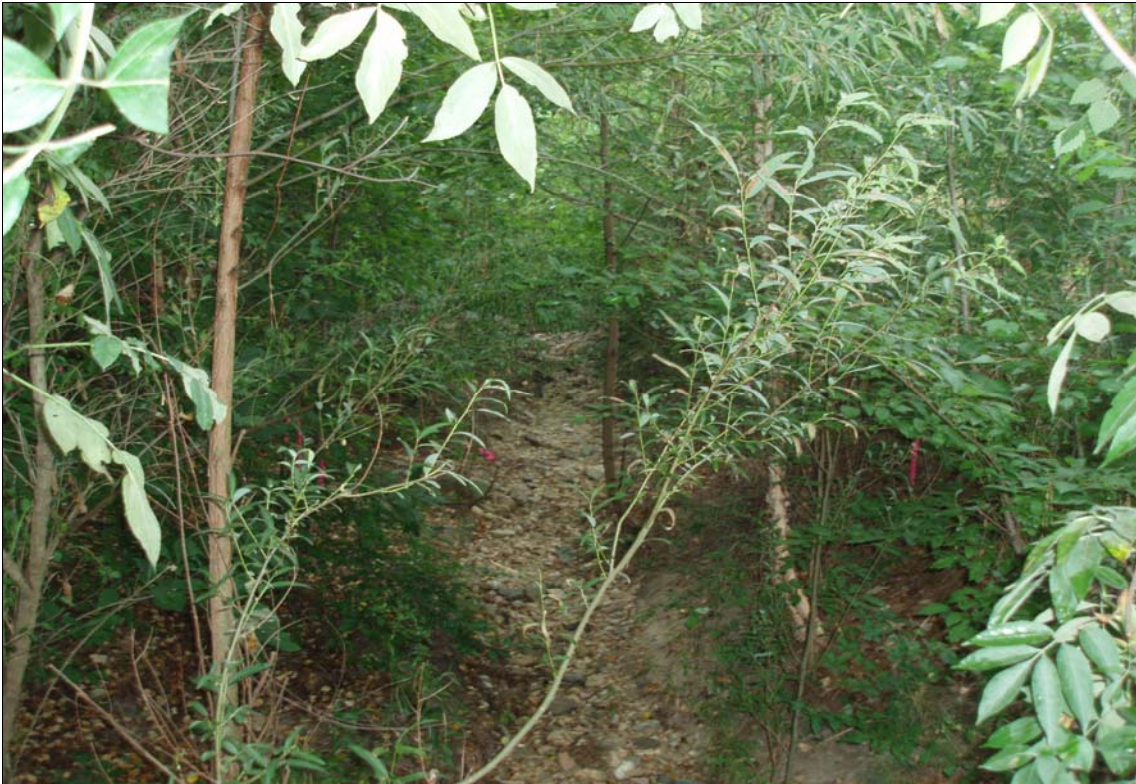
Vegetation Plot 1 Supplemental Photo – Taken looking upstream toward the center of the plot from established Photo Point #3. 7/9/09 - MY 05

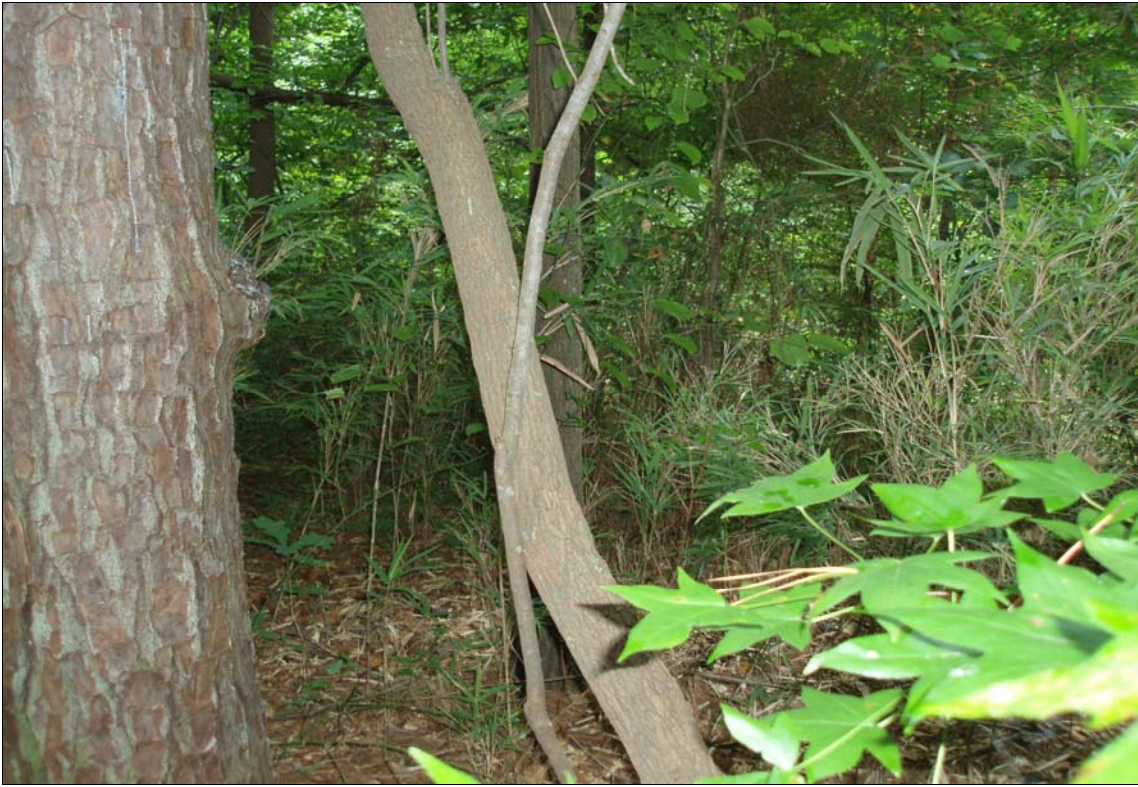
Vegetation Plot 2 Photo – Taken looking south from the northern corner. 7/9/09 - MY 05

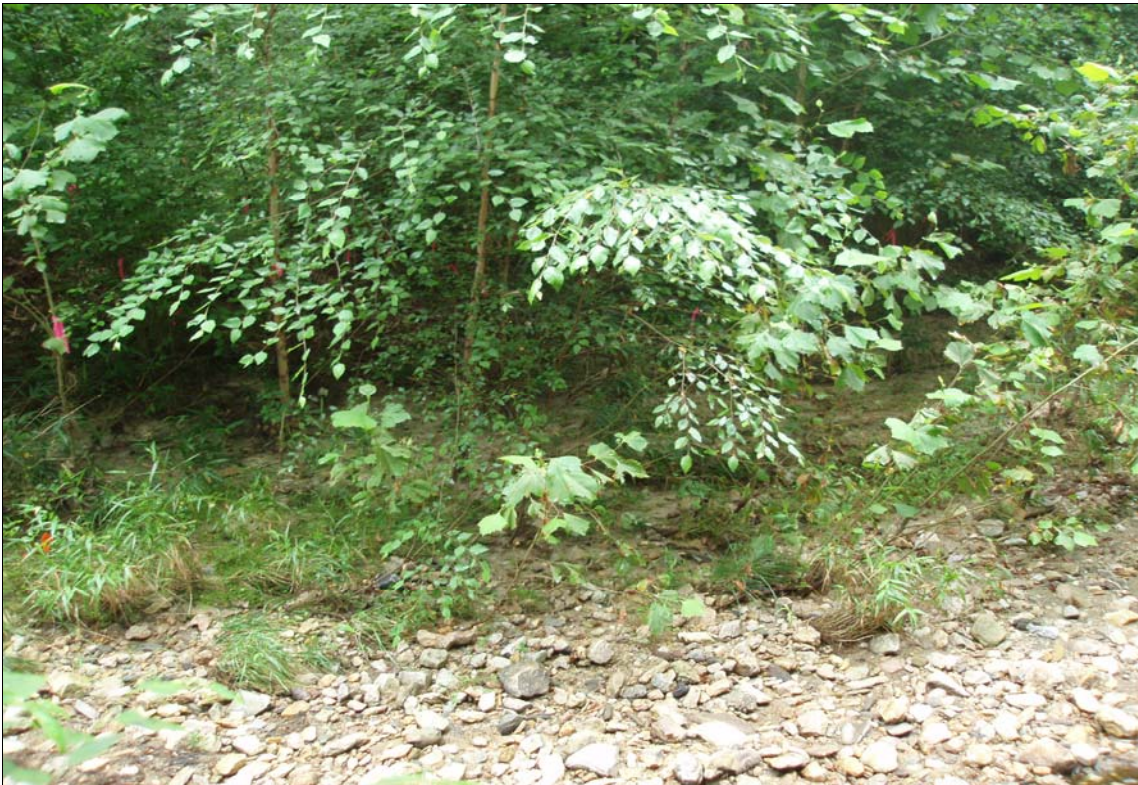
Vegetation Plot 2 Supplemental Photo – Taken looking at center of plot from the top of the right bank across the stream from the vegetation plot. 7/9/09 - MY 05

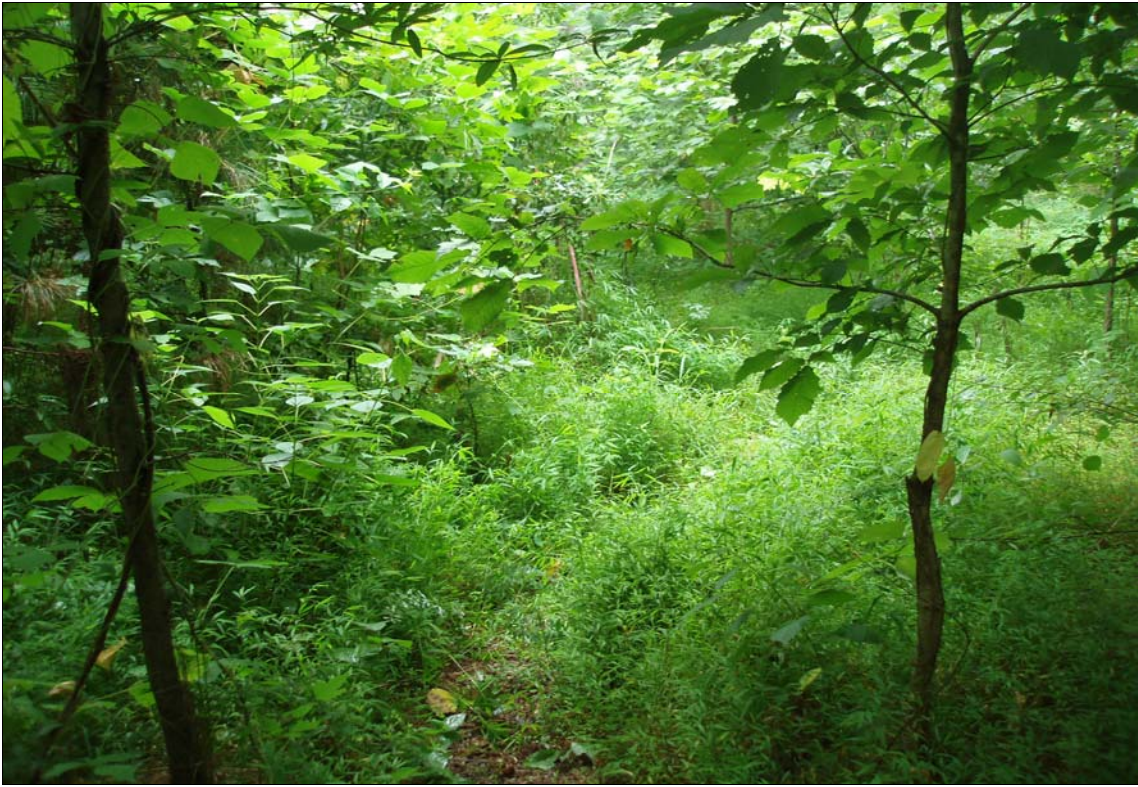
Vegetation Plot 3 Photo – Taken looking east from the western corner. 7/9/09 - MY 05

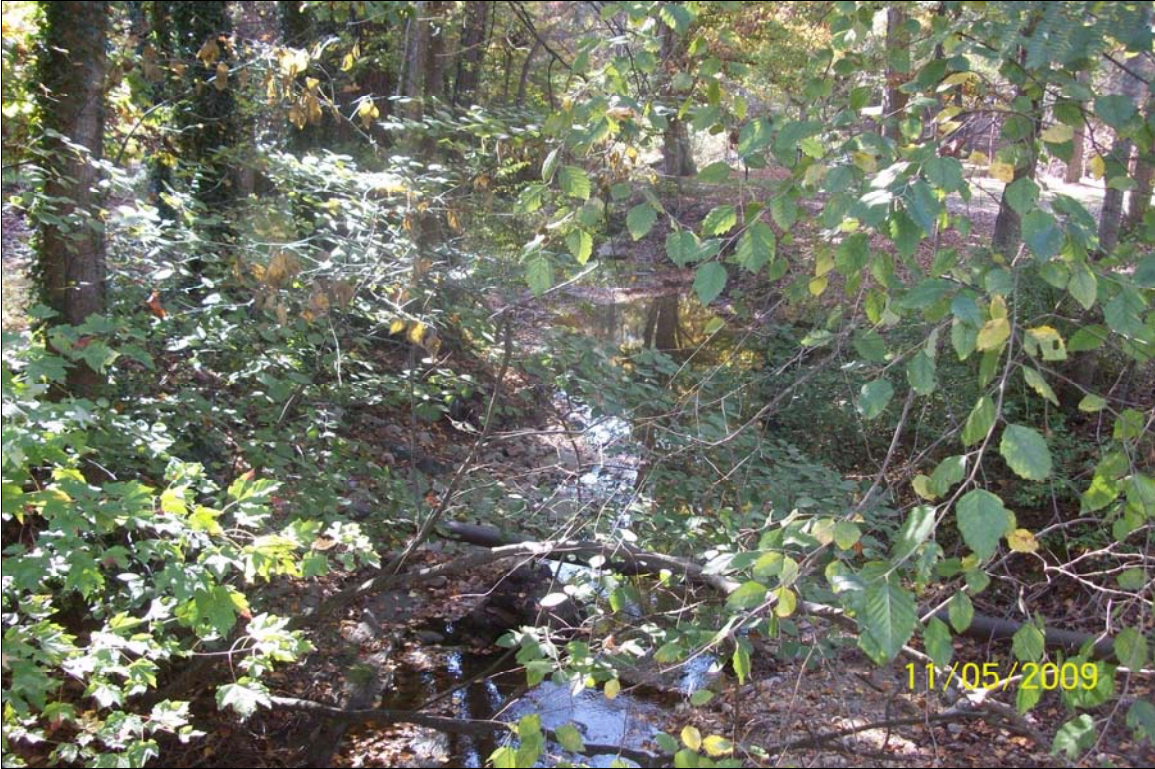
Photo Point 1 – Taken looking downstream from bridge on Kaplan Drive. 11/5/09 - MY 05

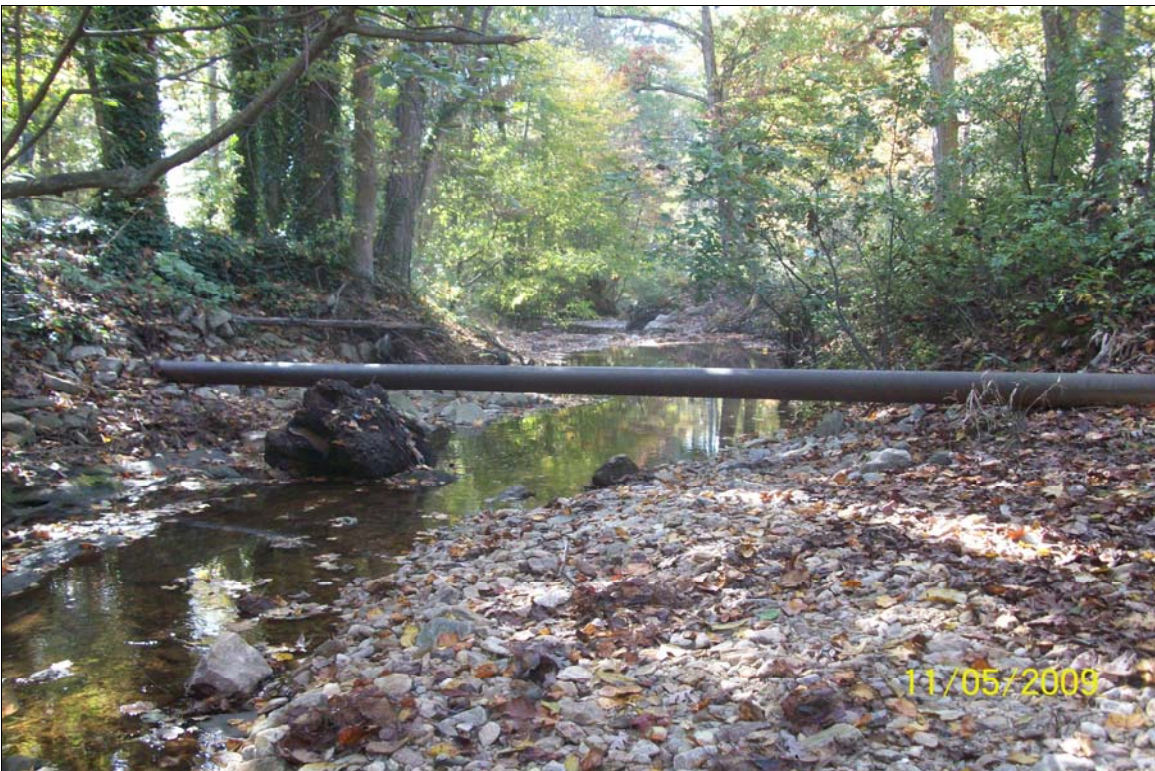
Photo Point 1, supplemental – Taken looking downstream from streambed in front of bridge on Kaplan Drive. 11/5/09 - MY 05

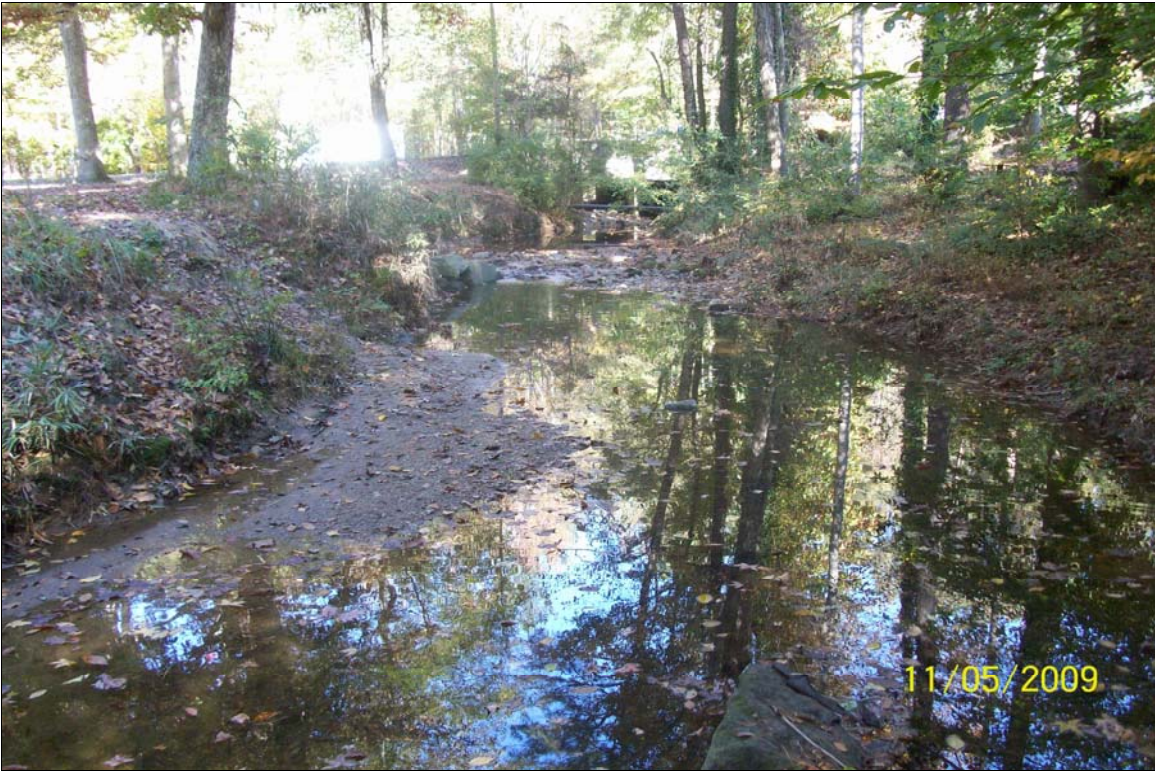
Photo Point 2 – Taken looking upstream. 11/5/09 - MY 05

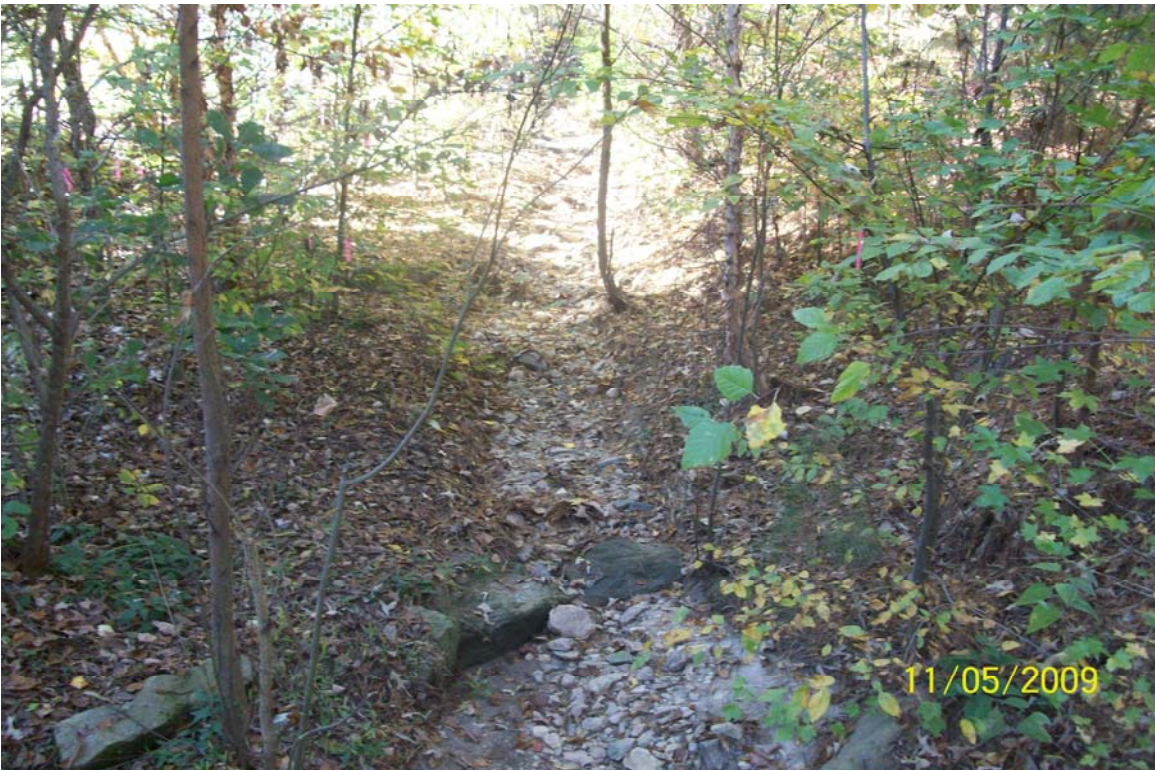
Photo Point 3 – Taken looking upstream. 11/5/09 - MY 05

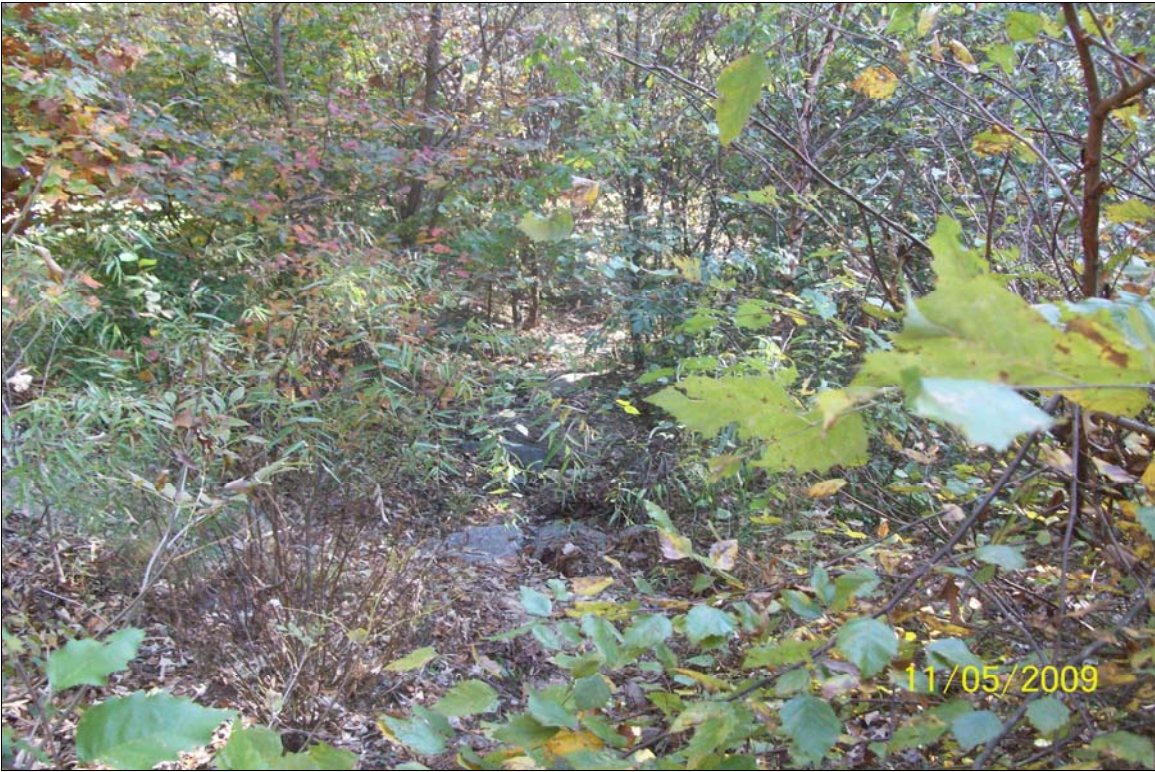
Photo Point 3 – Taken looking downstream. 11/5/09 - MY 05

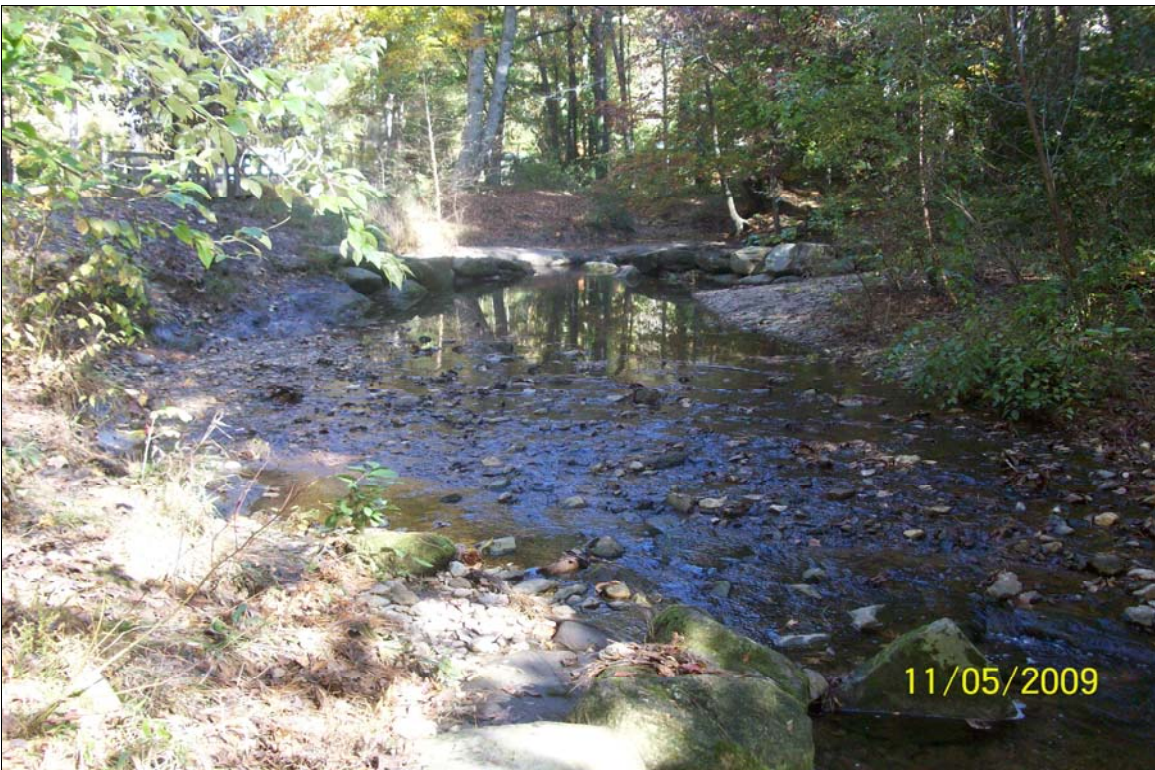
Photo Point 4 – Taken looking upstream. 11/5/09 - MY 05

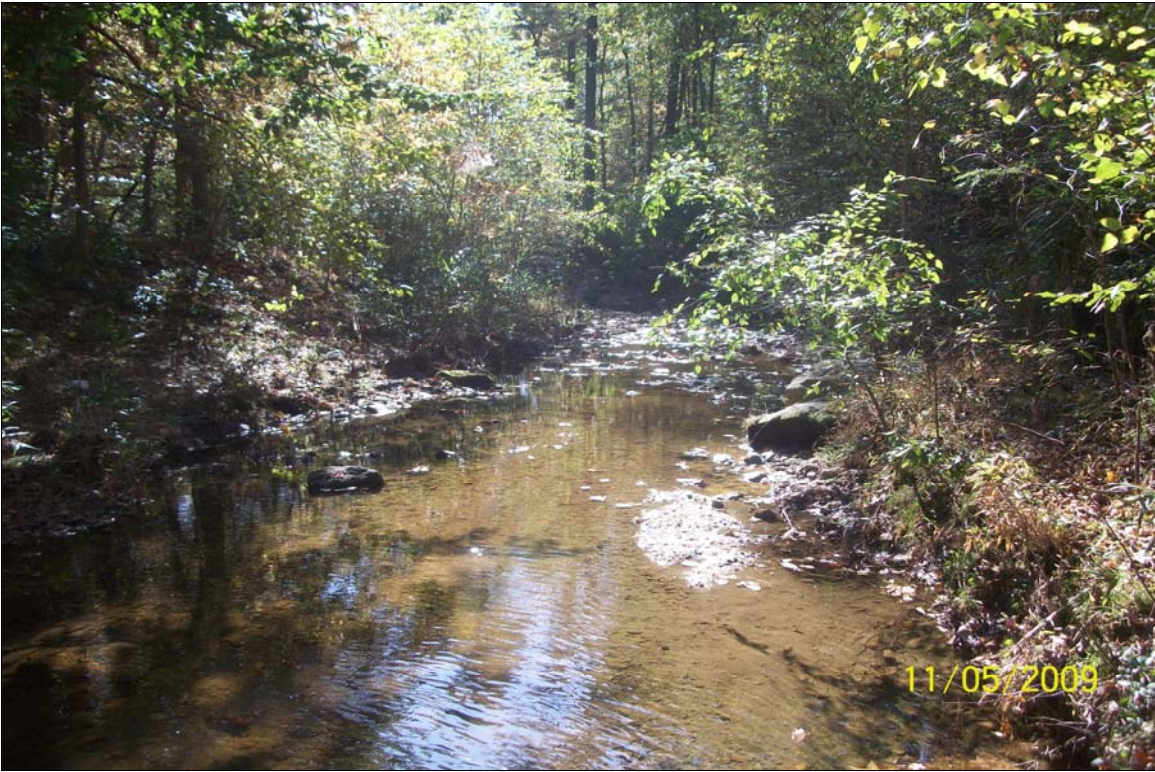
Photo Point 4 – Taken looking downstream. 11/5/09 - MY 05

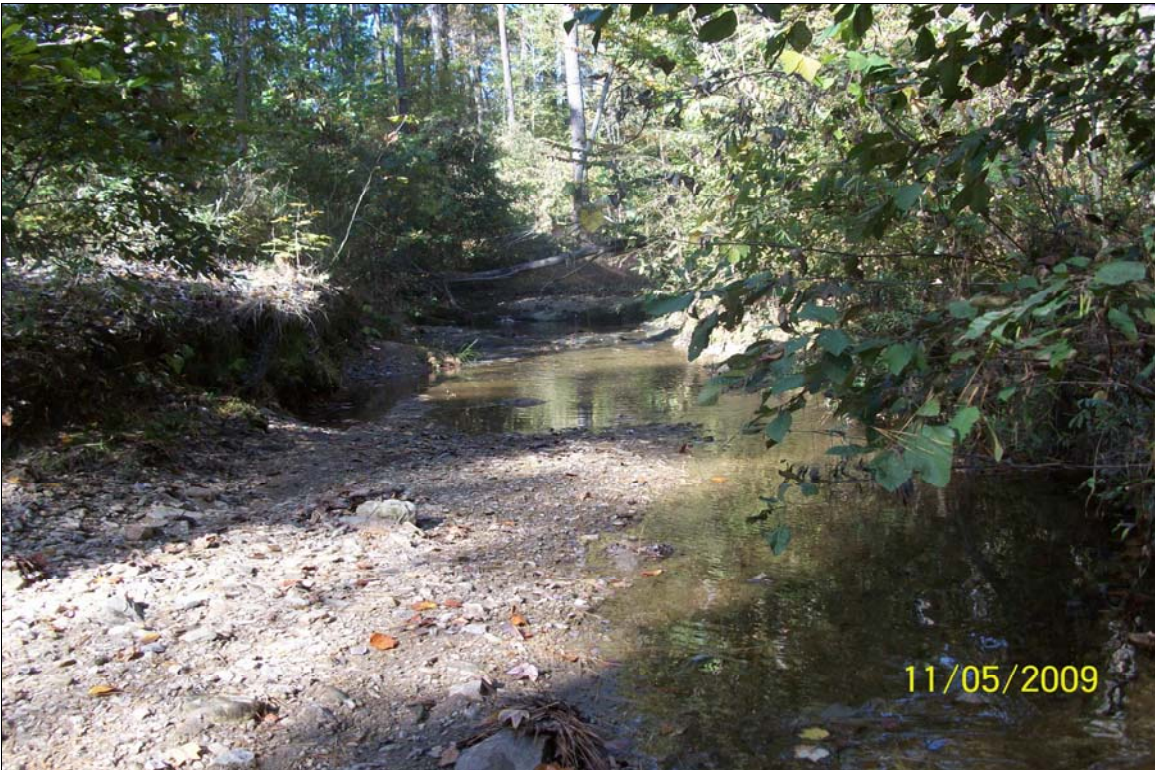
Photo Point 5 – Taken looking upstream. 11/5/09 - MY 05

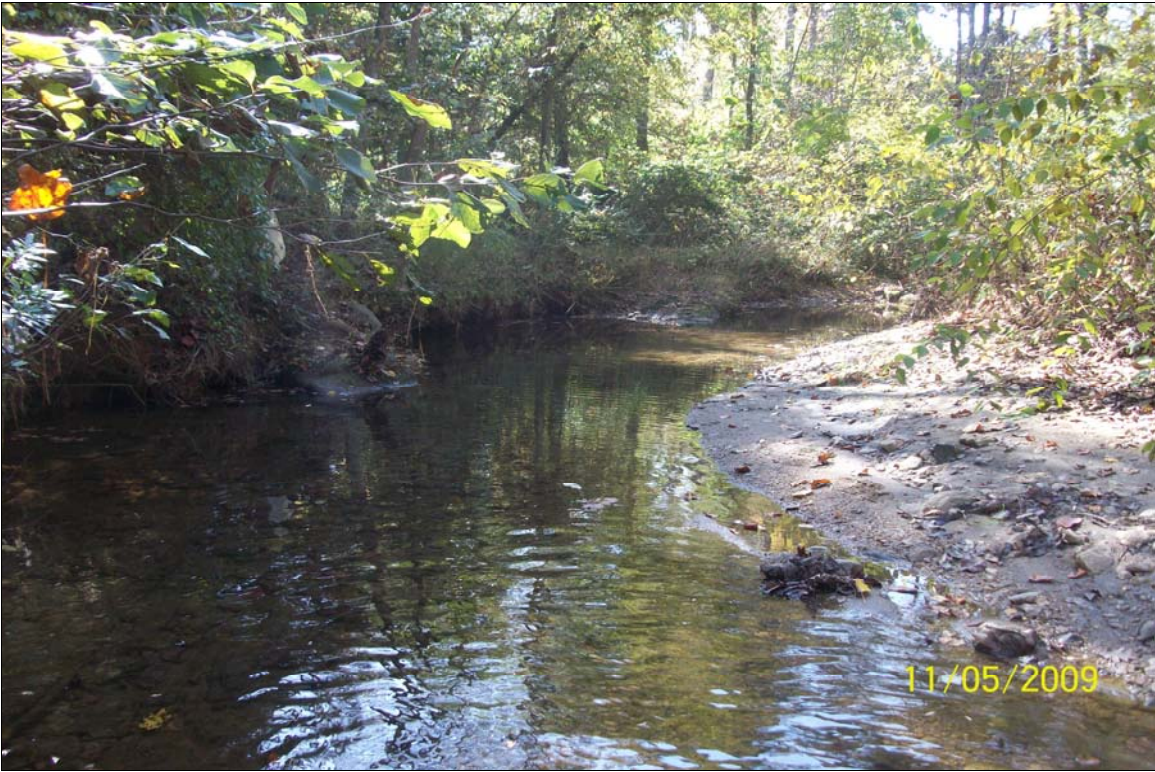
Photo Point 5 – Taken looking downstream. 11/5/09 - MY 05

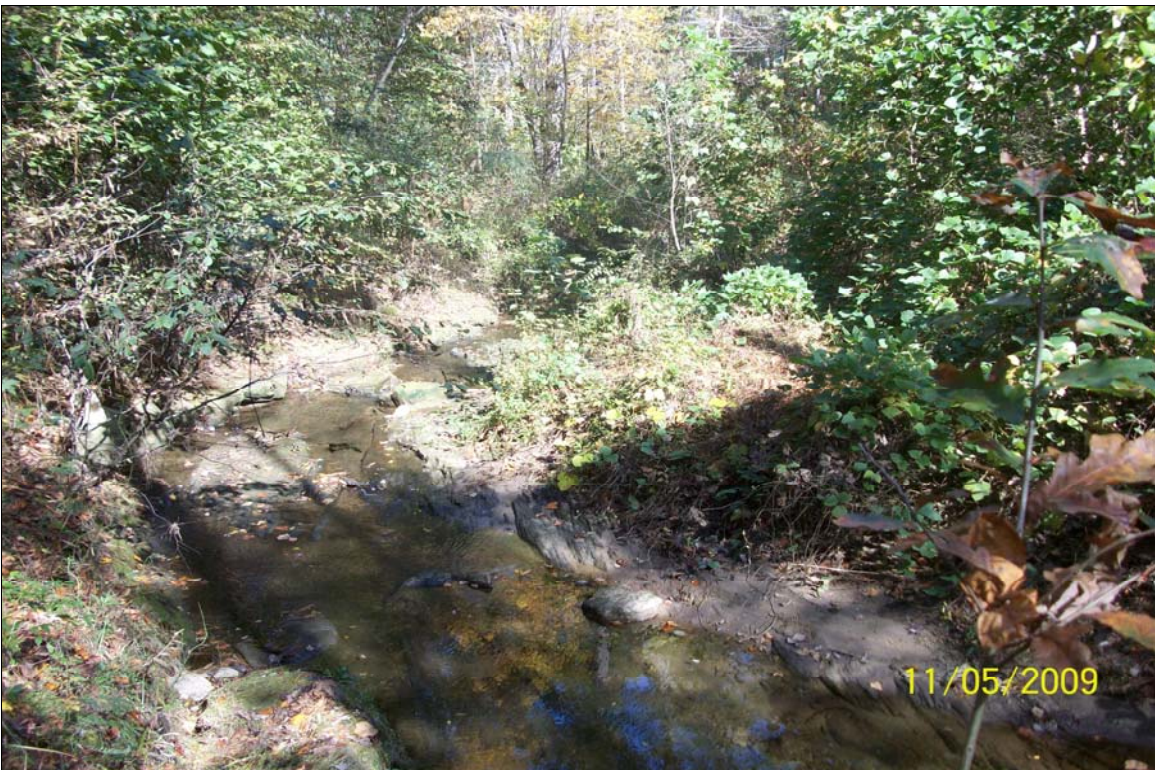
Photo Point 6 – Taken looking upstream. 11/5/09 - MY 05

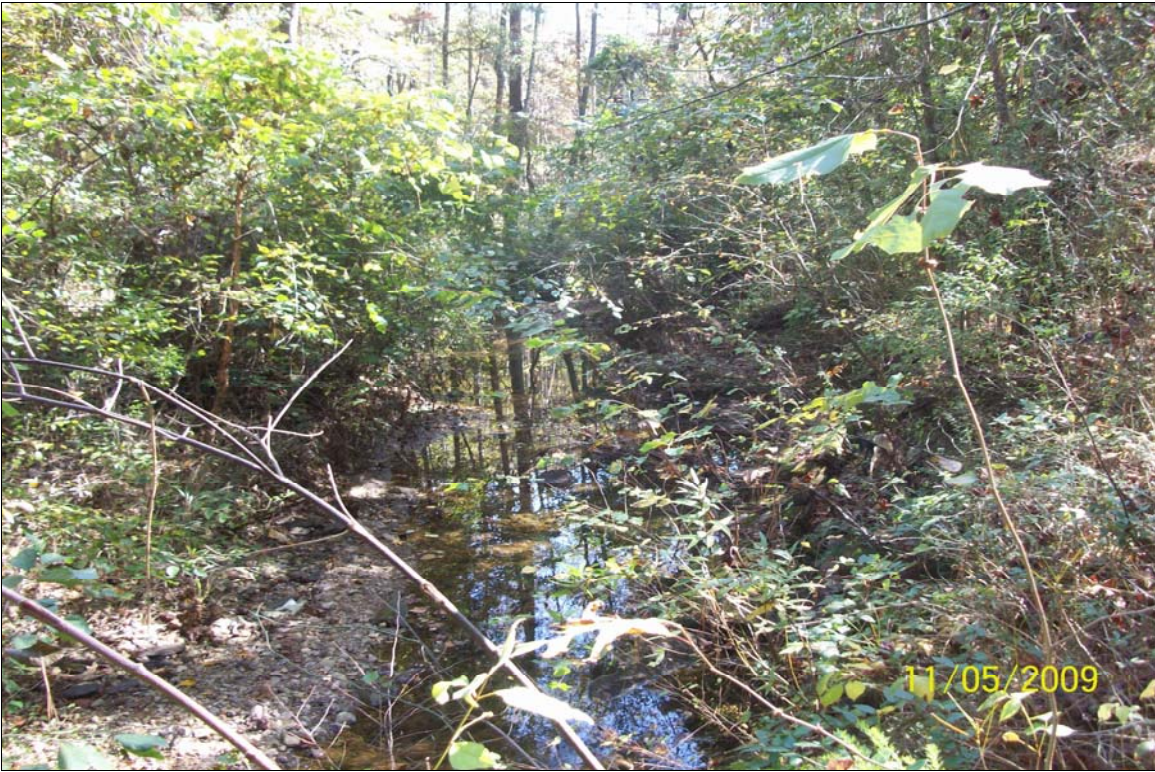
Photo Point 6 – Taken looking downstream. 11/5/09 - MY 05
