**KEY BRANCH MITIGATION SITE
(Project No. .00013)**

MONITORING YEAR 2 (2005)

Submitted to:
North Carolina Department of Environment and Natural Resources
Ecosystem Enhancement Program
Raleigh, North Carolina

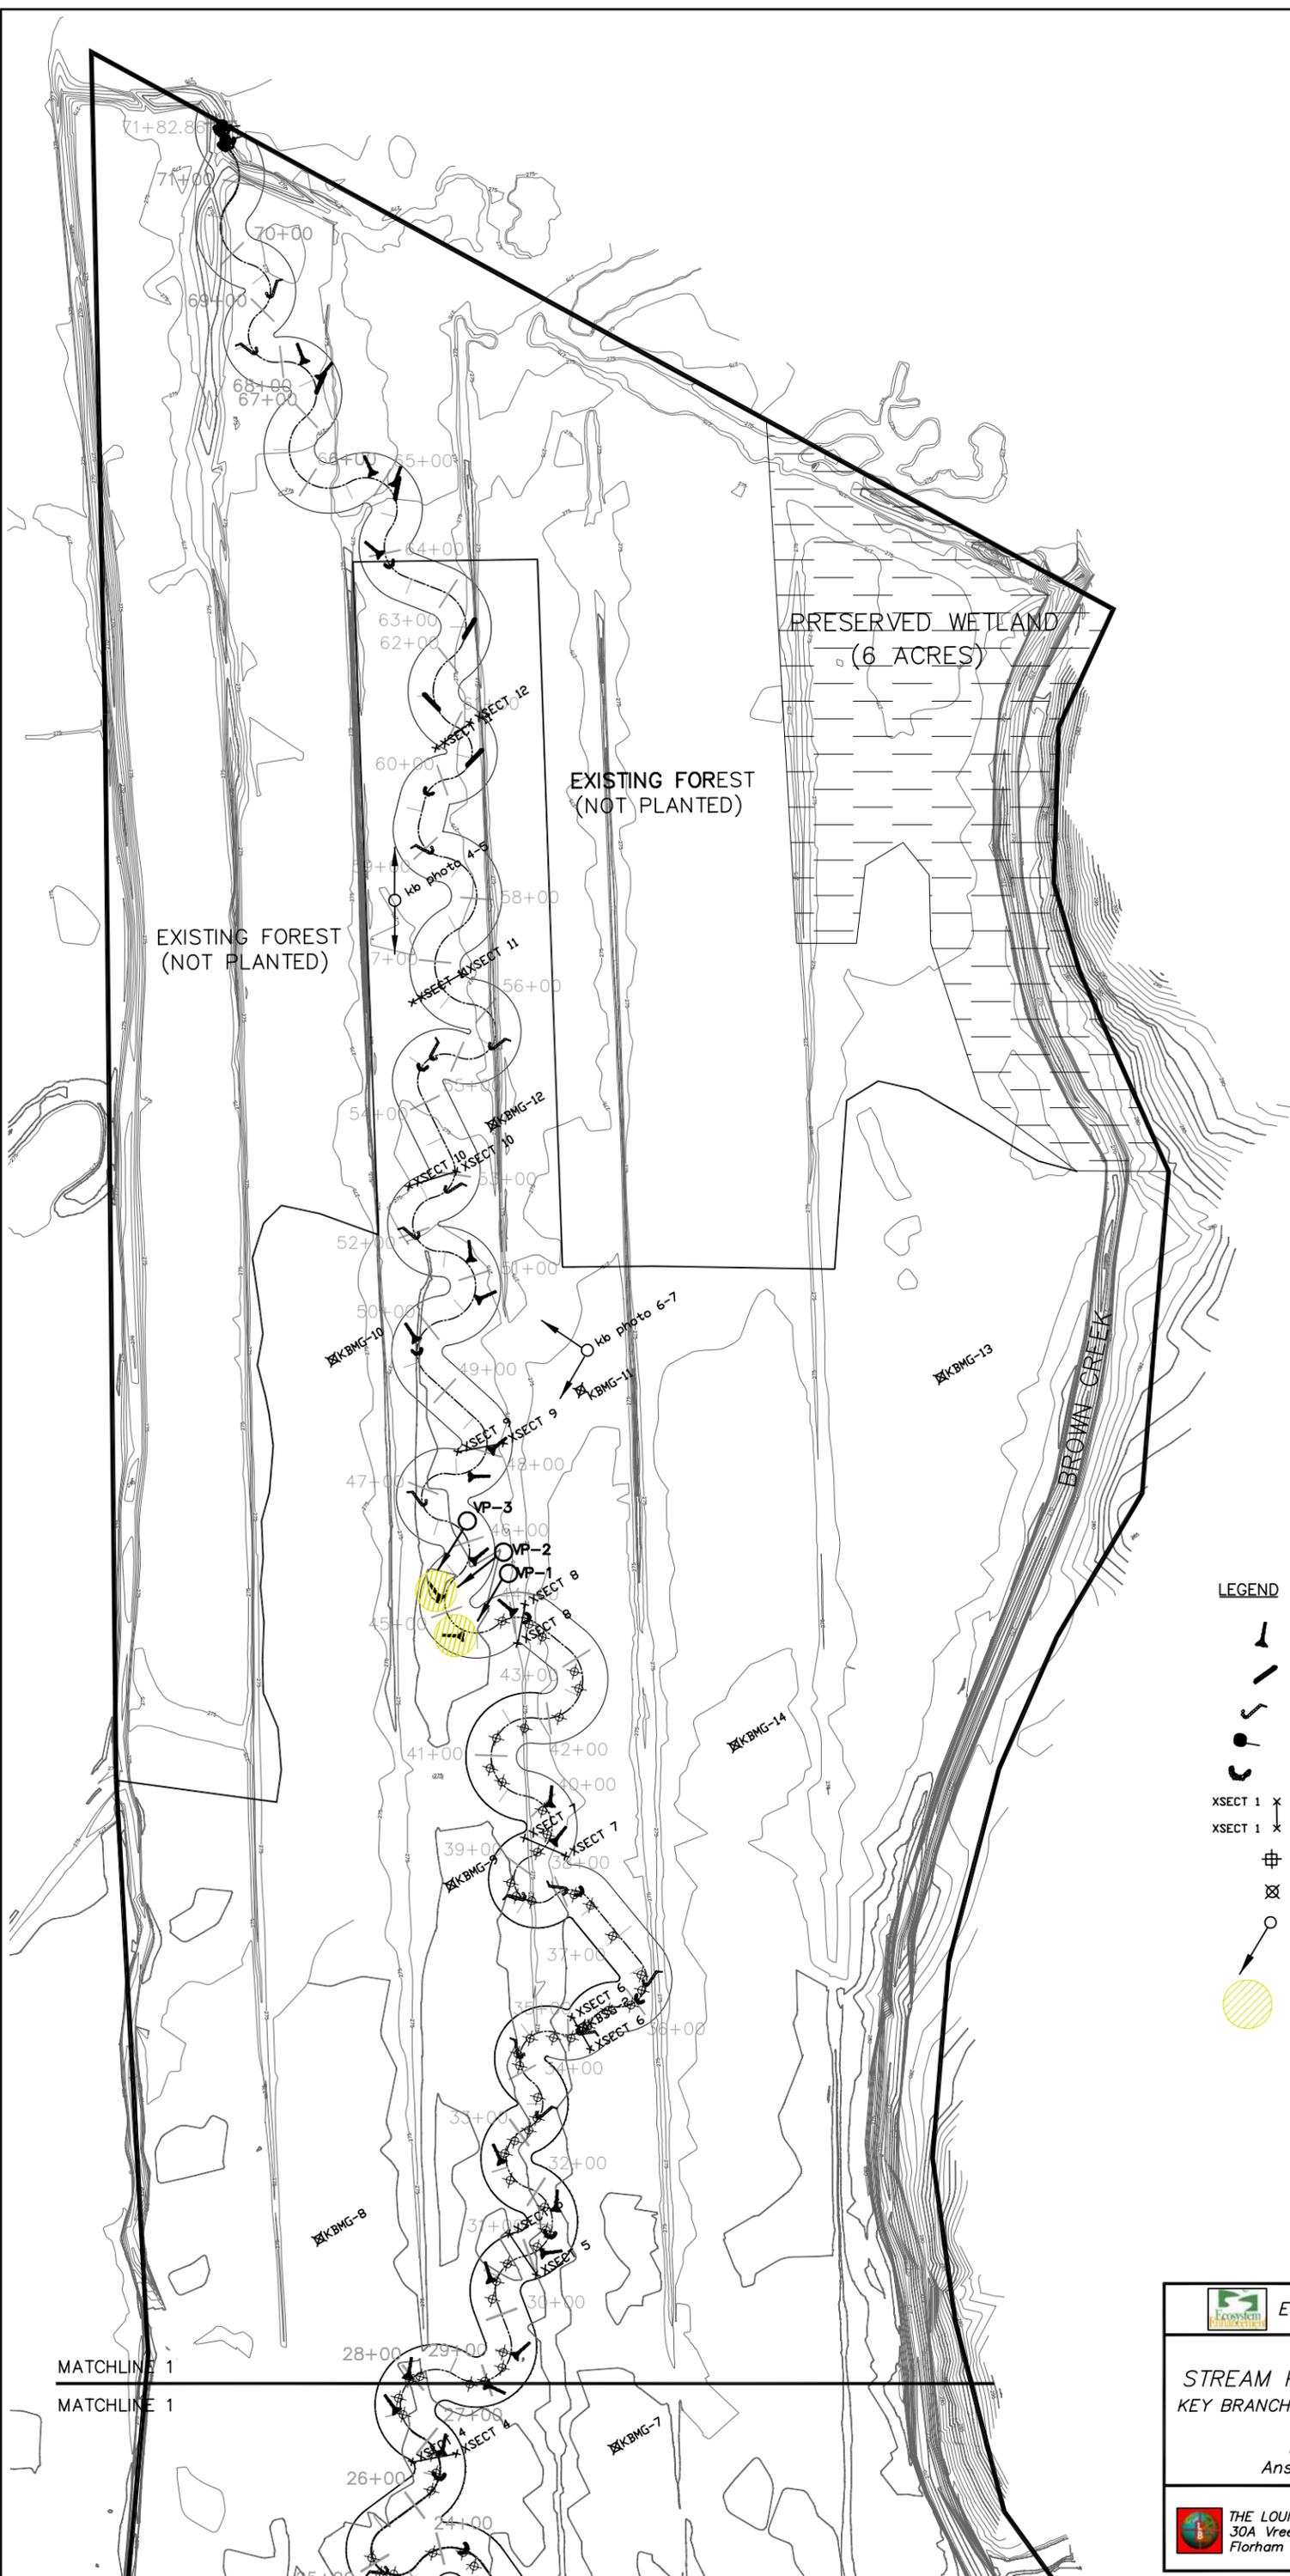
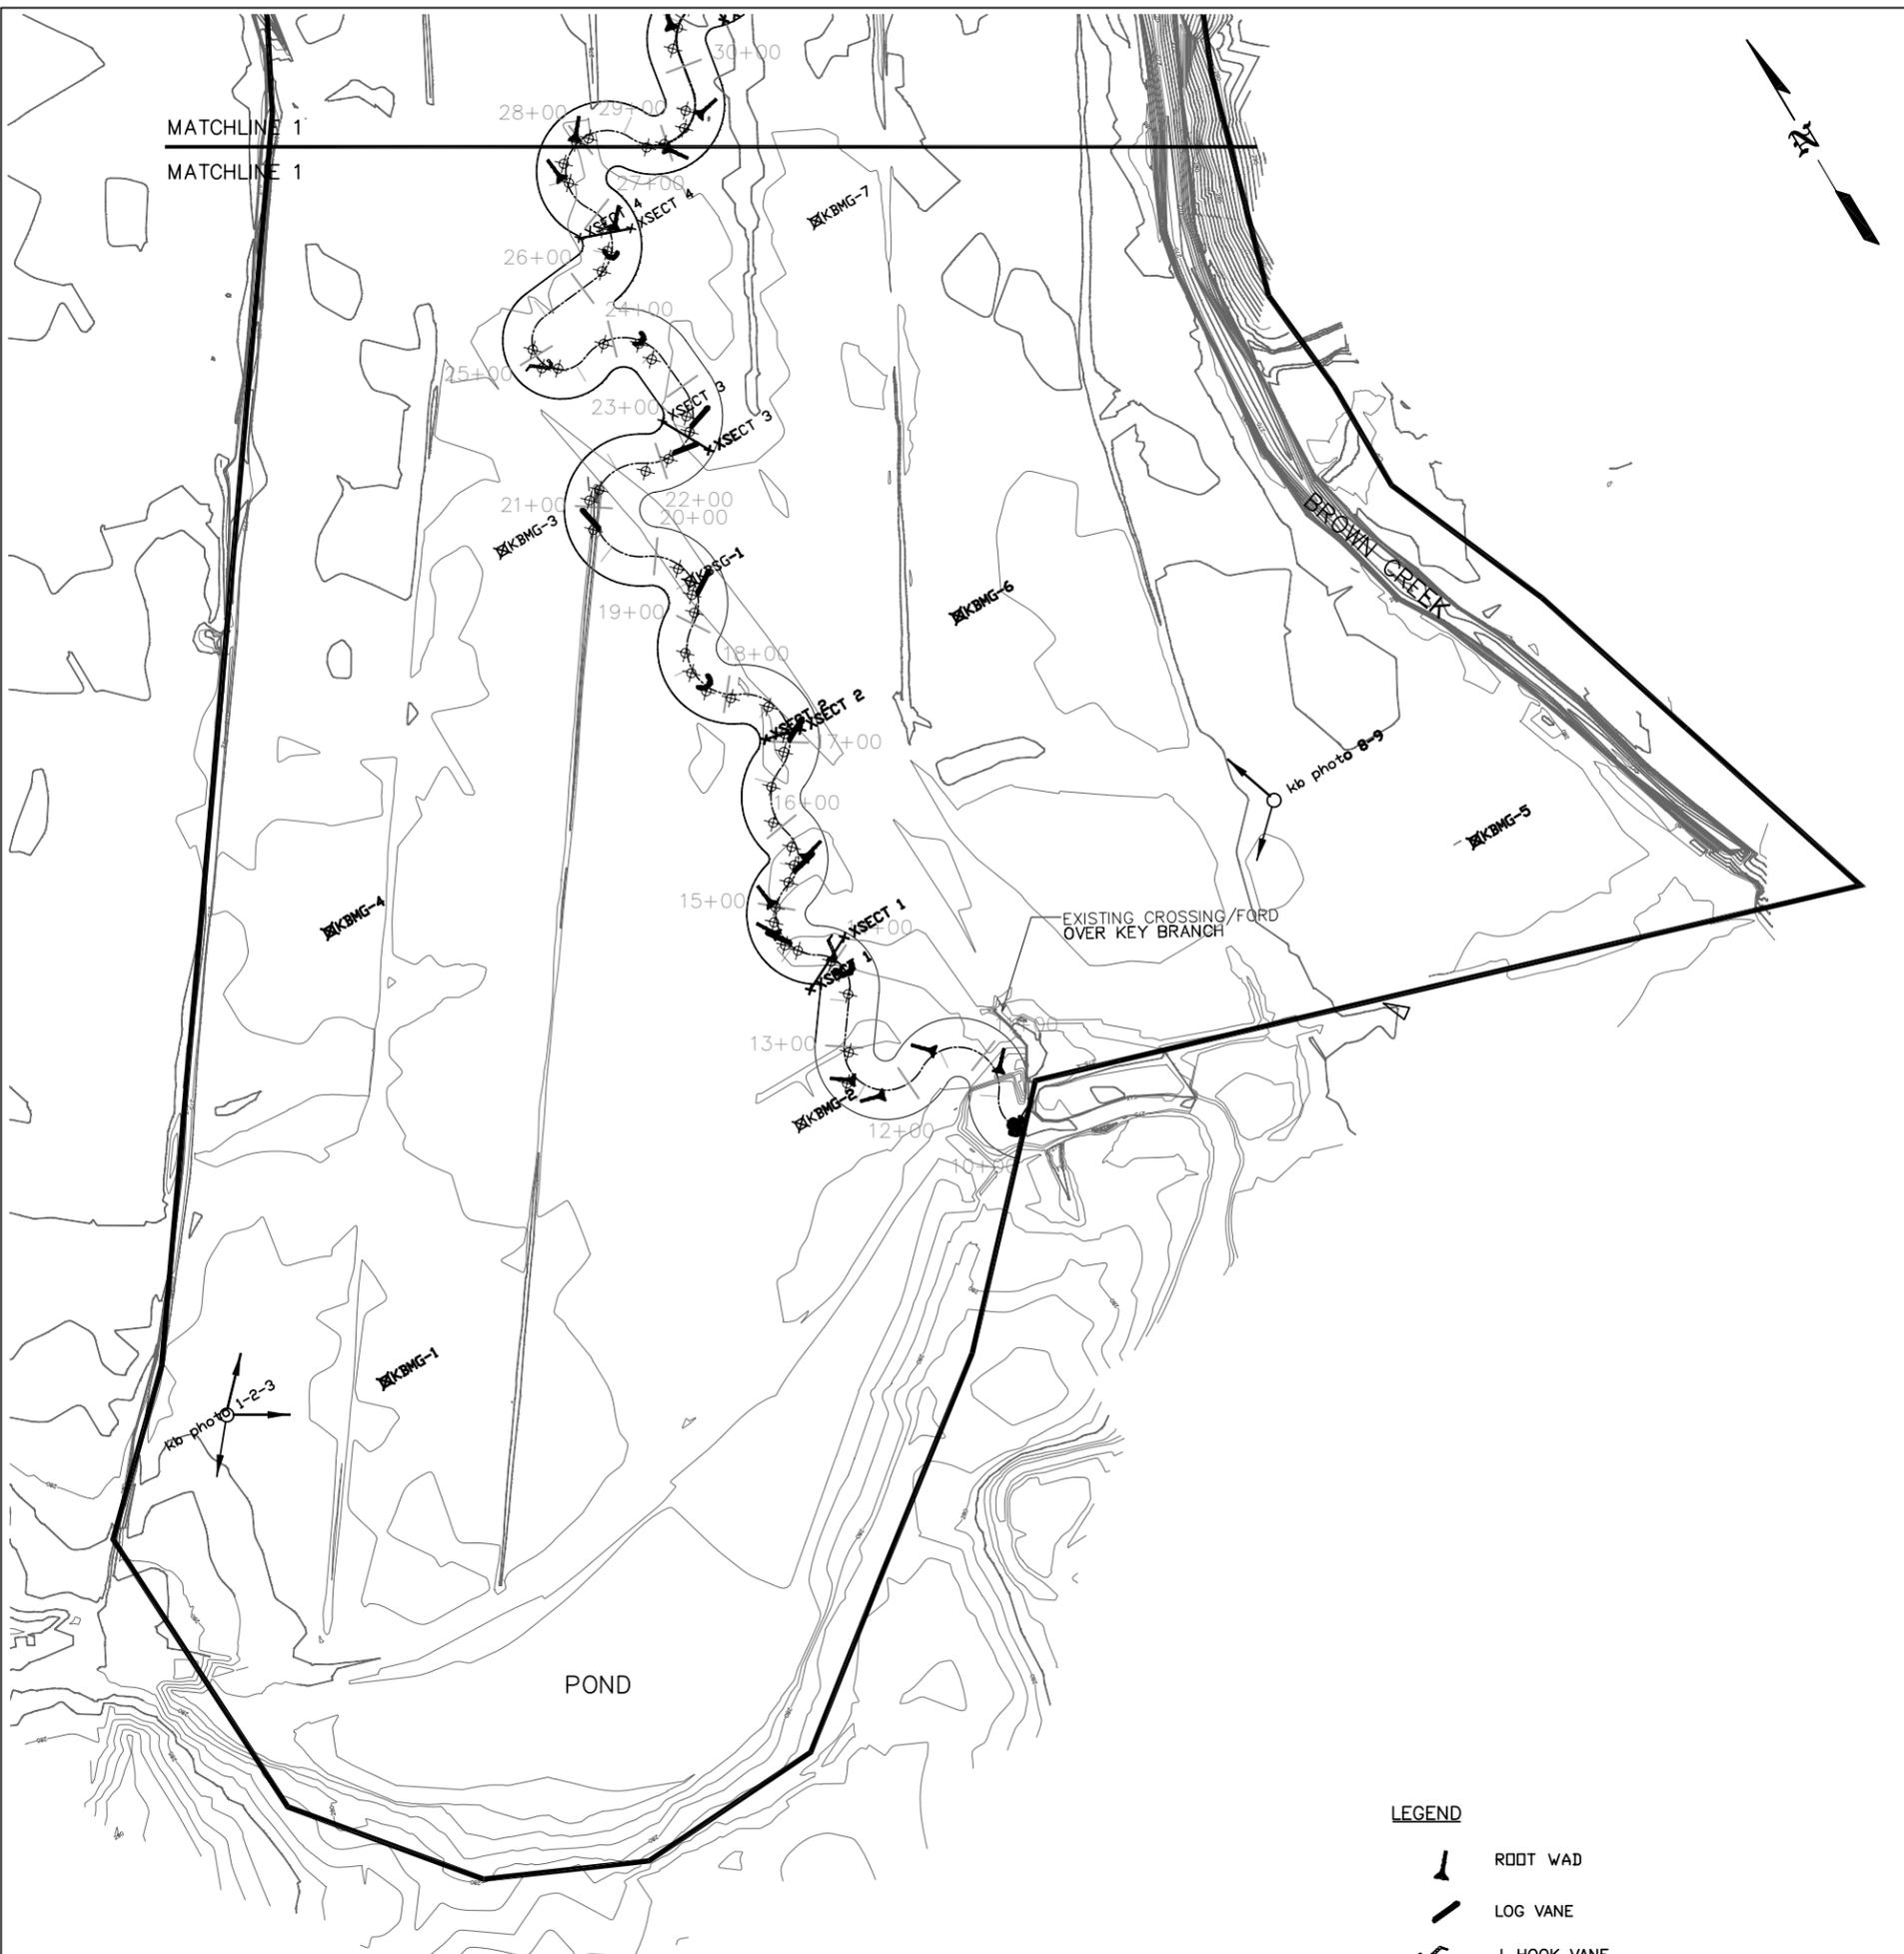
B1. Stream Problem Areas Plan View

The only stream problem feature observed at the site was bank scour behind two root wads on the outside of the same meander bend (Appendix B1). This meander bend appears to constrict flow during over bank events. The bank at the upstream-most root wad (Sta. 44+70) is vertical, extending from the in-stream end of the structure along the structure arm. Erosion observed along the bank at this location is evidence of an eddy present during high flows. A small area of scour has developed behind the downstream root wad (45+20 to 45+40) from over bank events flowing over and around the arm of the root wad. No maintenance is recommended for either structure, as light scour around the edges of natural root wads and streams are naturally-occurring features. If the scour pocket should expand in subsequent monitoring years, then maintenance will be warranted.

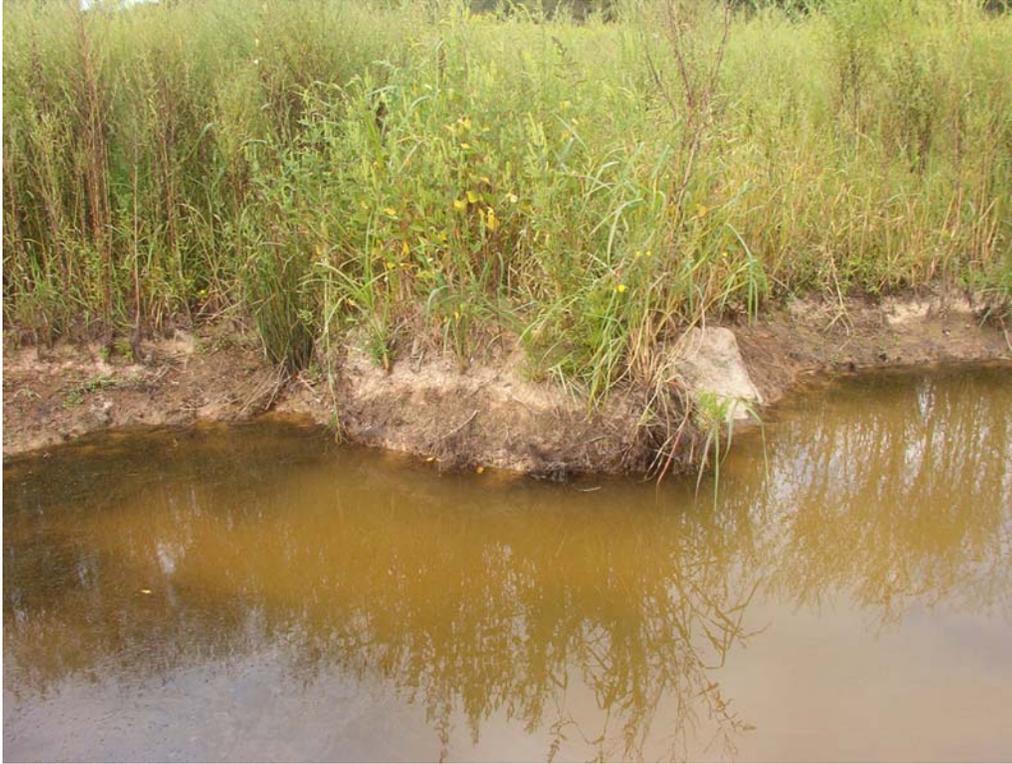
Table IX. Stream Problem Areas			
Project Number .00013 (Key Branch Mitigation Site)			
Feature Issue	Station Numbers	Suspected Cause	Photo #
Aggradation/ Bar Formation	N/A	N/A	N/A
Bank Scour	44+70	channel constriction	VPA 1
	45+20 - 45+40	channel constriction	VPA 2, VPA 3
Engineered Structures	N/A	N/A	N/A
Others	N/A	N/A	N/A

VPA 1. Station 44+70 - Evidence of eroding vertical banks and exposed root

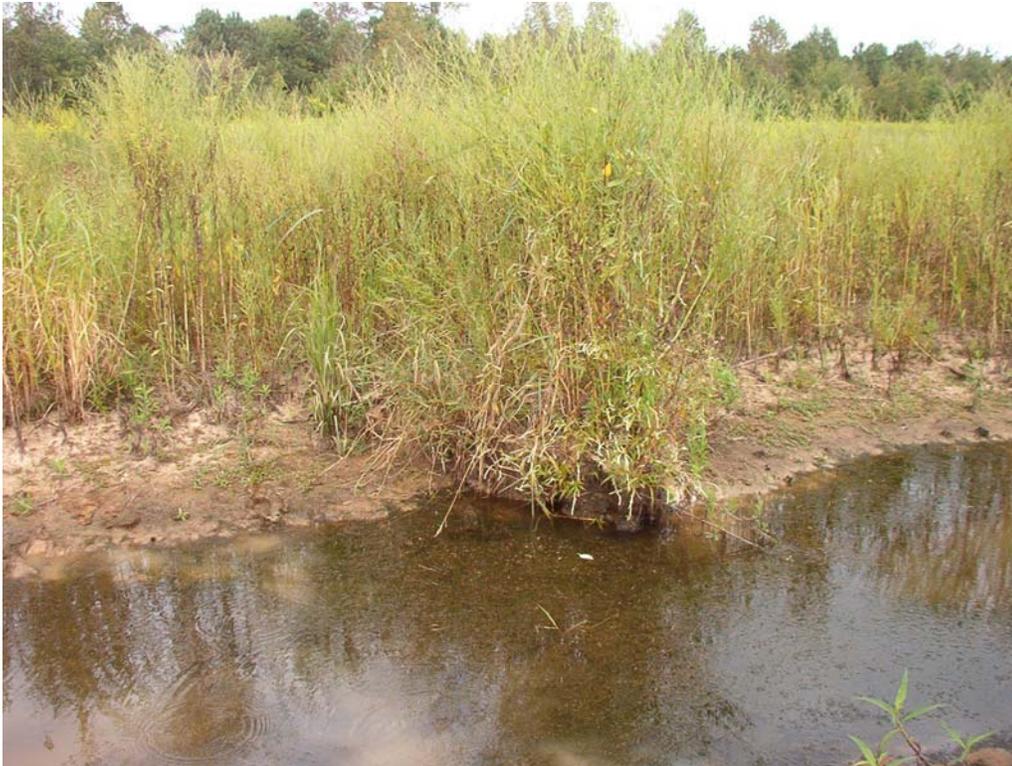
VPA 2. Station 45+20 to 45+40 - Evidence of bank scour behind root wad.

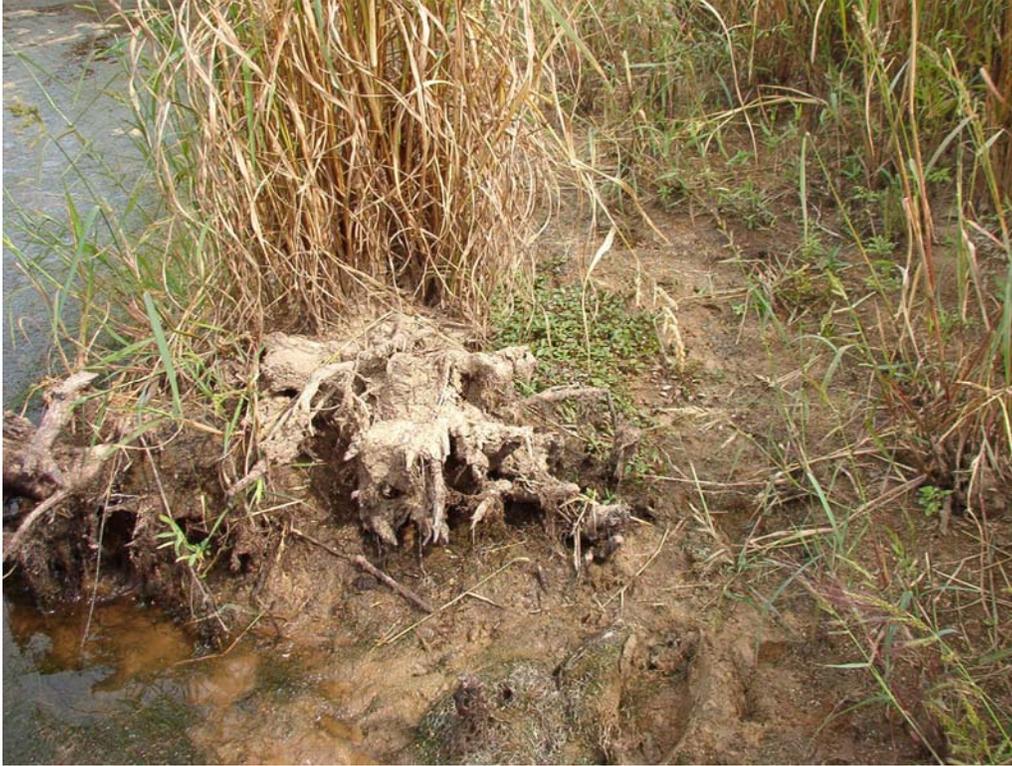
VPA 3. Station 45+20 to 45+40 - Evidence of bank scour behind root wad.

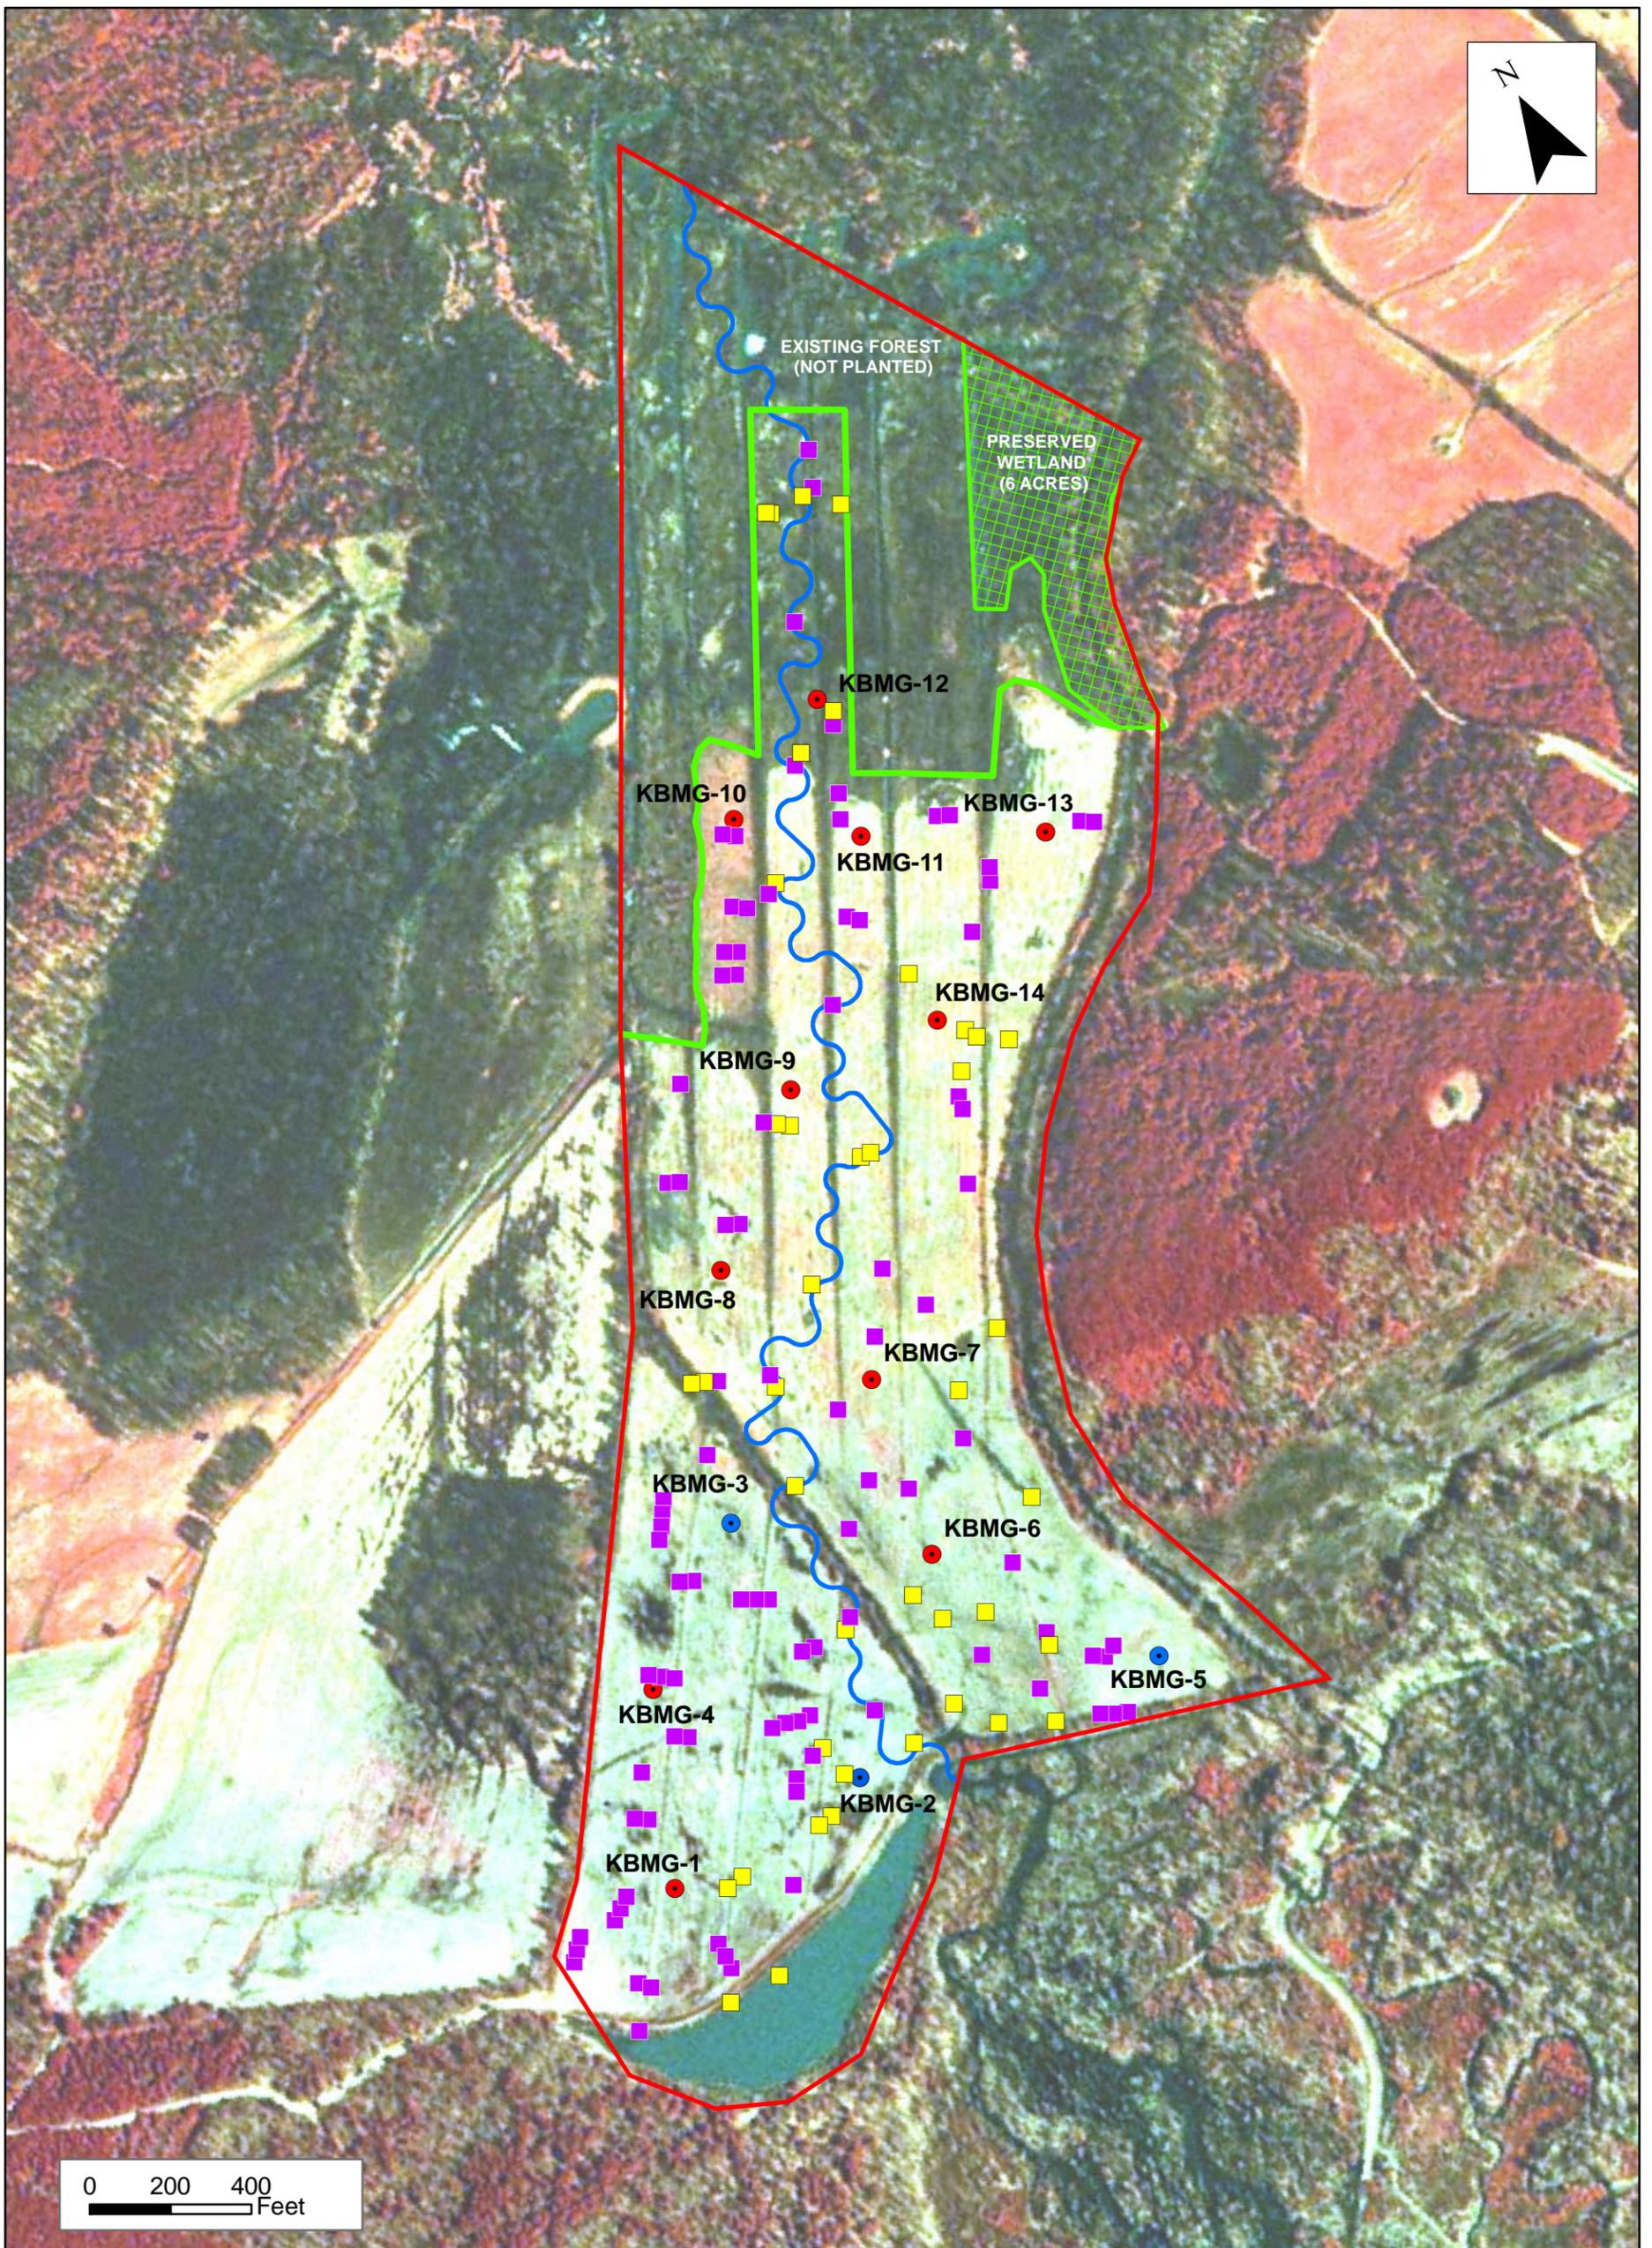
C1. Wetland Problem Areas Plan View

Three of the 14 monitoring gauges met the wetland criteria, with the upper 12 inches of the soil surface remaining saturated for more than 30 consecutive days, or 12.5 percent of the growing season. The remaining monitoring gauges failed before July 2005, resulting in an incomplete description of hydrological activity during the growing season. Comparative analysis of 2004 data found that six of the failed monitoring gauges in 2005 (KBMGs 1, 6, 7, 8, 11, 12) met the wetland hydrology criteria in 2004. Gauges that did not meet the criteria in both monitoring years (KBMGs 9, 10, 13, 14) appeared to be saturated for longer periods in 2005. Therefore, it is possible that had the six gauges performed properly, the results would illustrate that the hydrological regime for the site is indicative of a wetland.

* Gauge data for growing season absent due to gauge failure prior July 2005.
