# Key Branch Stream and Wetland Restoration Site Year-7 Annual Monitoring Report (2010)

**Anson County, North Carolina  
WBS Element 34398.4.1  
TIP No. R-2239WM  
NCEEP Project 206**

**December 2010**

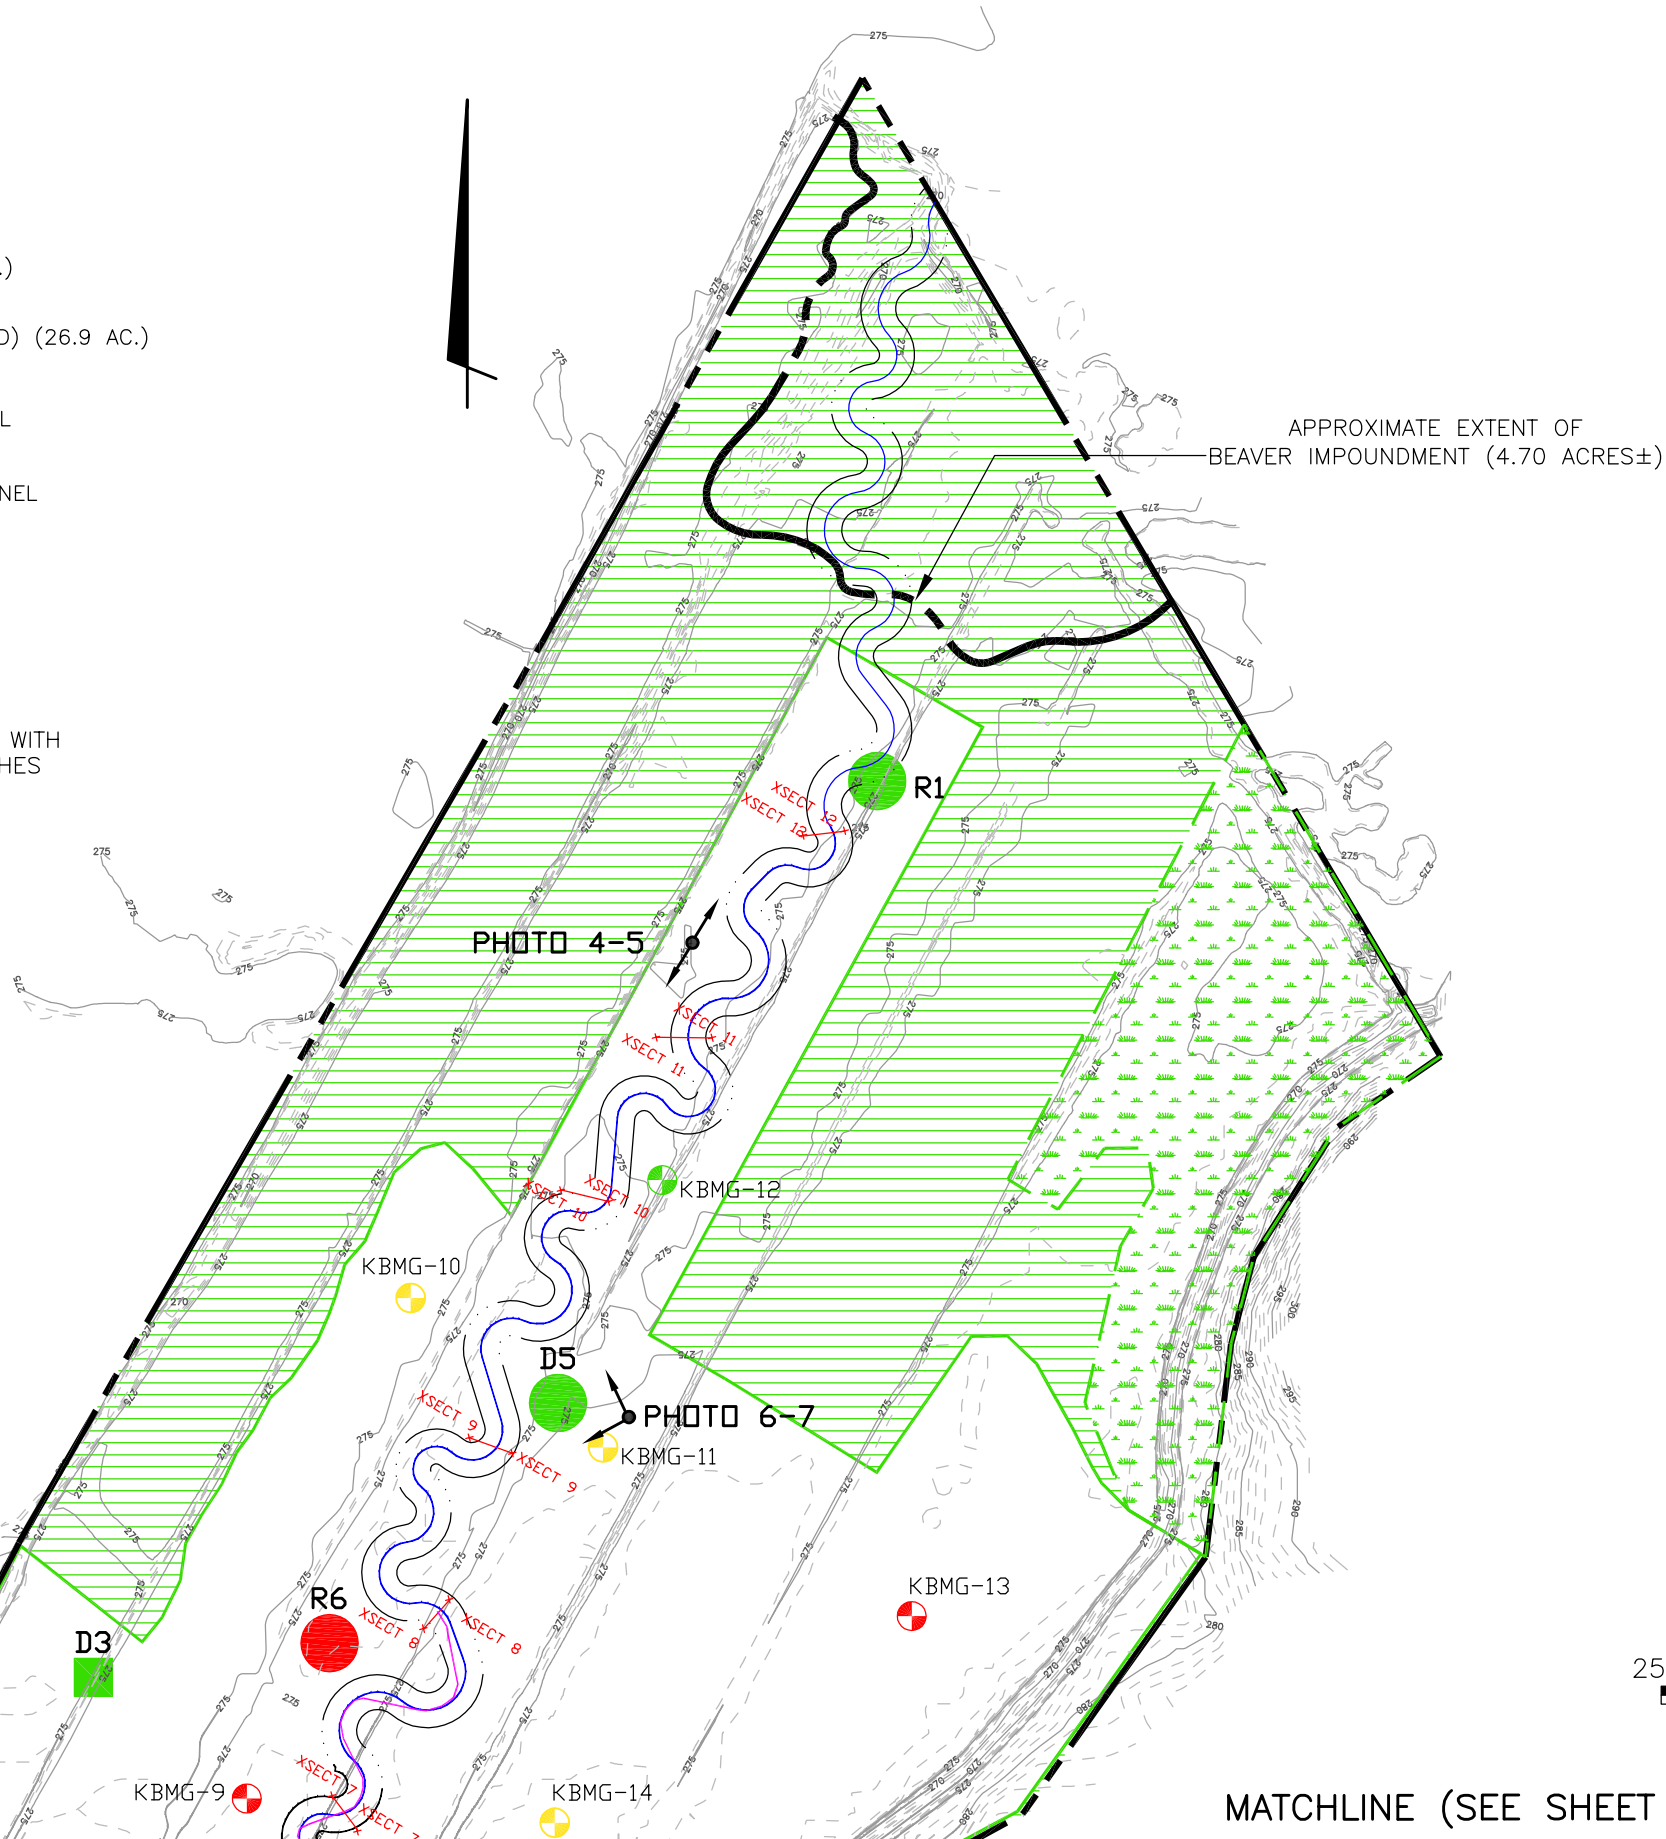
Since the construction of Key Branch, a beaver impoundment located approximately 150 feet upstream of the end of the project has caused the water to back up throughout the reach (see Figure 2, Appendix A). Two additional beaver impoundments found at the start of the site have been removed as recent as November 2010 (see photos in

APPROXIMATE EXTENT OF  
BEAVER IMPOUNDMENT (4.70 ACRES±)

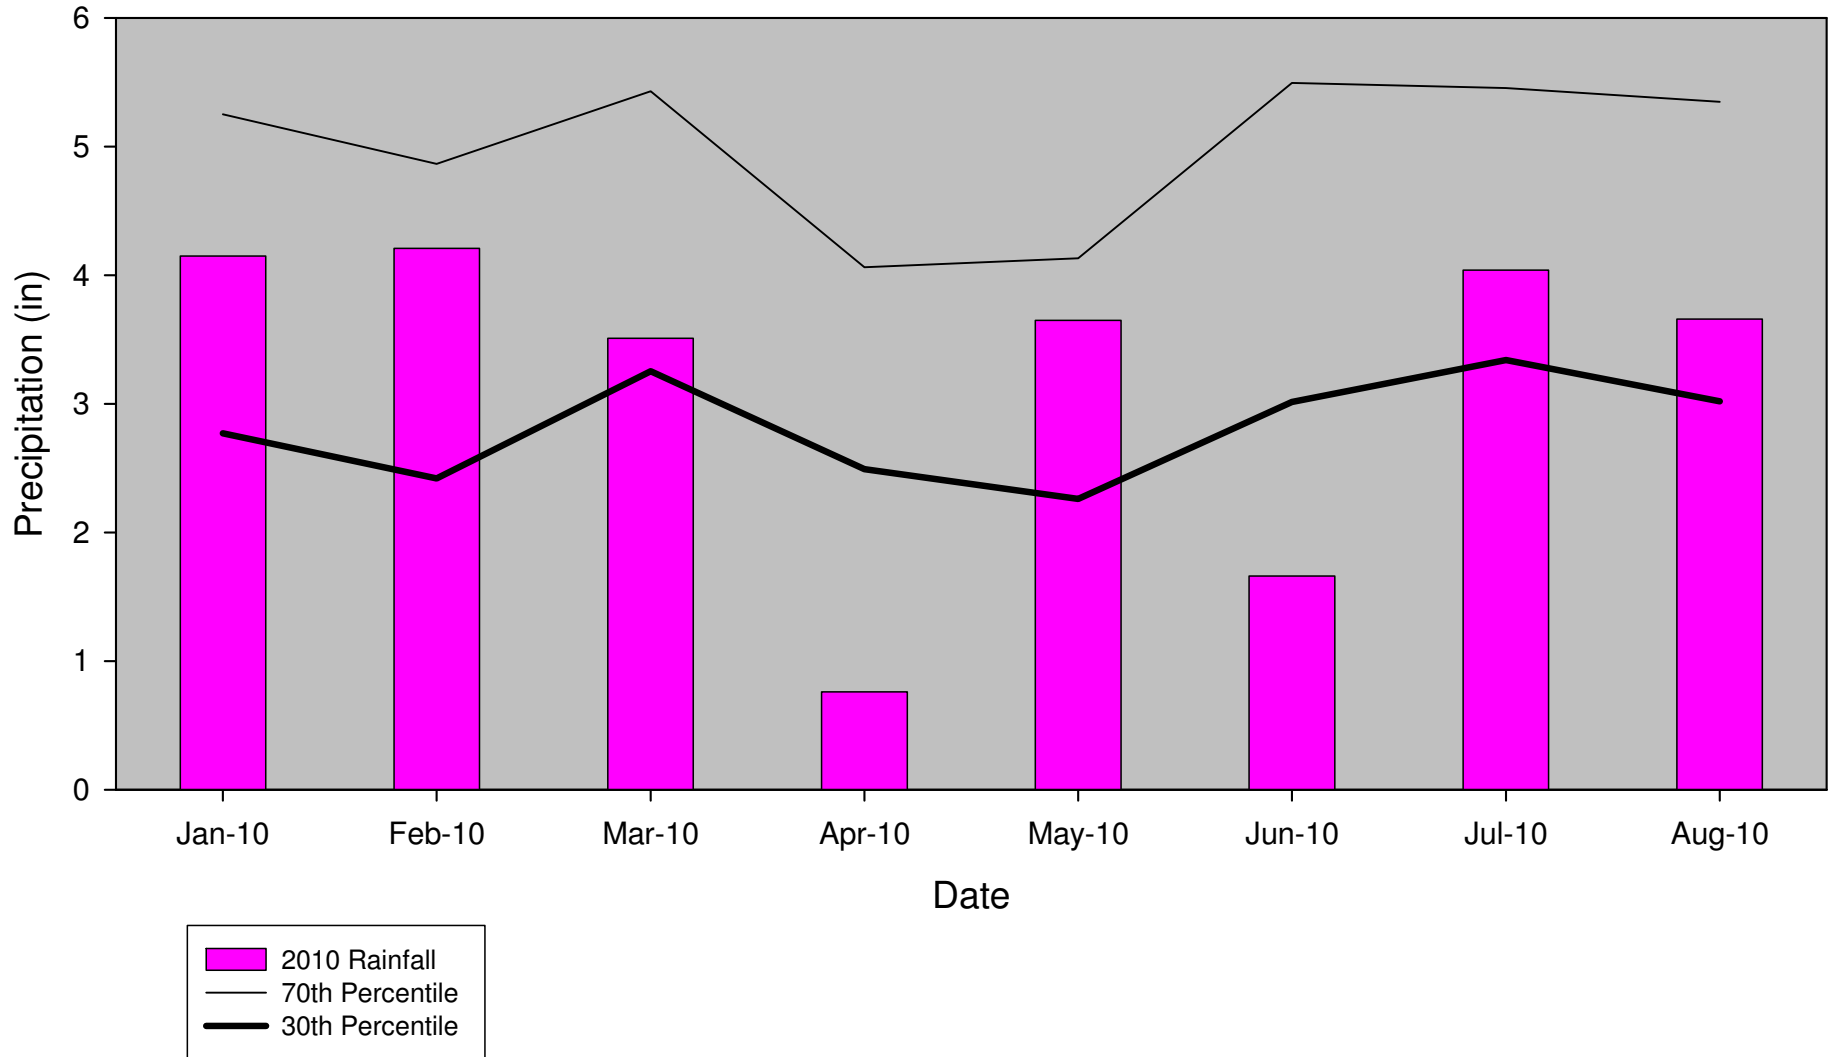
**Fig 3. Key Branch 30-70 Percentile Graph 2010  
Wadesboro, NC**

Figure 3 shows a comparison of 2010 monthly rainfall to historical precipitation for the area. The figure shows average rainfall data collected between 1948 and 2010 and compares 30 percent and 70 percent of all observations with the actual 2010 monthly rainfall amount to determine average. (Climate data only available through August 2010)

The Site experienced 6 months of average rainfall throughout the monitoring period. The months of April and June received below average rainfall. April and June experienced amounts less than half of the monthly average. On balance, the yearly precipitation was close to the historical average.

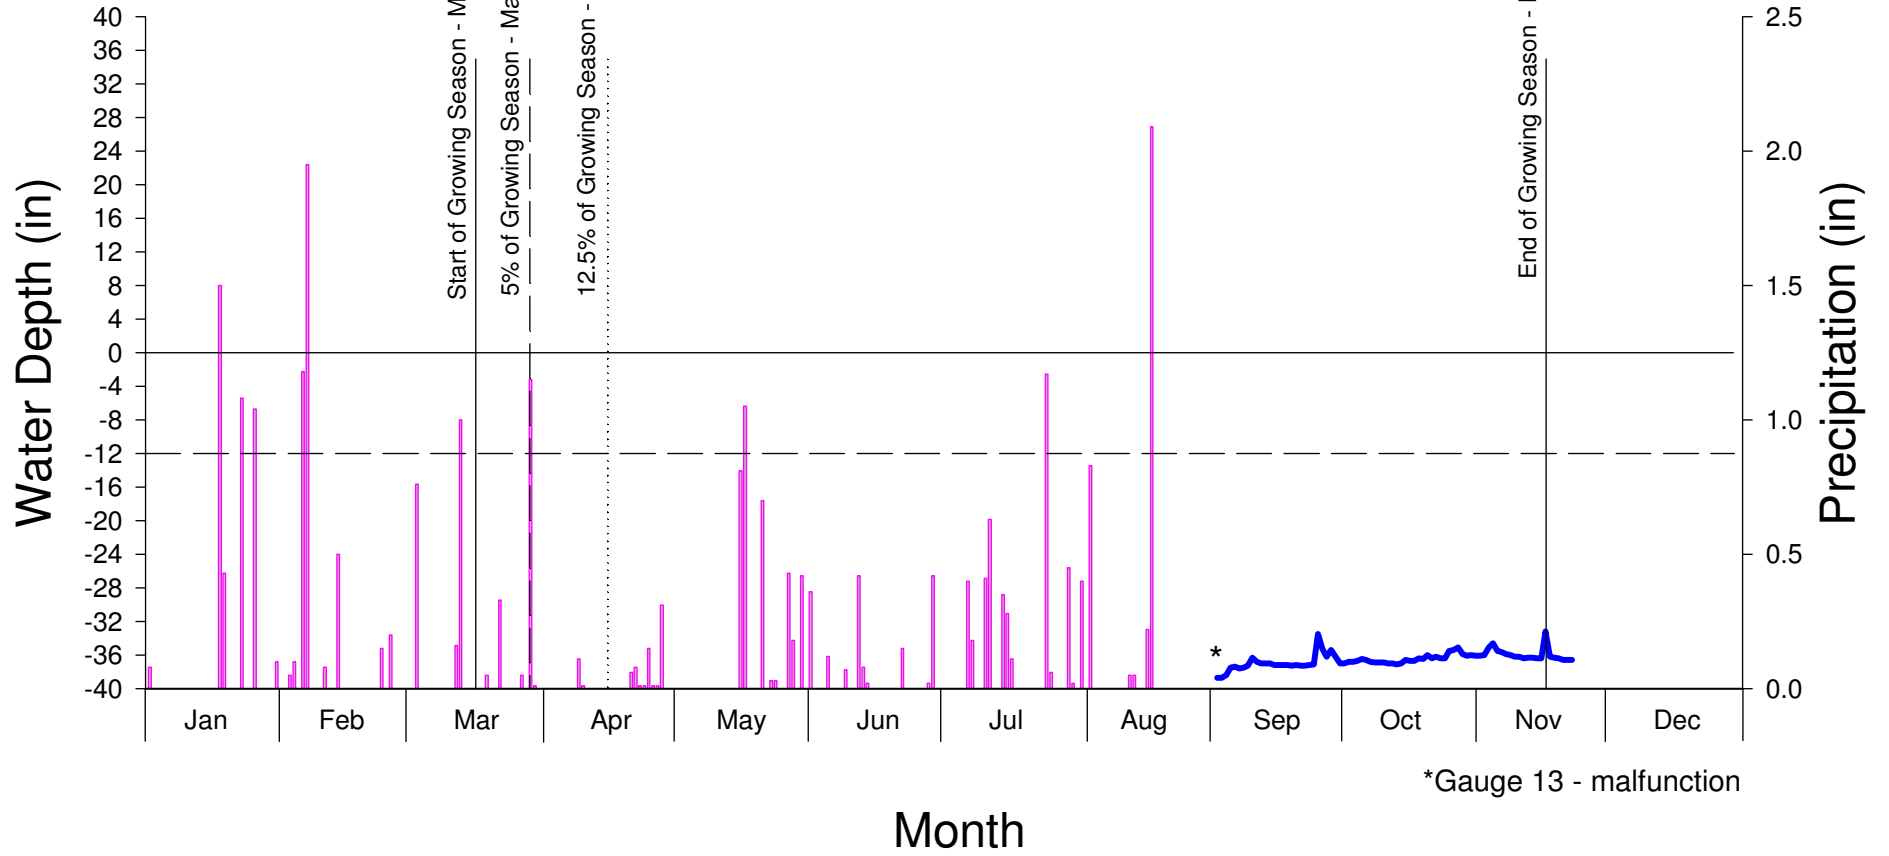
# Key Branch 2010 \*Monitoring Gauge 13 - A27BDE0

\*gauge malfunctions repeatedly throughout monitoring period

\*Gauge 13 - malfunction

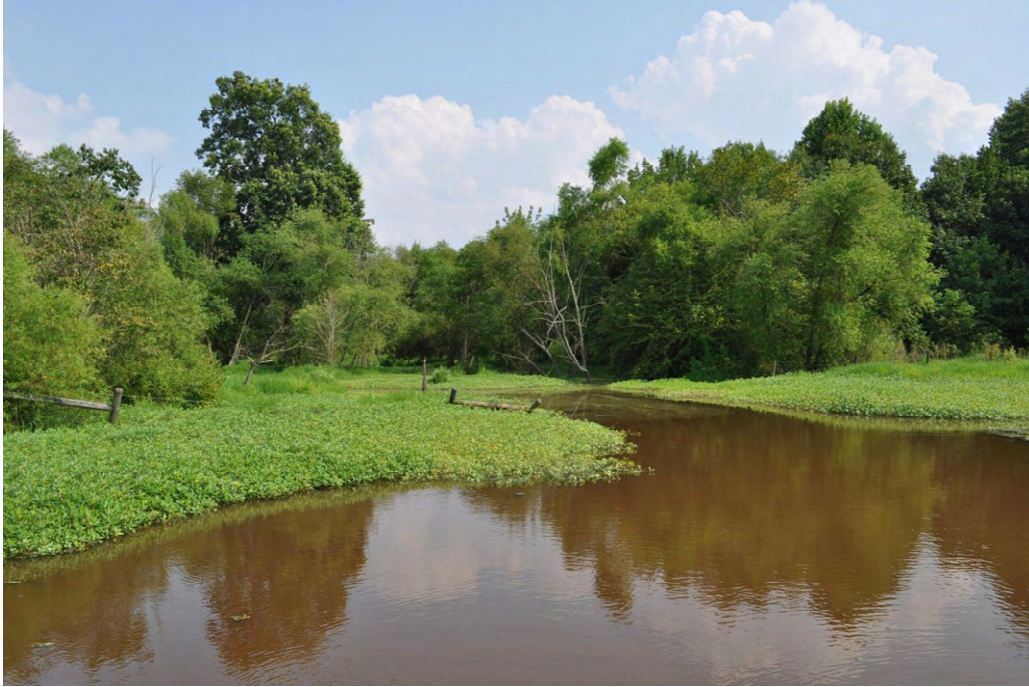
Appendix C). EEP dispatched wildlife control specialists on multiple occasions over the projects monitoring period to remove beaver and the associated dams, however, the combination of the sites size, wetland extent and abundant beaver population surrounding the site has made for persistent recolonization. Creeping water primrose (*Ludwigia hexapetala*), an exotic invasive, was found growing densely throughout the stream channel.

Beaver impoundment July 1, 2010

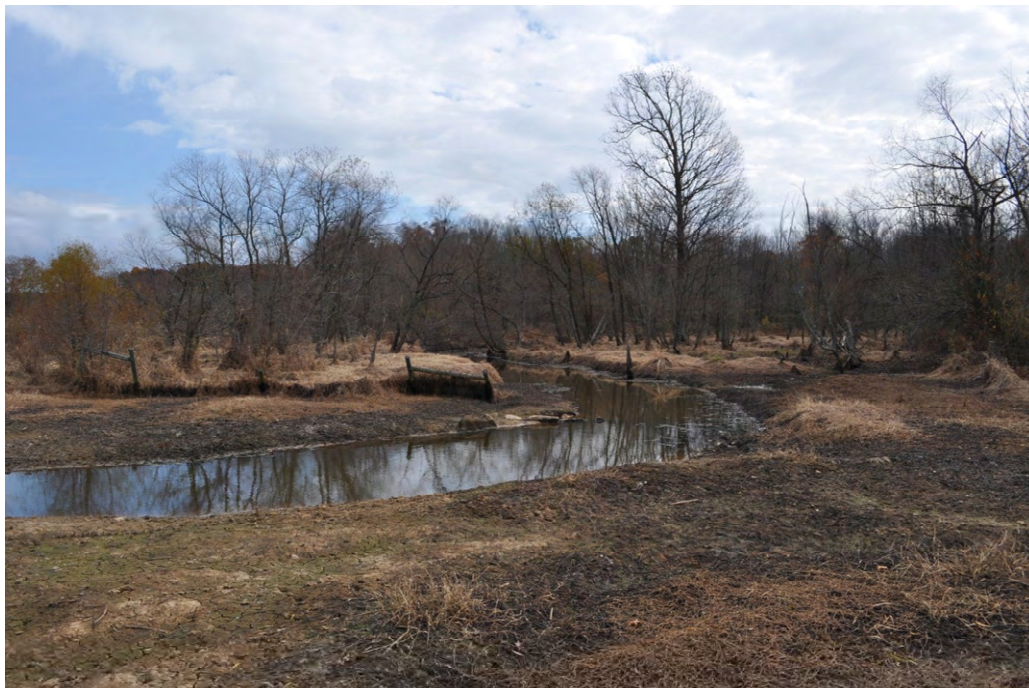
After beaver dam removed. November 23, 2010
