Key Branch Stream and Wetland Restoration Site Year-8 Annual Monitoring Report (2011)

**Anson County, North Carolina
WBS Element 34398.4.1
TIP No. R-2239WM
NCEEP Project 206**

December 2011

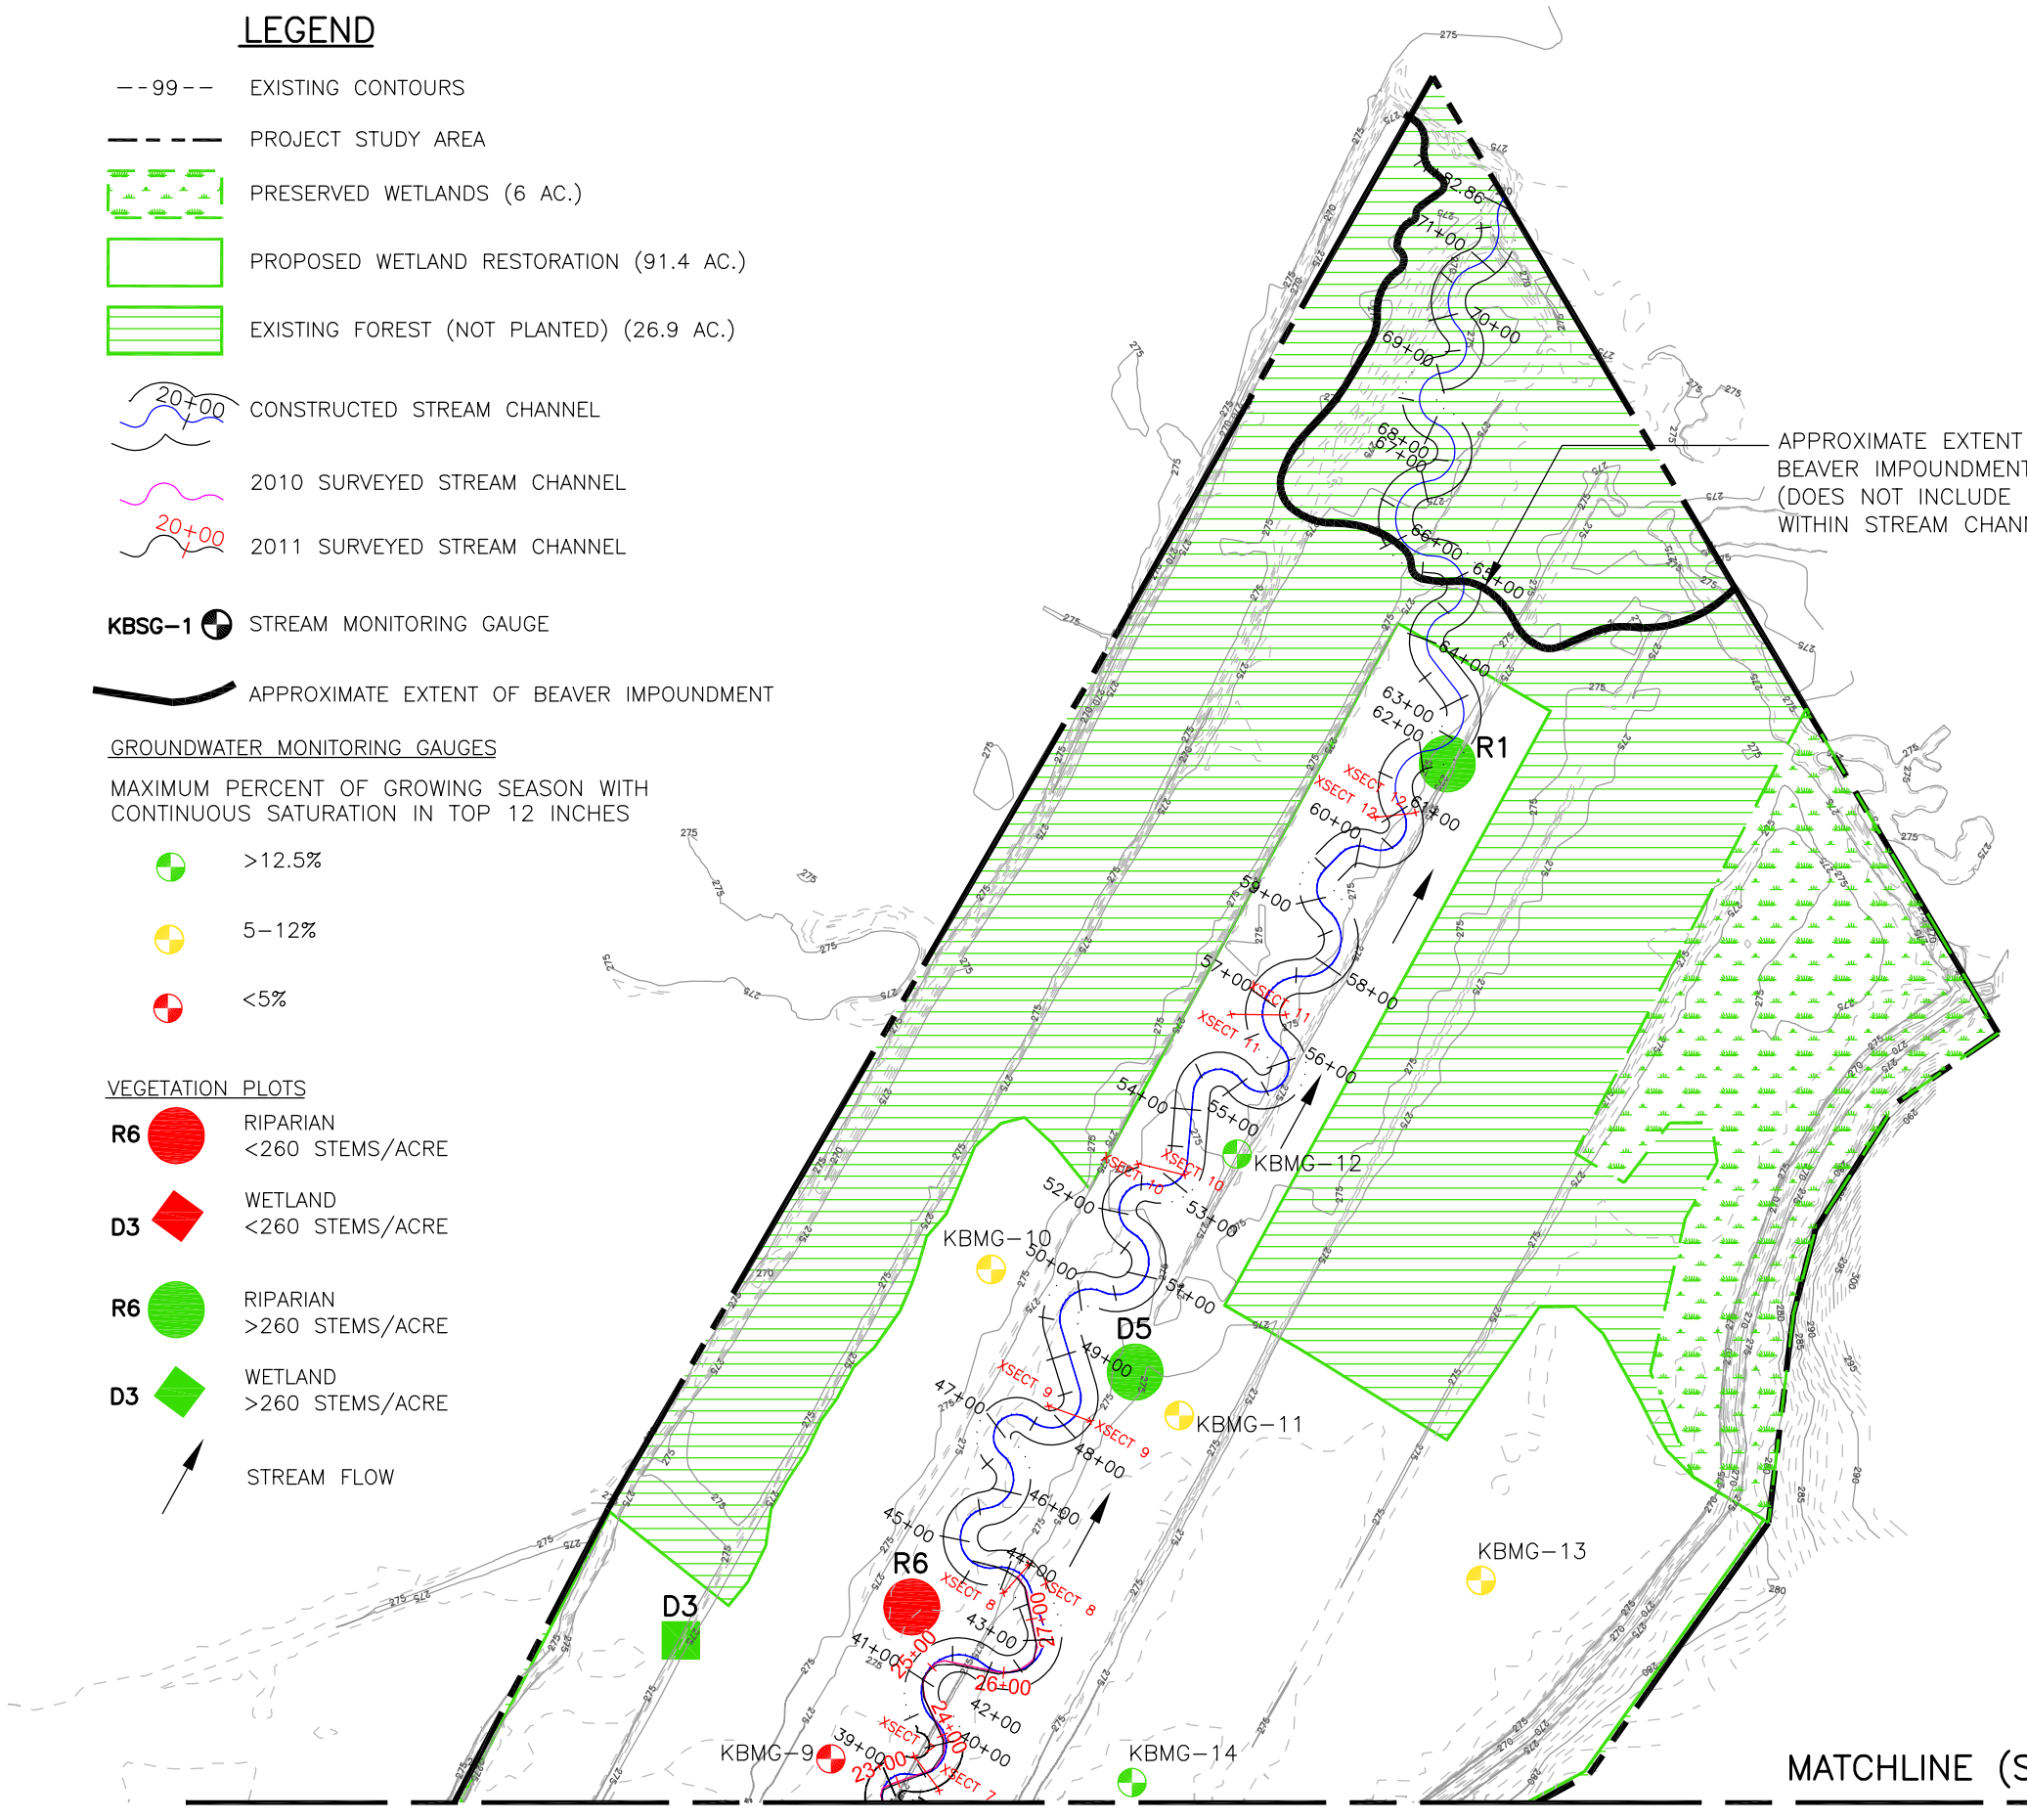
APPROXIMATE EXTENT OF BEAVER IMPOUNDMENT (4.70 ACRES±)
(DOES NOT INCLUDE UPSTREAM IMPACTS WITHIN STREAM CHANNEL)

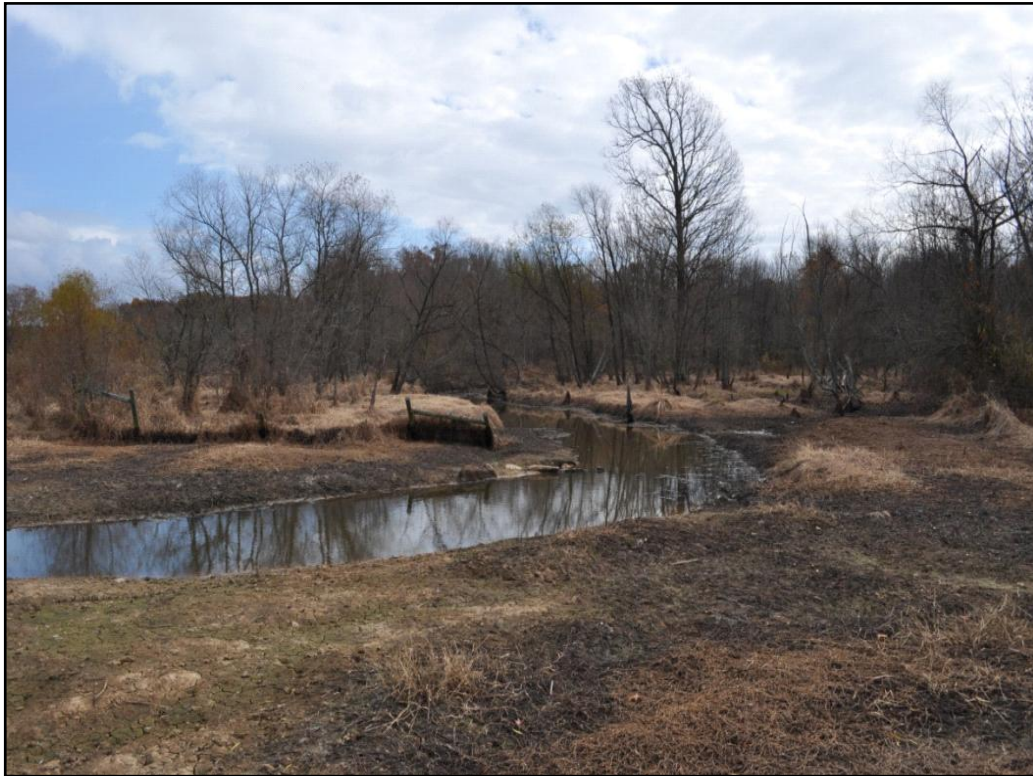
After beaver dam removal at top of site. November 23, 2010

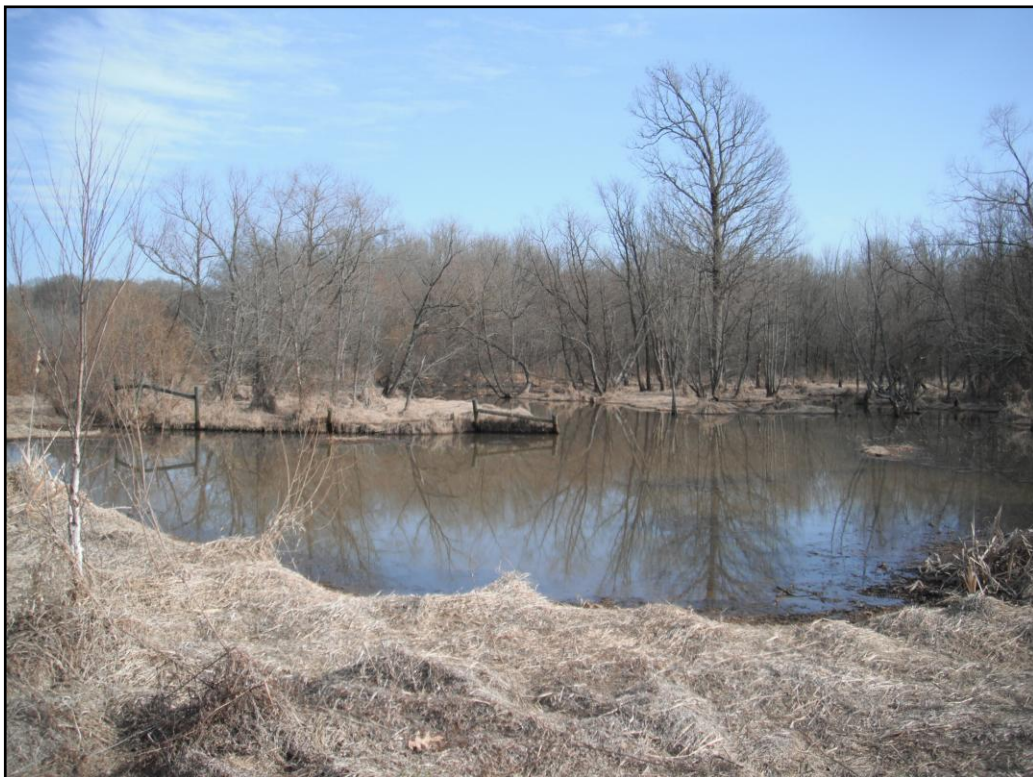
Although the restored reach met criteria for success, beaver are abundant in the area and have persistently recolonized the Site after prior removal efforts. Beaver are active with dams above and below the Site as well as within the Site boundaries at the upper end (Figure 2, Appendix A). They were removed most recently in late 2010 and re-established dams in 2011. As per the North Carolina Ecosystem Enhancement Program another removal effort has been contracted with monthly monitoring scheduled for the Site until close out. The beavers' presence has altered the function of the stream. Instead of a flowing stream, parts of the site are characterized as a lentic system. The stream has experienced limited flow in the summer months promoting vegetative growth in the channel. This condition has been caused by a combination of factors including multiple dry summers, beaver dams above the Site, and the low slope of the stream channel.

Beavers had returned to top of site by February 23, 2011

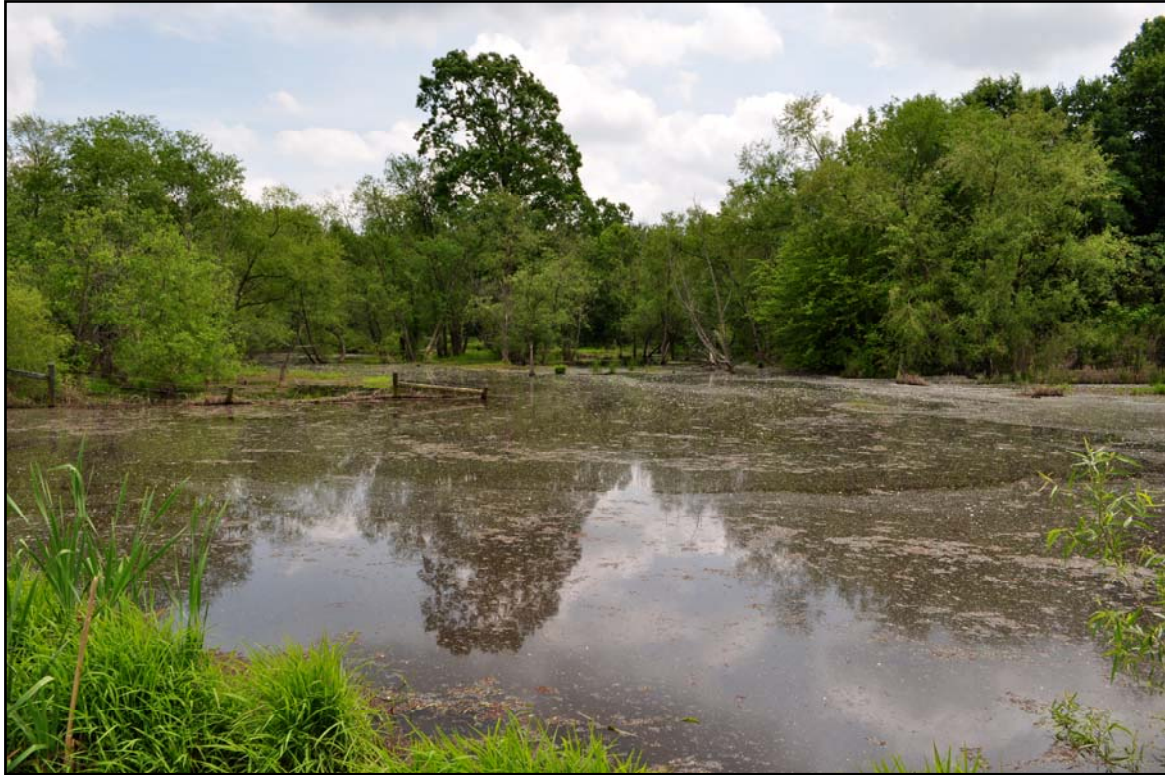
Beaver pond at top of site – May 5, 2011

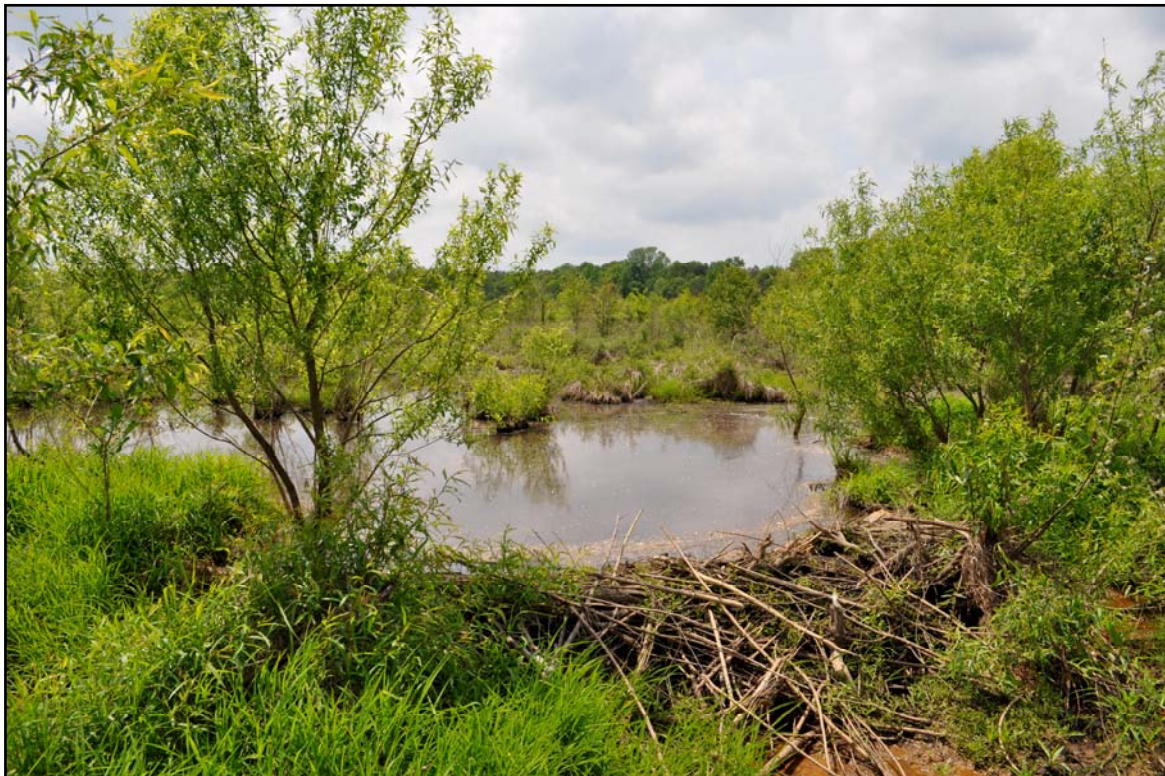
2nd beaver dam near top of site - May 5, 2011
