MONITORING YEAR 1 ANNUAL REPORT

KEY MILL MITIGATION SITE

Surry County, NC
NCDEQ Contract No. 7180
DMS Project No. 100025
USACE Action ID No. SAW-2017-01504
NCDEQ DWR Certification No. 17-1045
RFP #: 16-006993

Data Collection Period: October 2020 – December 2020
Final Submission Date: March 25, 2021

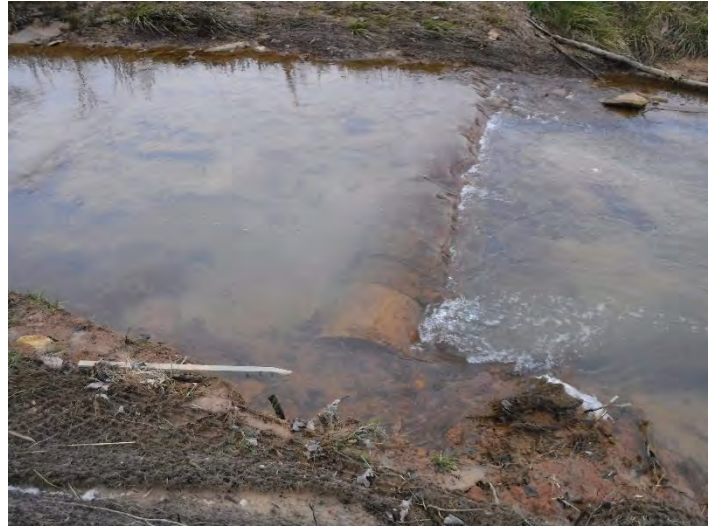
Bull Creek R3 Structure Failure at Station 157+00 – Looking from Right bank (12/30/2020)

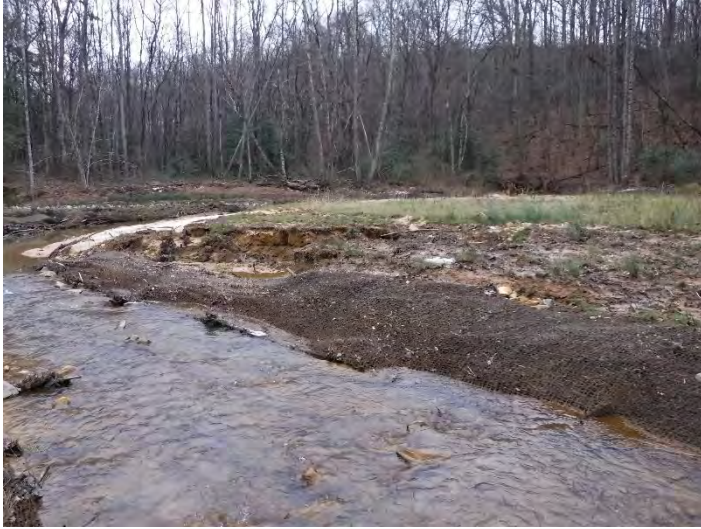
Bull Creek R3 Right Bank Scour at Station 165+50 – looking downstream (12/30/2020)

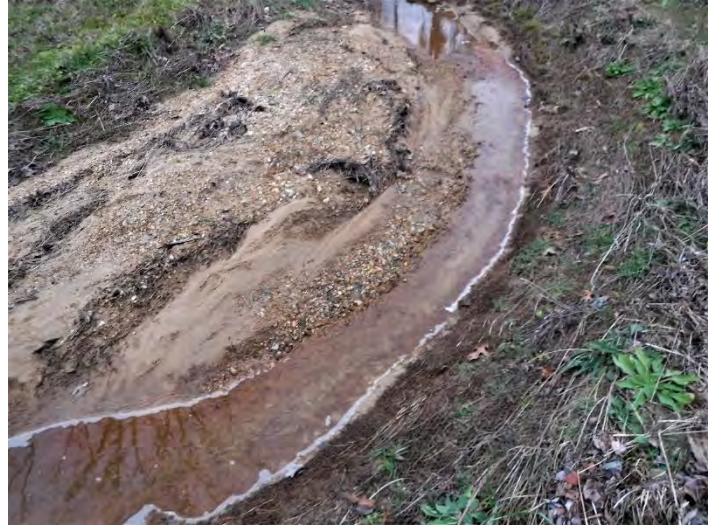
UTC3 Aggradation at Station 408+52 – looking upstream (12/30/2020)

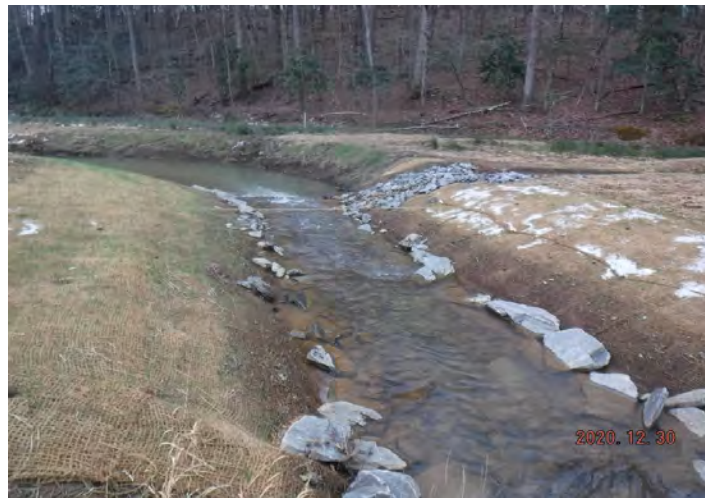
*Repairs conducted during MY1 resulted in a slight shift in the cross-section alignment between the MY0 and MY1 cross-section pin locations; therefore the plot was adjusted so that the cross-sections lined up for easier comparison.

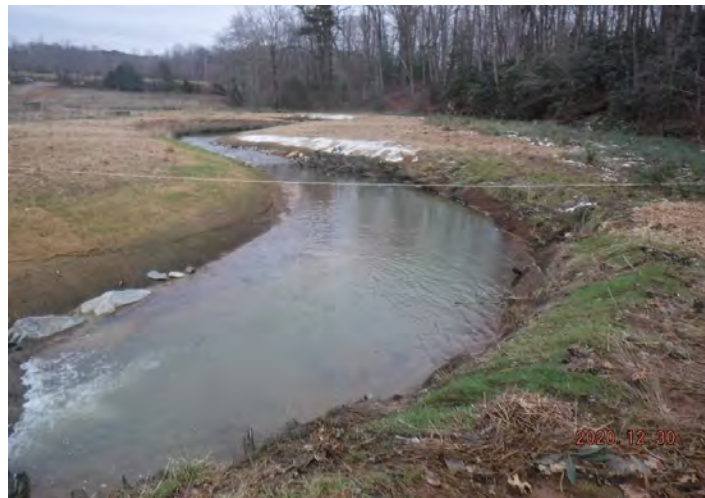
*Repairs were conducted on the left bank of XS3 during MY1 prior to the collection of the MY1 cross-section data and photos. The MY1 plot line shows the repaired cross-sectional profile. Also the station number for XS3 was incorrectly reported on the MY0 cross-section plot, it should have been reported as Station 110+48 as shown in the above plot.

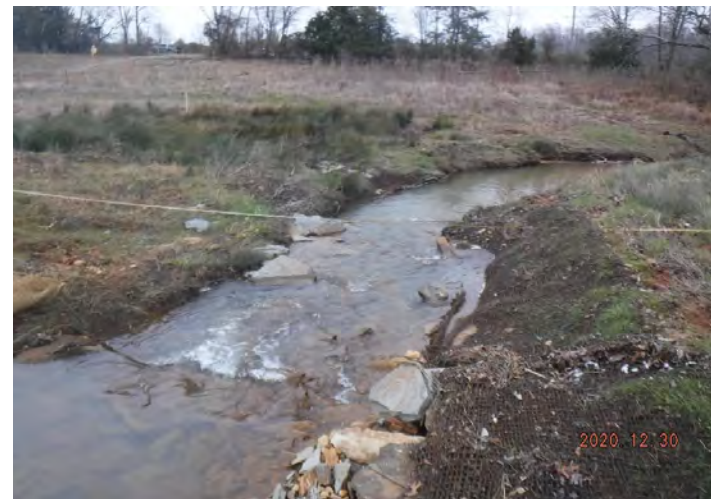
*Repairs were conducted on the right bank of XS4 during MY1 prior to the collection of the MY1 cross-section data and photos. The MY1 plot line shows the repaired cross-sectional profile. Also the station number for XS4 was incorrectly reported on the MY0 cross-section plot, it should have been reported as Station 115+88 as shown in the above plot.
