AS-BUILT BASELINE MONITORING REPORT

KEY MILL MITIGATION SITE

Surry County, NC
NCDEQ Contract No. 7180
DMS Project No. 100025
USACE Action ID No. SAW-2017-01504
Yadkin River Basin
HUC 03040101

Data Collection Period: September 2019 – July 2020
Submission Date: October 5, 2020

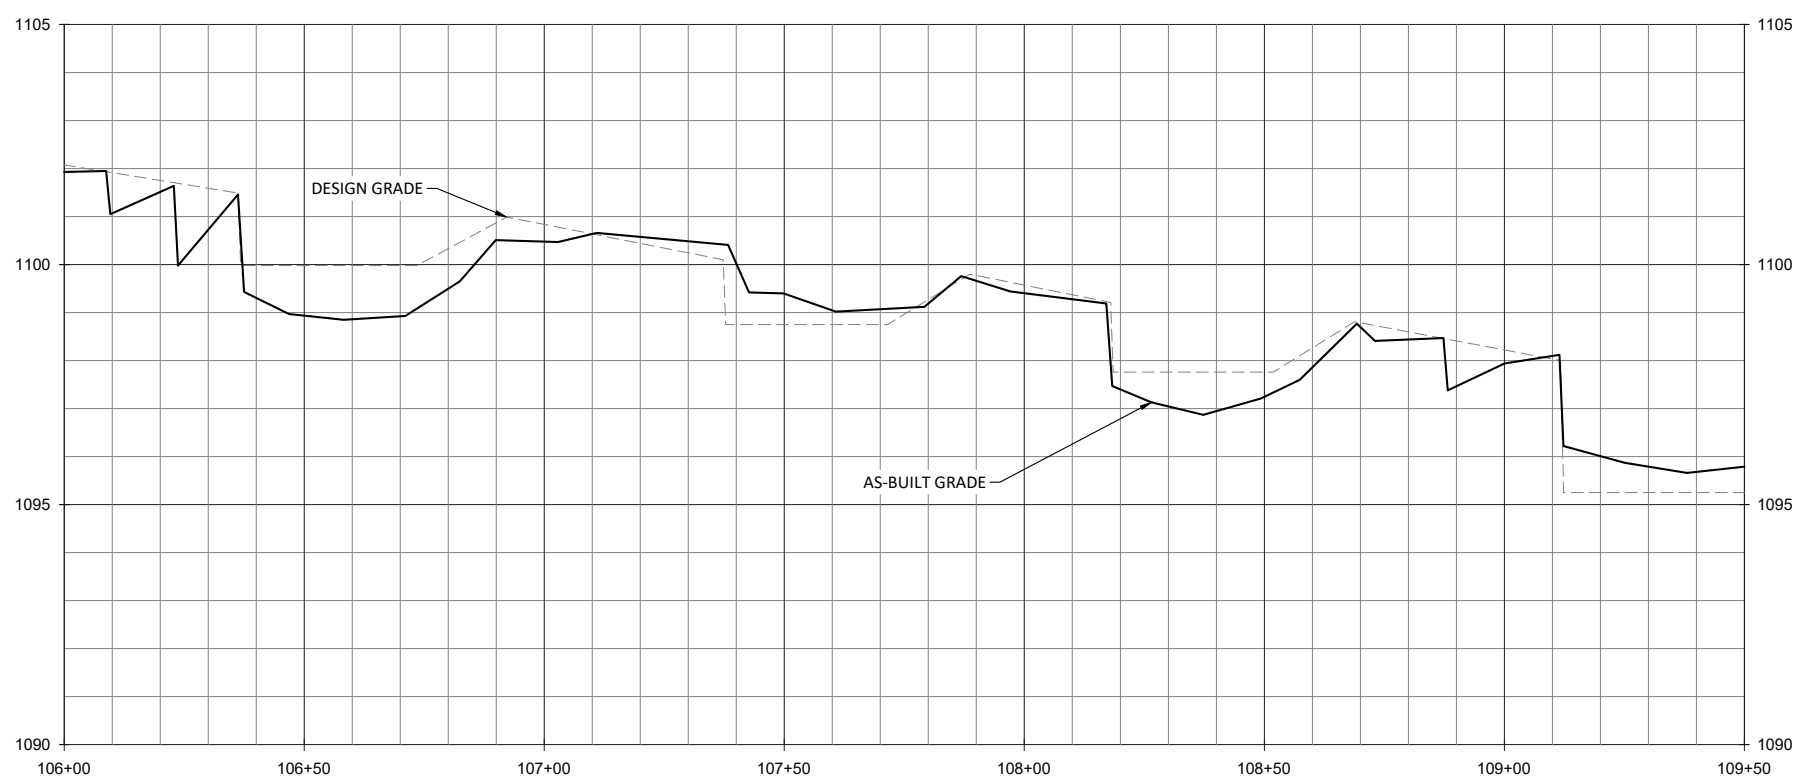
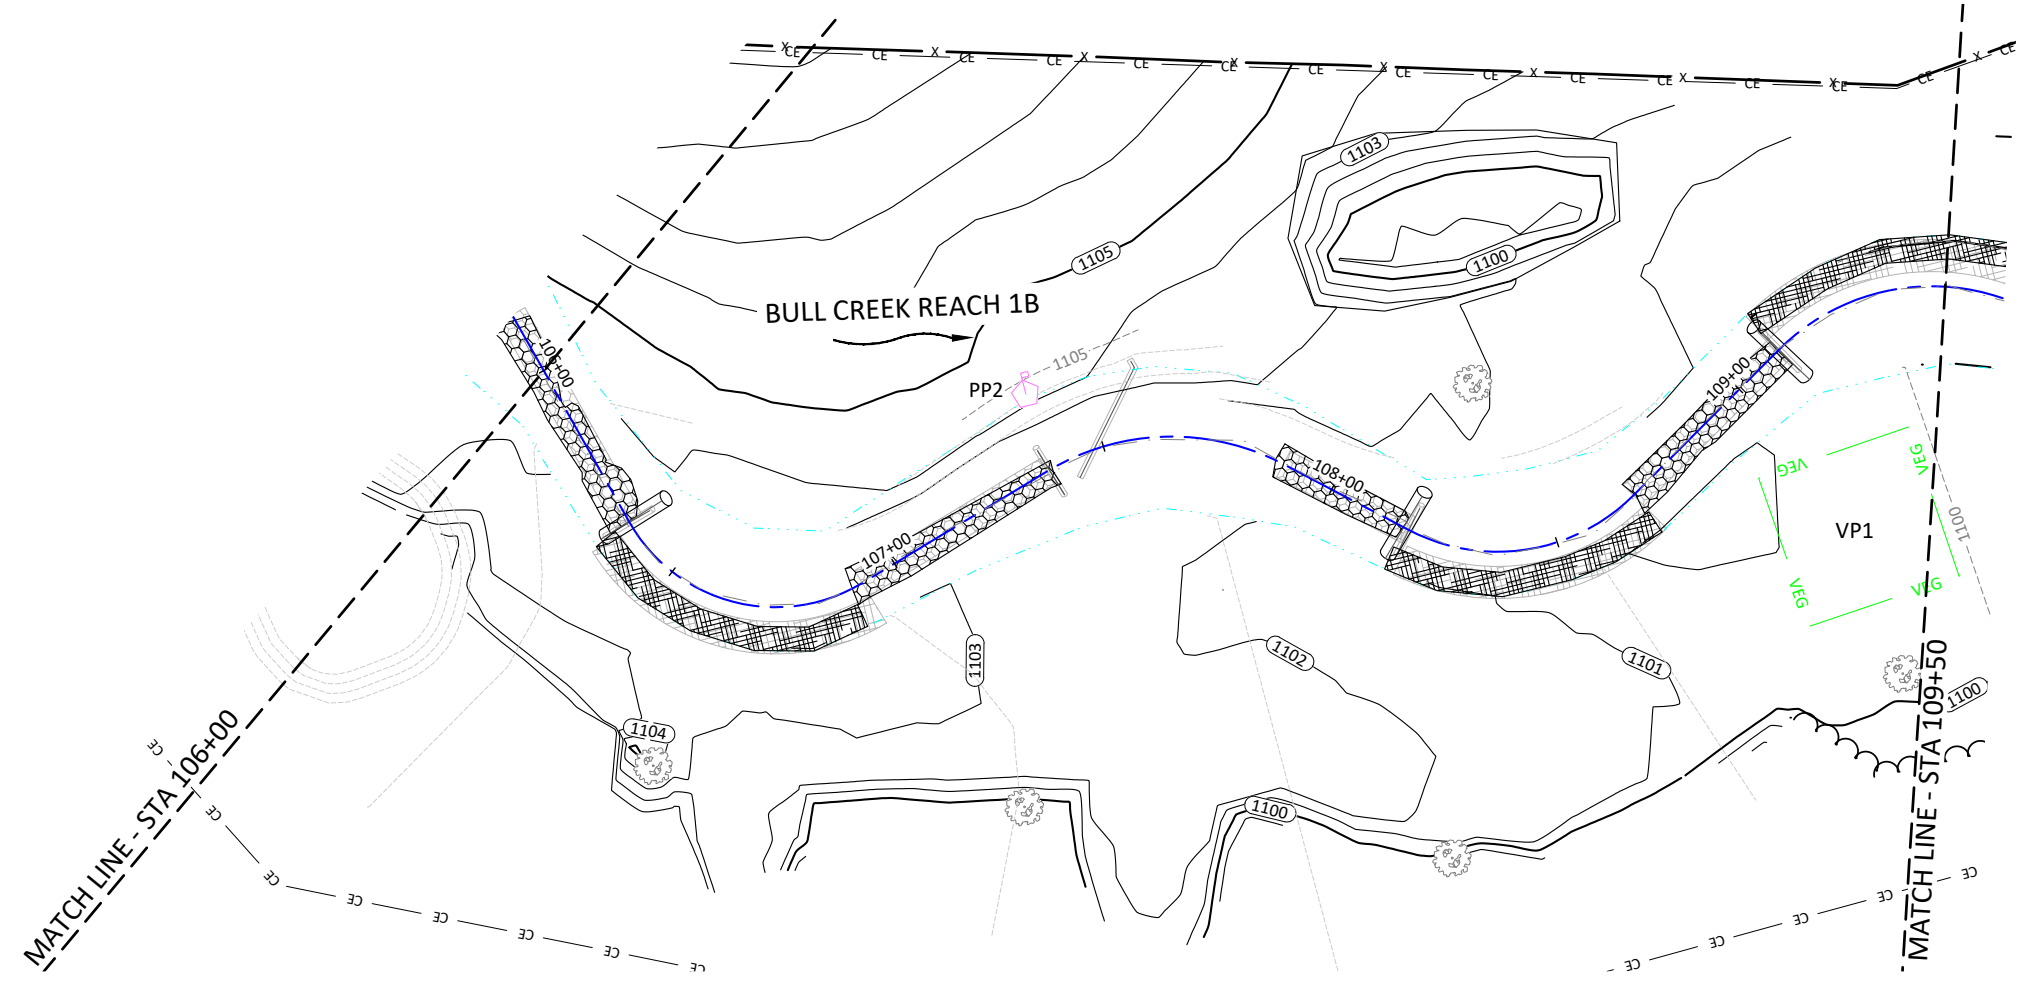
NOTE:
 1. STA. 107+40: THE LOG SILL AND LOG VANE WERE OMITTED DUE TO PRESENCE OF BEDROCK.

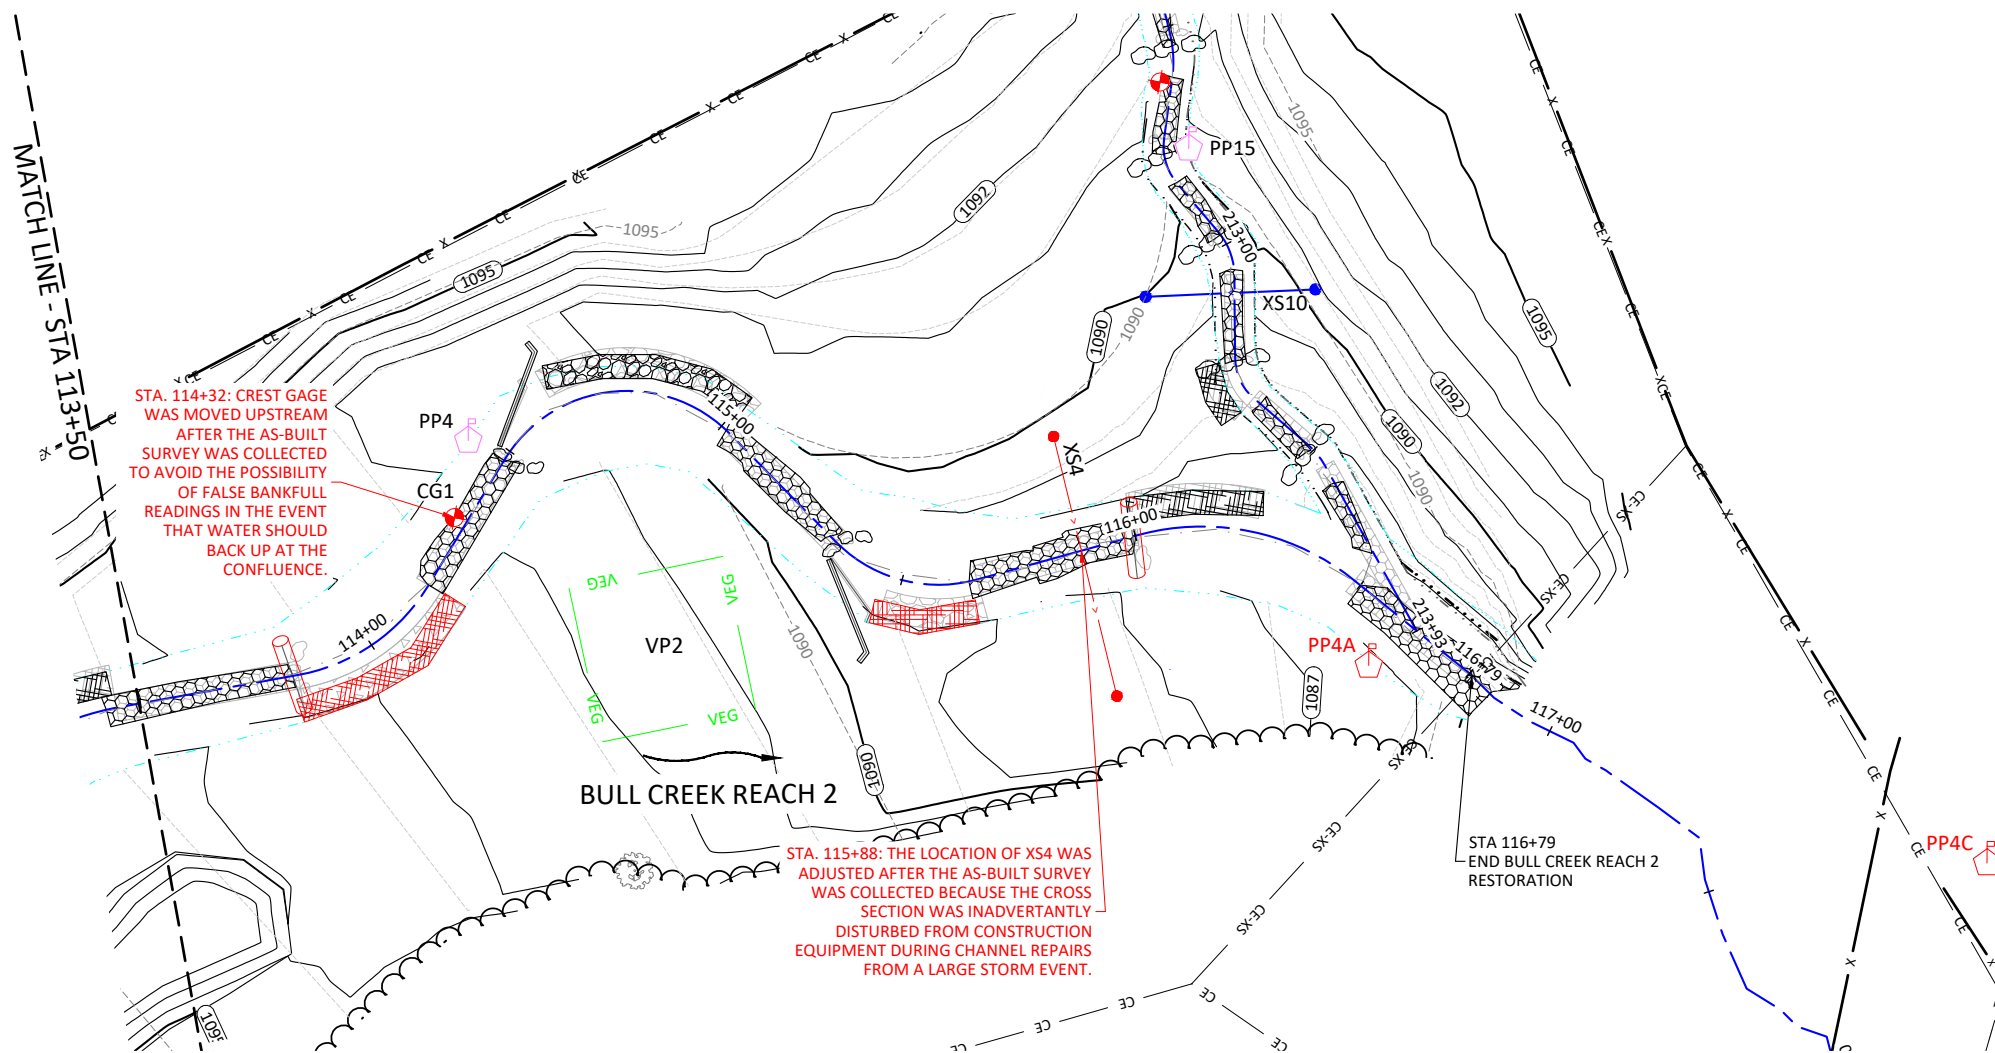
STA. 114+32: CREST GAGE WAS MOVED UPSTREAM AFTER THE AS-BUILT SURVEY WAS COLLECTED TO AVOID THE POSSIBILITY OF FALSE BANKFULL READINGS IN THE EVENT THAT WATER SHOULD BACK UP AT THE CONFLUENCE.

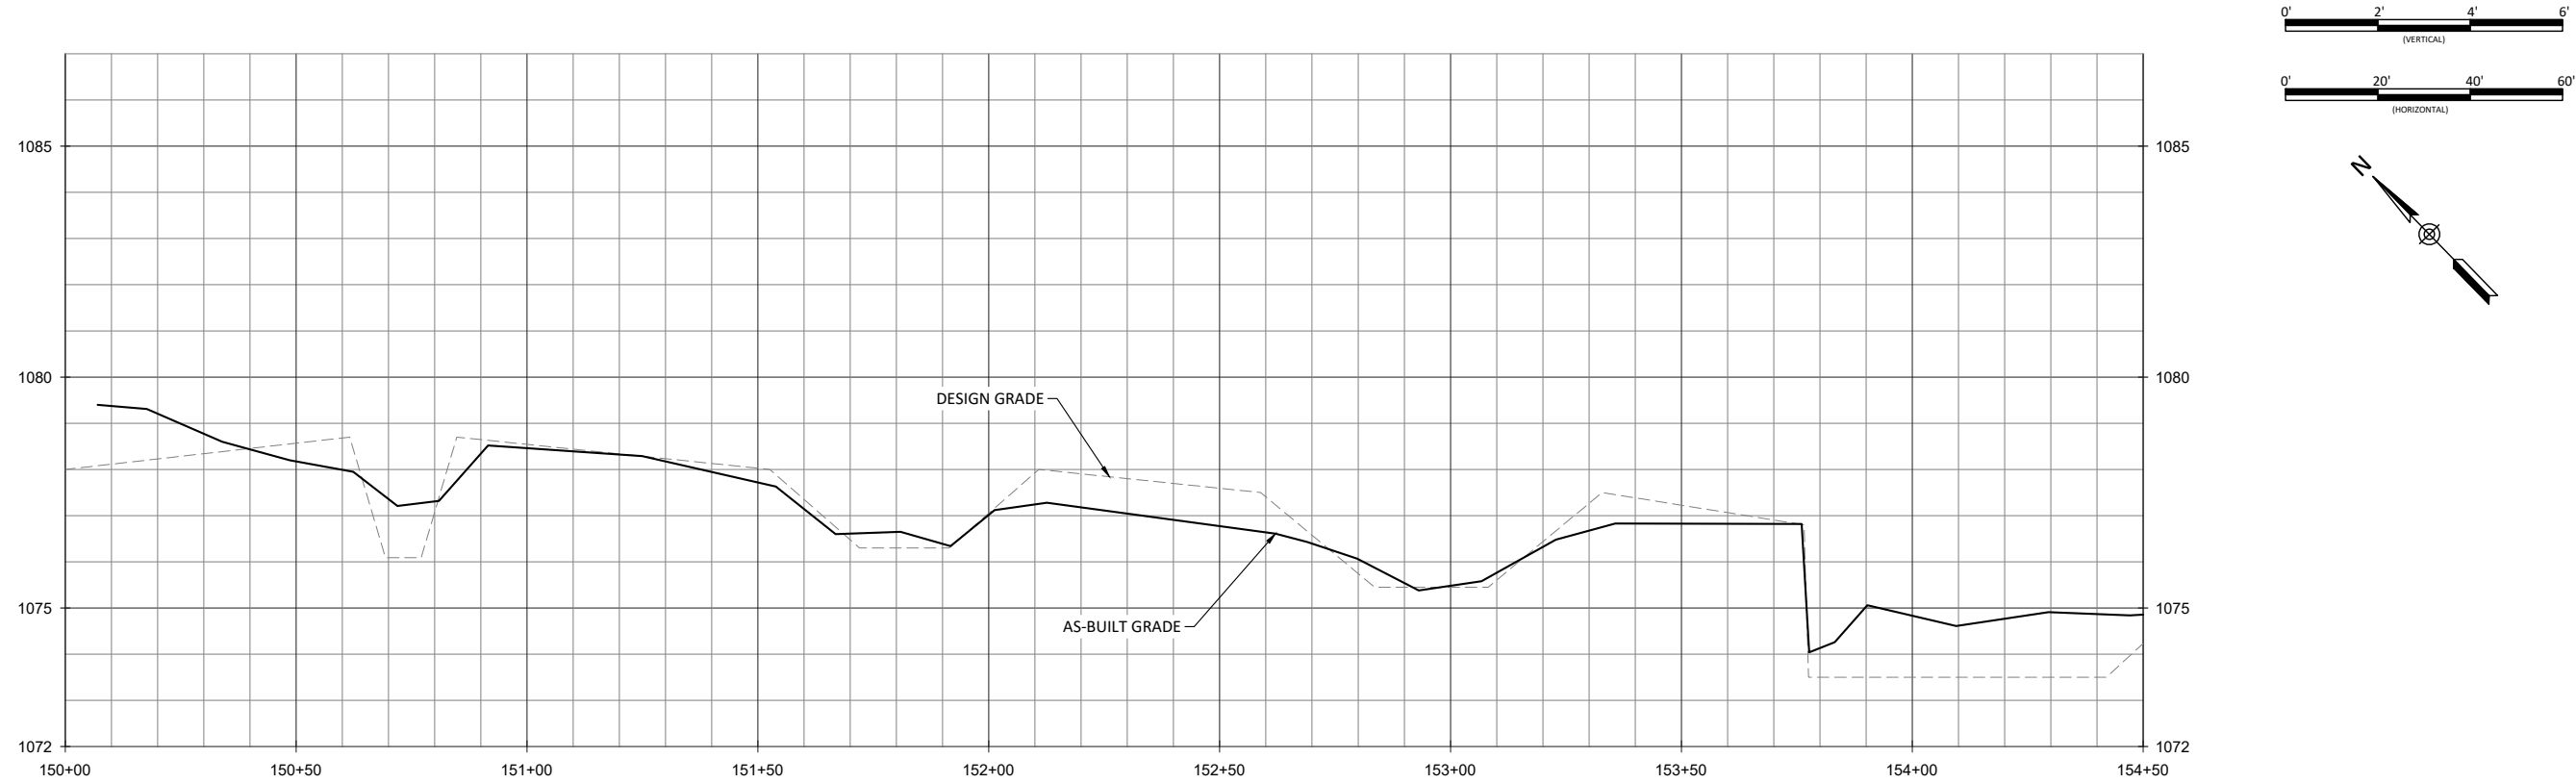
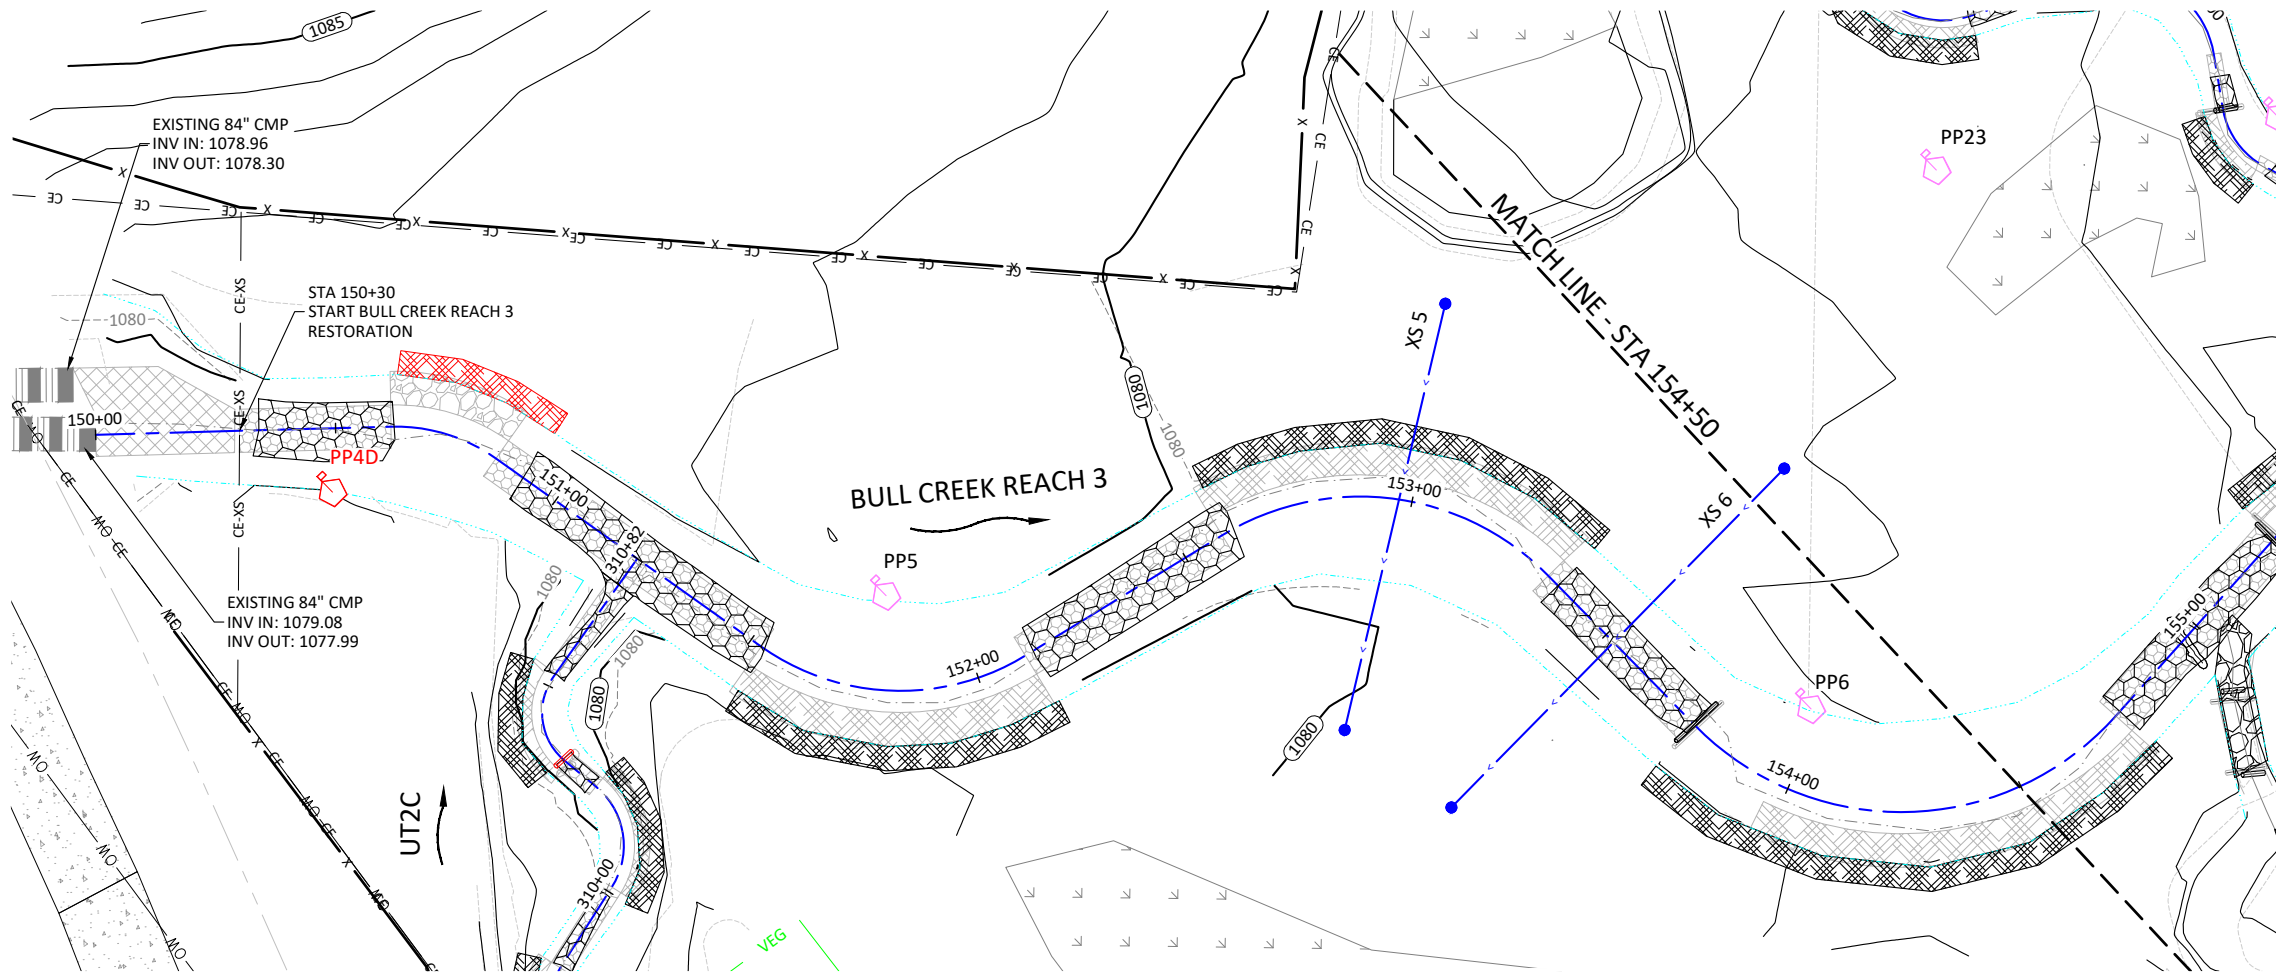
- NOTE:**
1. STA. 150+50: PHOTO POINT 4D WAS ADDED AFTER THE SURVEY WAS COMPLETED AT THE REQUEST OF DMS TO CAPTURE THE CONSERVATION EASEMENT BREAK.
 2. STA. 150+62: BOULDER TOE REPLACED WITH BRUSH TOE DUE TO LOCAL MATERIAL AVAILABILITY AND TO IMPROVE IN-STREAM HABITAT.

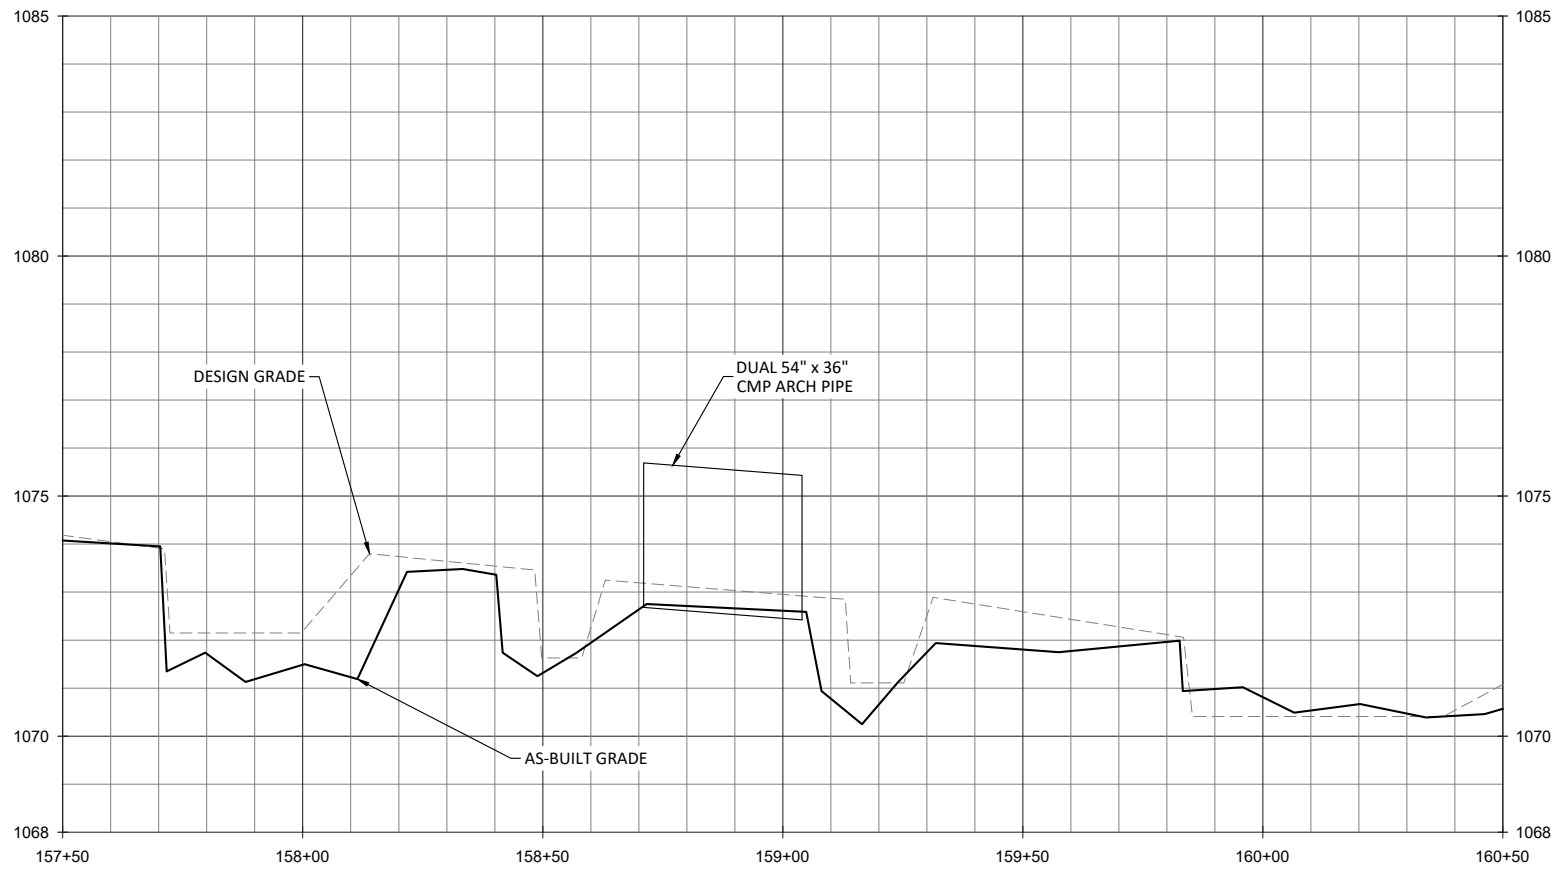
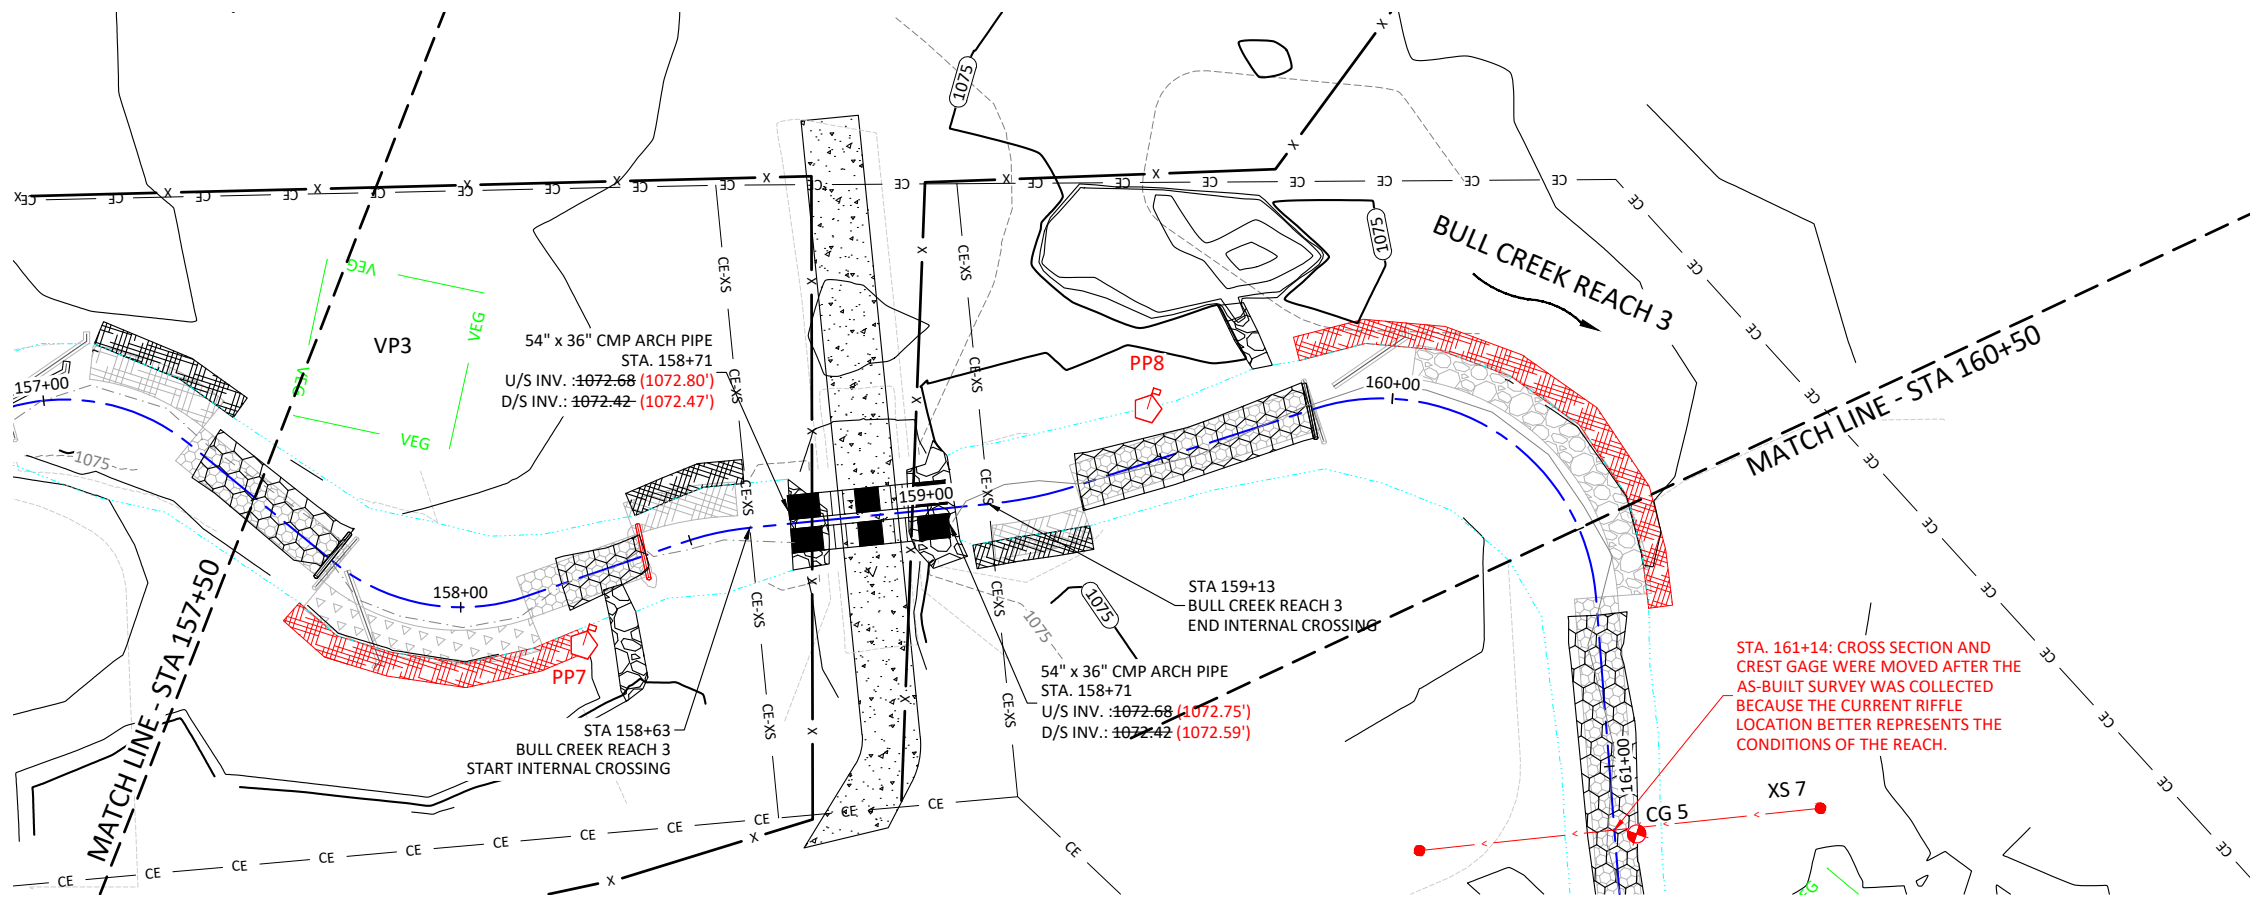
- NOTE:**
1. STA. 157+72: BRUSH MATTRESS REPLACED WITH BRUSH TOE DUE TO TIME OF YEAR OF INSTALLATION. LOG VANE REMOVED DUE TO BANK STABILITY AND HABITAT ENHANCEMENT PROVIDED BY BRUSH TOE.
 2. STA. 158+22: PHOTO POINT 7 WAS MOVED AFTER THE SURVEY WAS COMPLETED AT THE REQUEST OF DMS TO CAPTURE A DOWNSTREAM VIEW OF THE CULVERT CROSSING.
 3. STA. 158+40: ROCK SILL REPLACED WITH LOG SILL DUE TO LOCAL MATERIAL AVAILABILITY AND SIMILAR FUNCTIONALITY.
 4. STA. 159+50: PHOTO POINT 8 WAS MOVED AFTER THE SURVEY WAS COMPLETED AT THE REQUEST OF DMS TO CAPTURE AN UPSTREAM VIEW OF THE CULVERT CROSSING.
 5. STA. 159+84: BRUSH TOE WAS SUBSTITUTED FOR BOULDER TOE AND LOG VANE REMOVED DUE TO LOCAL MATERIAL AVAILABILITY AND THE BANK STABILITY AND HABITAT ENHANCEMENT PROVIDED BY BRUSH TOE.

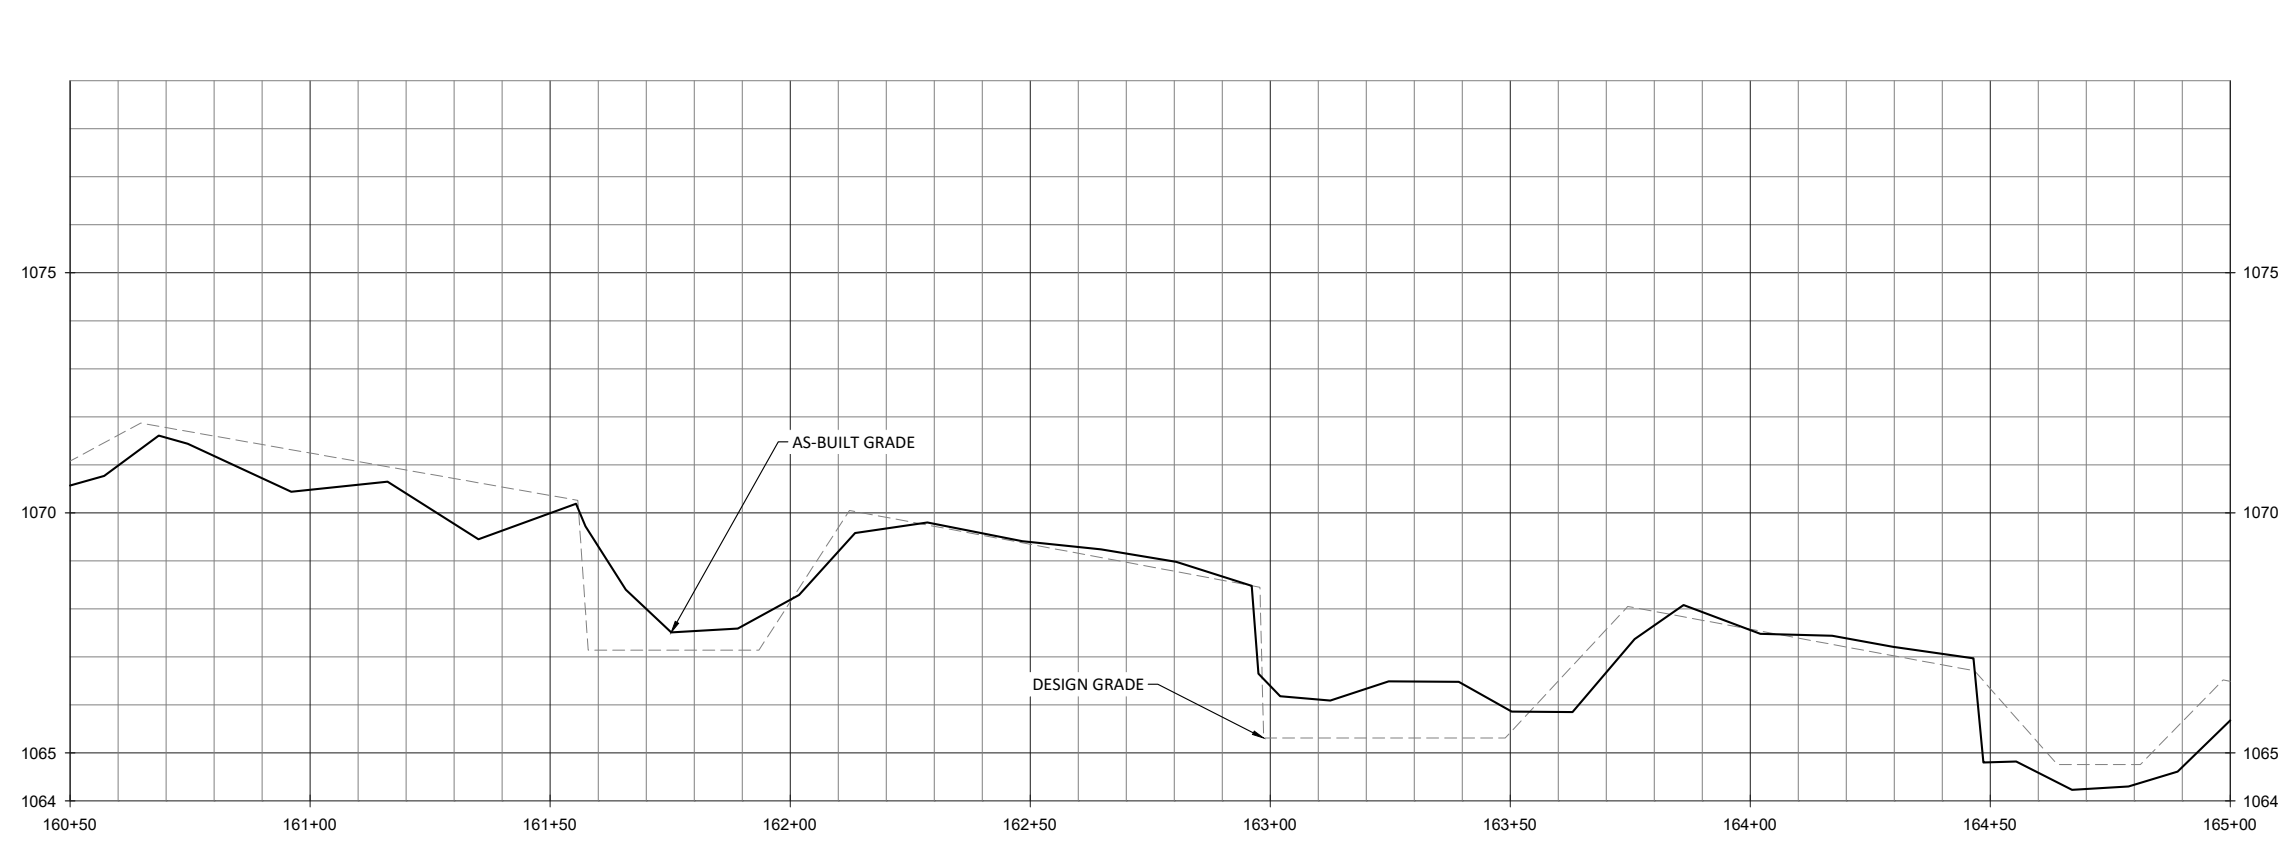
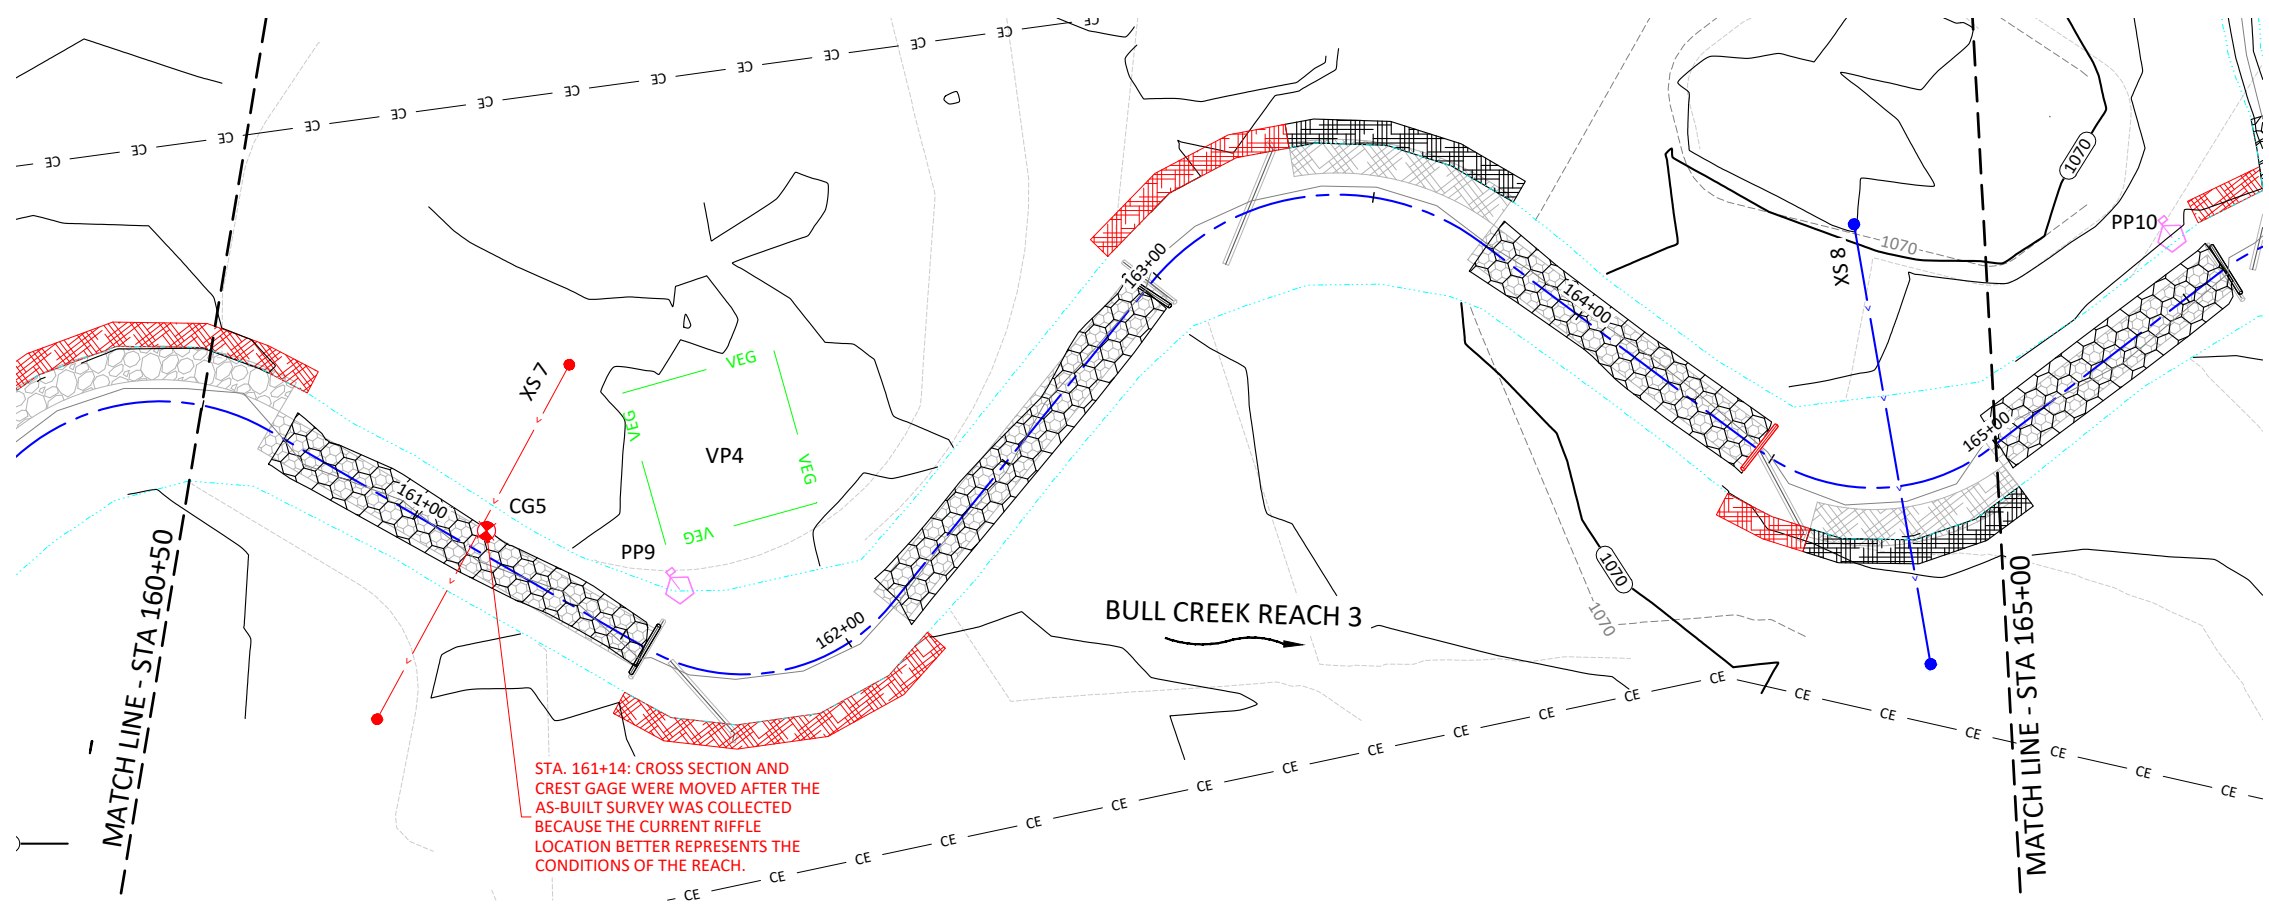
- NOTE:**
1. STA. 161+56: LOG VANE REMOVED AND BRUSH TOE ADDED TO OUTSIDE BANK TO IMPROVE STABILITY FOR THE ENTIRE OUTSIDE BANK.
 2. STA. 163+30: LOG VANE REMOVED AND BRUSH TOE EXTENDED DUE TO AVAILABILITY OF MATERIALS AND TO IMPROVE STREAM BANK STABILITY AND HABITAT.
 3. STA. 164+47: LOG VANE REMOVED, LOG SILL ADDED AND BRUSH TOE EXTENDED DUE TO LOCAL AVAILABILITY OF MATERIALS AND TO IMPROVE CHANNEL STABILITY AND HABITAT.

STA. 161+14: CROSS SECTION AND
 CREST GAGE WERE MOVED AFTER THE
 AS-BUILT SURVEY WAS COLLECTED
 BECAUSE THE CURRENT RIFFLE
 LOCATION BETTER REPRESENTS THE
 CONDITIONS OF THE REACH.

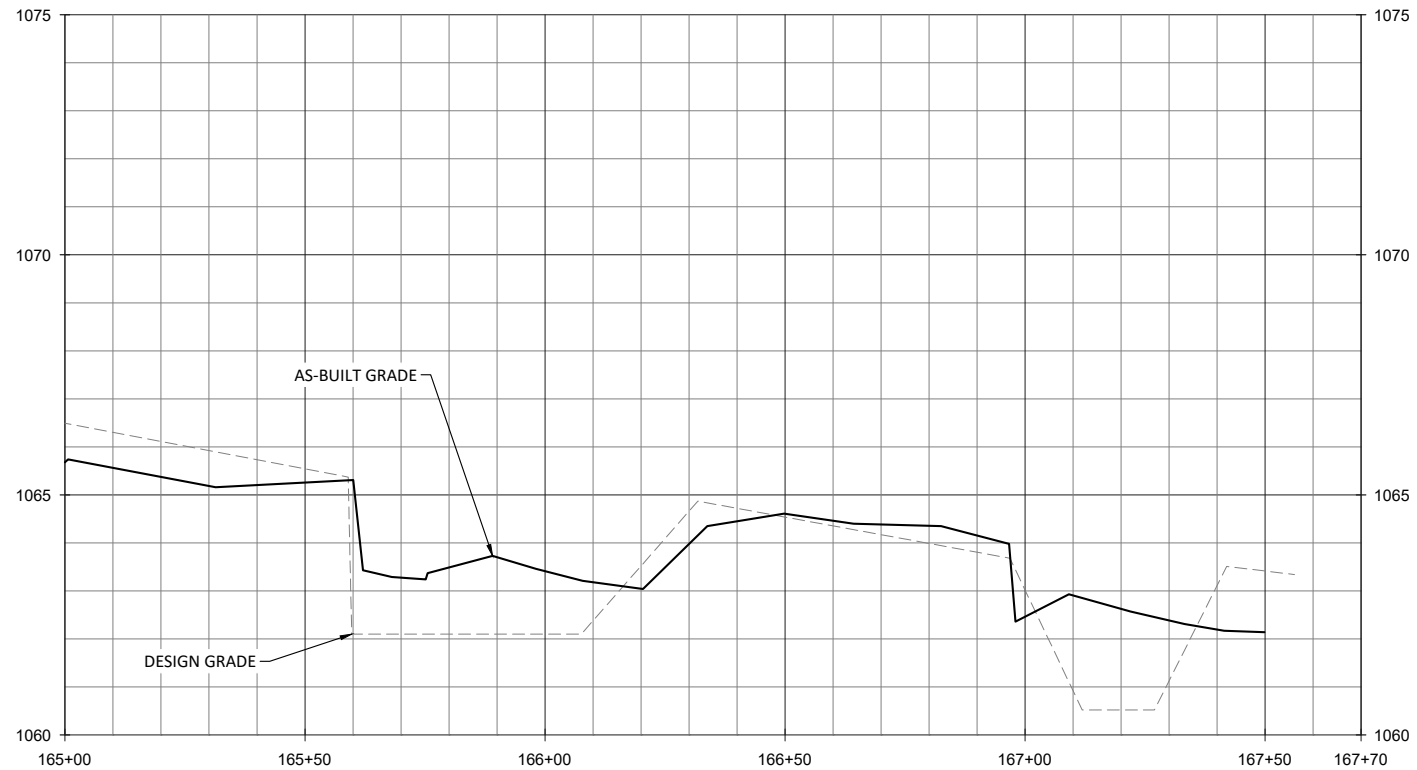
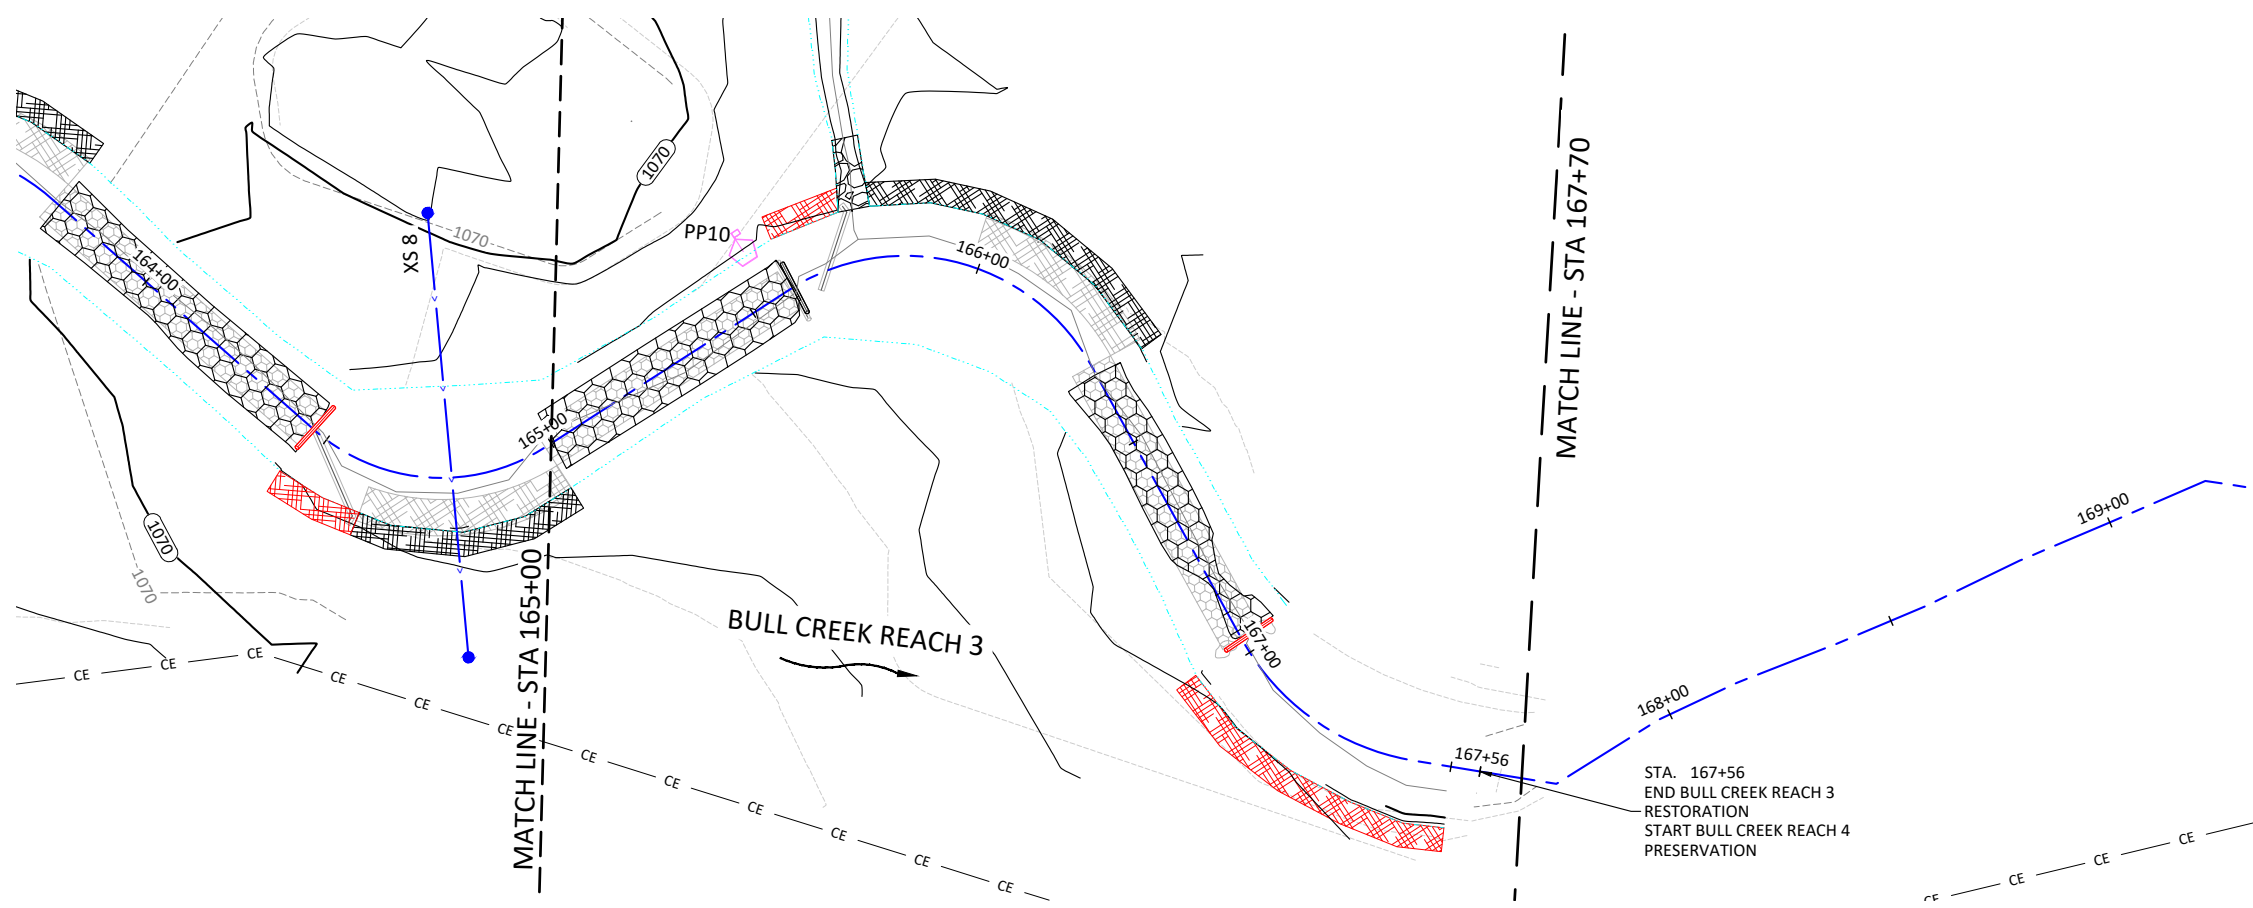
- NOTE:**
1. STA. 165+75: LOG VANE REMOVED AND BRUSH TOE EXTENDED DUE TO AVAILABILITY OF MATERIALS AND THE IMPROVED HABITAT PROVIDED BY BRUSH TOE.
 2. STA. 166+97: LOG SILL WAS SUBSTITUTED FOR ROCK SILL DUE TO LOCAL MATERIAL AVAILABILITY AND SITE CONDITIONS.
 3. STA. 167+00: BRUSH TOE WAS ADDED TO IMPROVE BANK STABILITY.
