AS-BUILT BASELINE MONITORING REPORT

KEY MILL MITIGATION SITE

Surry County, NC
NCDEQ Contract No. 7180
DMS Project No. 100025
USACE Action ID No. SAW-2017-01504
Yadkin River Basin
HUC 03040101

Data Collection Period: September 2019 – July 2020
Submission Date: October 5, 2020

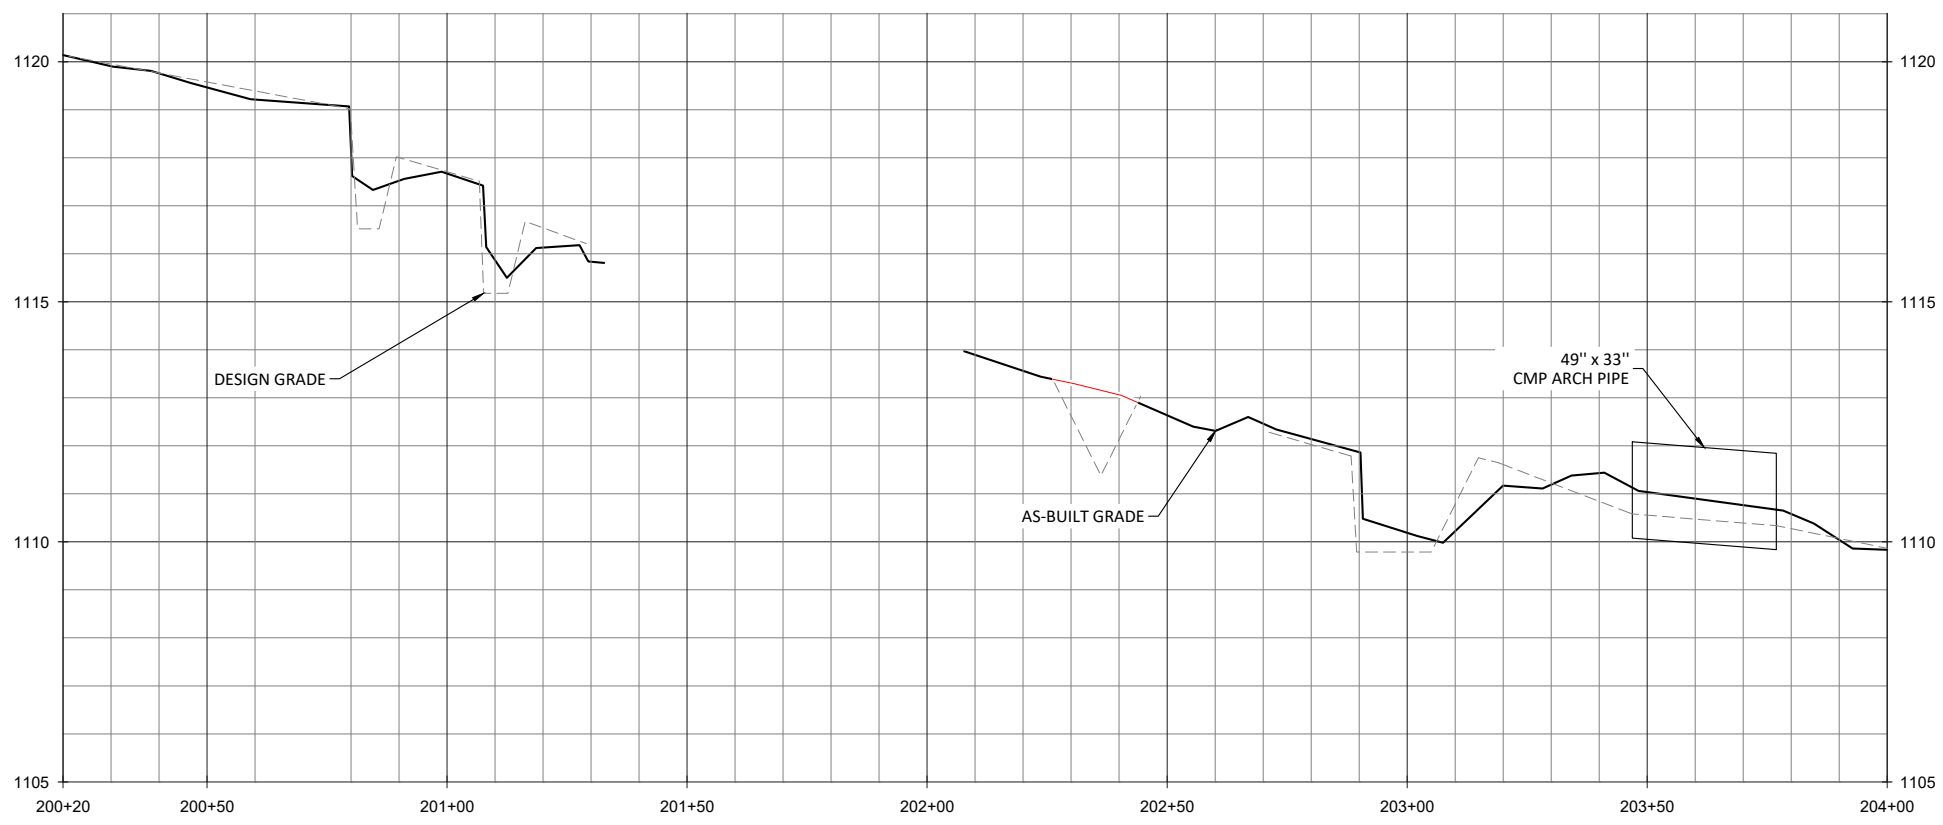
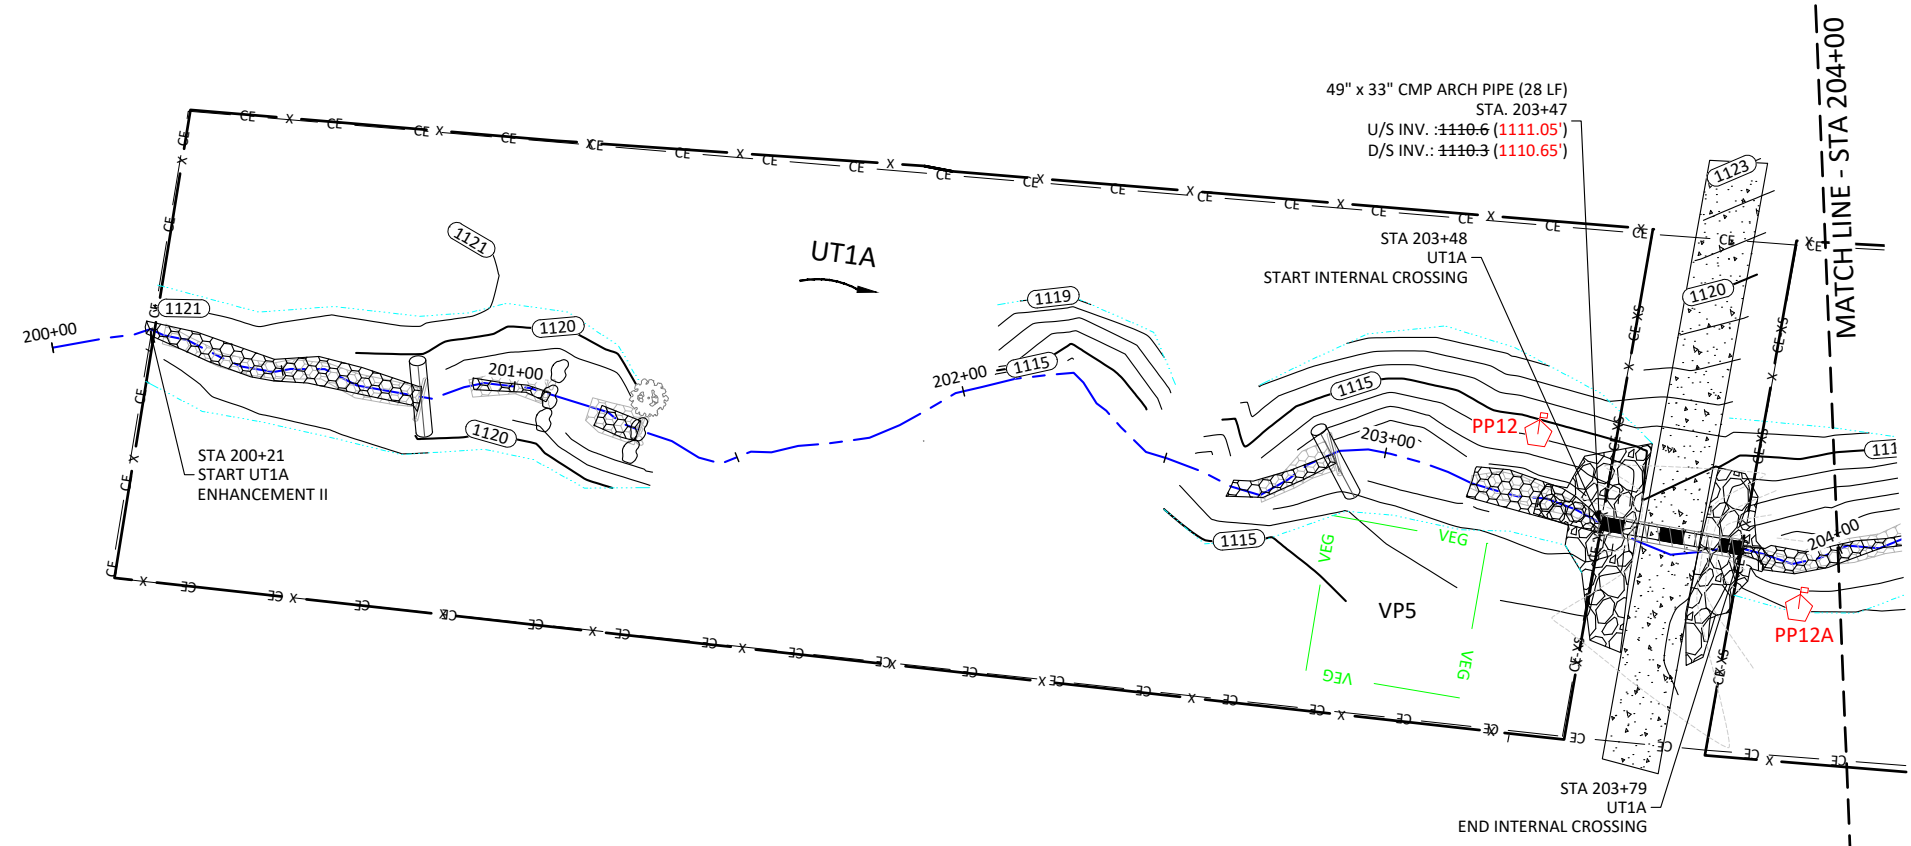
- NOTES:**
1. STA. 202+26: POOL WAS NOT EXCAVATED DUE TO EXISTING PROFILE STABILITY.
 2. STA. 203+32: PHOTO POINT 12 WAS MOVED AFTER THE SURVEY WAS COMPLETED AT THE REQUEST OF DMS TO CAPTURE A DOWNSTREAM VIEW OF THE CULVERT CROSSING.
 3. STA. 203+90: PHOTO POINT 12A WAS ADDED AFTER THE SURVEY WAS COMPLETED AT THE REQUEST OF DMS TO CAPTURE AN UPSTREAM VIEW OF THE CULVERT CROSSING.

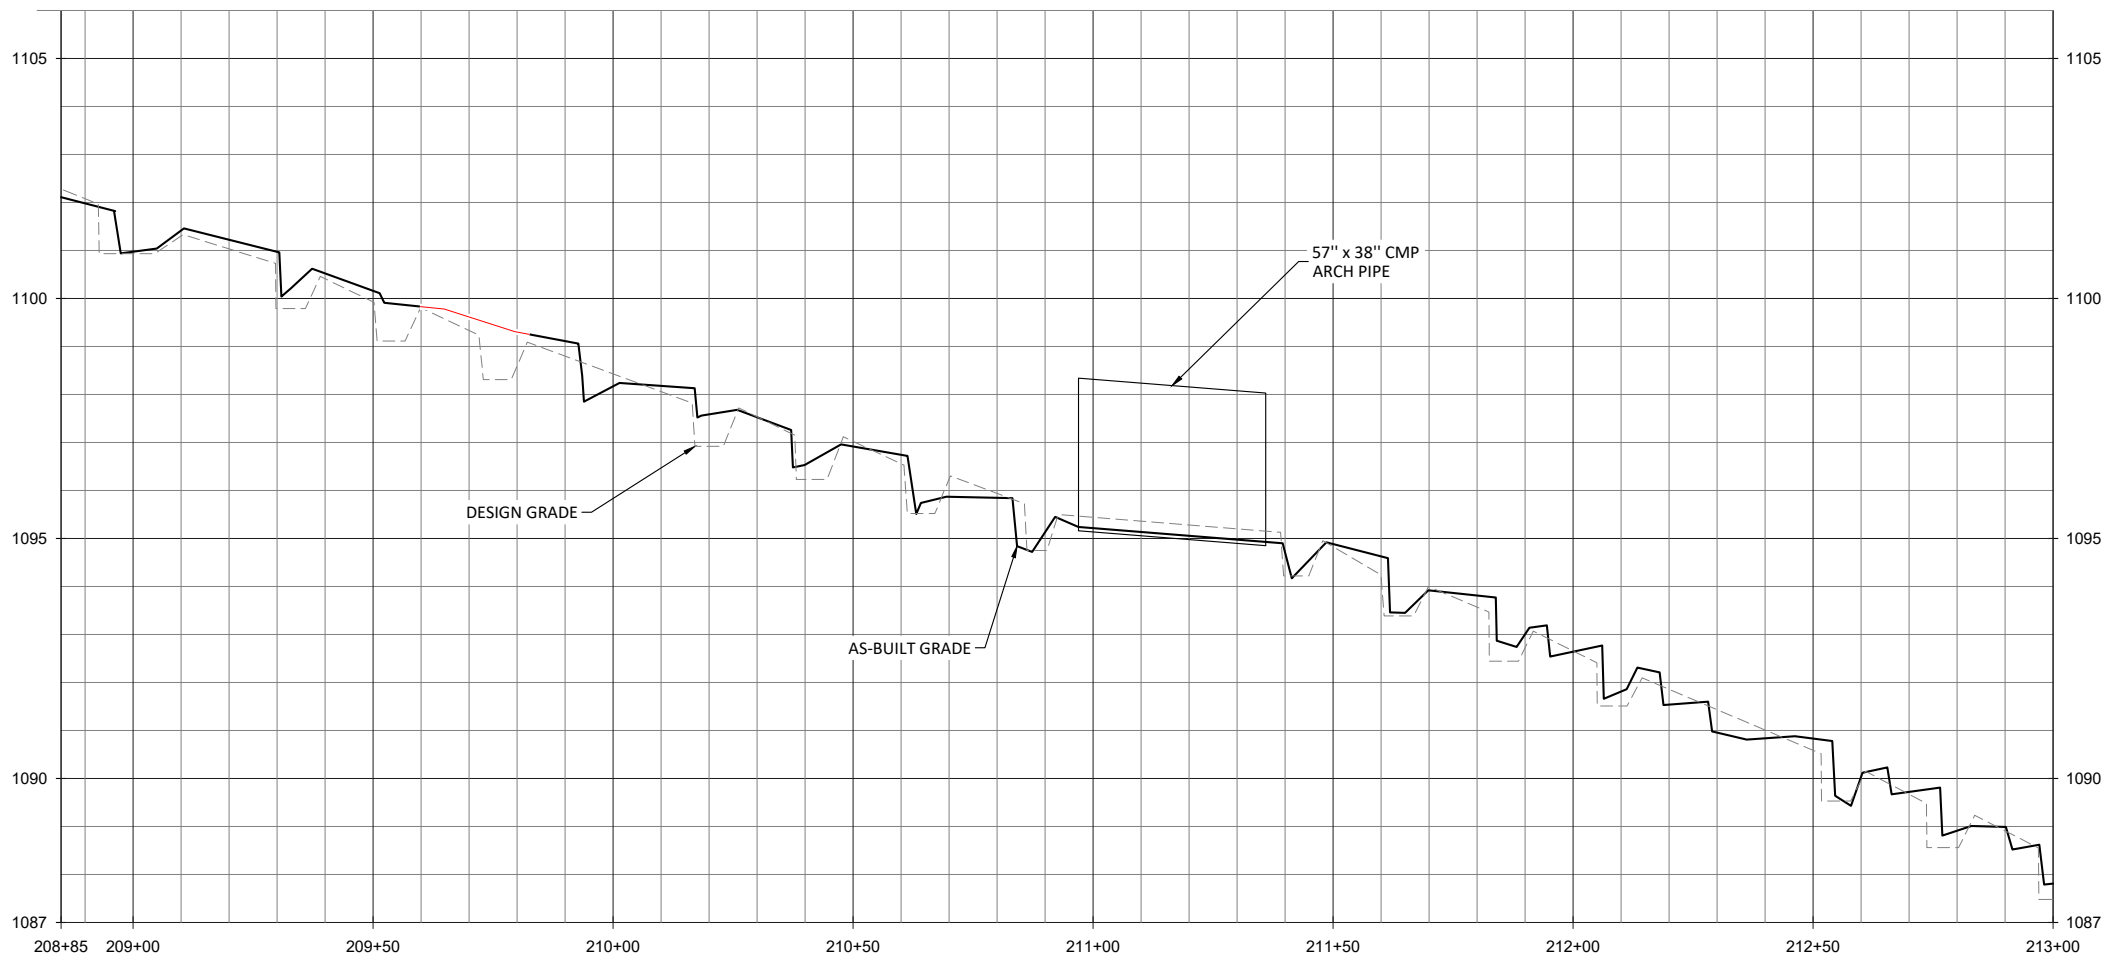
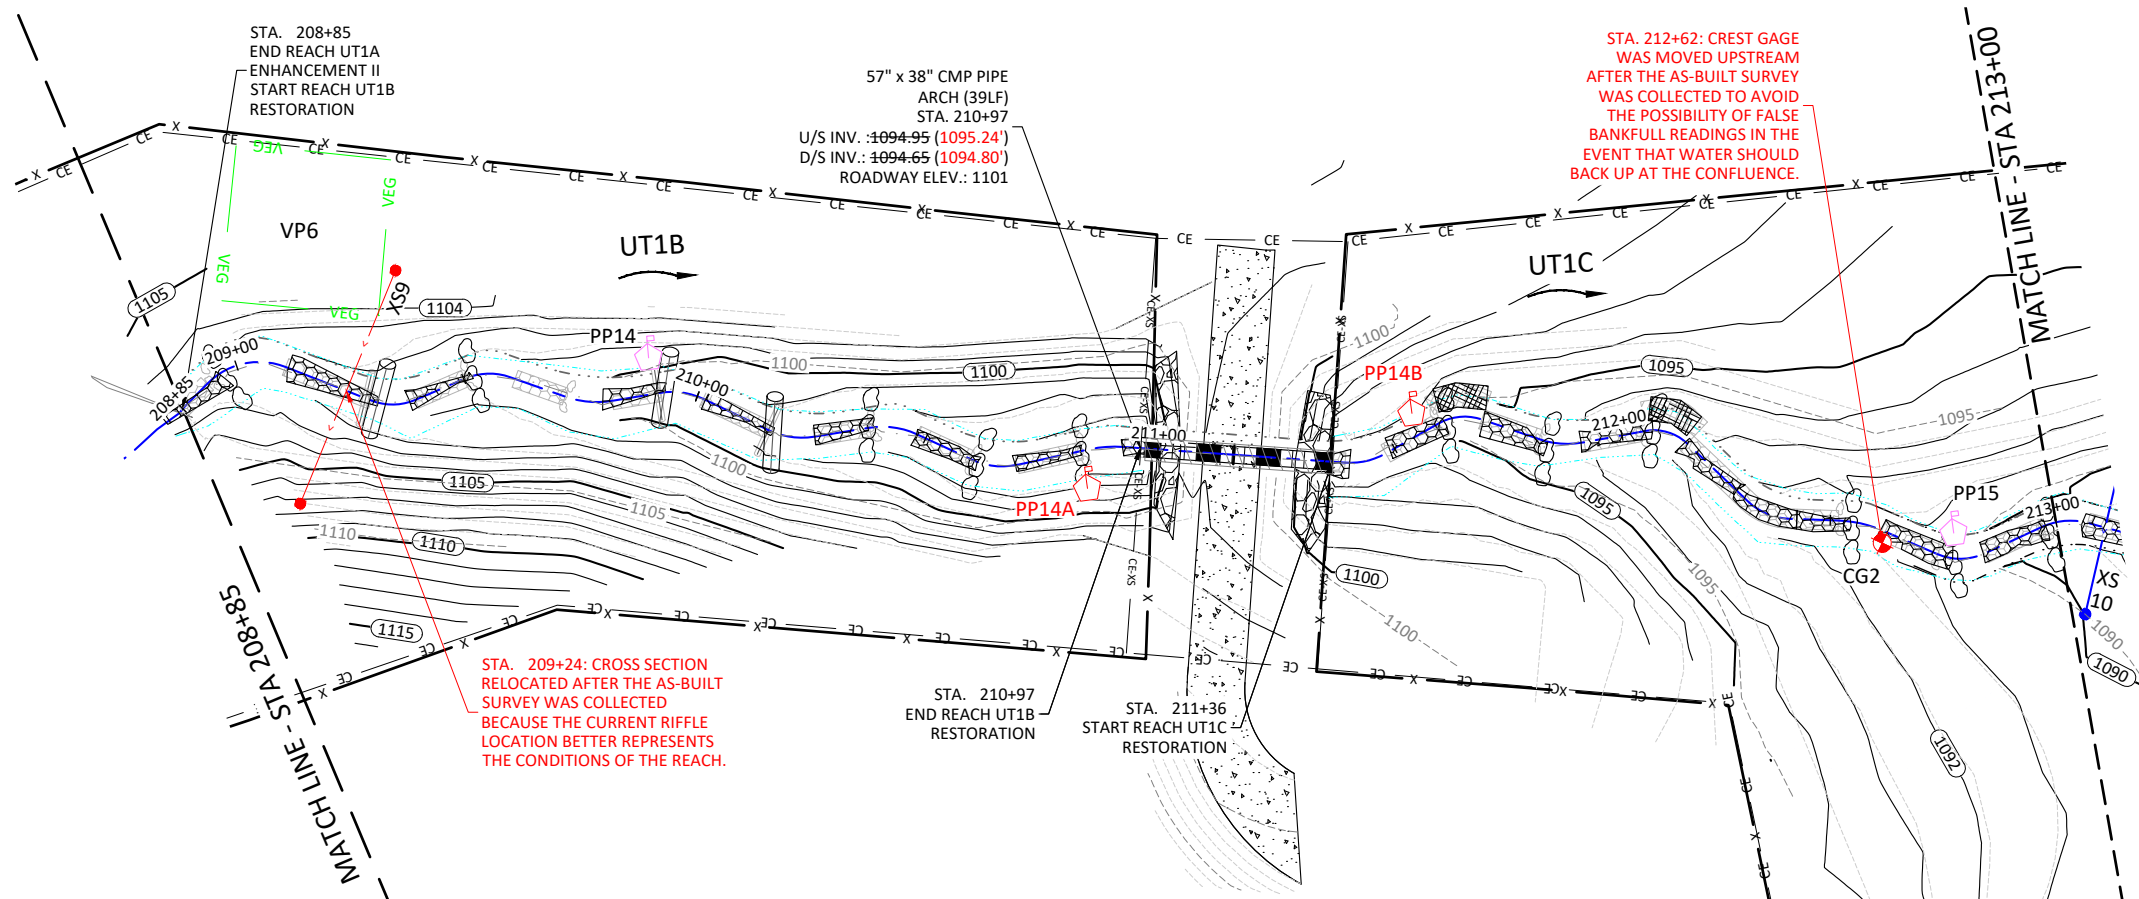
Key Mill Mitigation Site - Record Drawings
Surry County, North Carolina
 UT1B
 Stream Plan and Profile

- NOTE:**
1. STA. 209+65: RIFFLE, ROCK SILL AND POOL WERE OMITTED DUE TO SUFFICIENT STABILITY AND SLOPE ON THE REACH.
 2. STA. 210+83: PHOTO POINT 14A WAS ADDED AFTER THE SURVEY WAS COMPLETED AT THE REQUEST OF DMS TO CAPTURE A DOWNSTREAM VIEW OF THE CULVERT CROSSING.
 3. STA. 211+57: PHOTO POINT 14B WAS ADDED AFTER THE SURVEY WAS COMPLETED AT THE REQUEST OF DMS TO CAPTURE AN UPSTREAM VIEW OF THE CULVERT CROSSING.
 4. STA. 212+35: UPSTREAM ROCK AND ROLL RIFFLE BOULDER SILL WAS OMITTED AND RIFFLE WAS EXTENDED TO CONNECT TO DOWNSTREAM ROCK AND ROLL RIFFLE.

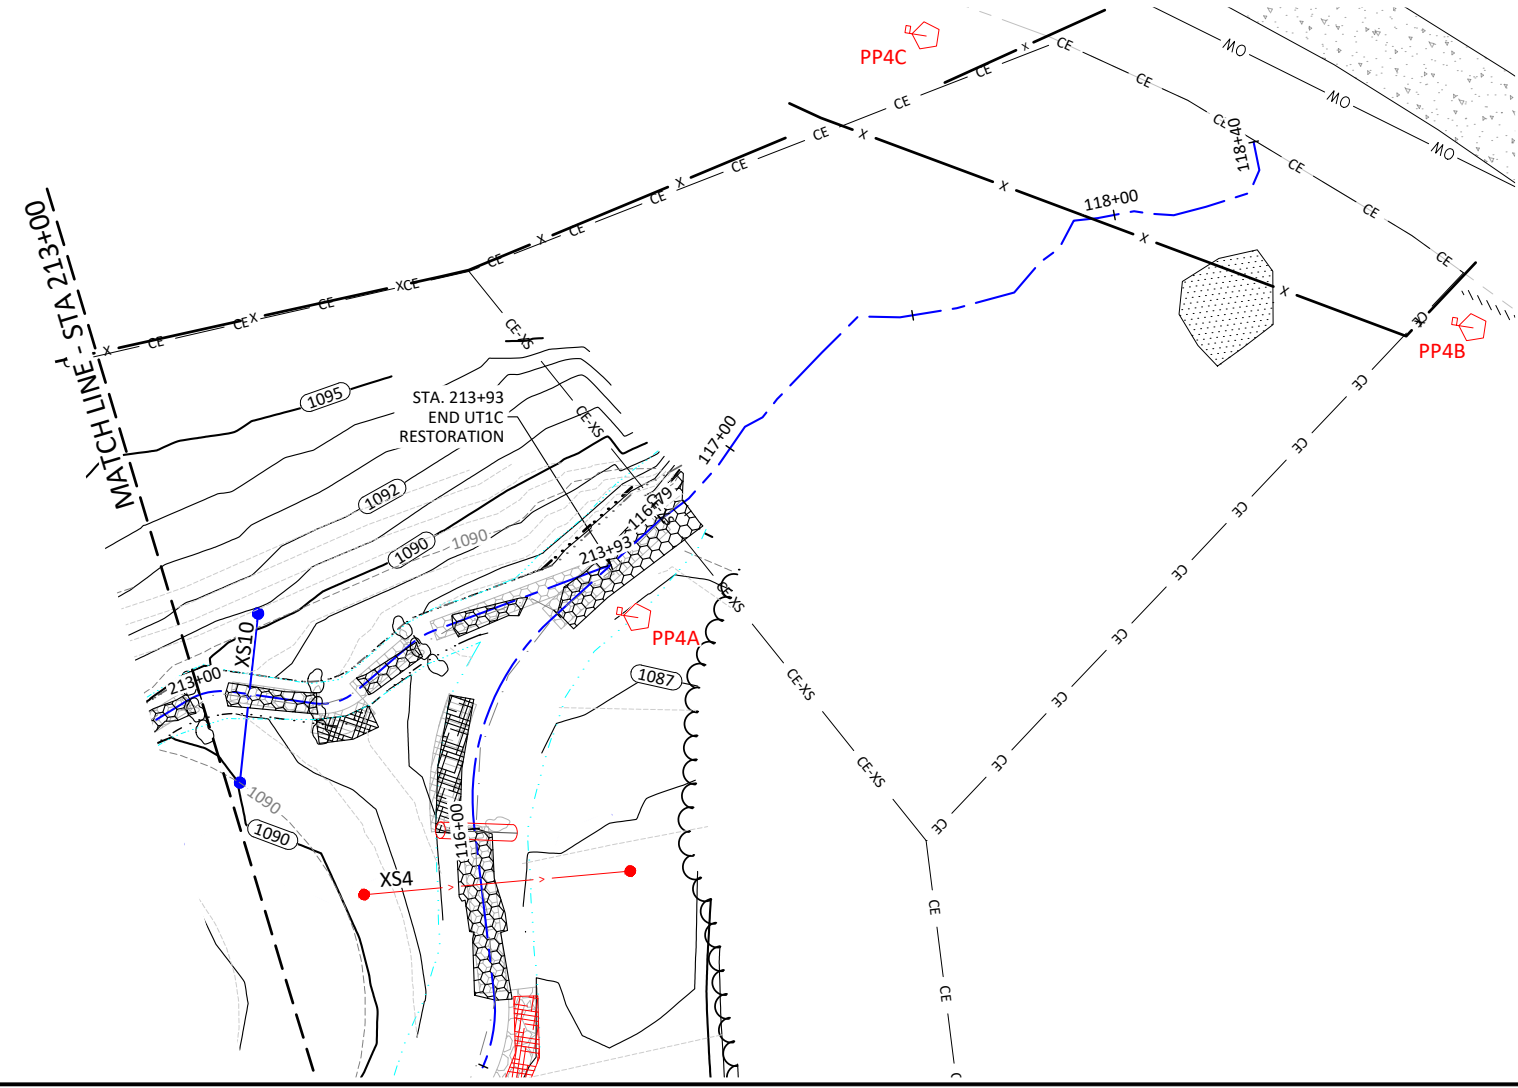
NOTE:
 1. STA. 118+30: PHOTO POINT 4B AND 4C WERE ADDED AFTER THE SURVEY WAS COMPLETE AT THE REQUEST OF DMS TO CAPTURE VIEWS ACROSS THE CATTLE CROSSING.

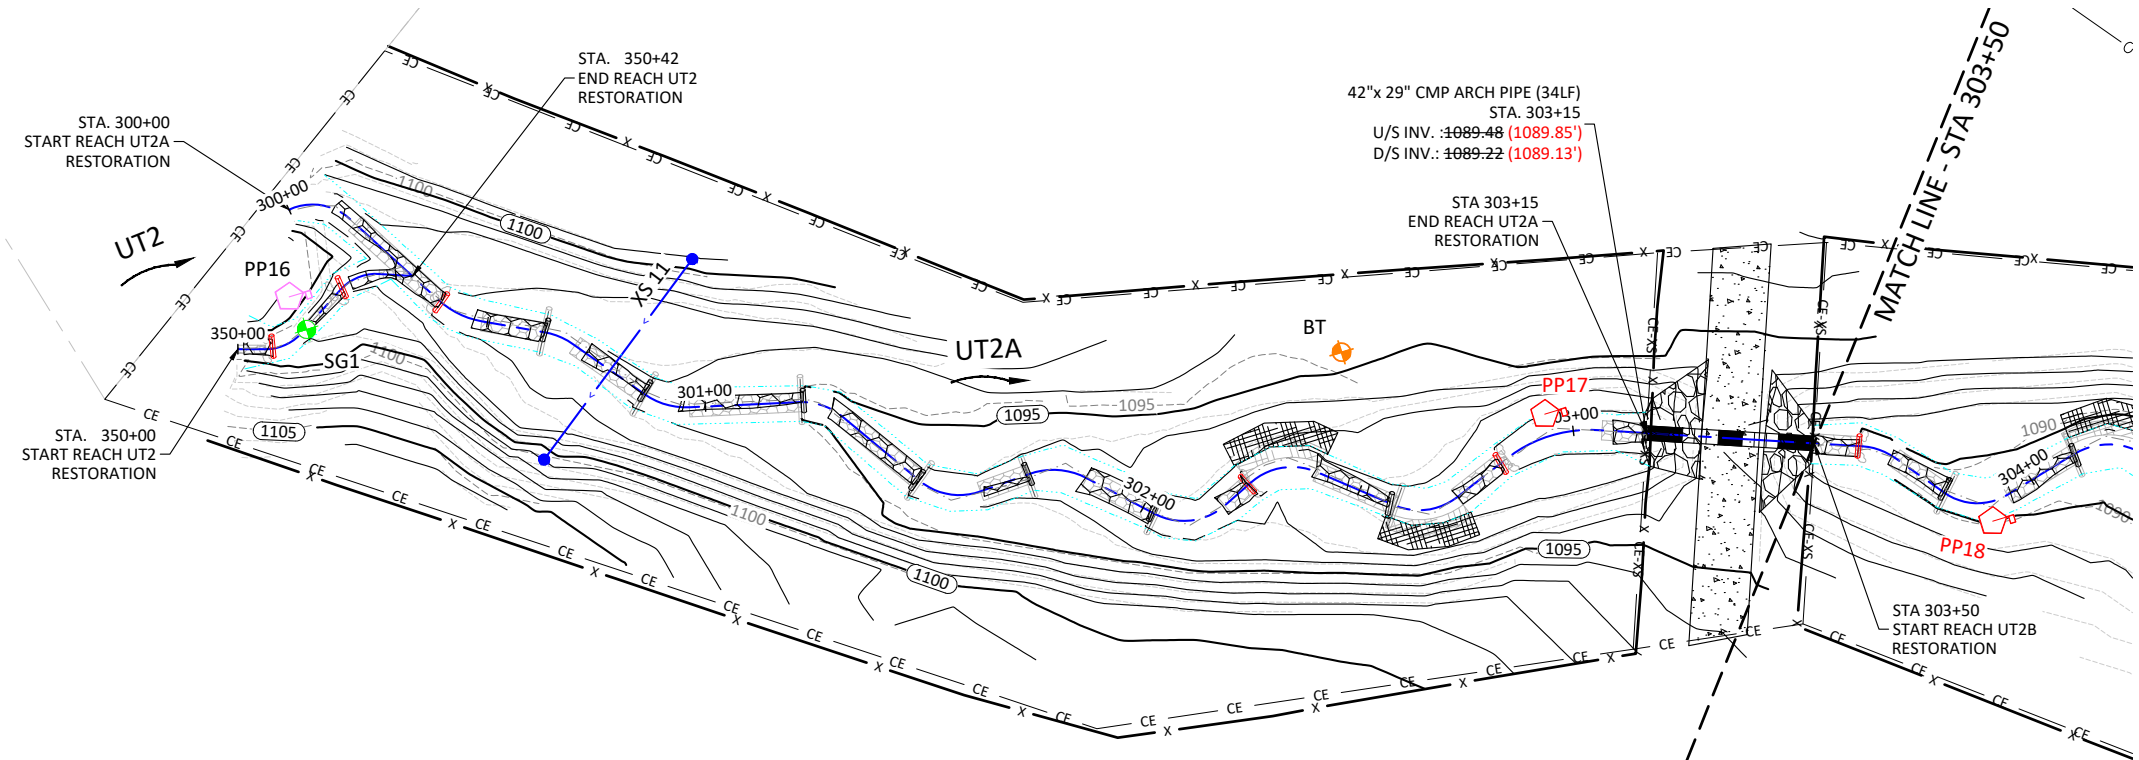
UT2A
 Stream Plan and Profile

- NOTE:**
1. STA. 300+40, 302+25, & 302+83: ROCK SILLS REPLACED WITH LOG SILLS DUE TO LOCAL MATERIAL AVAILABILITY AND SIMILAR FUNCTIONALITY.
 2. STA. 302+95: PHOTO POINT 17 WAS MOVED AFTER THE SURVEY WAS COMPLETED AT THE REQUEST OF DMS TO CAPTURE A DOWNSTREAM VIEW OF THE CULVERT CROSSING.

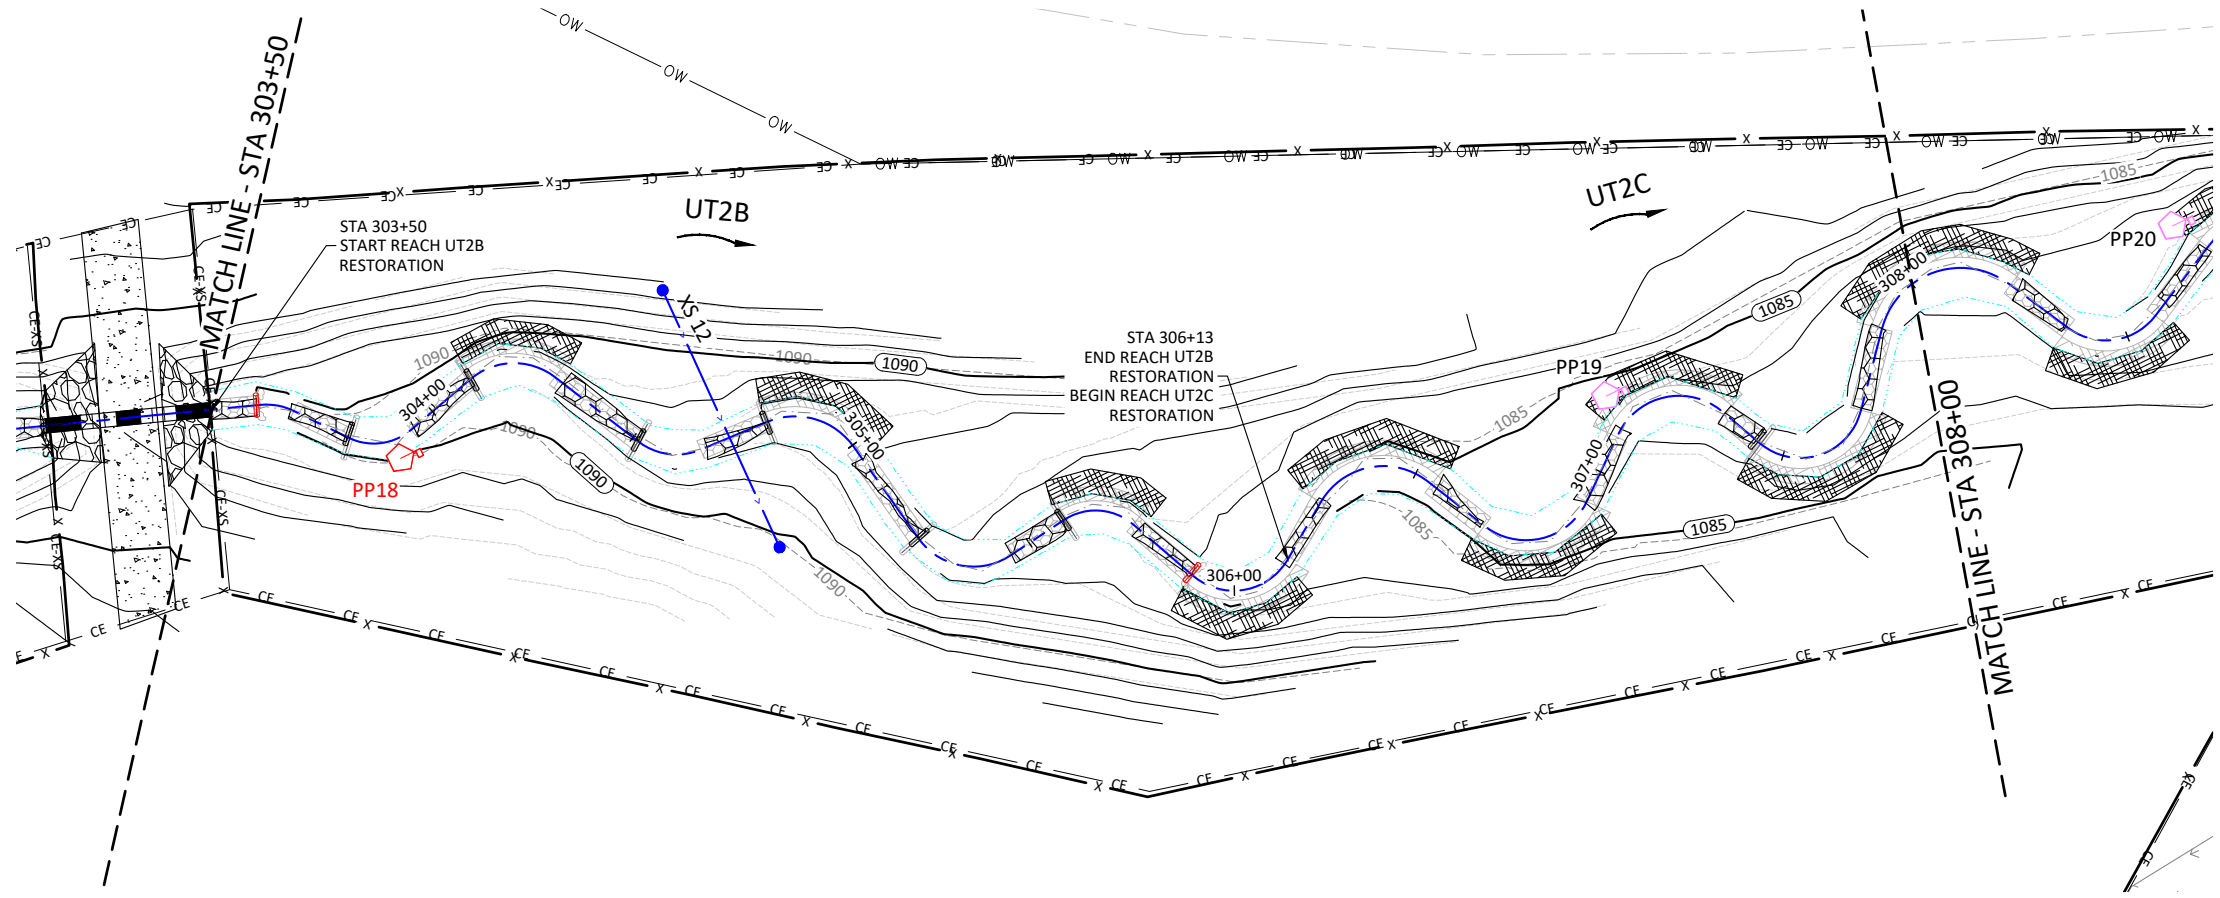
UT2B
Stream Plan and Profile

- NOTE:**
1. STA. 303+59 & 305+90: ROCK SILLS REPLACED WITH LOG SILLS DUE TO LOCAL MATERIAL AVAILABILITY AND SIMILAR FUNCTIONALITY.
 2. STA. 303+90: PHOTO POINT 18 WAS MOVED AFTER THE SURVEY WAS COMPLETED AT THE REQUEST OF DMS TO CAPTURE AN UPSTREAM VIEW OF THE CULVERT CROSSING.

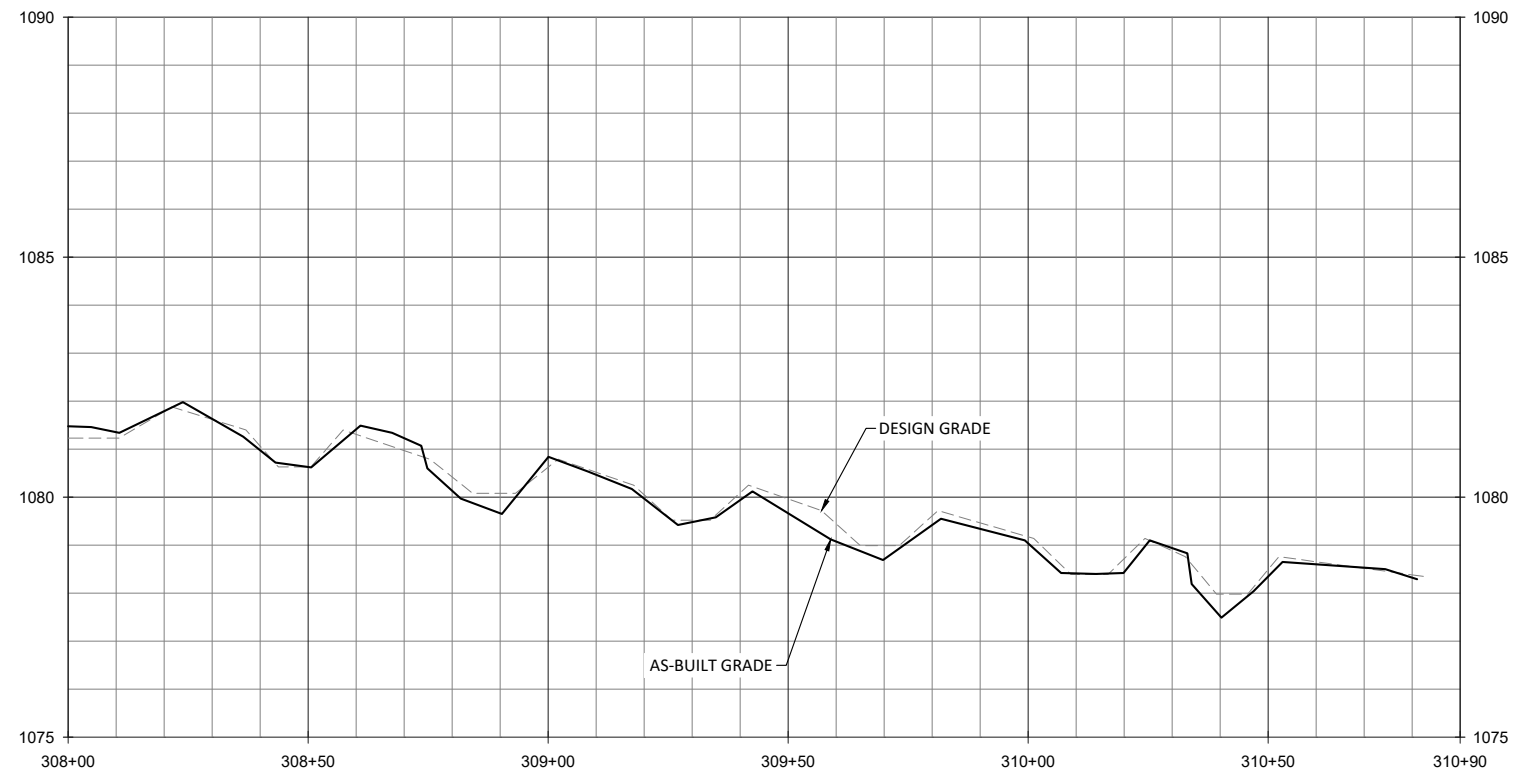
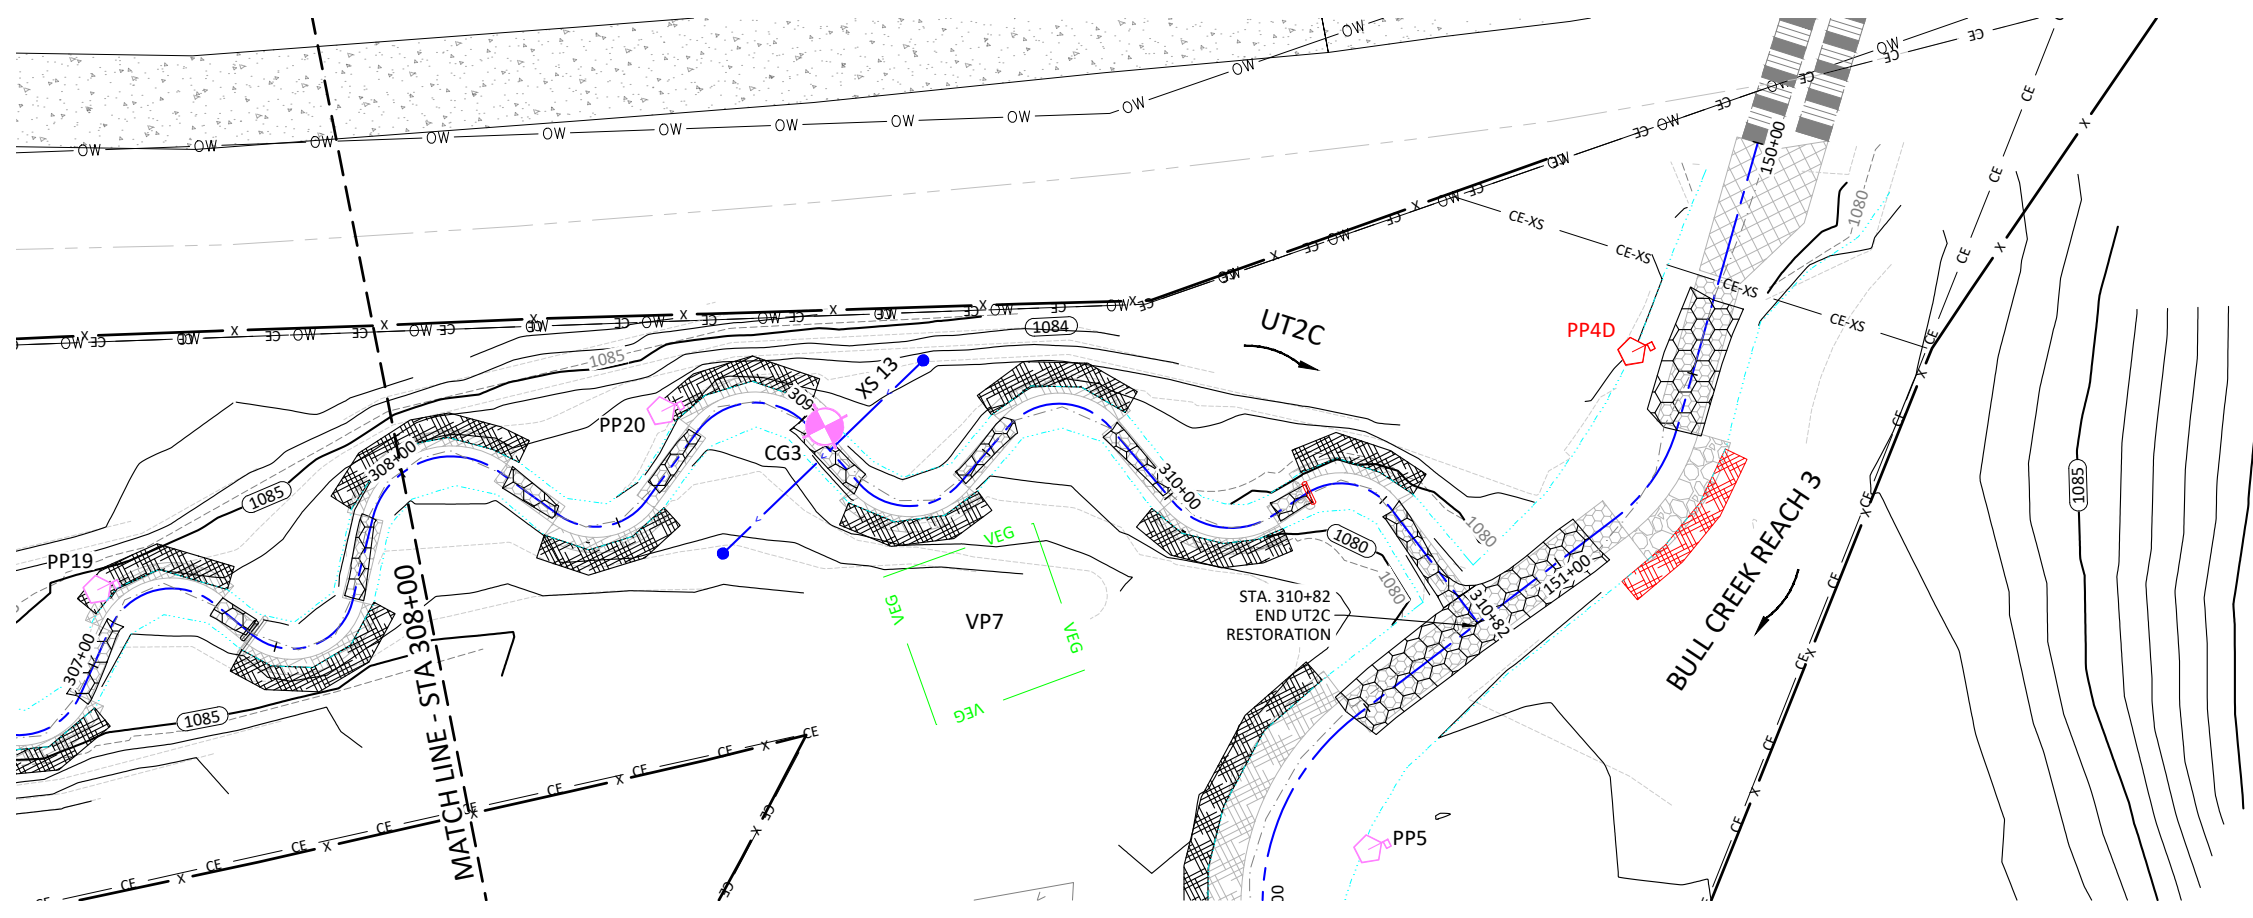
NOTE:
 1. STA. 310+33: ROCK SILL REPLACED WITH LOG SILL DUE TO LOCAL MATERIAL AVAILABILITY AND SIMILAR FUNCTIONALITY.

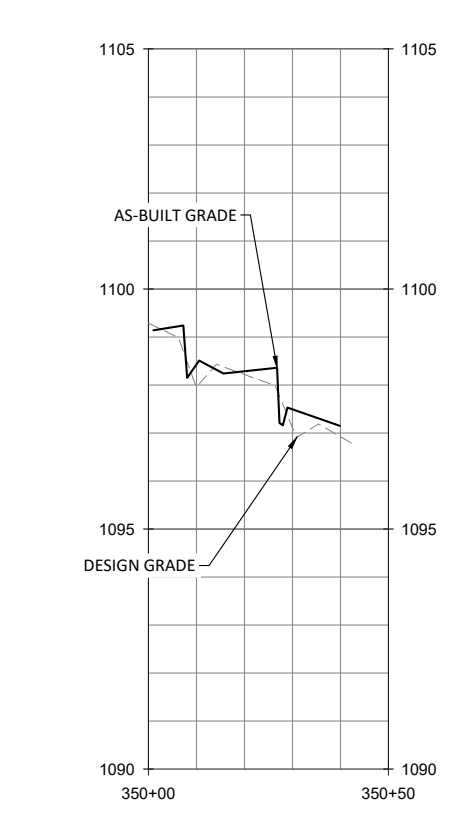
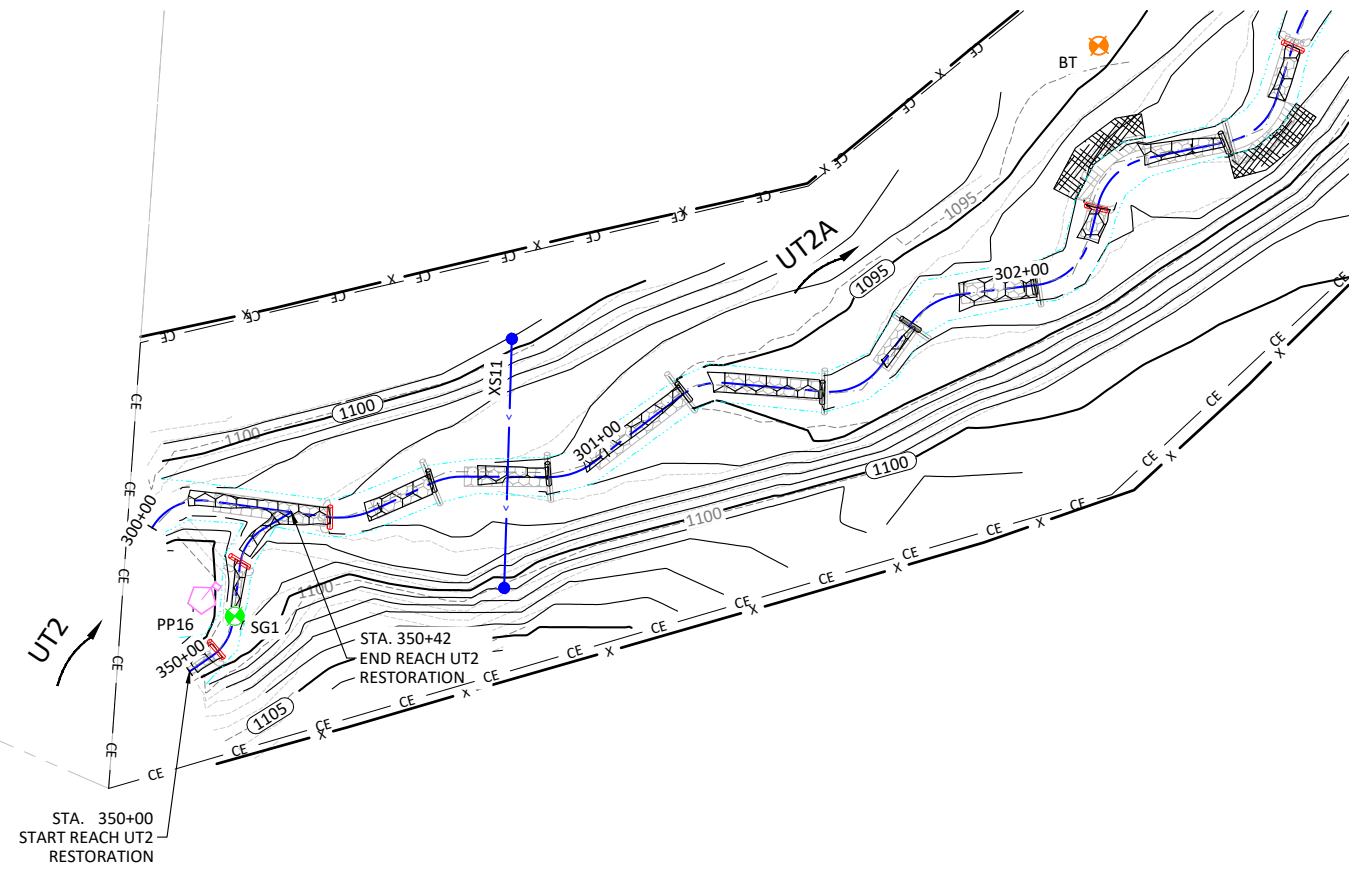
NOTE:
 1. STA. 350+08 & 350+27: ROCK SILLS REPLACED WITH LOG SILLS DUE TO LOCAL MATERIAL AVAILABILITY AND SIMILAR FUNCTIONALITY.

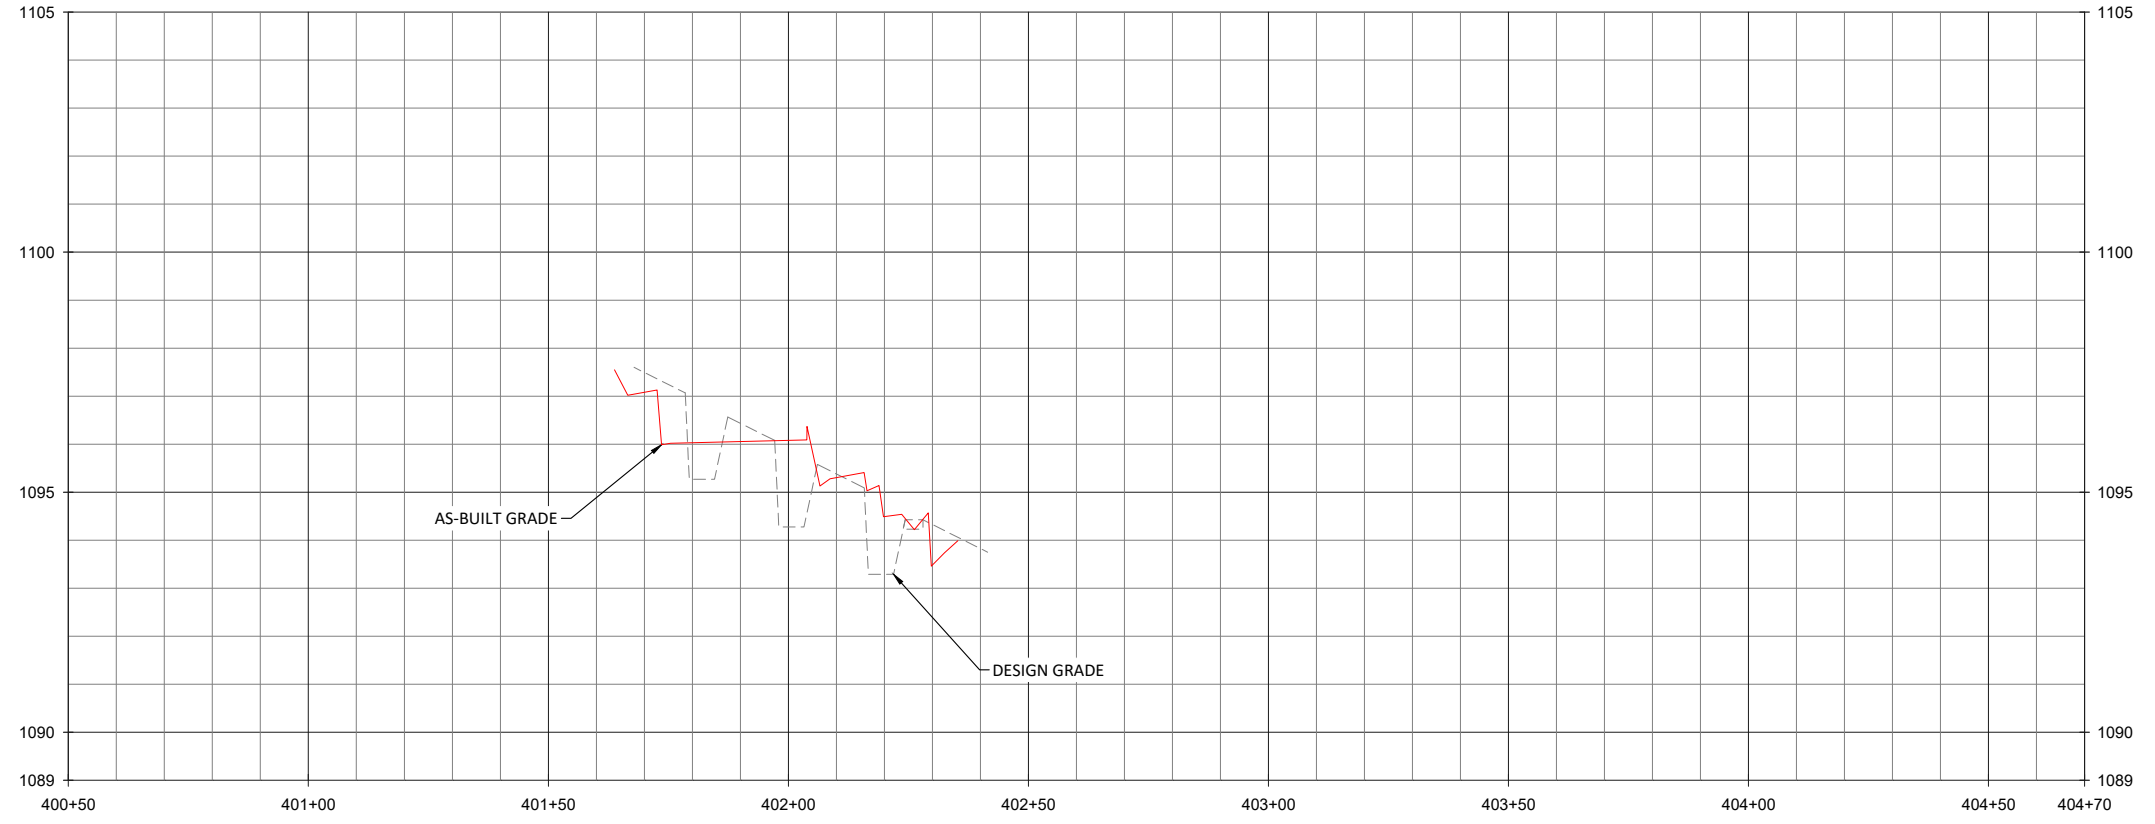
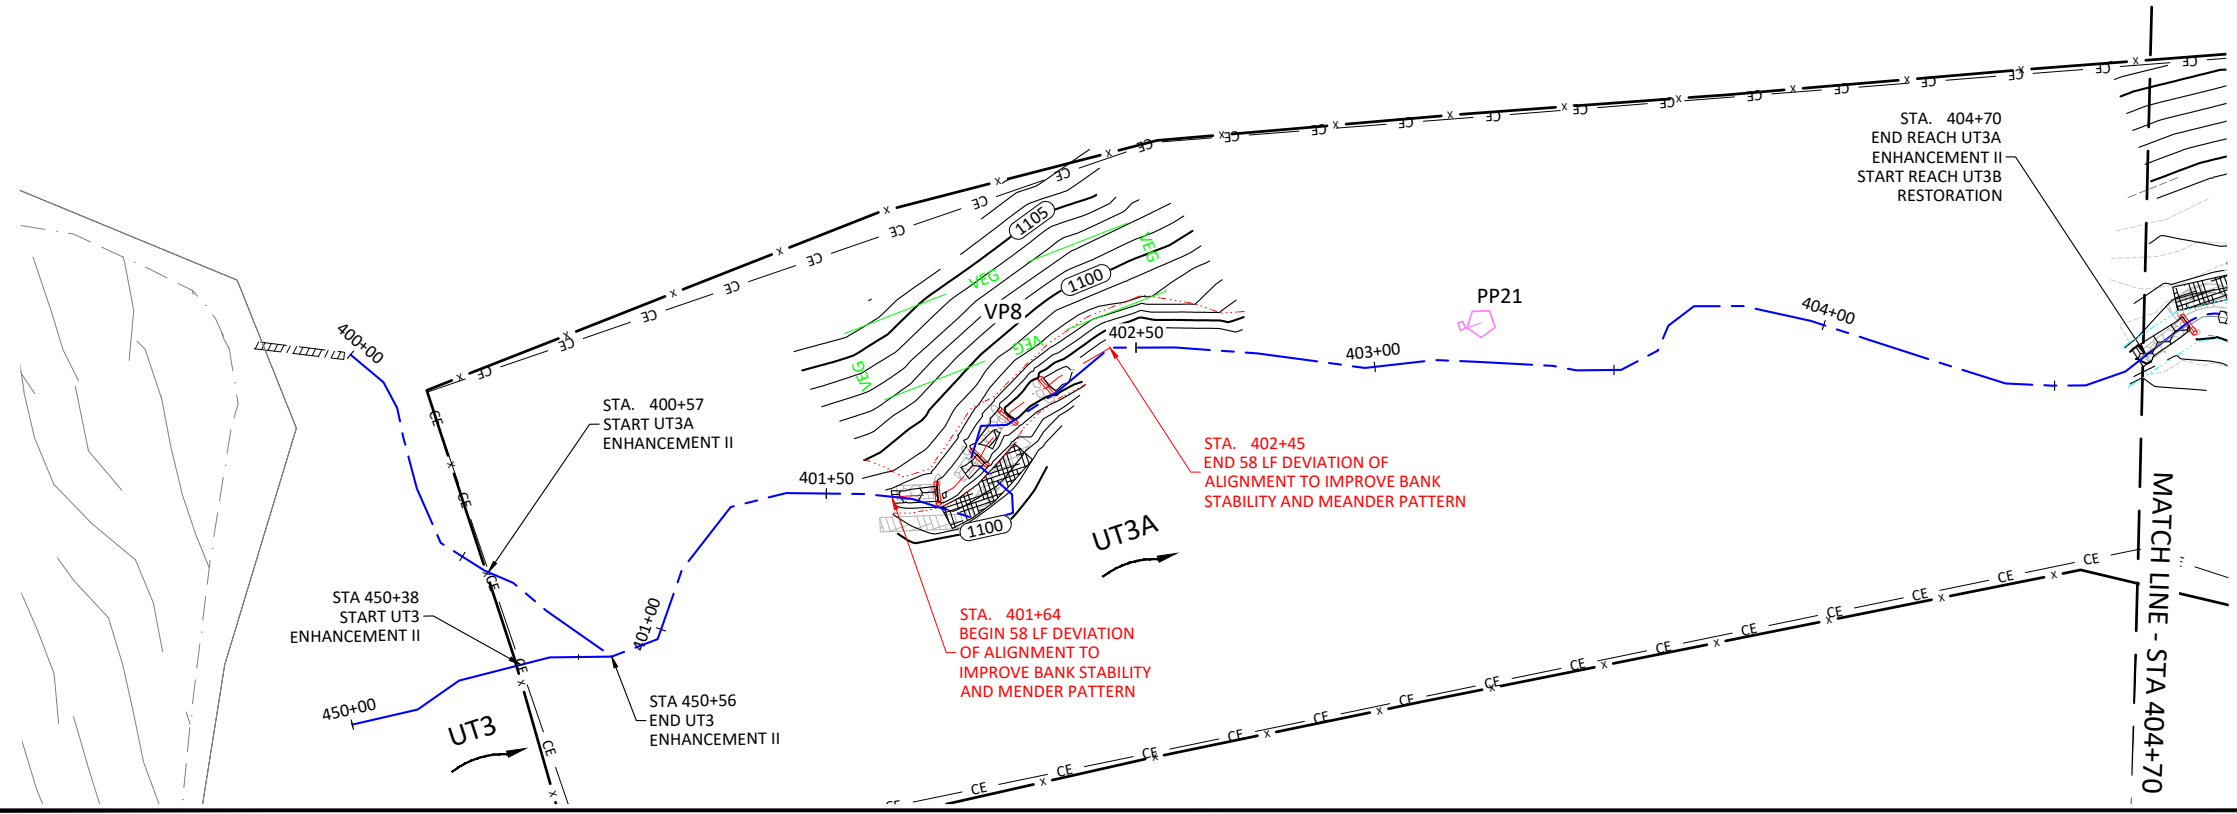
- NOTE:**
1. STA. 401+64 - 402+45: THE CHANNEL DESIGN WAS ALTERED AND REALIGNED TO IMPROVE BANK STABILITY AND MEANDER PATTERN WHICH RESULTED IN 58 LF OF CONSTRUCTED CHANNEL, COMPARED TO 81 LF IN THE ORIGINAL DESIGN.
 2. STA. 401+71 - 402+29: ROCK SILLS REPLACED WITH LOG SILLS DUE TO LOCAL MATERIAL AVAILABILITY AND SIMILAR FUNCTIONALITY.
