AS-BUILT BASELINE MONITORING REPORT

KEY MILL MITIGATION SITE

Surry County, NC
NCDEQ Contract No. 7180
DMS Project No. 100025
USACE Action ID No. SAW-2017-01504
Yadkin River Basin
HUC 03040101

Data Collection Period: September 2019 – July 2020
Submission Date: October 5, 2020

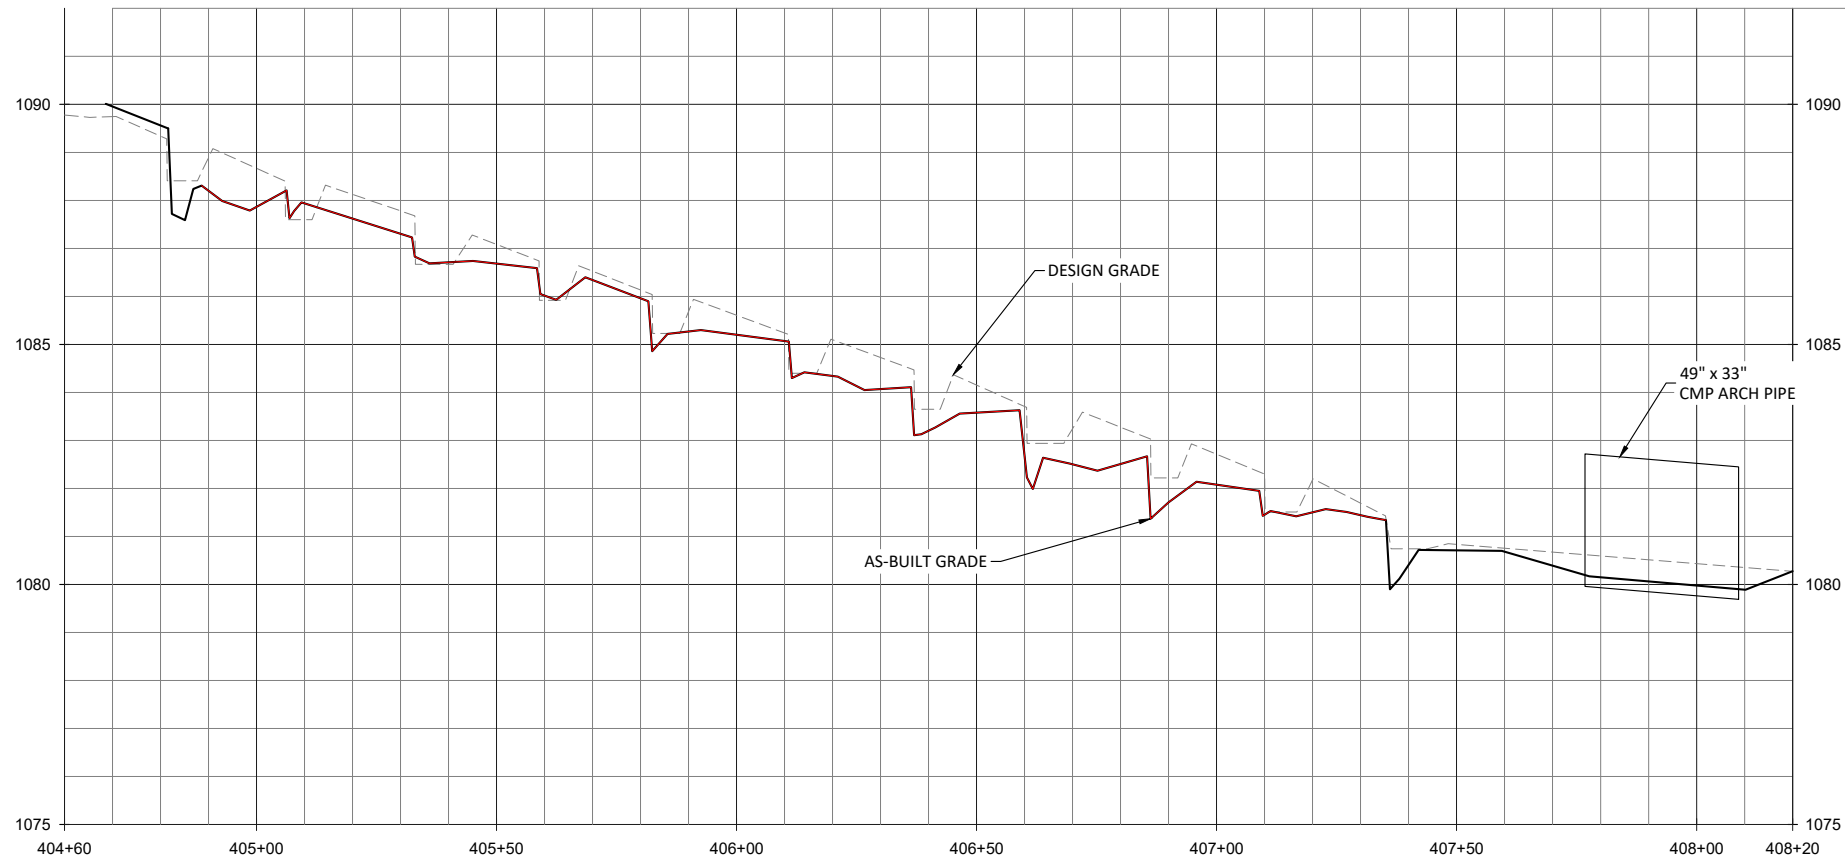
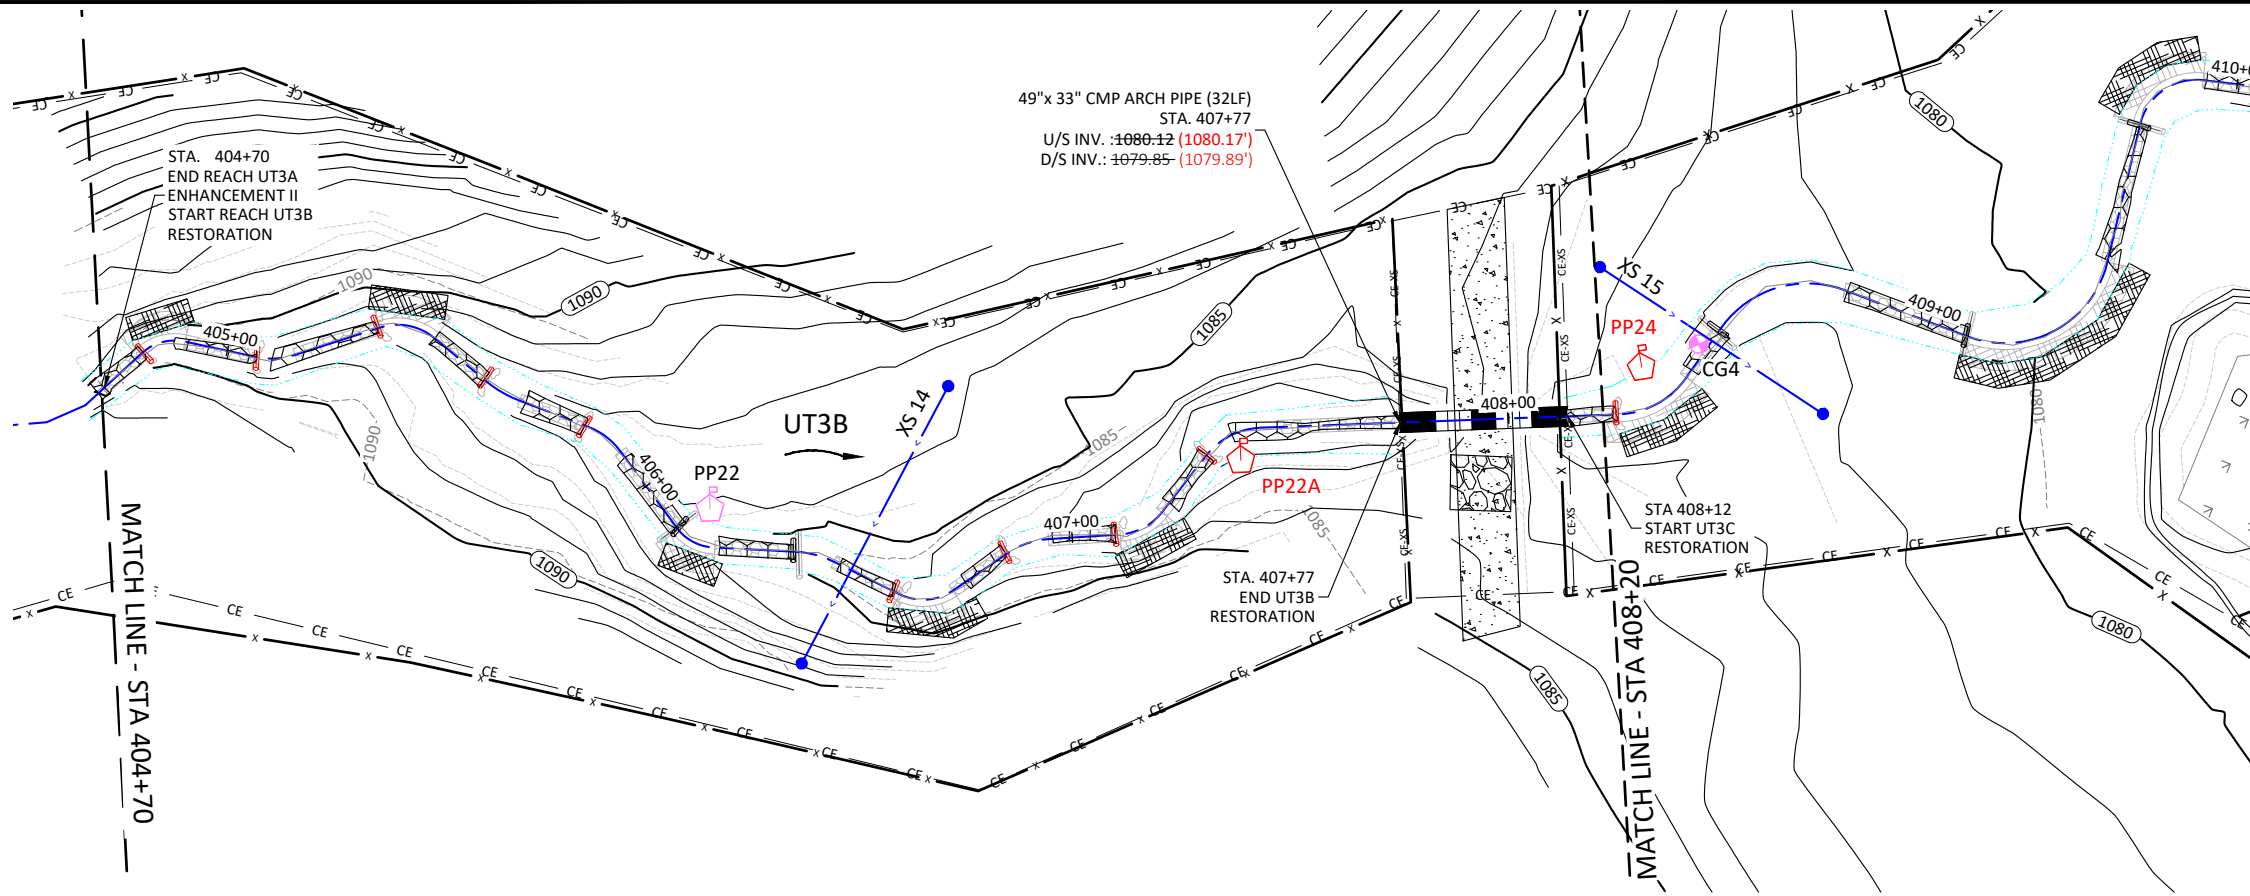
- NOTE:**
1. STA. 404+82, 405+06, 405+32, 405+58, 405+82, 406+59, 406+85, 407+09 AND 407+35: ROCK SILLS REPLACED WITH LOG SILLS DUE TO LOCAL MATERIAL AVAILABILITY AND SIMILAR FUNCTIONALITY.
 2. STA. 404+89 - 407+35: RIFFLE ELEVATIONS ADJUSTED DUE TO THE UPSTREAM TIE IN ELEVATION BEING CHANGED DUE TO FIELD CONDITIONS.
 3. STA. 407+41: PHOTO POINT 22A WAS ADDED AFTER THE SURVEY WAS COMPLETED AT THE REQUEST OF DMS TO CAPTURE A DOWNSTREAM VIEW OF THE CULVERT CROSSING.

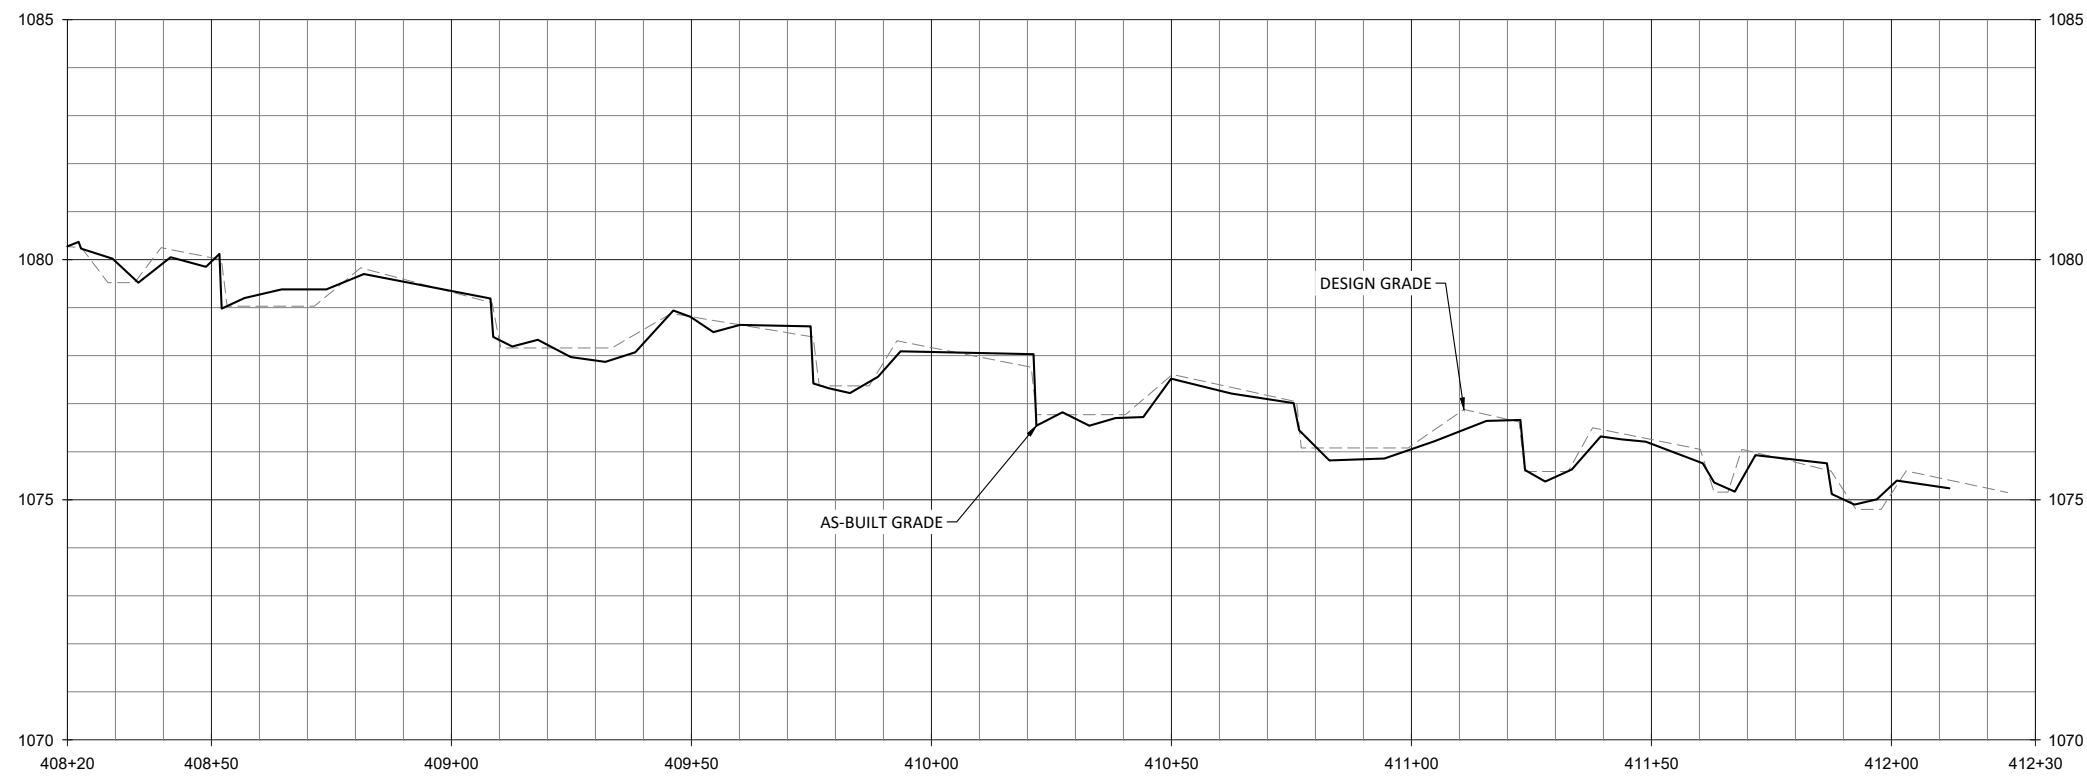
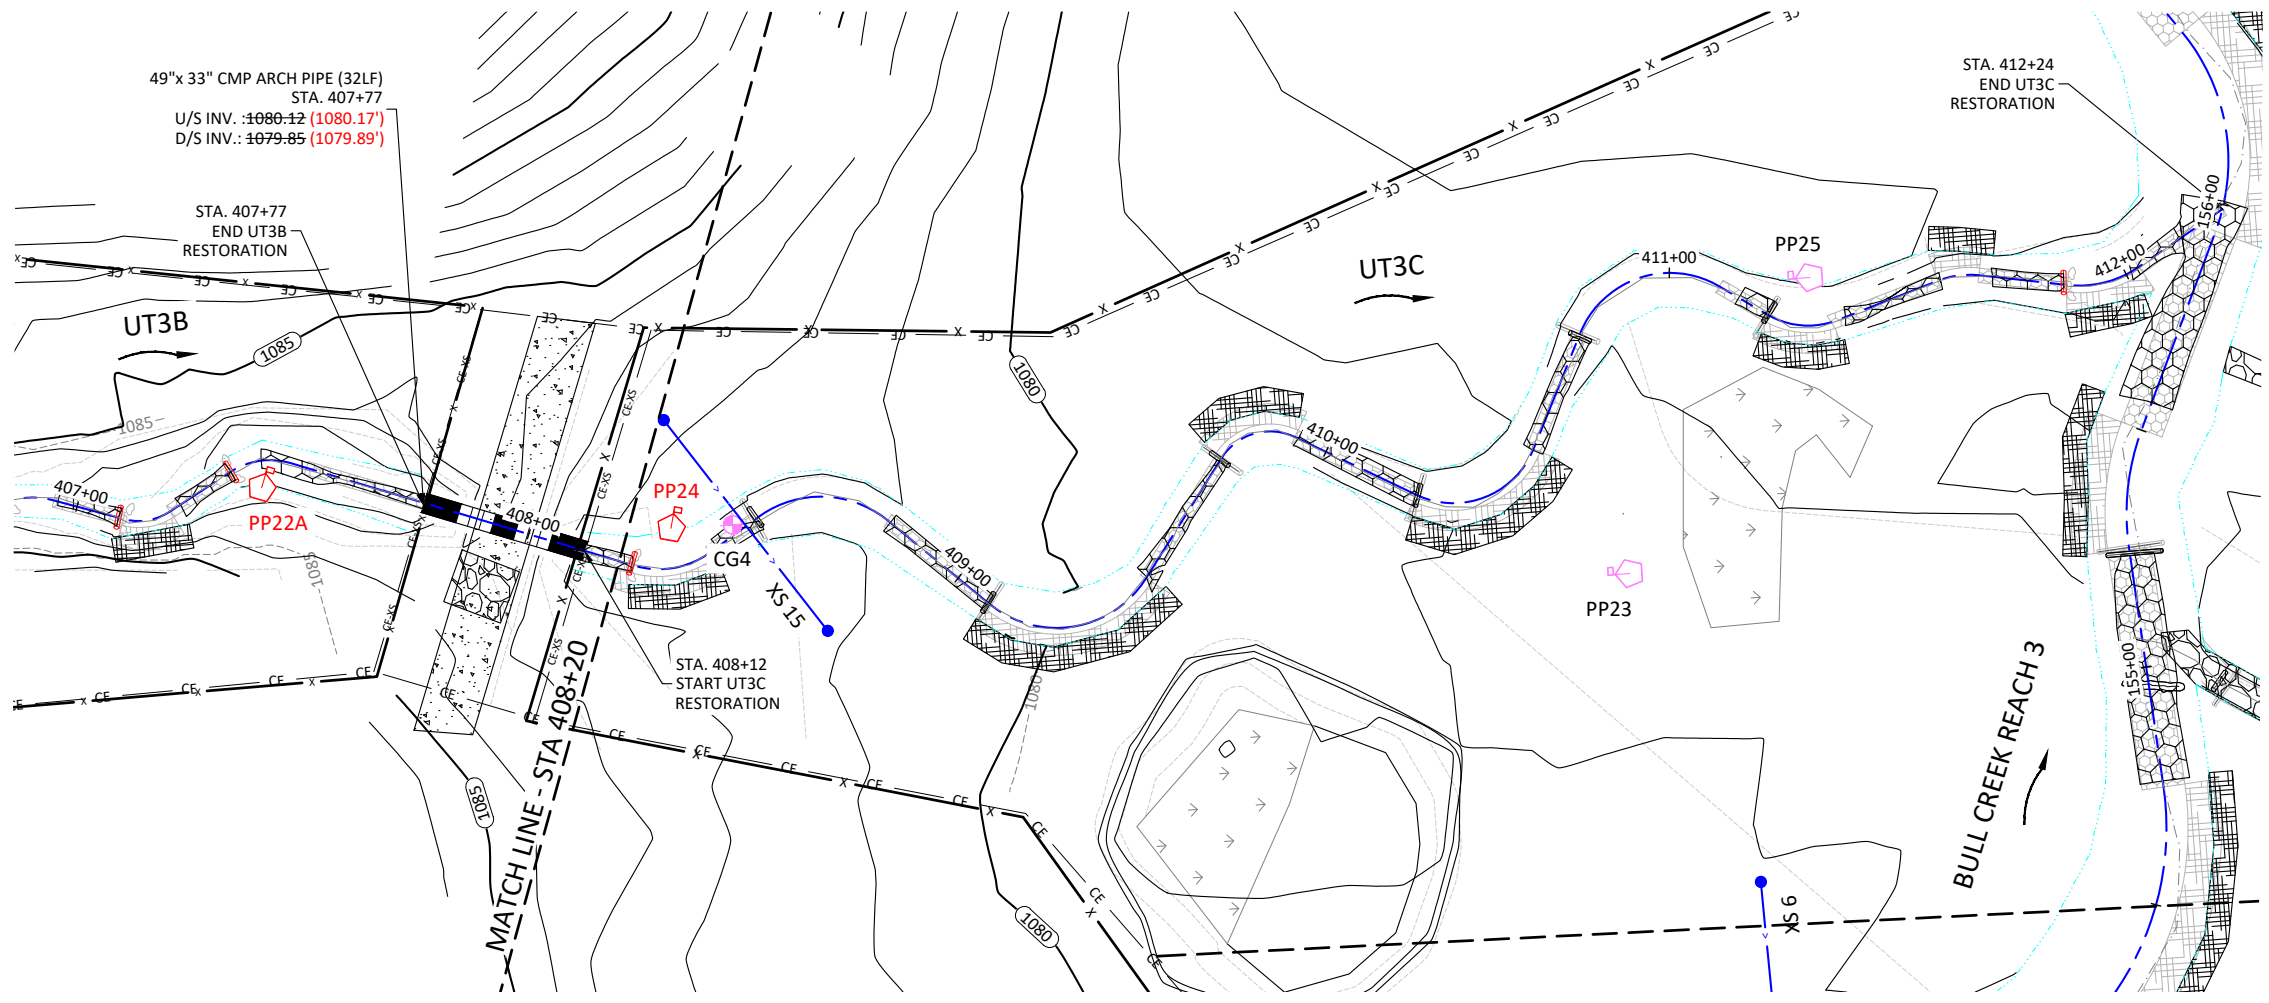
UT3C
 Stream Plan and Profile

- NOTE:**
1. STA. 408+22: ROCK SILLS REPLACED WITH LOG SILLS DUE TO LOCAL MATERIAL AVAILABILITY AND SIMILAR FUNCTIONALITY.
 2. STA. 408+33: PHOTO POINT 24 WAS MOVED AFTER THE SURVEY WAS COMPLETED AT THE REQUEST OF DMS TO CAPTURE AN UPSTREAM VIEW OF THE CULVERT CROSSING.
 3. STA. 411+86: ROCK SILL REPLACED WITH LOG SILL DUE TO LOCAL MATERIAL AVAILABILITY AND SIMILAR FUNCTIONALITY.
