MONITORING YEAR 3 ANNUAL REPORT

KEY MILL MITIGATION SITE

Surry County, NC

DMS Project No. 100025

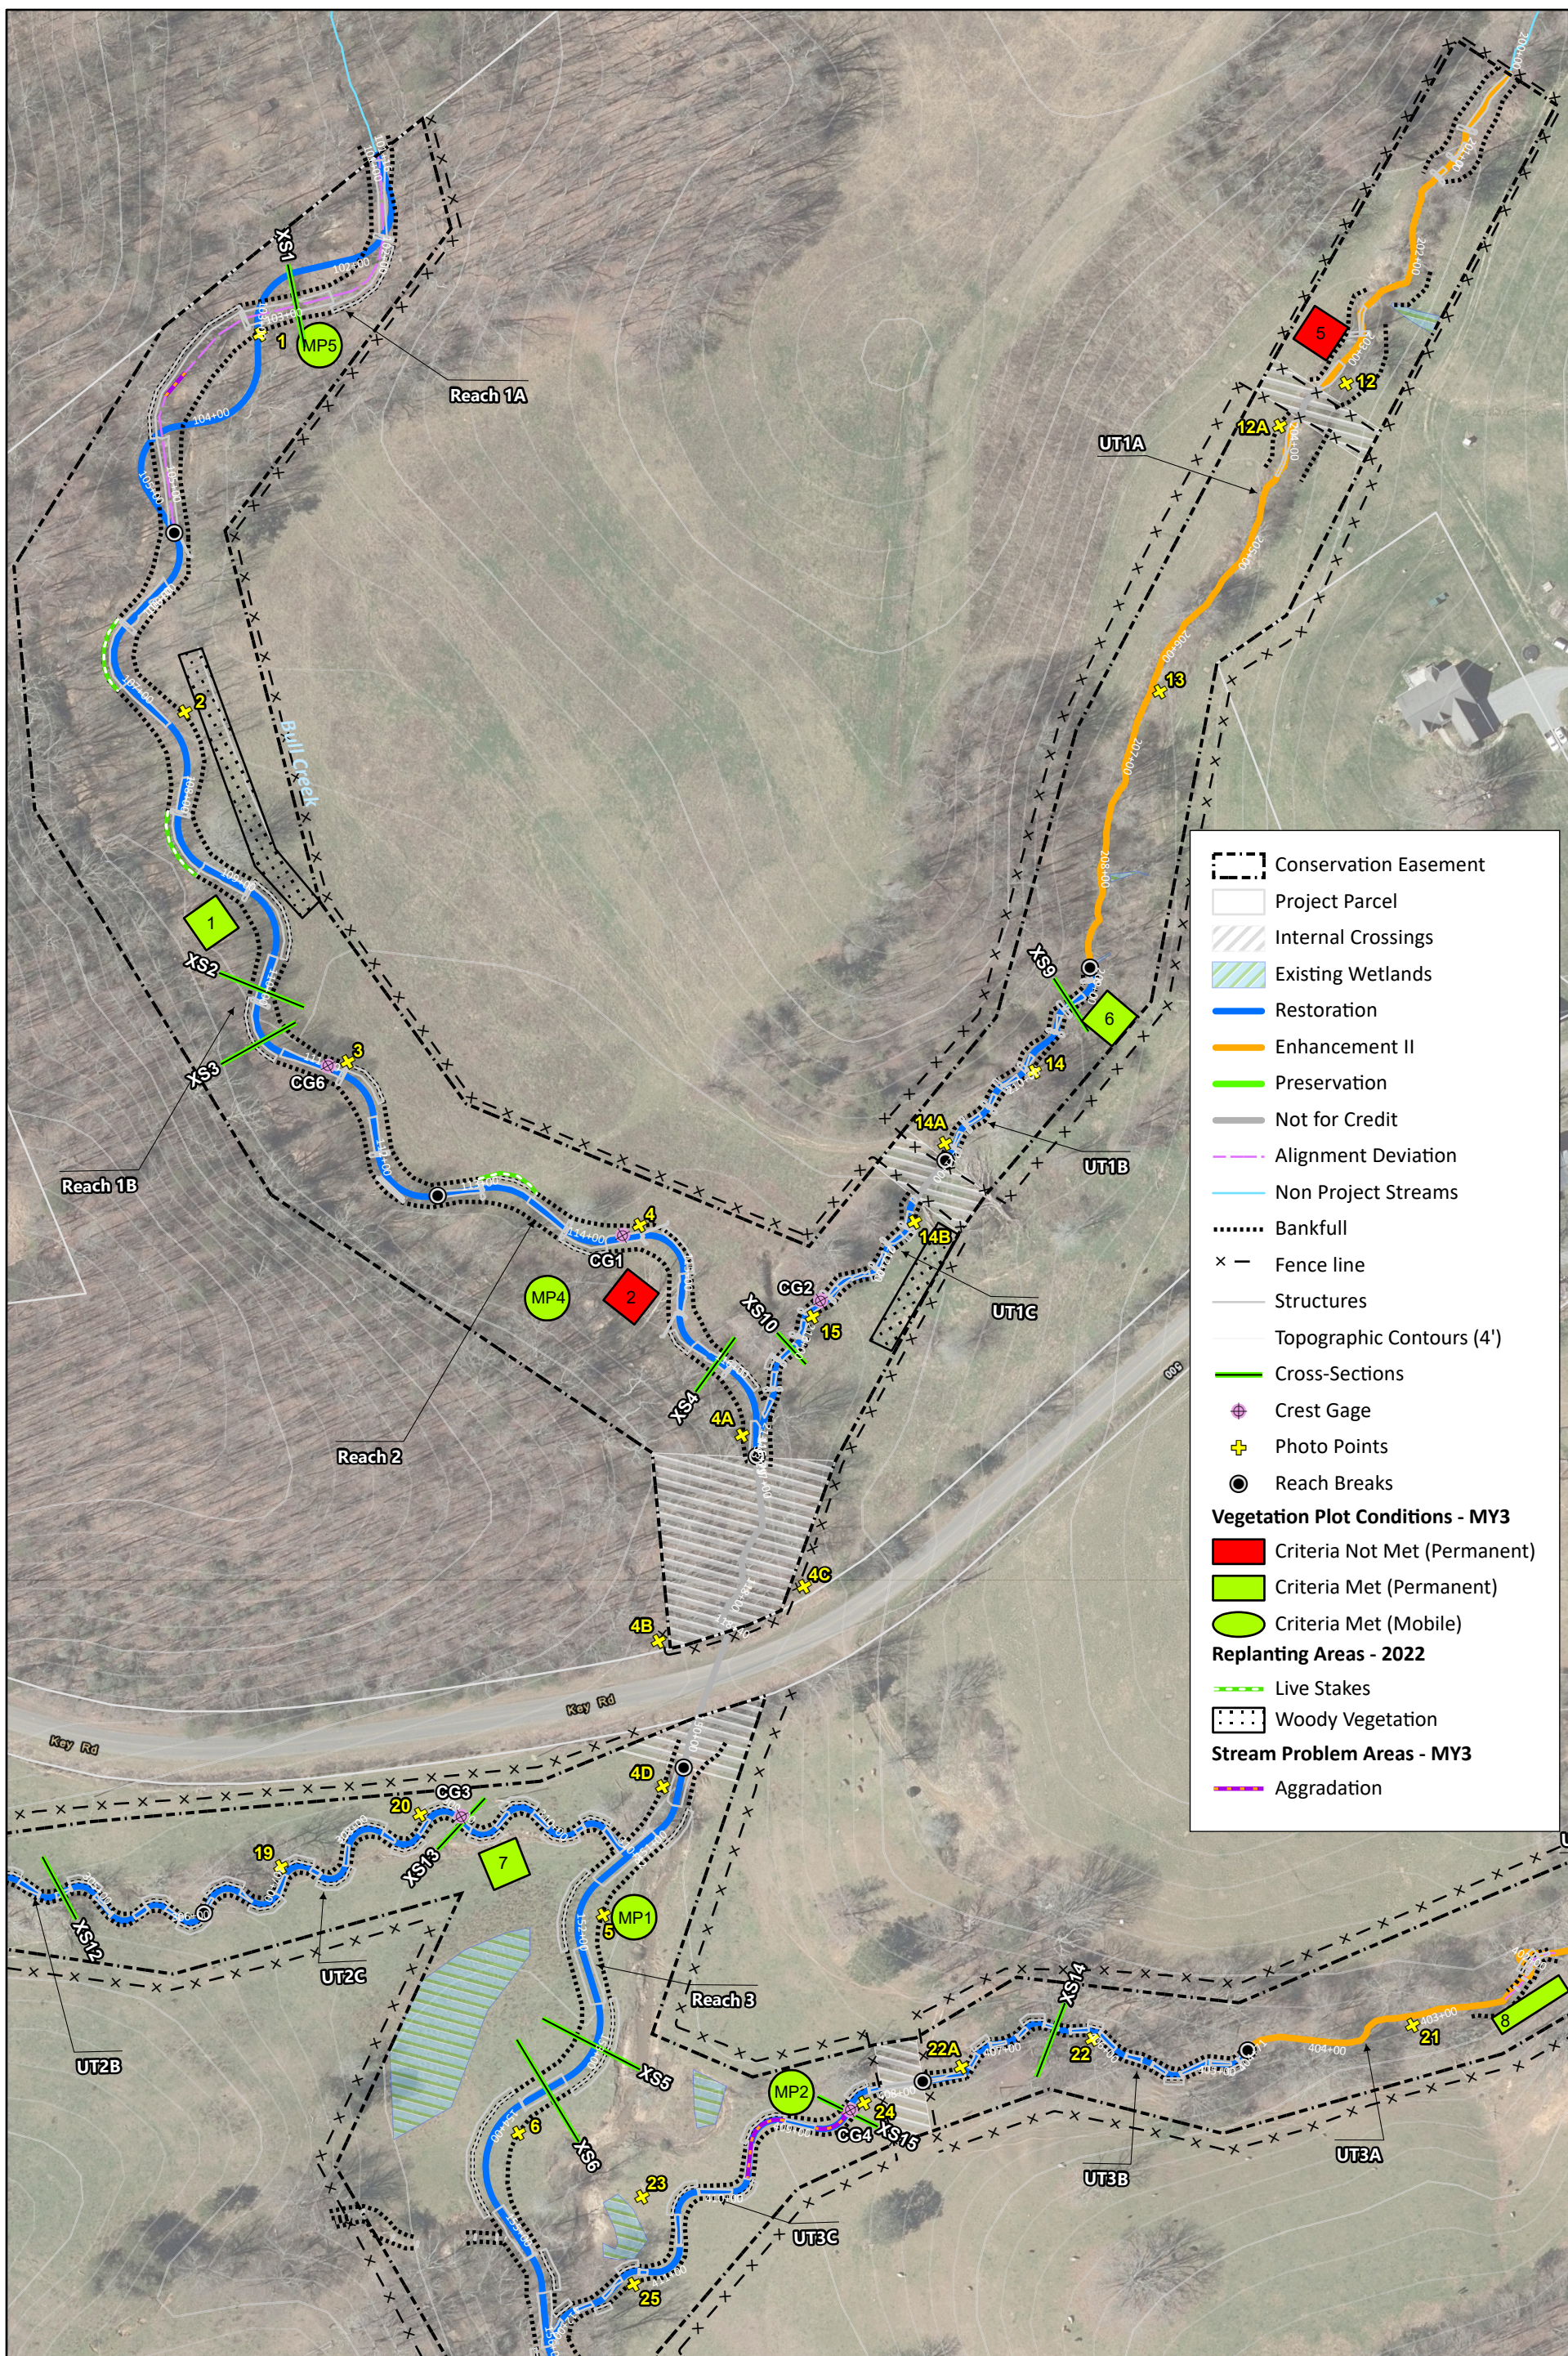
Figure 1a. Current Condition Plan View Map
 Key Mill Mitigation Site
 DMS Project No. 100025
 Monitoring Year 3 - 2022
 Surry County, NC

MY3 stream and visual assessments revealed that over 98% of the Site's reaches are stable and performing as intended. There were no new stream areas of concern (AOC) noted in MY3. Existing AOCs that were noted MY2, include localized instances of aggradation (Bull Creek Reach 1A and UT3C) and the displacement and piping of logs within a log roller riffle on Bull Creek Reach 3. Maintenance with the use of hand tools is scheduled to occur in early 2023 to repair the piping log within the riffle; however, Wildlands does not plan to reset the dislocated log since it is not currently causing any issues of instability. No maintenance is scheduled for the areas of localized aggradation, either. Sediment accumulation has ceased, and stream processes are starting to move it through the system. Areas of concern are noted in Figures 1a - 1c. See Appendix A for pictures pertaining to the Areas of Concern.

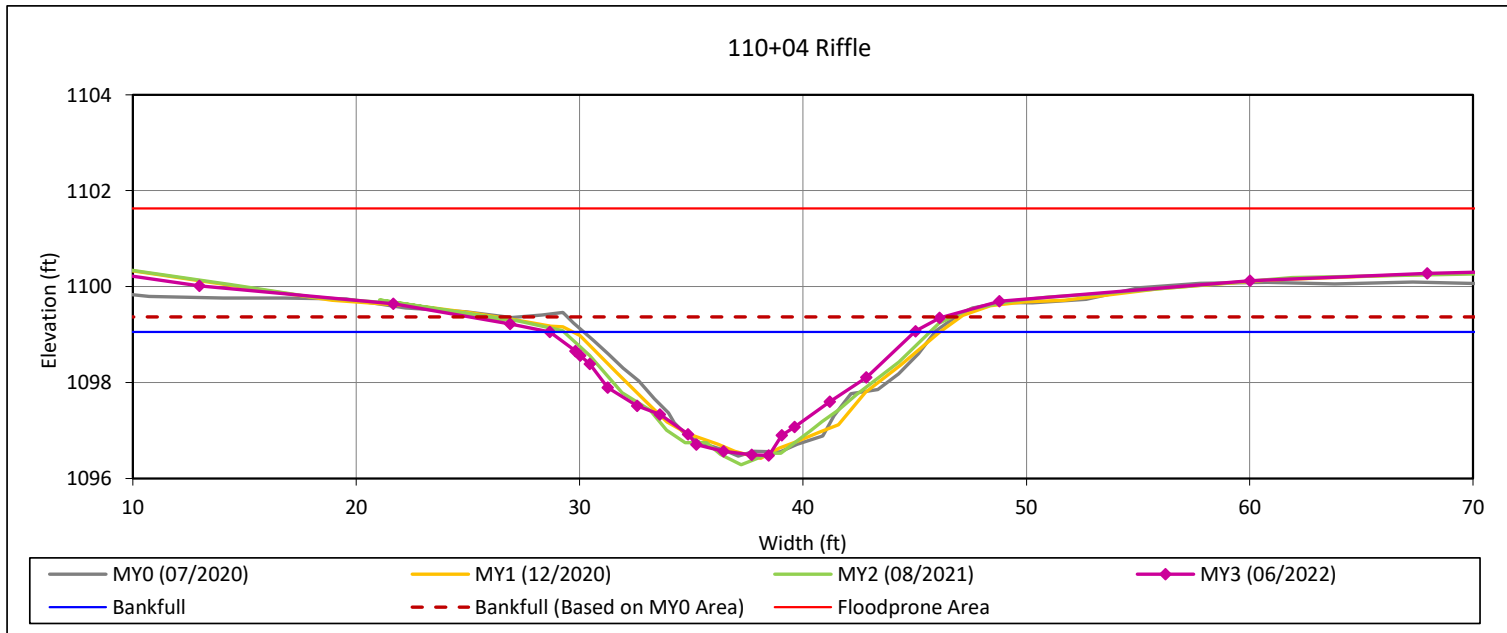
Cross-Section 2-Bull Creek Reach 1B

*Repairs conducted during MY1 resulted in a slight shift in the cross-section alignment between the MY0 and MY1 cross-section pin locations; therefore the plot was adjusted so that the cross-sections lined up for easier comparison.

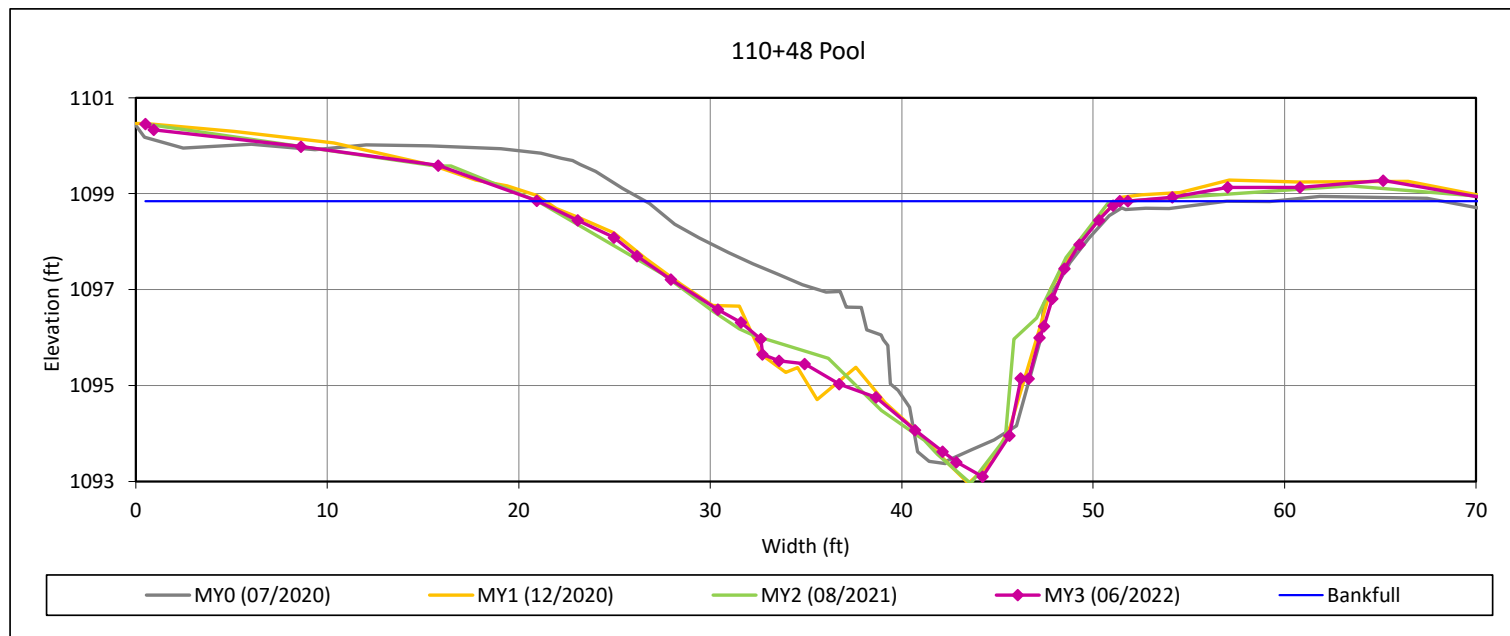
Cross-Section 3-Bull Creek Reach 1B

*Repairs were conducted on the left bank of XS3 during MY1 prior to the collection of the MY1 cross-section data and photos. The MY1 plot line shows the repaired cross-sectional profile. Also the station number for XS3 was incorrectly reported on the MY0 cross-section plot, it should have been reported as Station 110+48 as shown in the above plot.

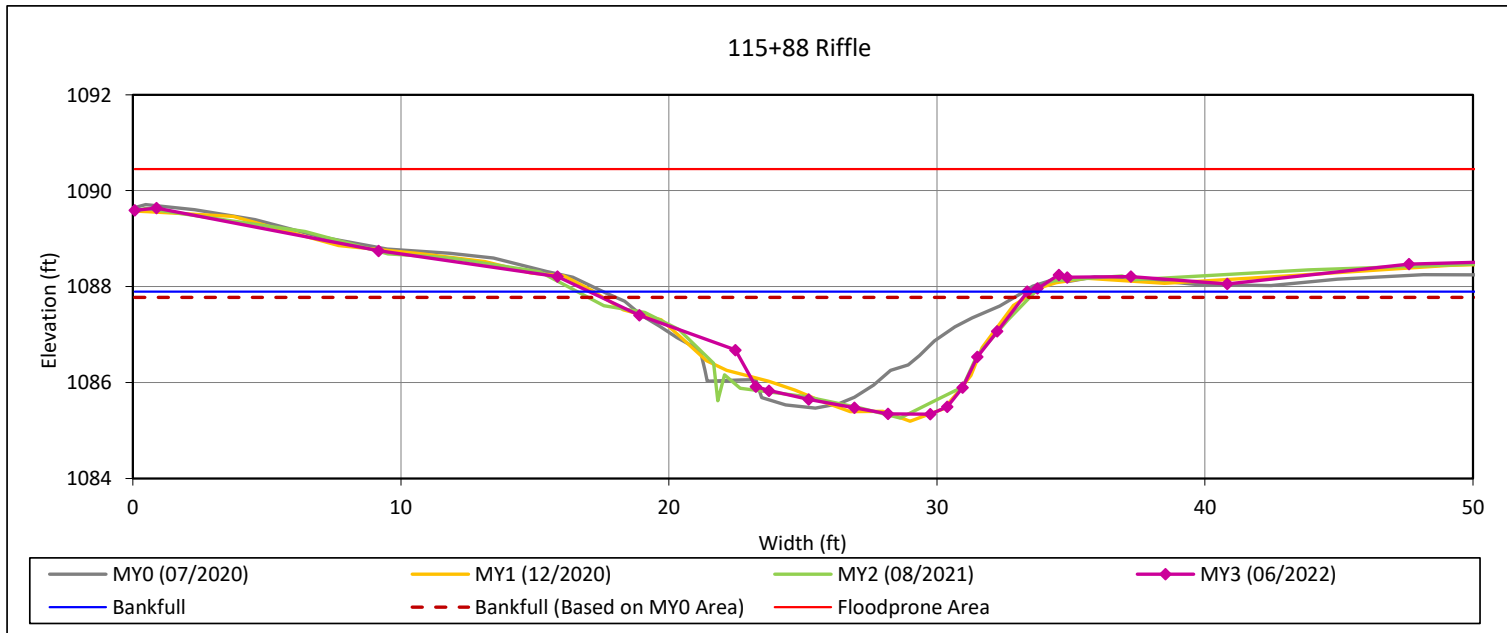
Cross-Section 4-Bull Creek Reach 2

*Repairs were conducted on the right bank of XS4 during MY1 prior to the collection of the MY1 cross-section data and photos. The MY1 plot line shows the repaired cross-sectional profile. Also the station number for XS4 was incorrectly reported on the MY0 cross-section plot, it should have been reported as Station 115+88 as shown in the above plot.

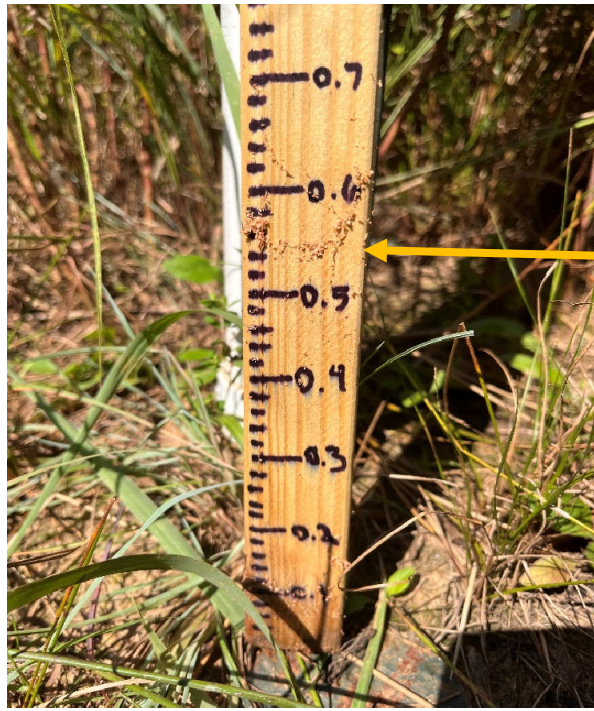
Bull Creek Reach 3: Manual Crest Gage #1 Bankfull Documentation (9/19/2022)

0.545 inches
