# MONITORING YEAR 4 ANNUAL REPORT

## KEY MILL MITIGATION SITE

Surry County, NC  
NCDEQ Contract No. 7180  
DMS Project No. 100025  
USACE Action ID No. SAW-2017-01504  
NCDEQ DWR Certification No. 17-1045  
RFP #: 16-006993 (September 16, 2016)

Data Collection Period: February 2023 – November 2023  
Submission: February 2024

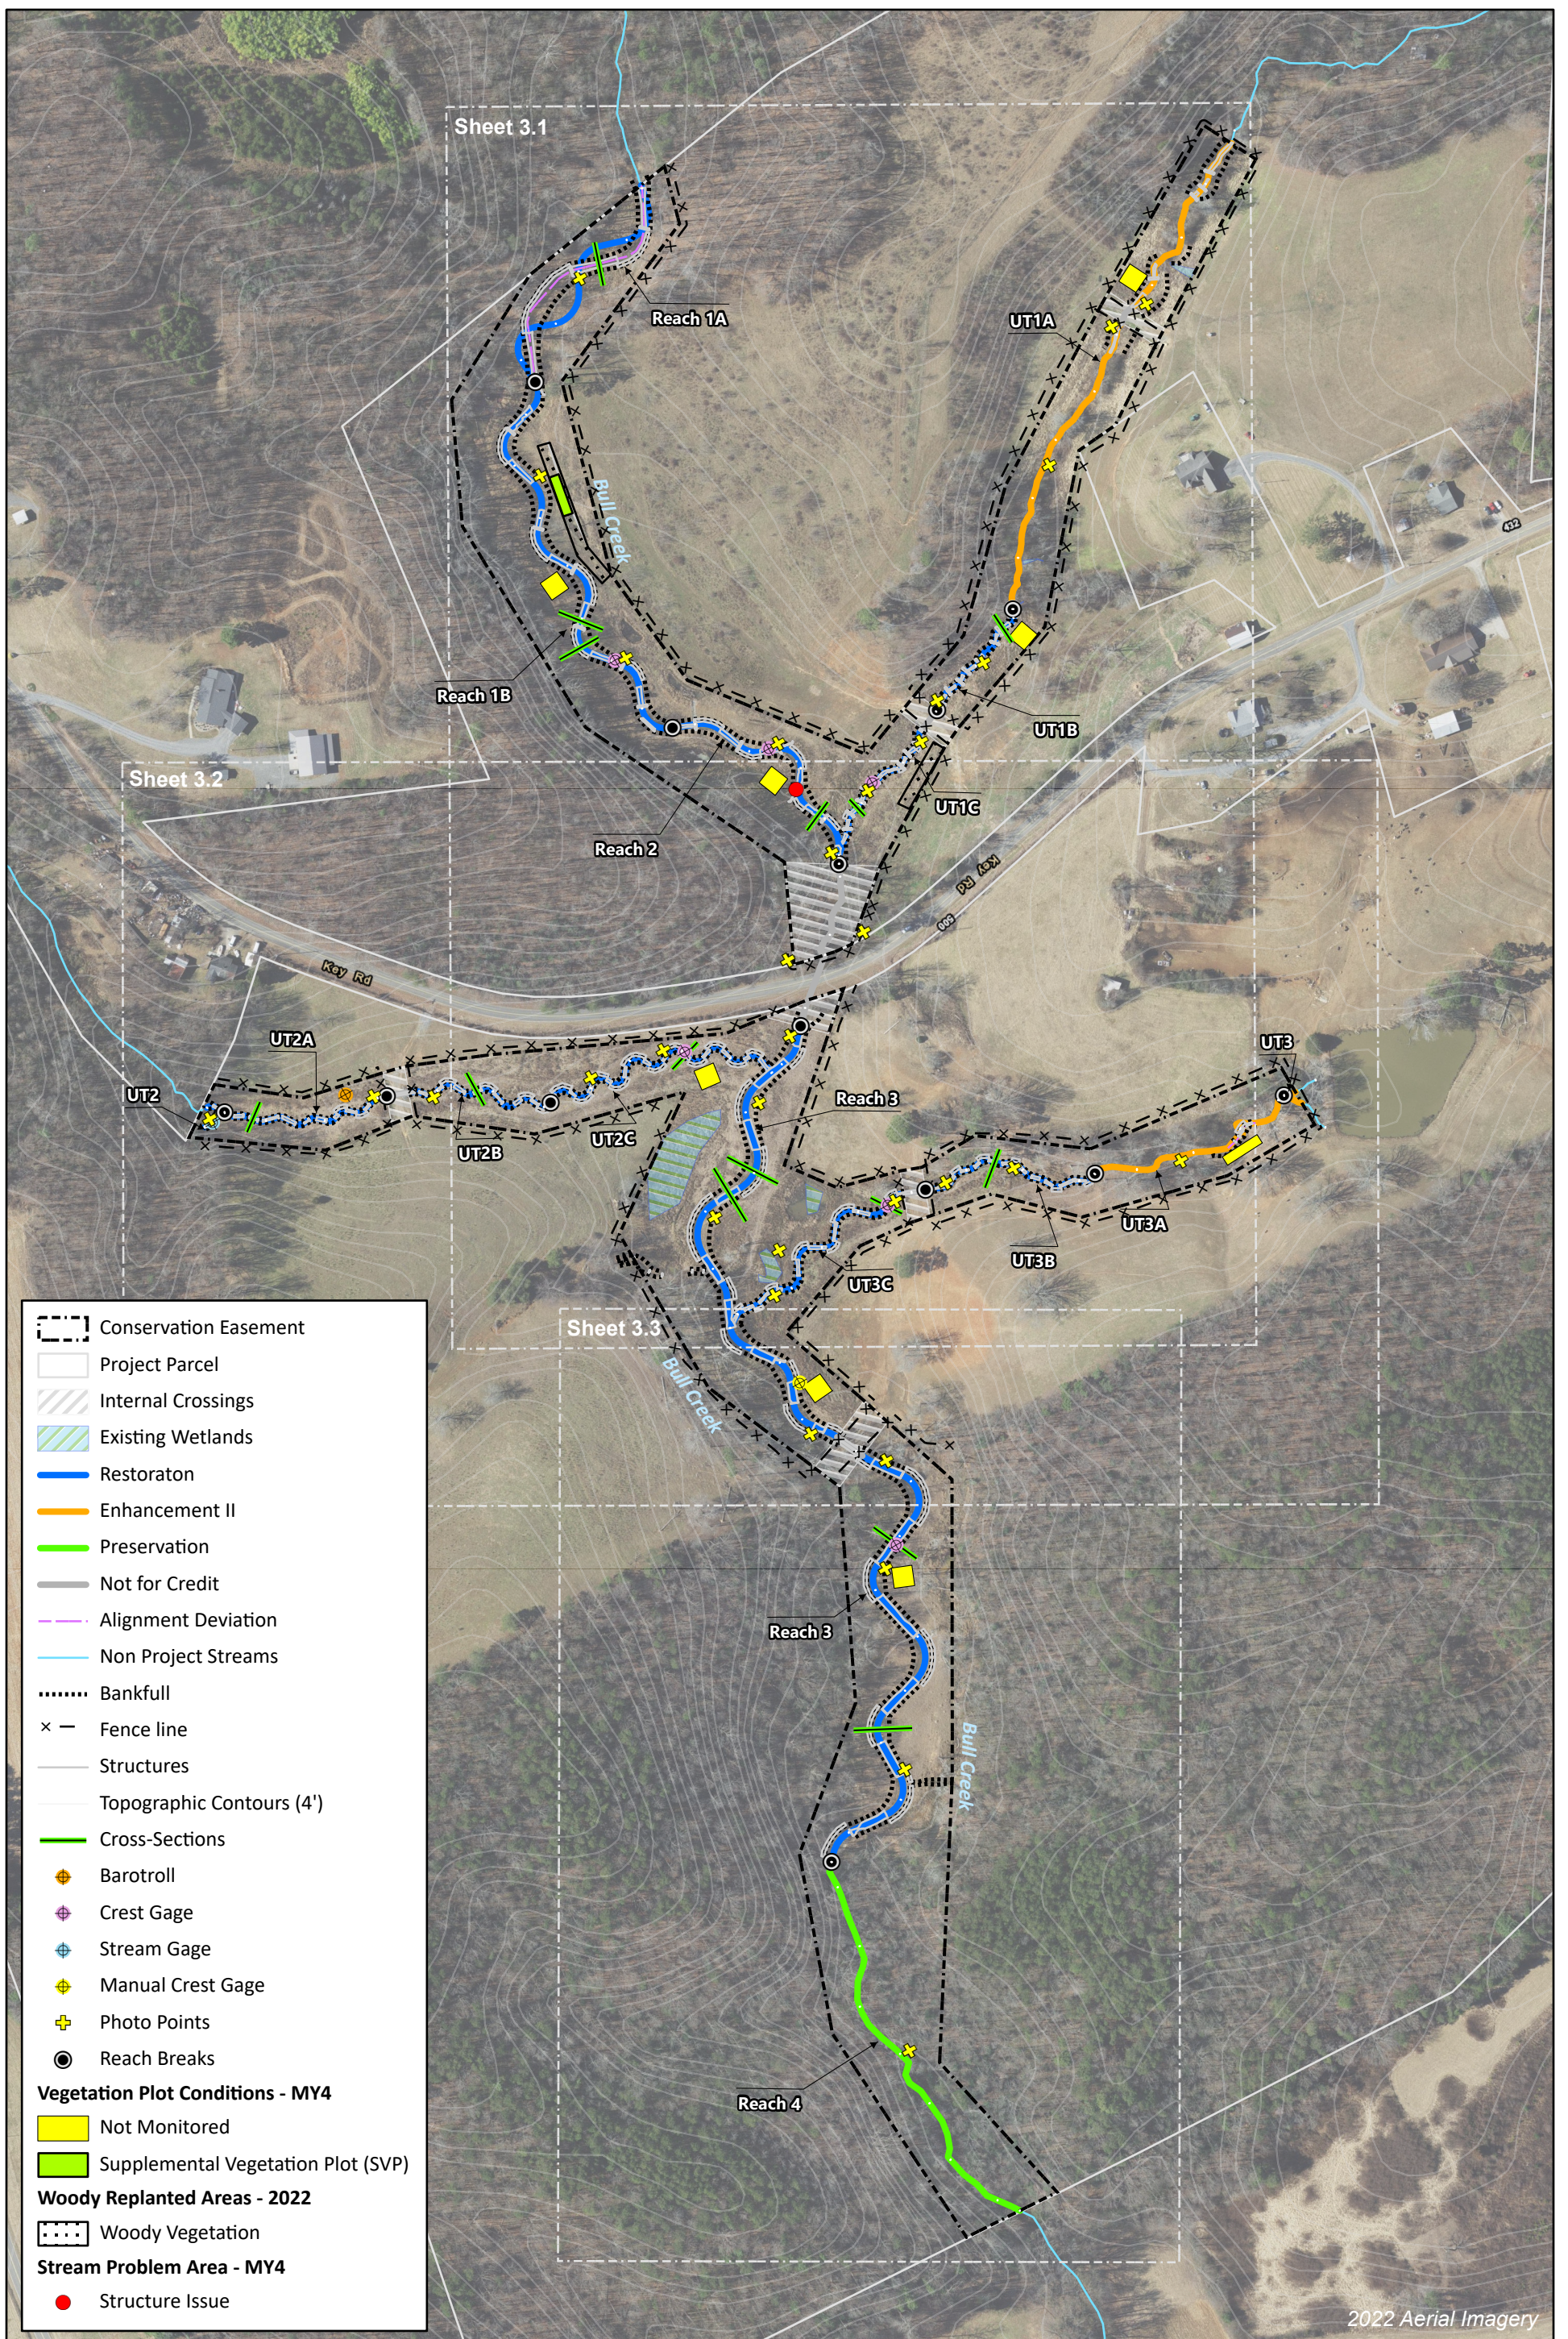
Figure 1. Current Conditions Plan View Map (Key)  
 Key Mill Mitigation Site  
 DMS Project No. 100025  
 Monitoring Year 4 - 2023  
 Surry County, NC

The MY4 visual assessment revealed that the majority of the project reaches, bed and banks are stable with only minor instances of scour and localized structure issues, neither of which compromise the channel or structure integrity. However, on Bull Creek Reach 2, there is active erosion and minor piping occurring behind a j-hook structure at station 115+30 caused by continuous storm events. Wildlands will conduct hand repairs in MY5 by re-grading and re-stabilizing the left bank. Repair activities will also include re-seeding, adding herbaceous plugs and live stake fascines to stabilize the banks and prevent excess sediment from entering the stream. Wildlands will continue to monitor all areas of concern and document repairs and management activities in the MY5 report. Refer to CCPV Figures 1 – 1c and Appendix A for stream stability tables, AOC photographs.

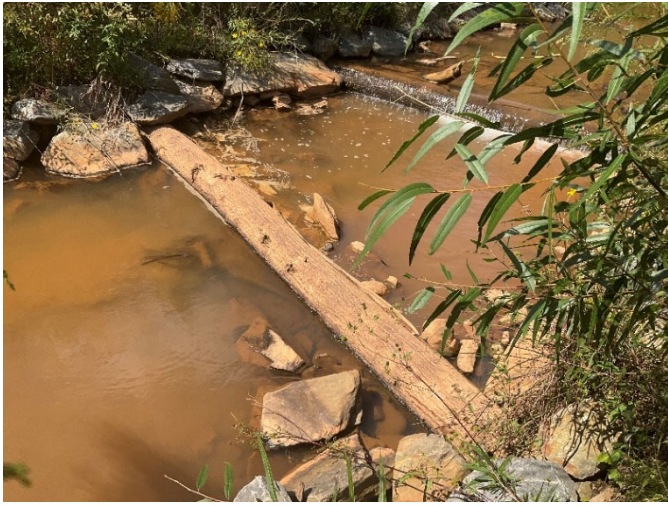
As discussed in the MY3 report, repairs were implemented in April of 2023 on the downstream extent of Bull Creek Reach 3 at station 164+00 to address displaced and piping lunker logs. Wildlands reset one structure by keying it back into the bed and bank and added stabilizing rock material to both banks for bank revetment and structure stability. For the second structure, since the log was not acting as a grade control measure, Wildlands notched a sizable portion in the center of the log to allow water to pass freely over the log to prevent any further piping beneath and erosion around the structure. Additionally, two areas of localized aggradation (Bull Creek Reach 1A and UT3C), have remained consistent in scale over the past few years and no longer pose a threat to channel stability; therefore, they have been removed as an AOC from the CCPV maps and from Table 4. Wildlands will continue to monitor these

Bull Creek Reach 3: Log roller riffle at station 164+00 with piping under one of the structure's logs (09/19/2022)

structures and stream areas to ensure that they are performing as intended. Refer to Appendix A for Repair Photographs and Table 4 Visual Stream Morphology Stability Assessment Table.

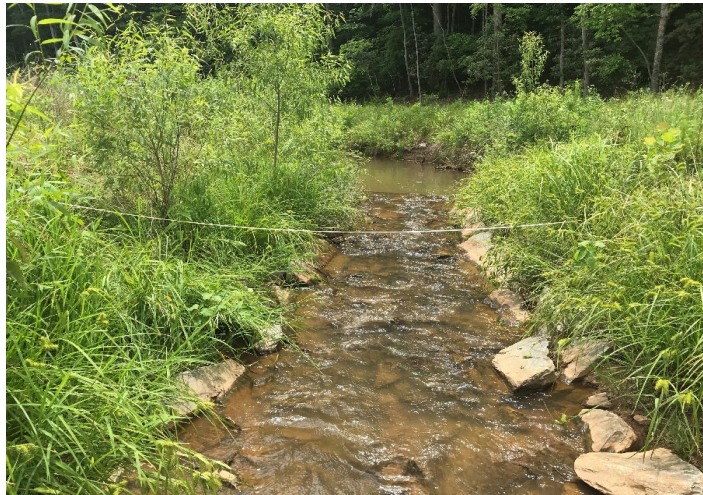
\*Repairs conducted during MY1 resulted in a slight shift in the cross-section alignment between the MY0 and MY1 cross-section pin locations; therefore the plot was adjusted so that the cross-sections lined up for easier comparison.

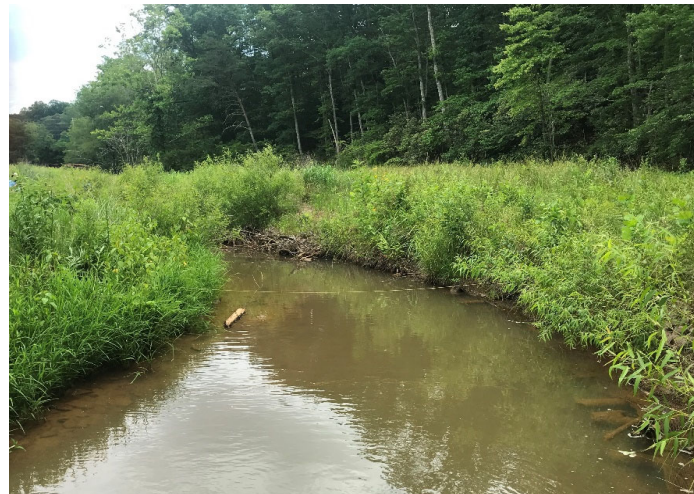
\*Repairs were conducted on the left bank of XS3 during MY1 prior to the collection of the MY1 cross-section data and photos. The MY1 plot line shows the repaired cross-sectional profile. Also the station number for XS3 was incorrectly reported on the MY0 cross-section plot, it should have been reported as Station 110+48 as shown in the above plot.

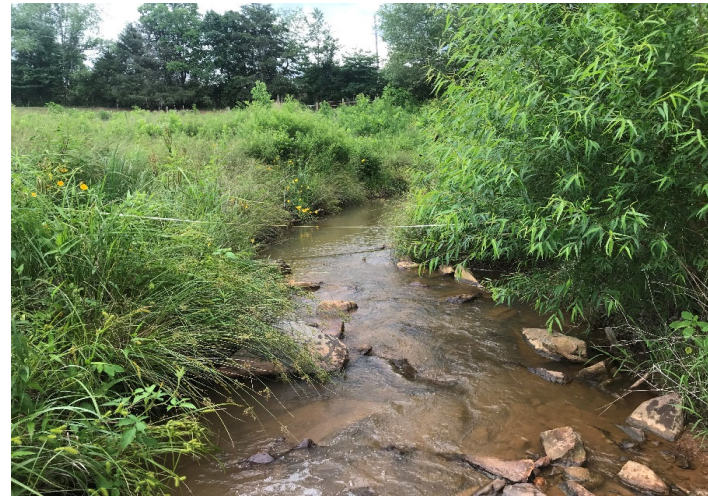
\*Repairs were conducted on the right bank of XS4 during MY1 prior to the collection of the MY1 cross-section data and photos. The MY1 plot line shows the repaired cross-sectional profile. Also the station number for XS4 was incorrectly reported on the MY0 cross-section plot, it should have been reported as Station 115+88 as shown in the above plot.

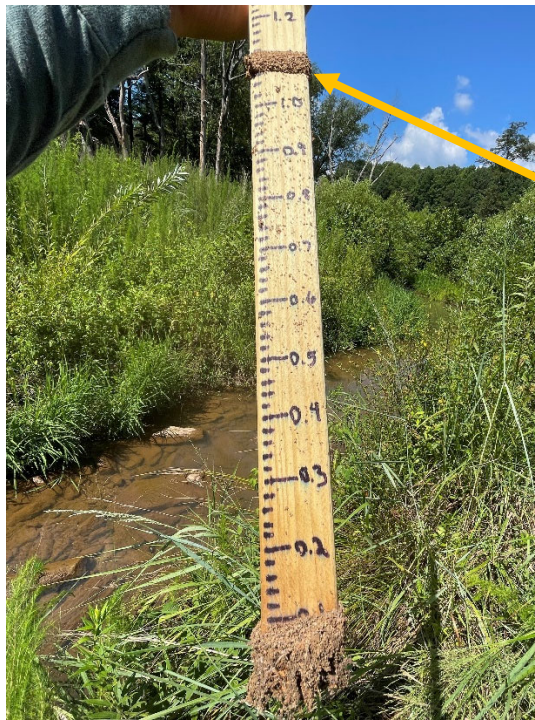
Bull Creek Reach 3: Manual Crest Gage #1 Bankfull Documentation observed on 7/31/2023
