Annual Monitoring Report (MY2)

KINGFIELD BUFFER MITIGATION SITE

Jones County, NC

DMS ID No. 100176

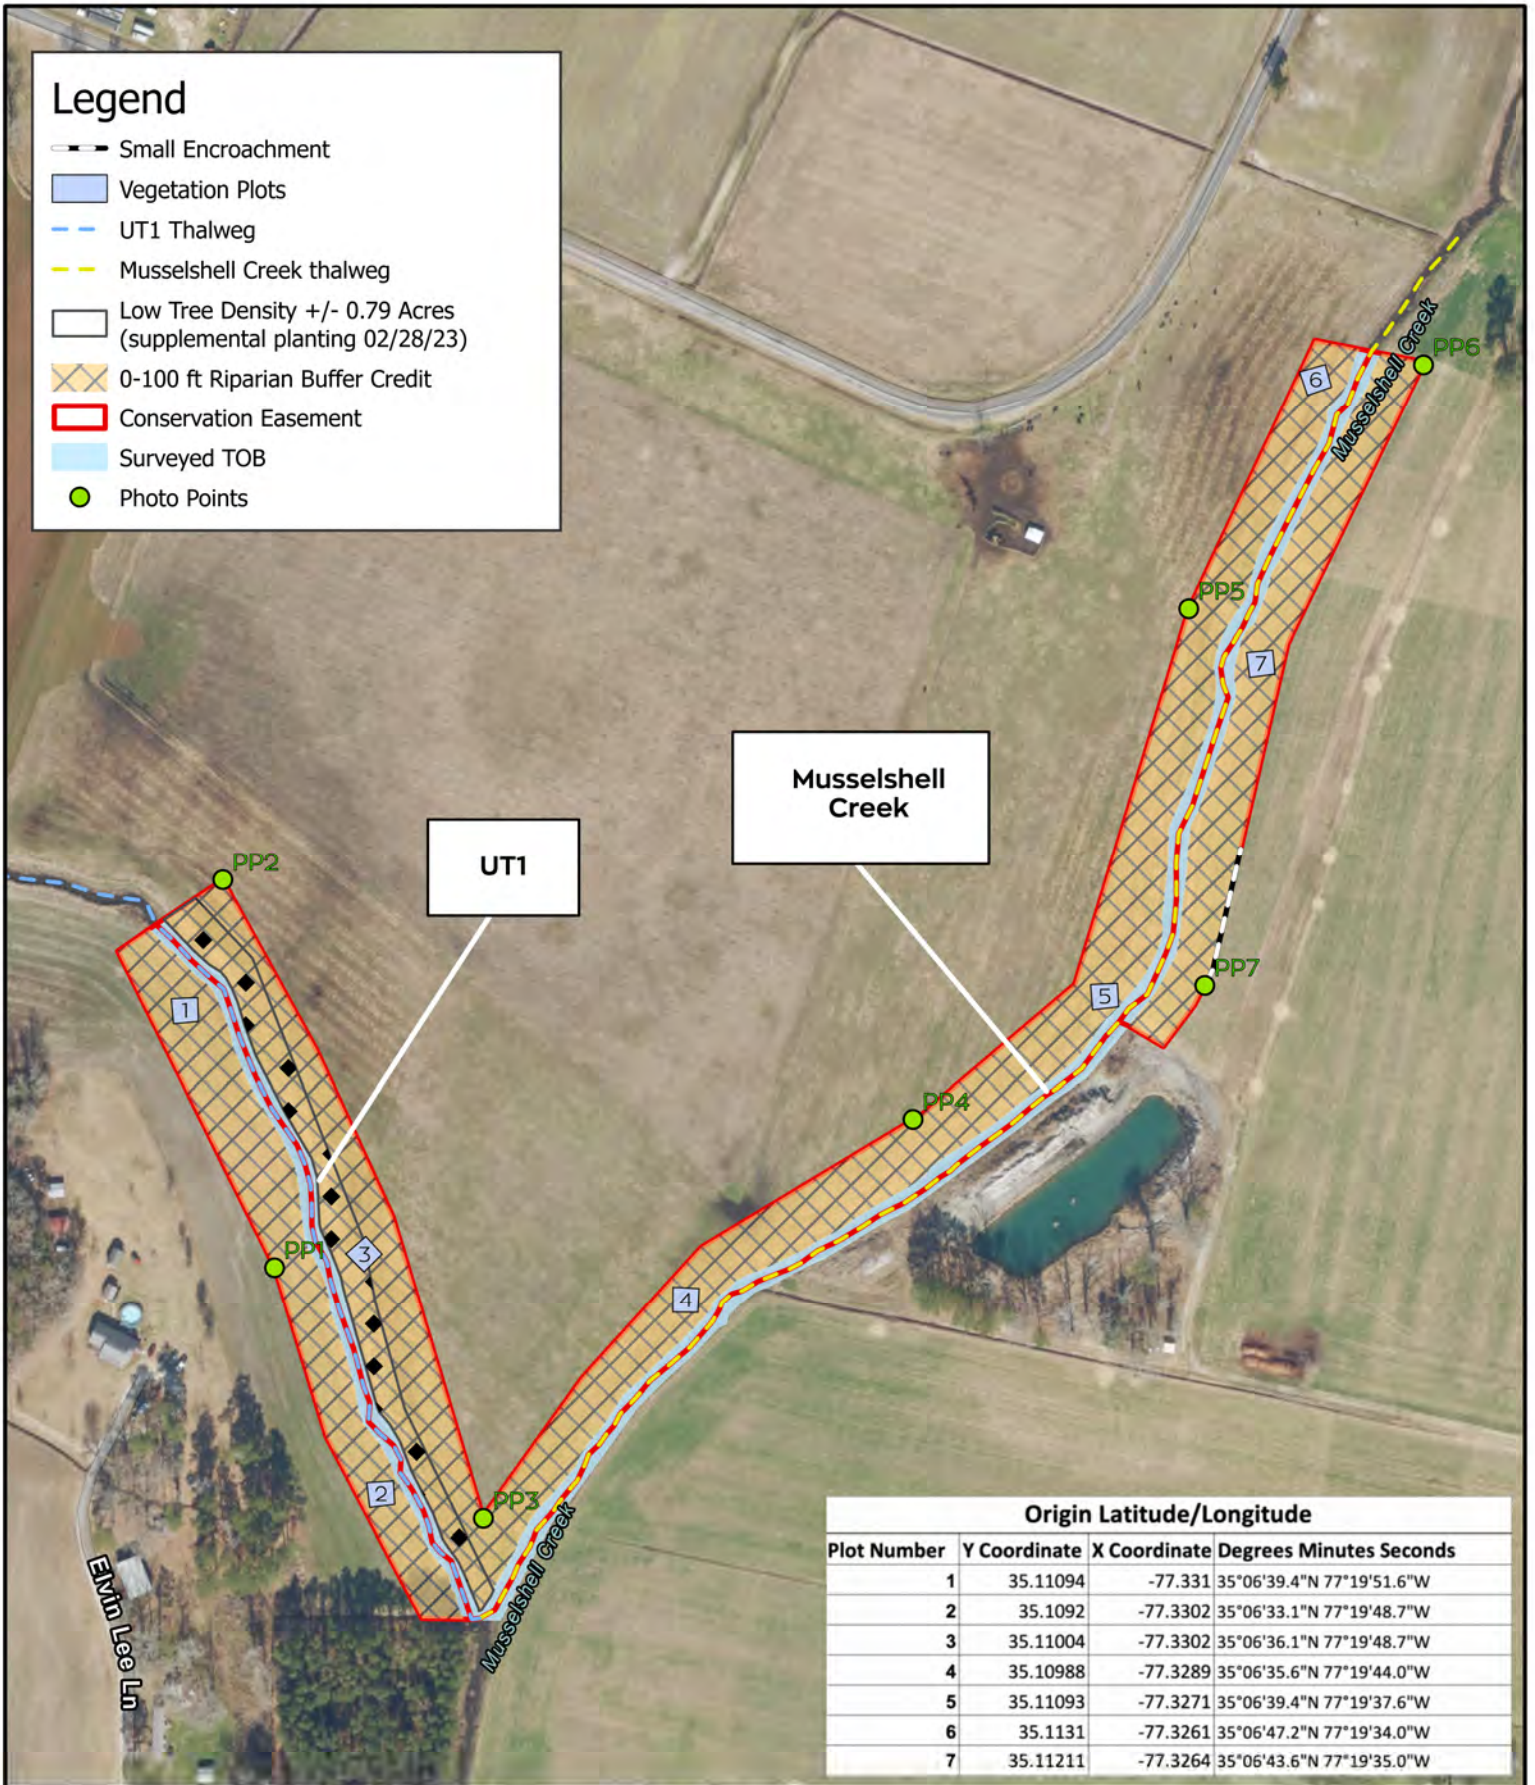
Figure 1: Current Condition Plan View
Kingfield Buffer Mitigation Site
Neuse 03020204
Jones County, North Carolina
December 2023

walk revealed scalloping along the easement boundary. The landowner was warned and horsetape and T-posts were installed to prevent future encroachment. Photos were provided to DMS early February 2023 to complete MY1. A scalloped border was observed at a December 2023 site walk and promptly marked off with horsetape and a T-post. The area of impact is noted on the CCPV and photo documentation provided in Appendix 2.

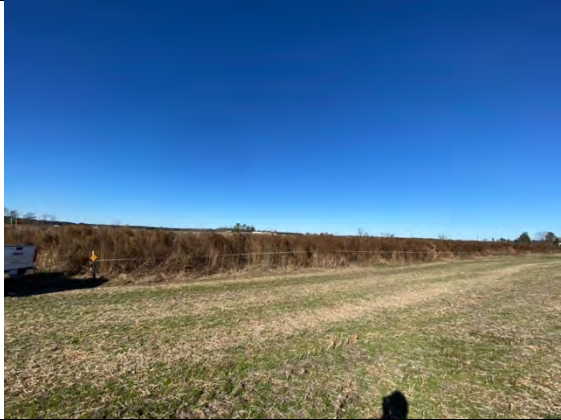
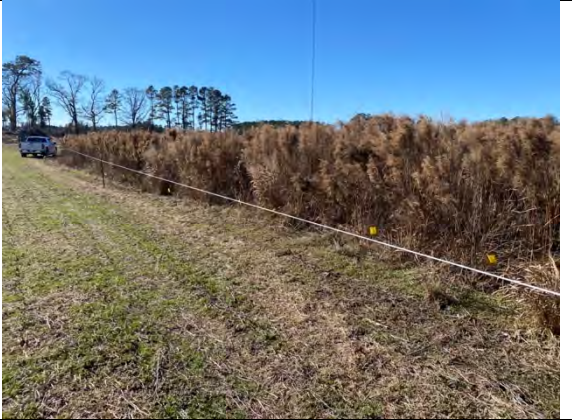
MY2 Updated Marking	MY2 Updated Marking
Photo #1

Date: 12/14/23		
Feature: Near PP7		
Direction: West, South
