**Kings Creek
Stream Restoration
NCEEP Project Number: 208
Monitoring Year 2
2010 Final Report**

**Submitted to
North Carolina Ecosystem Enhancement Program
North Carolina Department of Environment and Natural Resources
March 2011**

Kings Creek Stream Restoration 2010 Monitoring Report (MY 2)

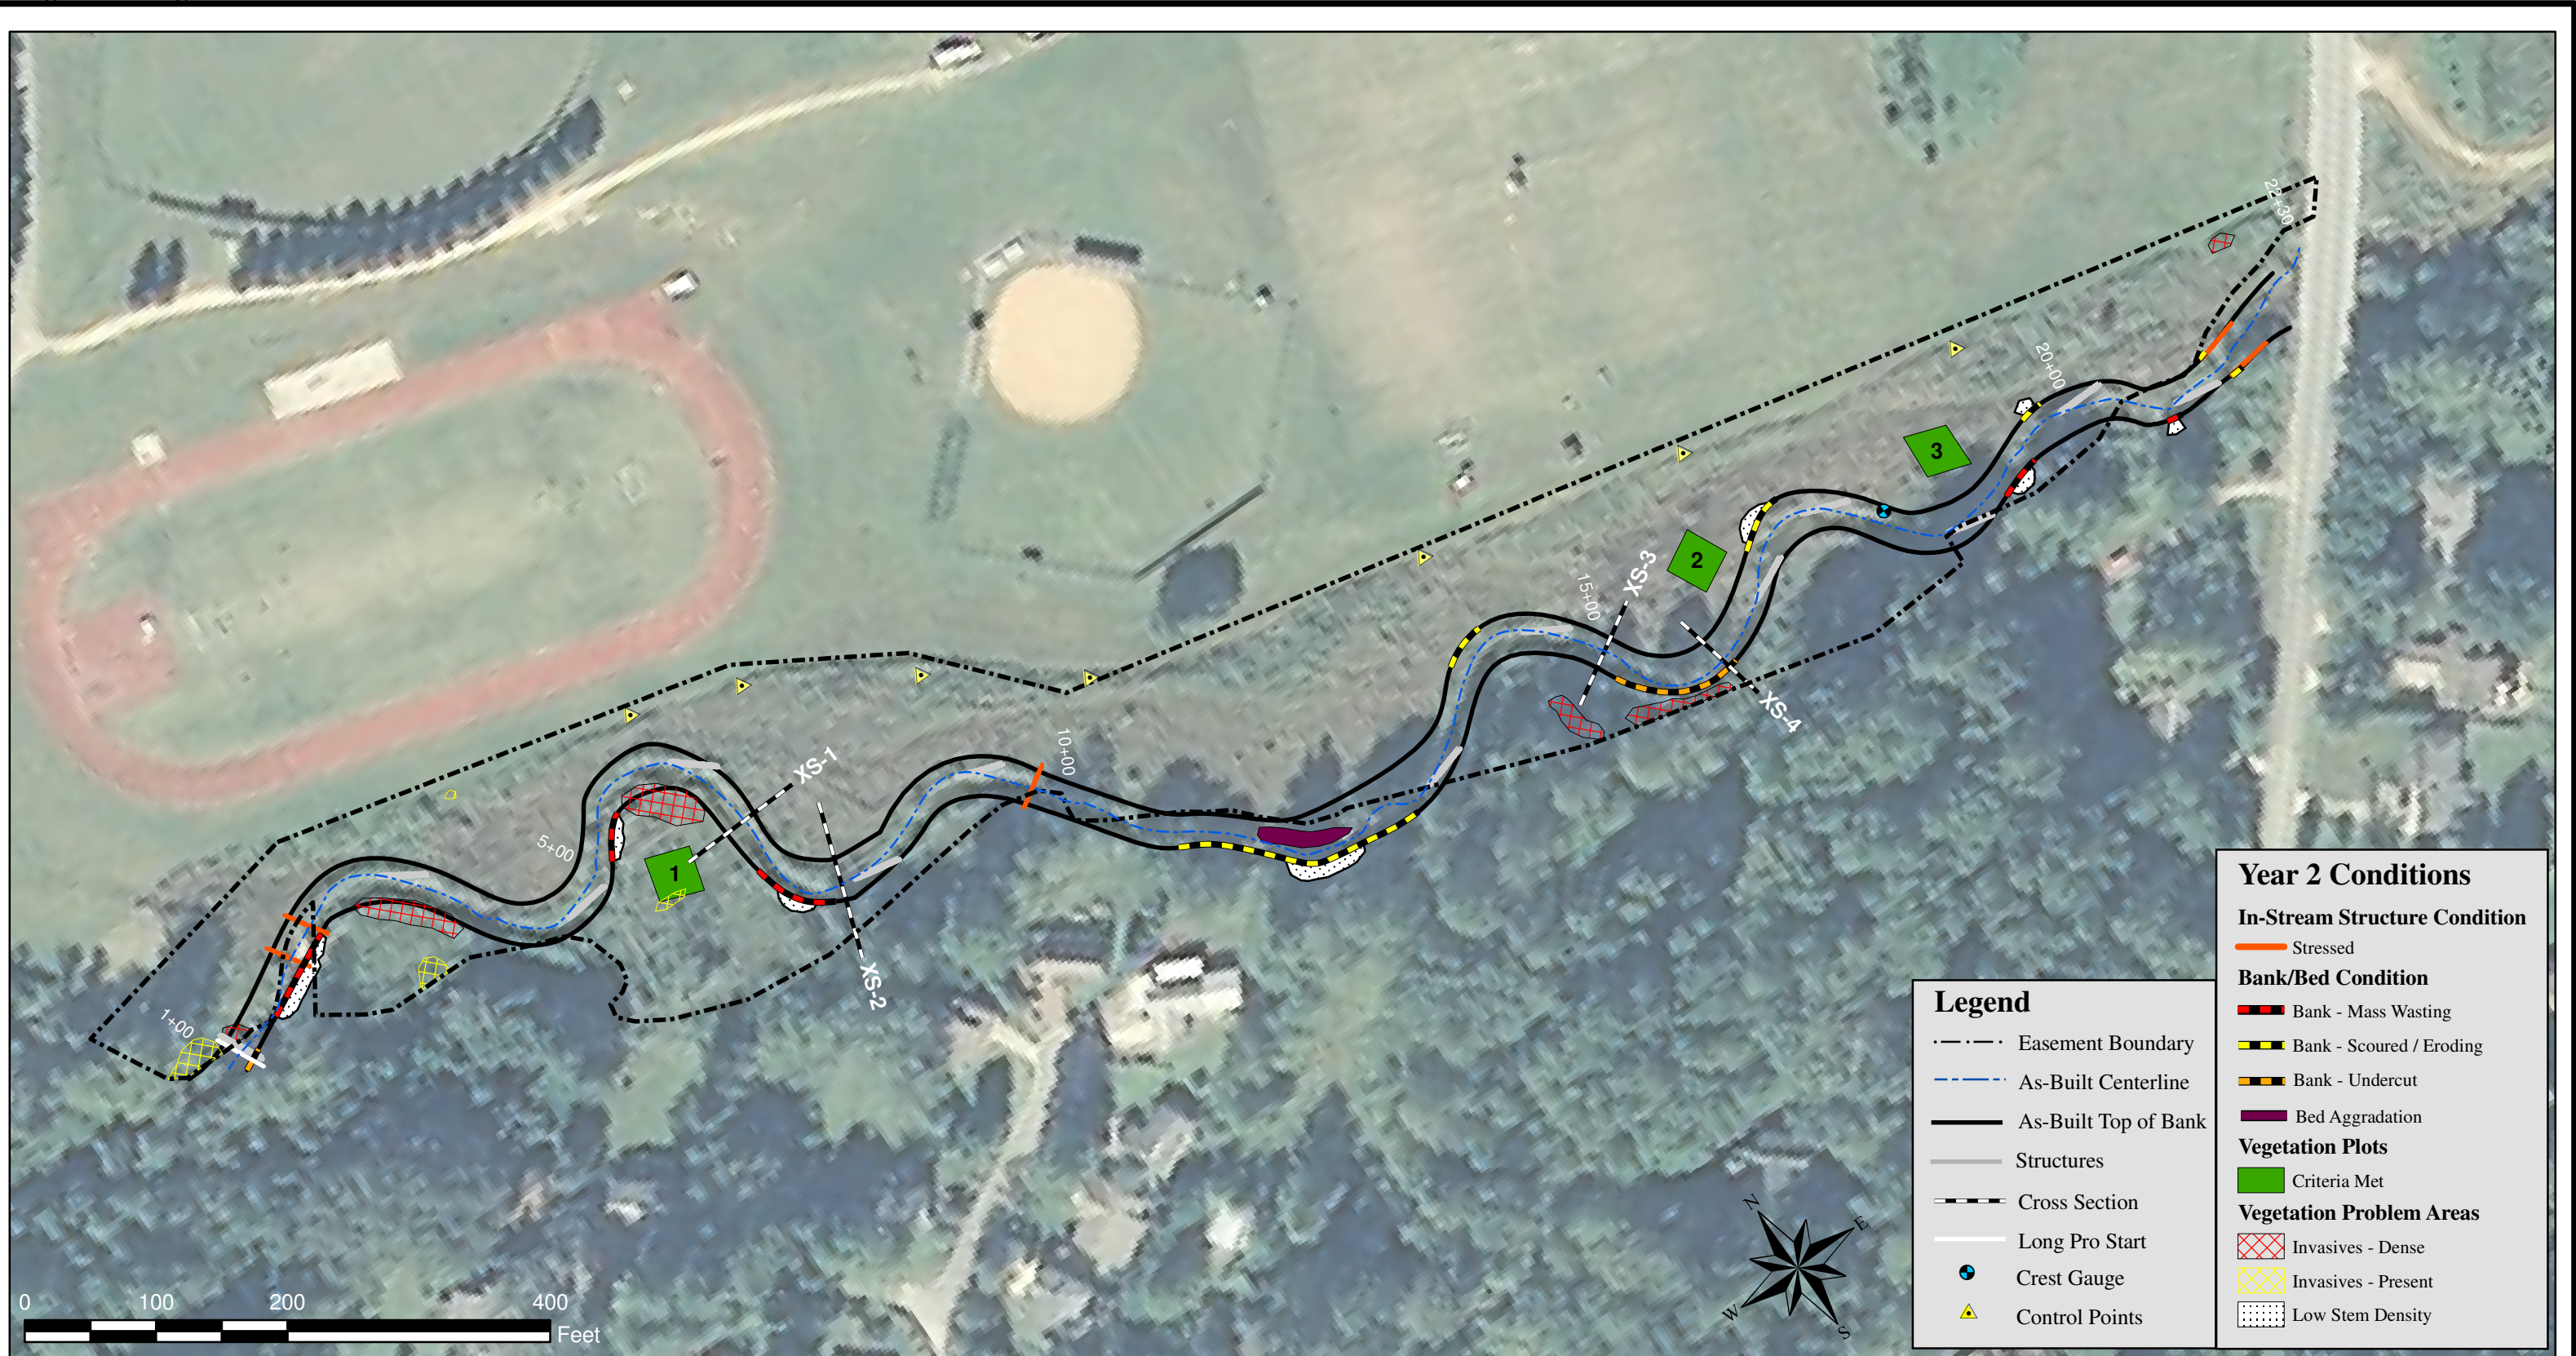
Figure 2. Integrated Current Condition Plan View

Stream longitudinal profiles have remained relatively stable among monitoring years. The primary stream issue observed during MY2 was bank erosion resulting from thalweg migration and low woody stem densities. All other morphological metrics indicated performance percentages averaging between 88 and 100%. Based on the presence of wrack lines and crest gauge monitoring two bankfull events were documented in MY2.
