**Kings Creek
Stream Restoration
NCEEP Project Number: 208
Monitoring Year 3
2011 Final Report**

**Submitted to
North Carolina Ecosystem Enhancement Program
North Carolina Department of Environment and Natural Resources
November 2011**

Kings Creek Stream Restoration 2011 Monitoring Report (MY 3)

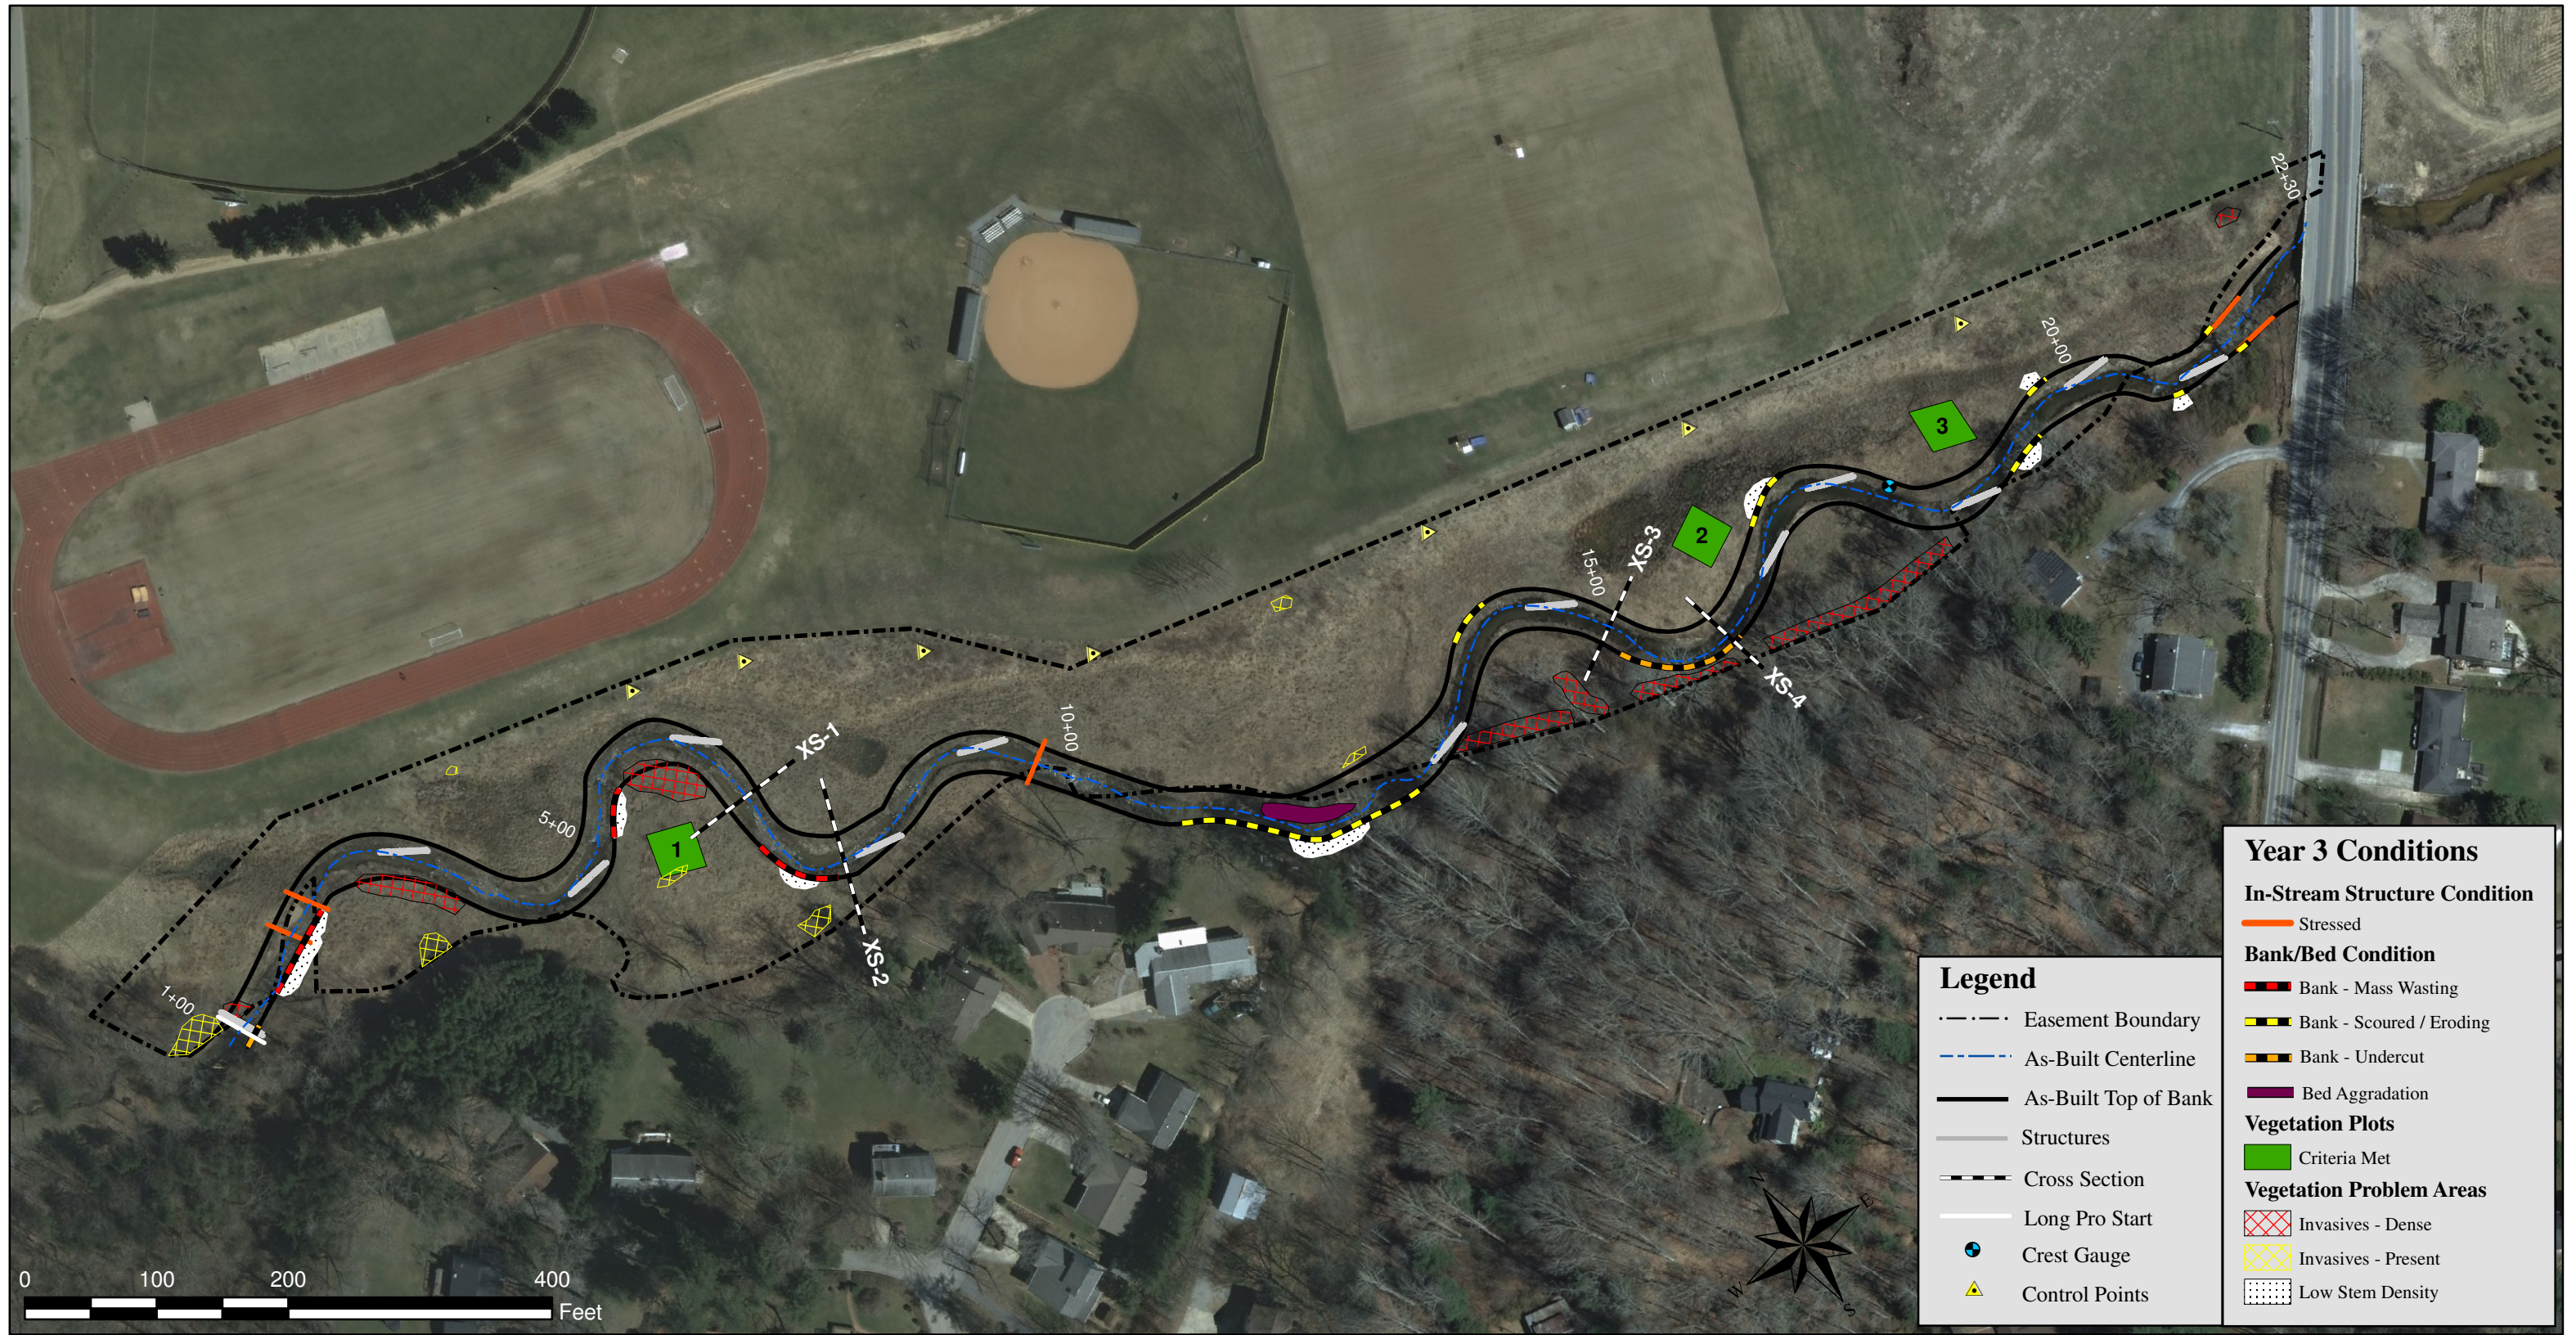
Figure 2. Integrated Current Condition Plan View

Stream longitudinal profiles have remained relatively stable among monitoring years. The primary stream issue observed during MY3 was bank erosion resulting from thalweg migration and low woody stem densities. All other morphological metrics indicated performance percentages averaging between 88 and 100%. Based on the presence of wrack lines and crest gauge monitoring two bankfull events were documented in MY3.
