**Kings Creek  
Stream Restoration  
NCEEP Project Number: 208  
Contract Number: D09082S  
Monitoring Year 5  
2013 Final Report**

**Submitted to  
North Carolina Ecosystem Enhancement Program  
North Carolina Department of Environment and Natural Resources  
November 2013**

# **Kings Creek Stream Restoration 2013 Monitoring Report (MY 5)**

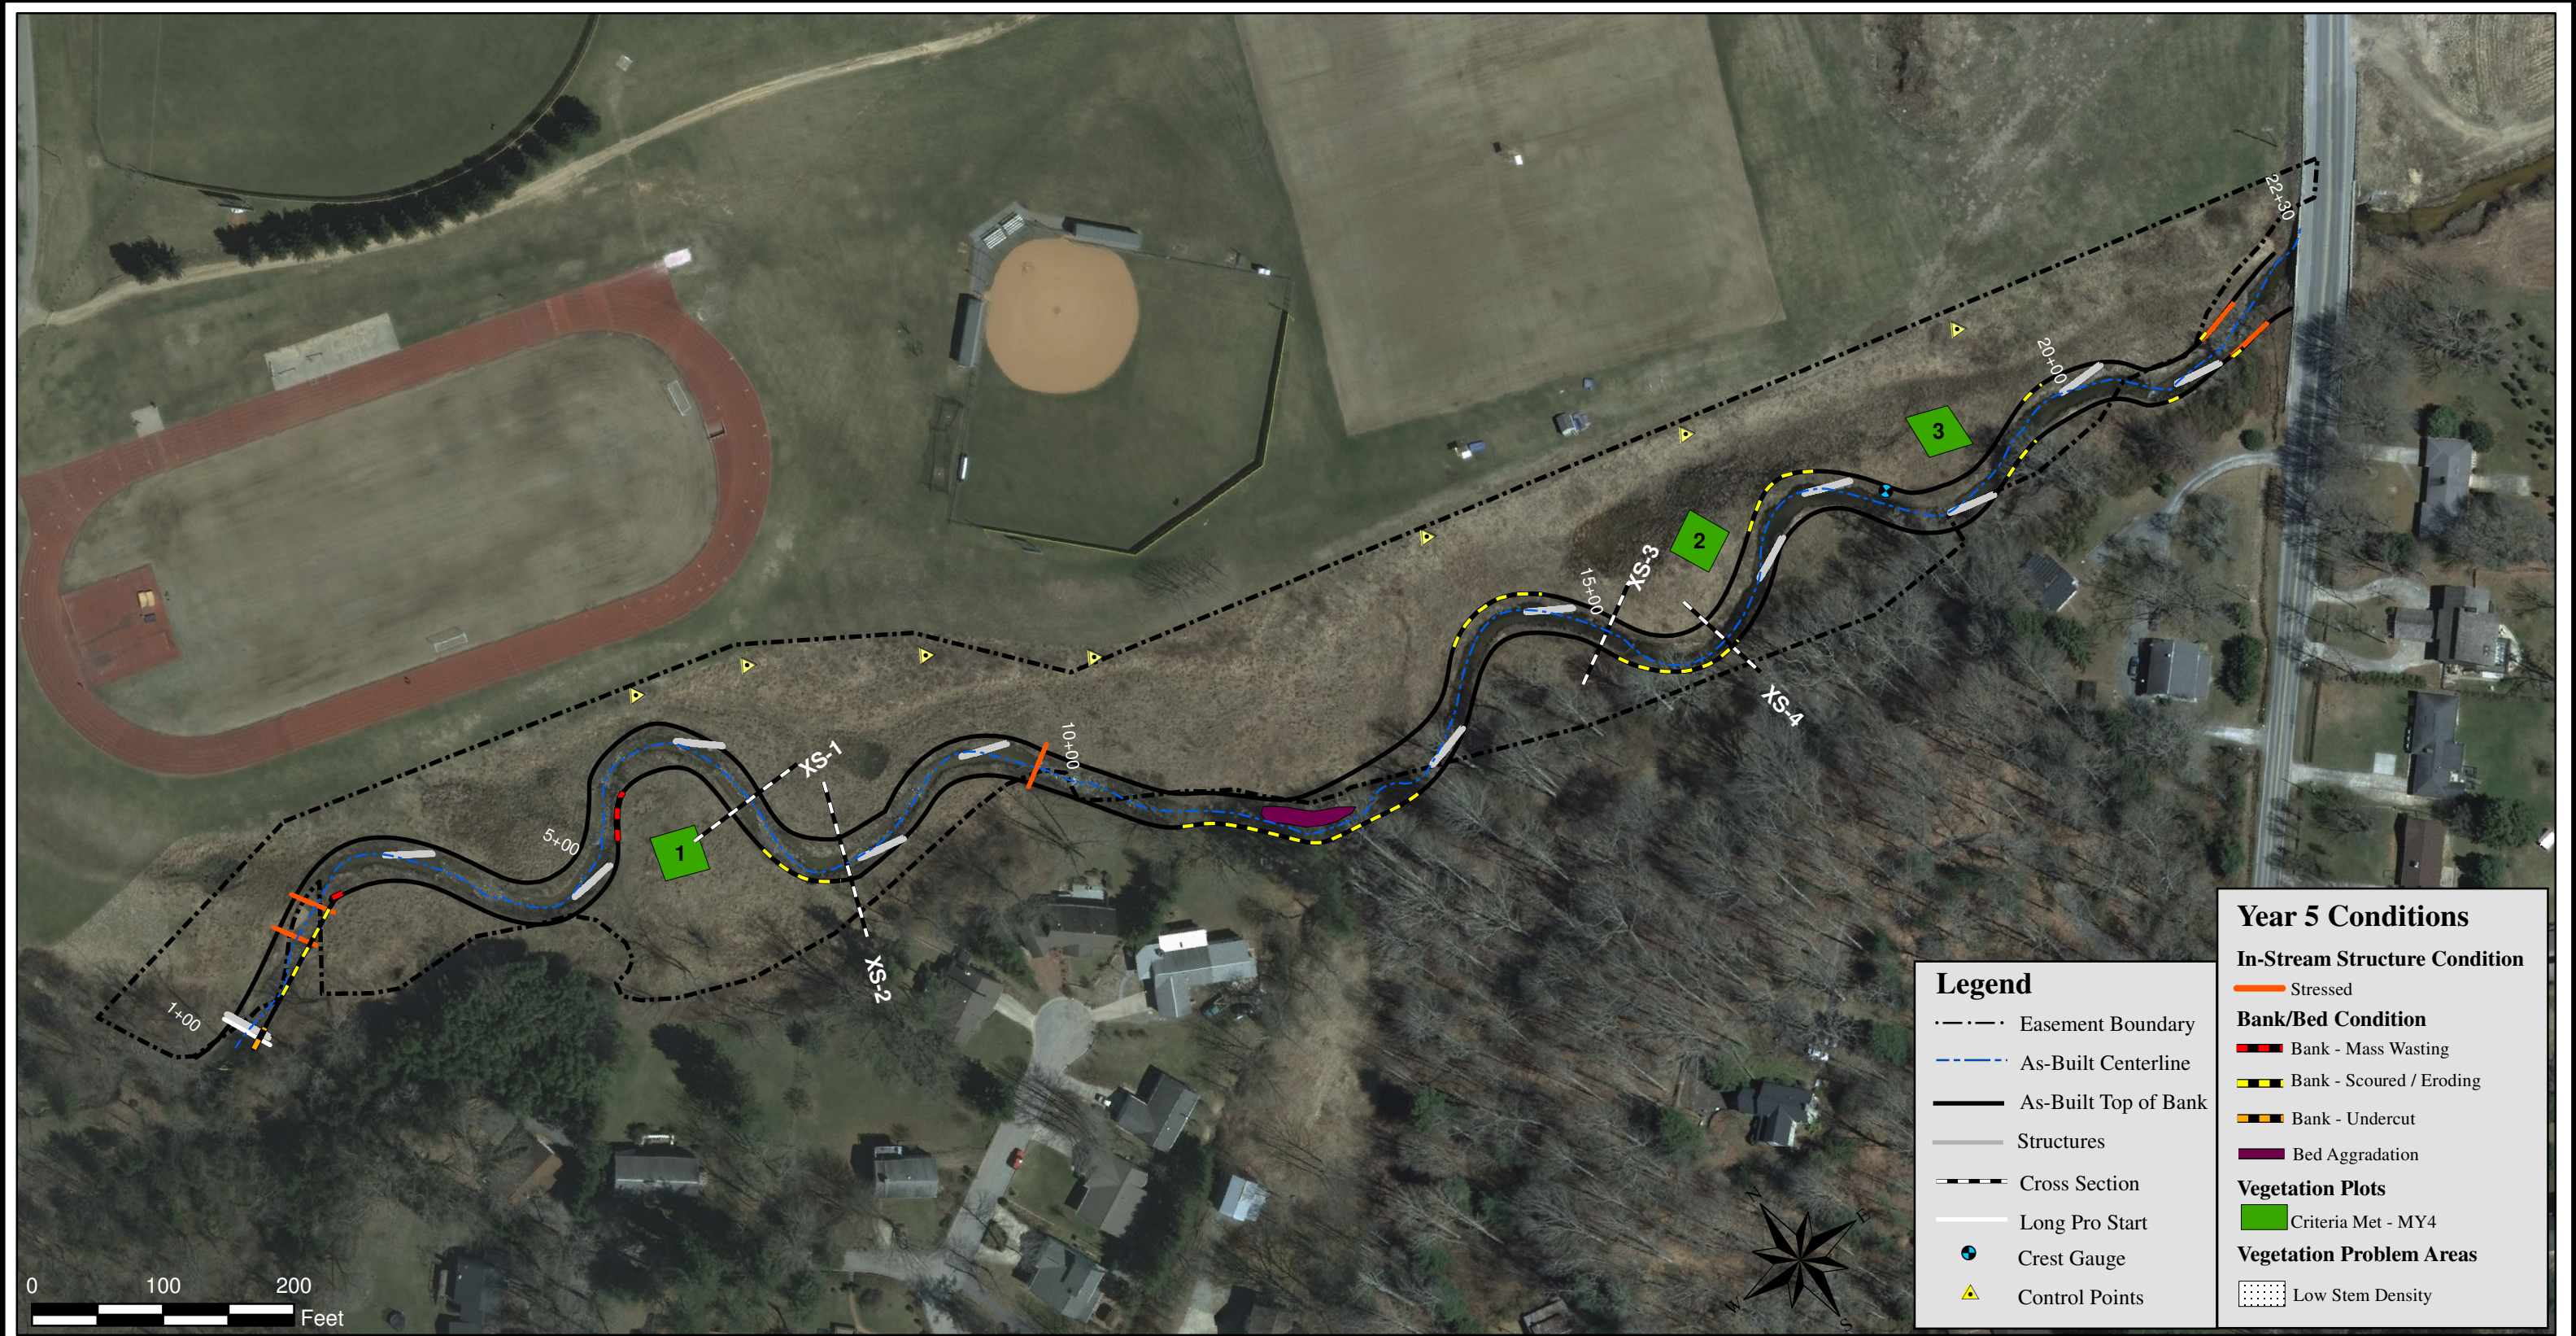
Figure 2. Integrated Current Condition Plan View Draft

Stream longitudinal profiles have remained relatively stable among monitoring years. The primary stream issue observed during MY5 was bank erosion resulting from thalweg migration and low woody stem densities. In particular, thalweg migration has continued at station 2+00 (83 feet) and 5+25 (38 feet) causing further bank erosion. These two areas of concern have continued to actively erode between monitoring years. Including these two areas, 16% of the project area is currently actively eroding. All other morphological metrics indicated performance percentages averaging between 88 and 100%. Two bankfull events, one event on January 31<sup>st</sup> and one event on July 3<sup>rd</sup>, were documented during MY5. The former was documented using wrack lines as well as the crest gauge. High rainfall in the area and anecdotal evidence of overbank flows confirmed the second bankfull event.
