Monitoring Report – MY6
FINAL VERSION
Lake Wendell Mitigation Project
Calendar Year of Data Collection: 2023

NCDEQ DMS Project Identification # 97081
NCDEQ DMS Contract # 6826
Neuse River Basin (Cataloging Unit 03020201)
USACE Action ID Number: SAW-2016-00876
NCDEQ DWR Project # 2016-0385 V2
Johnston County, NC
Contracted Under RFP # 16-006477
Data Collection Period: March & October 2023
Submission Date: December 29, 2023

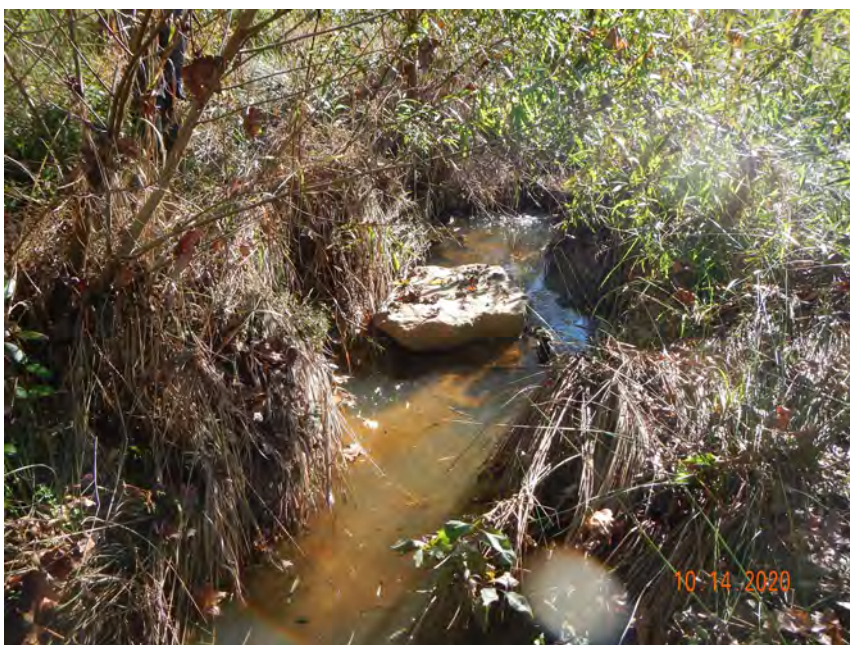
Minor piping was noted in MY3 at two in-stream structures near approximate stations 26+00 (SPA1) and 26+50 (SPA2). An additional log structure was found to have minor piping near station 24+00 (SPA4). Hand repair work was conducted during MY5 at SPA2 and SPA4. Crushed stone was added behind the log structures to prevent water from piping underneath. Livestakes were also added near the structures to prevent bank erosion. The hand work did not remediate the issues as piping has continued in MY6. While these three structures are not functioning as designed, there is not a systemic problem upstream or downstream. Monitoring of these areas will continue in MY7.

SPA1, October 14, 2020 (MY-03)

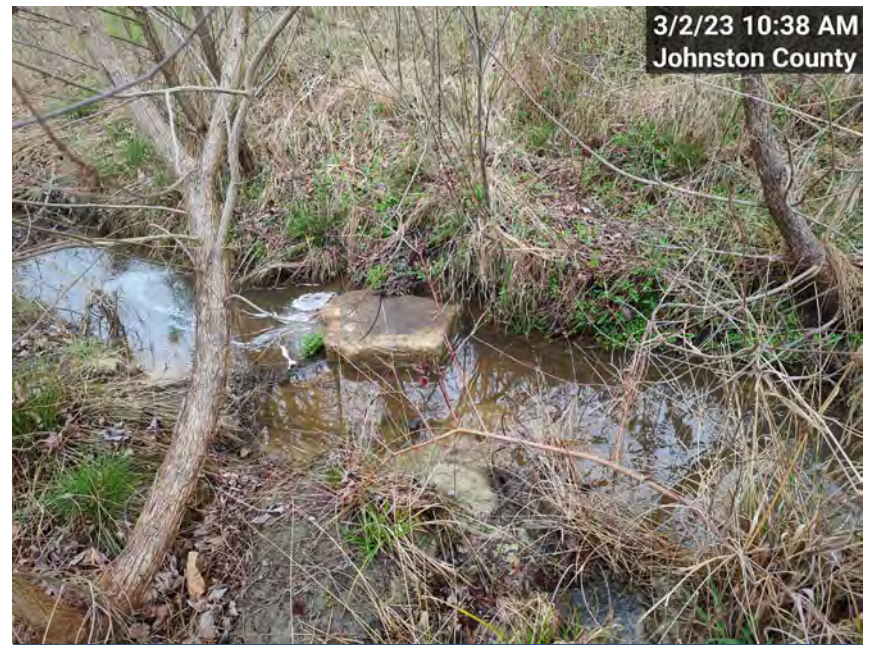
SPA1, March 2, 2023 (MY-06)

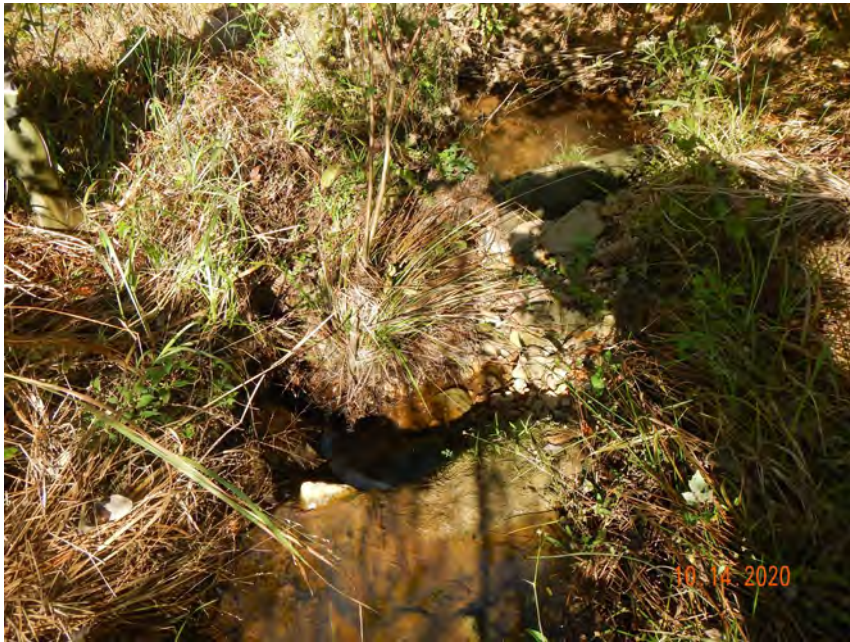
SPA2, October 14, 2020 (MY-03)

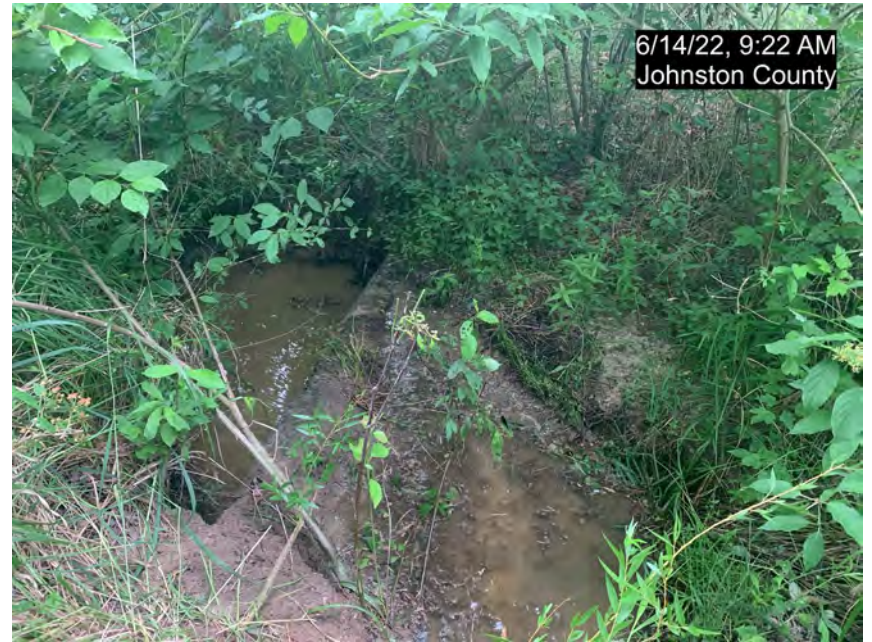
SPA2 (after repair), June 14, 2022 (MY-05)

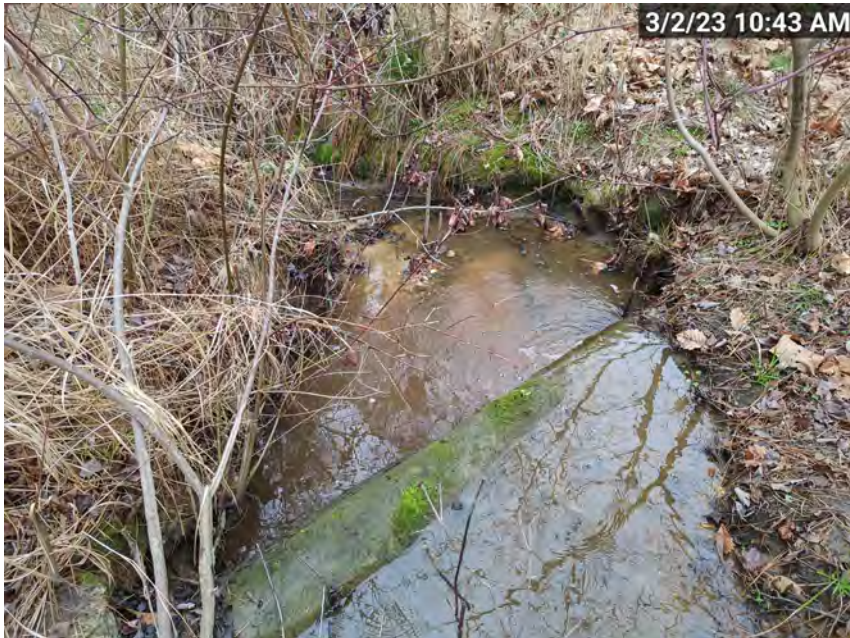
SPA2, March 2, 2023 (MY-06)

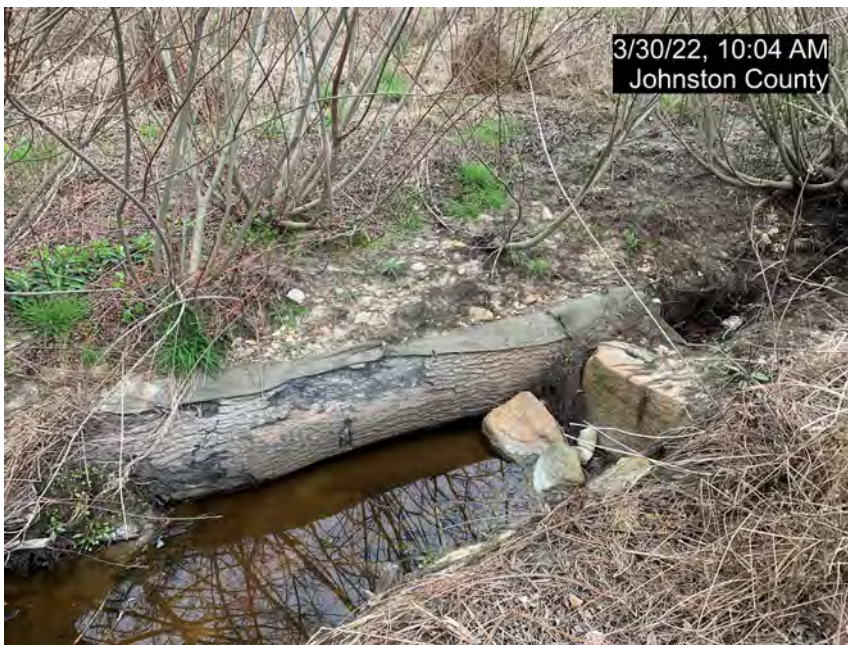
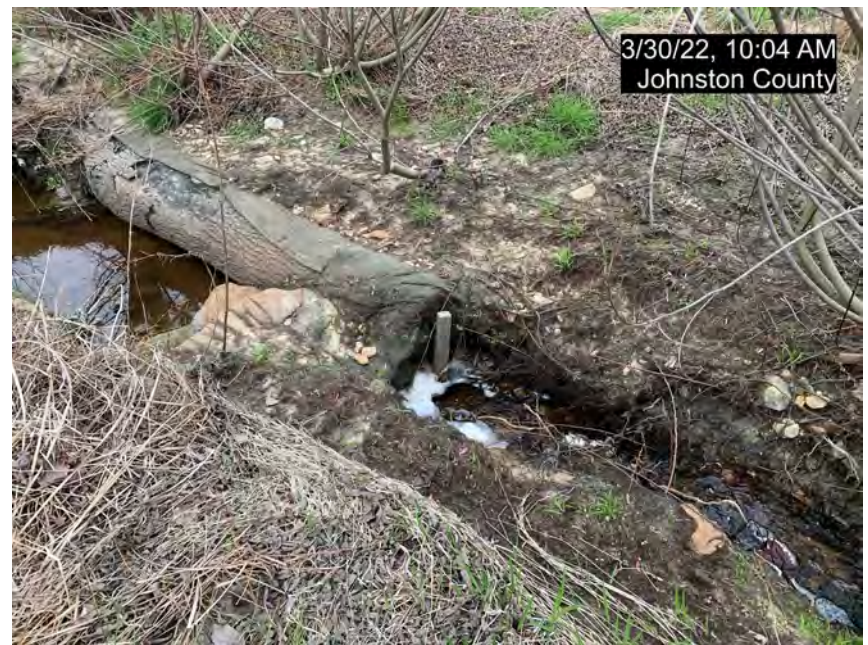
SPA4, March 30, 2022 (MY-05)

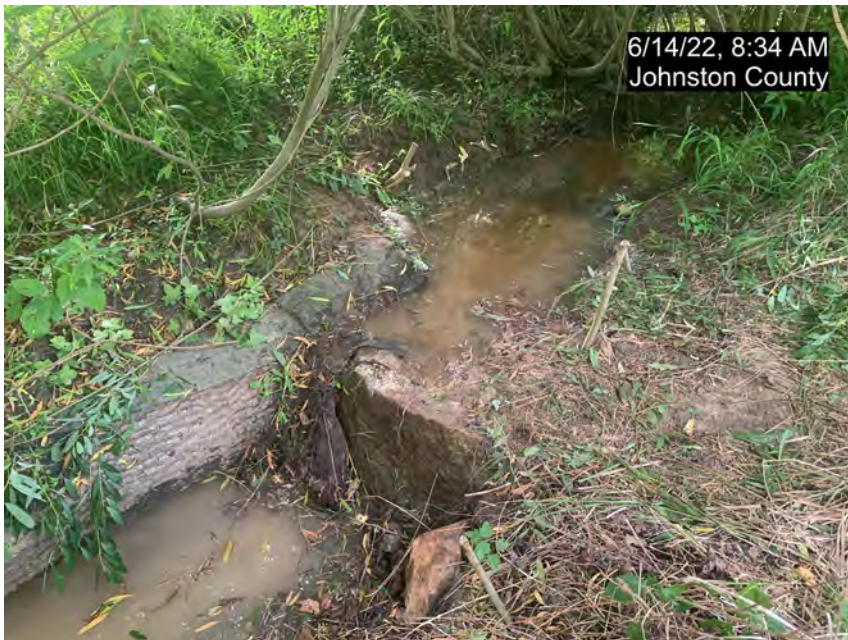
SPA4 (after repair), June 14, 2022 (MY-05)

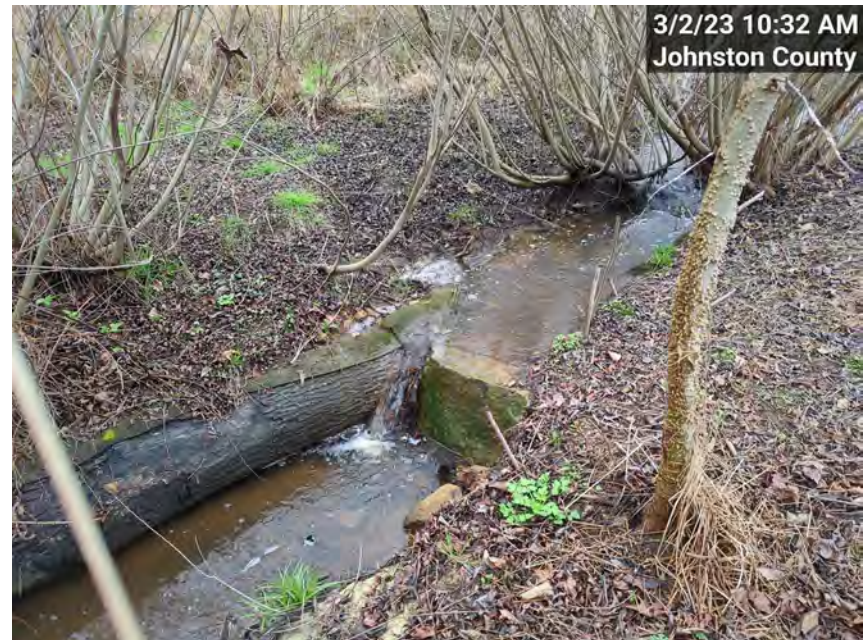
SPA4, March 2, 2023 (MY-06)

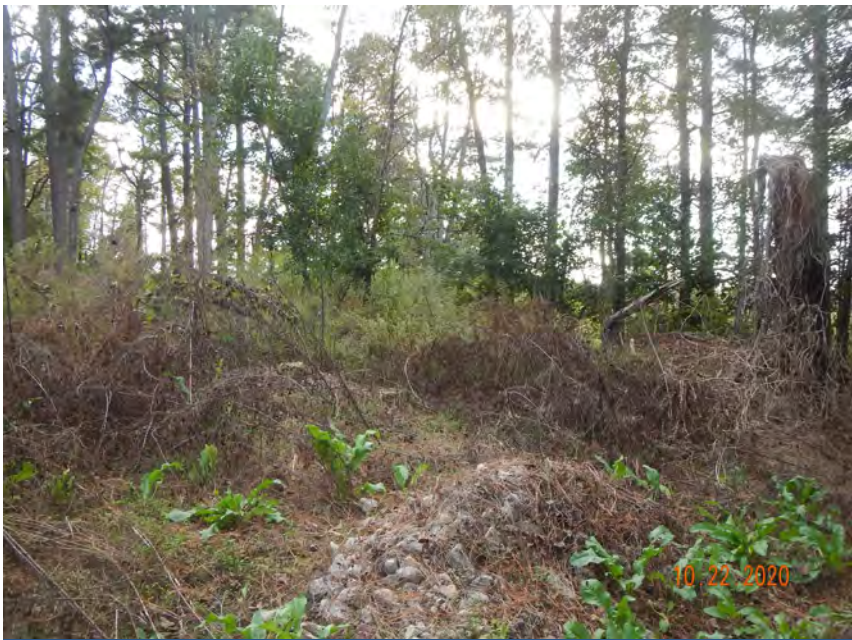
A previous area of concern (VPA1) located along R1 buffer as shown on the CCPV (noted first in MY1) was utilized as a temporary staging area during construction and contains invasive vegetation (kudzu) along the right buffer. The area was treated twice during the 2023 year in June and August (see table below for treatments). Following these treatments, the percent cover of kudzu was reduced to approximately one percent. The entirety of VPA1 was planted with trees from the approved list in the mitigation plan on February 1st, 2021 (see table below for plant list). Due to a low stem count observed during the Buffer Close Out meeting on July 19, 2023, there was a request for a random transect in VPA1 during MY6 (see Appendix E for Buffer Close out correspondence). A random vegetation plot in VPA1 was surveyed on October 10th, 2023 (see table below for results). The transect did not meet stem requirements and will require a supplemental planting of 20 containerized trees in the dormant season prior to MY7. All proposed planted trees will be species included in the approved mitigation plan or approved by the IRT prior to planting. This area will continue to be treated for Kudzu during MY7 and documented in future reports.

Kudzu Problem Area (VPA1), October 22, 2020 (MY-03)

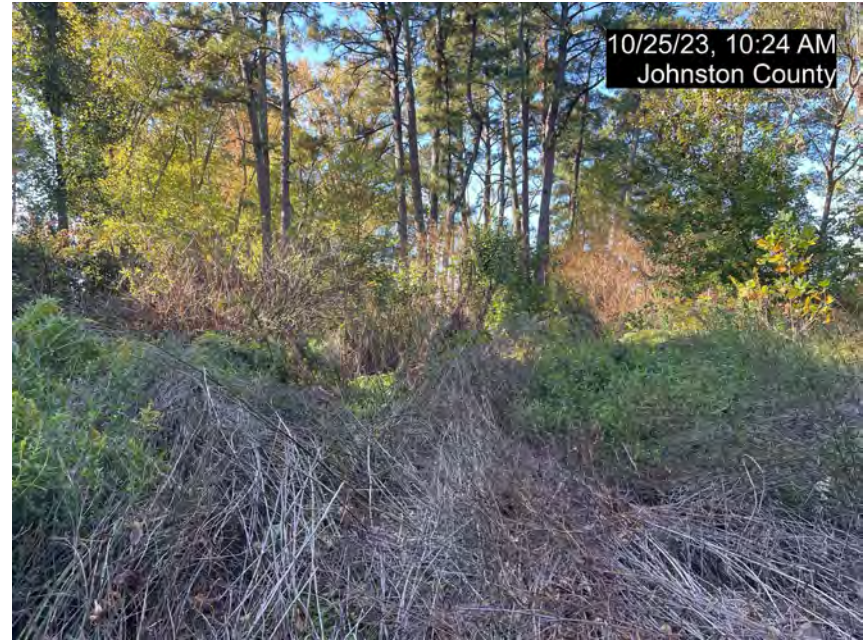
Kudzu Problem Area (VPA1), October 25, 2023 (MY-06)

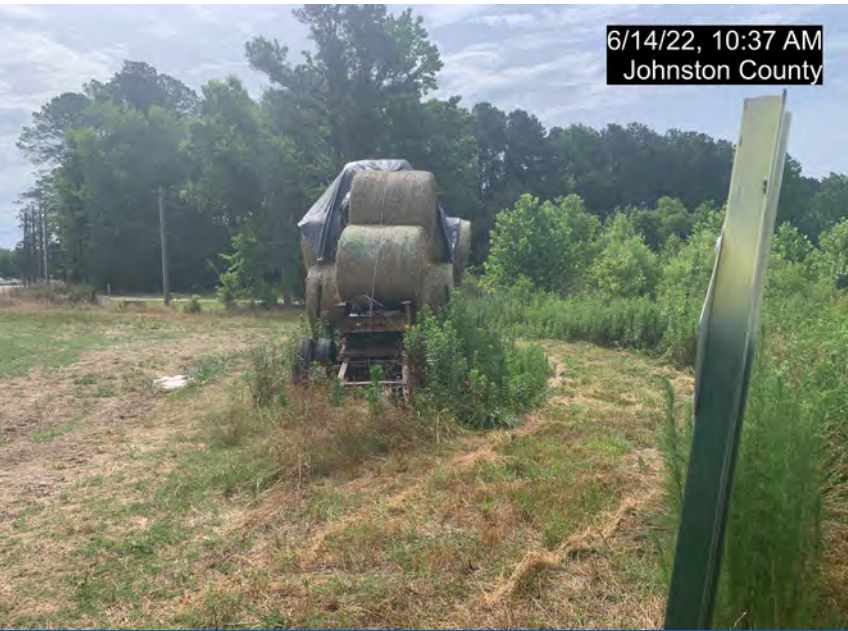
- 2. Pg. 9, Section 5.4: Was any further encroachment of VPA3 noted during MY6? Did you get any response from the landowner after contact regarding VPA3?** WLS Response: No further encroachment of VPA3 was noted in MY6. The WLS project manager spoke to the landowner via phone after the attorney letter was received, and the letter was acknowledged.

Encroachment Area (VPA3), June 14, 2022 (MY-05)

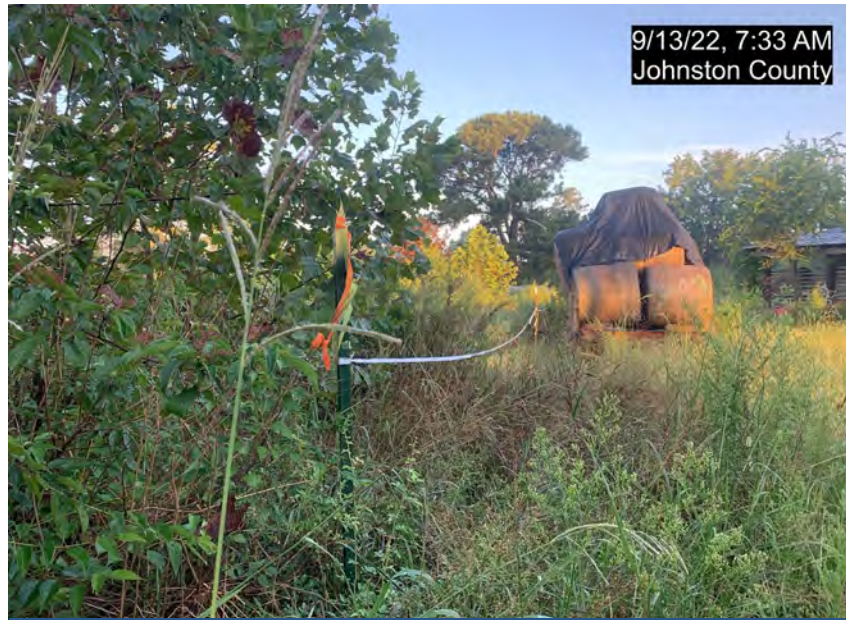
Encroachment Area (VPA3), September 13, 2022 (MY-05)

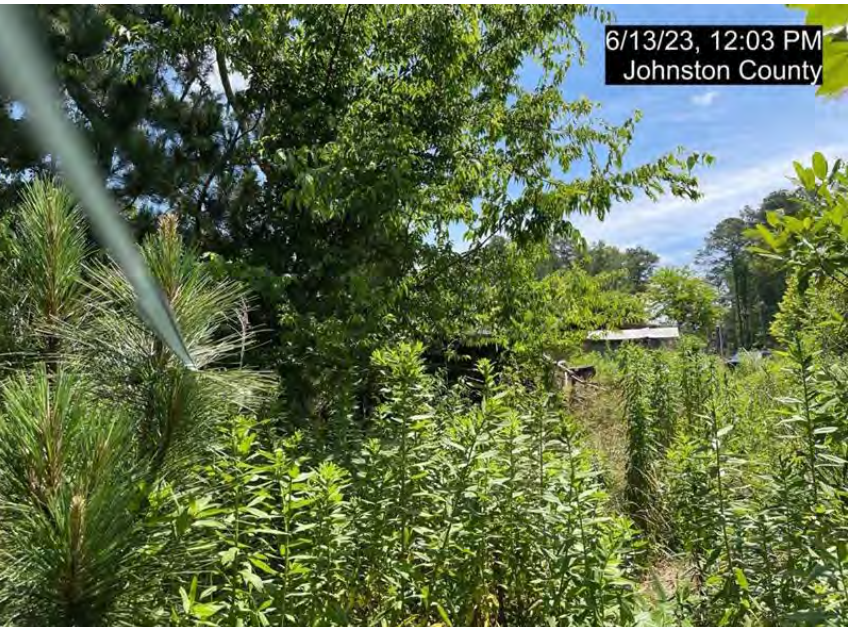
Encroachment Area (VPA3), June 13, 2023 (MY-06)

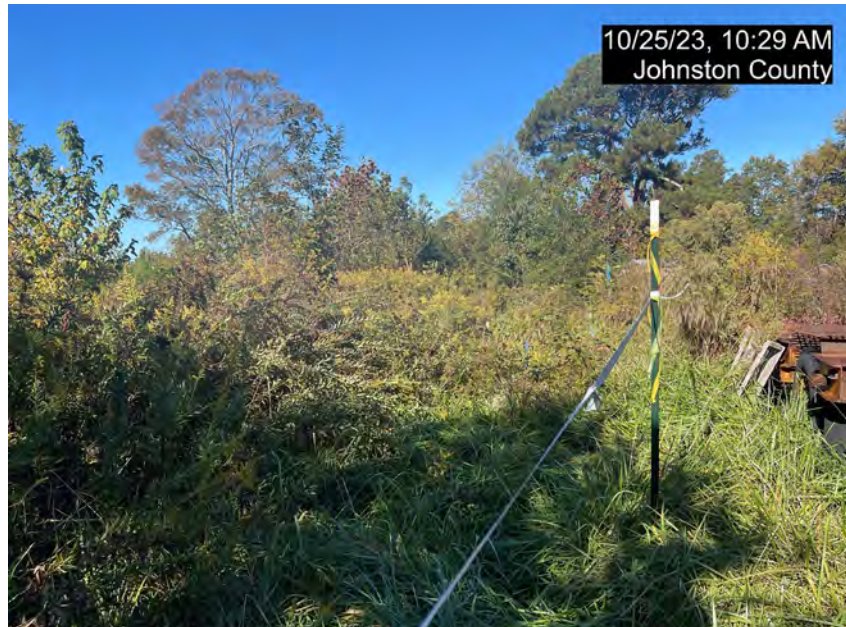
Encroachment Area (VPA3), Replanted area, October 25, 2023 (MY-06)

- 3. Pg. 9, Section 5.4: Please indicate that the proposed planted trees will only be species included in the approved mitigation plan or be approved by the IRT prior to planting.** WLS Response: Verbiage has been added in Section 5.4 to ensure that the proposed planted trees will only be species included in the approved mitigation plan or approved by the IRT prior to planting.
