Monitoring Report – Year 1
FINAL VERSION
Lake Wendell Mitigation Project
Calendar Year of Data Collection: 2018

NCDEQ DMS Project Identification # 97081
NCDEQ DMS Contract # 6826
Neuse River Basin (Cataloging Unit 03020201)
USACE Action ID Number: SAW-2016-00876
NCDEQ DWR Project # 2016-0385
Johnston County, NC
Contracted Under RFP # 16-006477

Data Collection Period: March-November 2018, Submission Date: March 2019

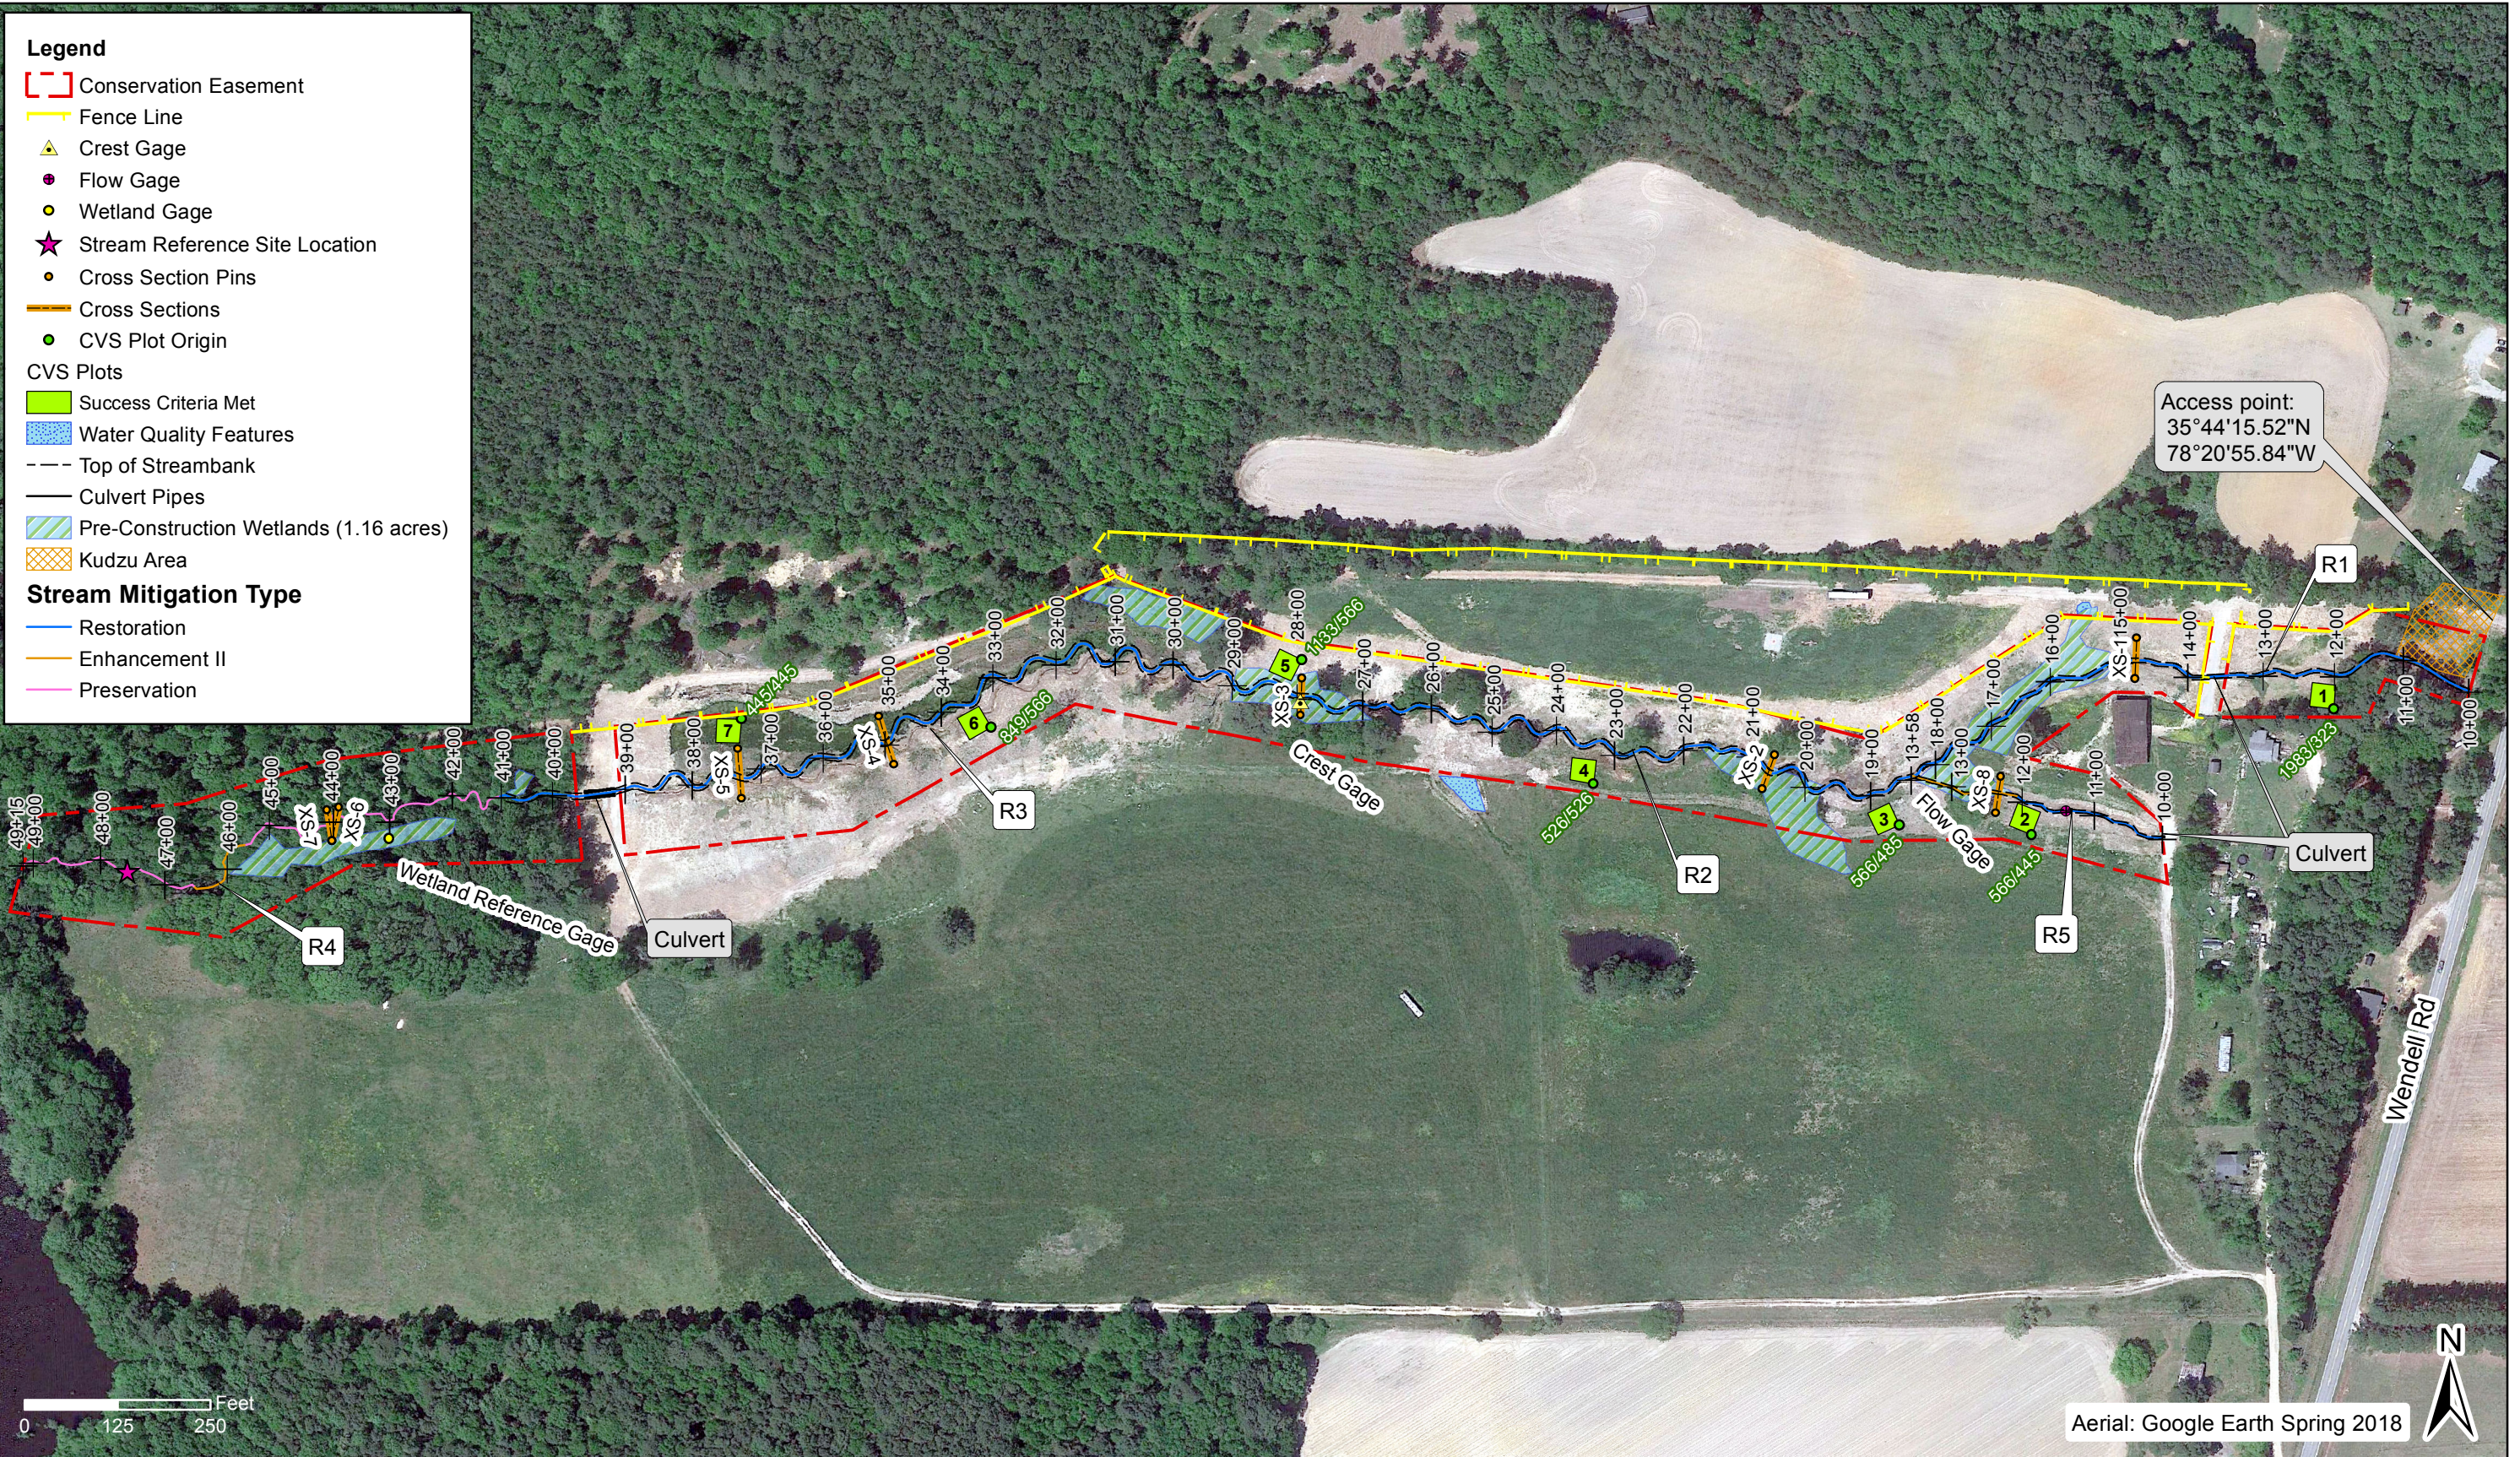
Table 5.
Project
Reach ID
Assessed Length

Visual Stream Morphology Stability Assessment
Lake Wendell Mitigation Project (NCDEQ DMS Project ID# 97081)
R1, R2, R3, R4, R5
4221

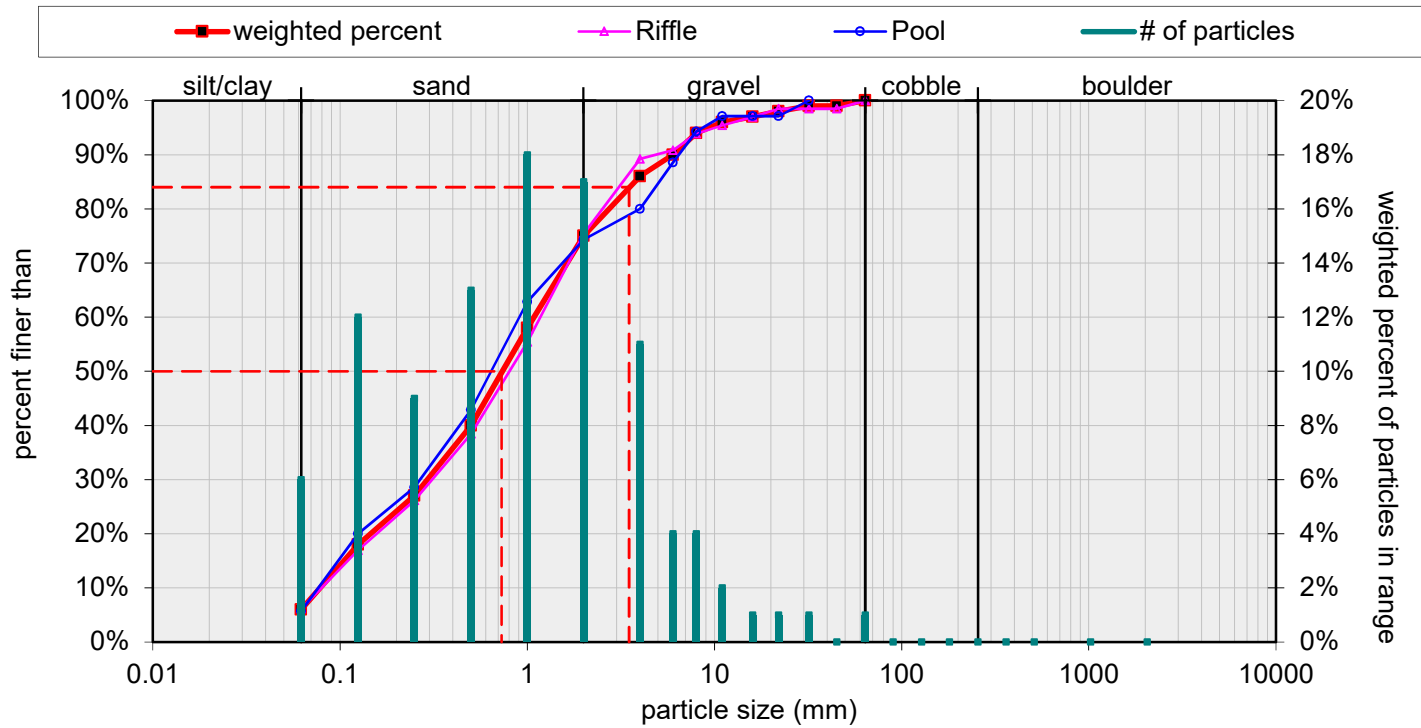
MY1 - Lake Wendell Mitigation Project, Sediment Sample

Size (mm)		Size Distribution		Type	
D16	0.11	mean	0.6	silt/clay	6%
D35	0.38	dispersion	5.7	sand	69%
D50	0.73	skewness	-0.06	gravel	25%
D65	1.3			cobble	0%
D84	3.5			boulder	0%
D95	9.4
