Monitoring Report – MY2
FINAL VERSION
Lake Wendell Mitigation Project
Calendar Year of Data Collection: 2019

NCDEQ DMS Project Identification # 97081
NCDEQ DMS Contract # 6826
Neuse River Basin (Cataloging Unit 03020201)
USACE Action ID Number: SAW-2016-00876
NCDEQ DWR Project # 2016-0385
Johnston County, NC
Contracted Under RFP # 16-006477

Data Collection Period: June-October 2019, Submission Date: December 2019

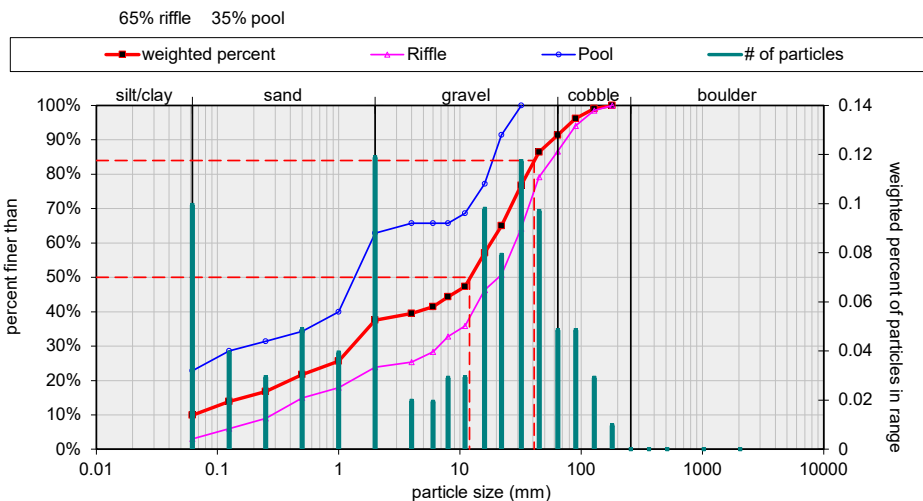
Weighted pebble count by bed features Lake Wendell Mitigation Project MY2

A representative sediment sample was collected in R3 at a constructed riffle to assess streambed material condition and stability. The dominant substrate for the project was verified as coarse sand (Figure 2). The post-construction riffle substrate sampling indicated no significant change in streambed material condition or stability during MY2.

MY2	Riffle		Pool	
	Channel materials		Channel materials	
	D16 =	0.64	D16 =	0.062
	D35 =	10	D35 =	0.55
	D50 =	21	D50 =	1.4
	D84 =	57	D84 =	19
	D95 =	97	D95 =	26

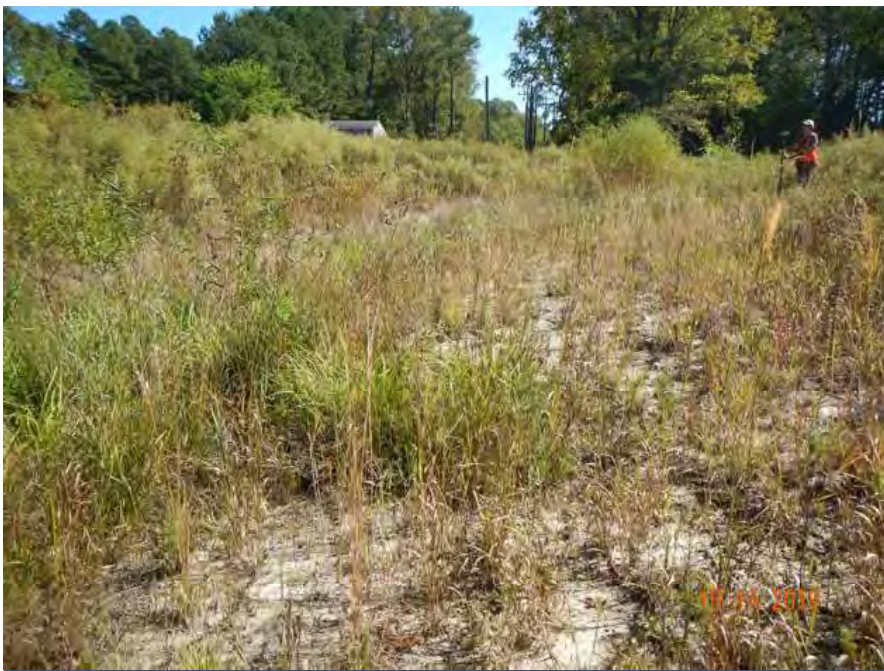
VPA1 Bare ground Area (photo east) 10/14/2019

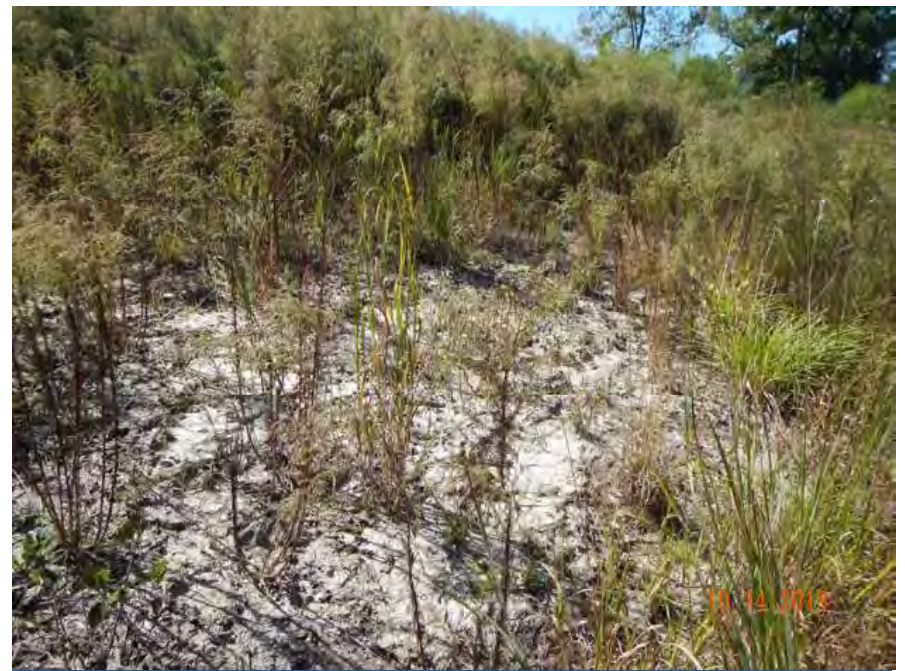
VPA2 Bare ground Area (photo west) 10/14/2019

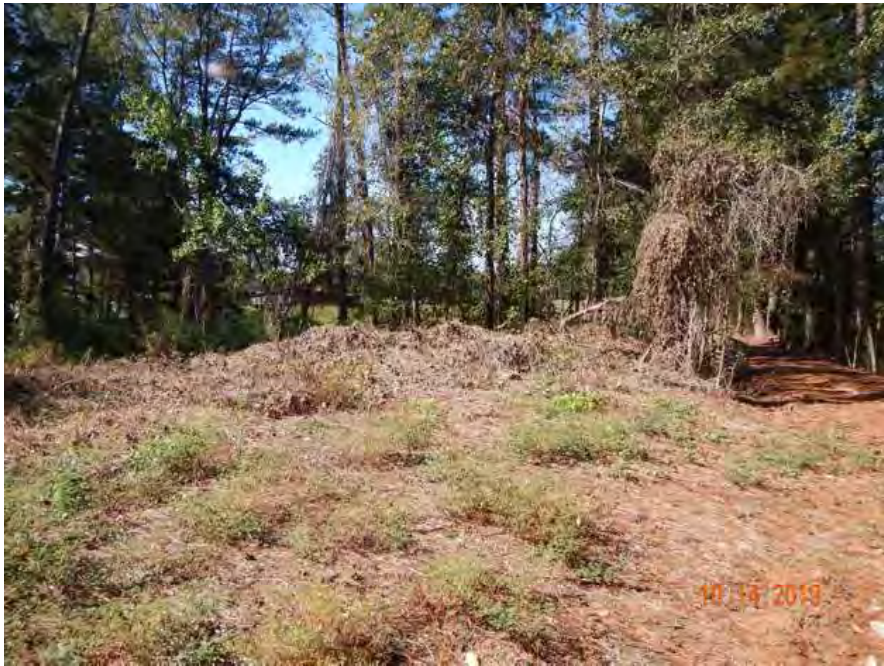
During the project construction, invasive species exotic vegetation was either mechanically removed or chemically treated both to control its presence and reduce its spread within the conservation easement areas. During MY2 vegetation assessment, one area of concern was observed along R1 buffer as shown on the Figure 1. This area was utilized as a temporary staging area during construction and contains invasive species vegetation (kudzu) along the right buffer. This area was treated twice, using a 3 percent solution of Garlon 3A during MY2, on August 15th and September 24th, 2019. WLS will continue to monitor and treat the kudzu during MY3.

VPA3 Kudzu (photo west) 10/14/2019
