Monitoring Report – MY3
FINAL VERSION
Lake Wendell Mitigation Project
Calendar Year of Data Collection: 2020

NCDEQ DMS Project Identification # 97081
NCDEQ DMS Contract # 6826
Neuse River Basin (Cataloging Unit 03020201)
USACE Action ID Number: SAW-2016-00876
NCDEQ DWR Project # 2016-0385
Johnston County, NC
Contracted Under RFP # 16-006477
Data Collection Period: September-October 2020
Submission Date: December 11, 2020

Mitigation Project Name Lake Wendell Mitigation Project
DMS ID 97081
River Basin Neuse
Cataloging Unit 03020201
County Johnston

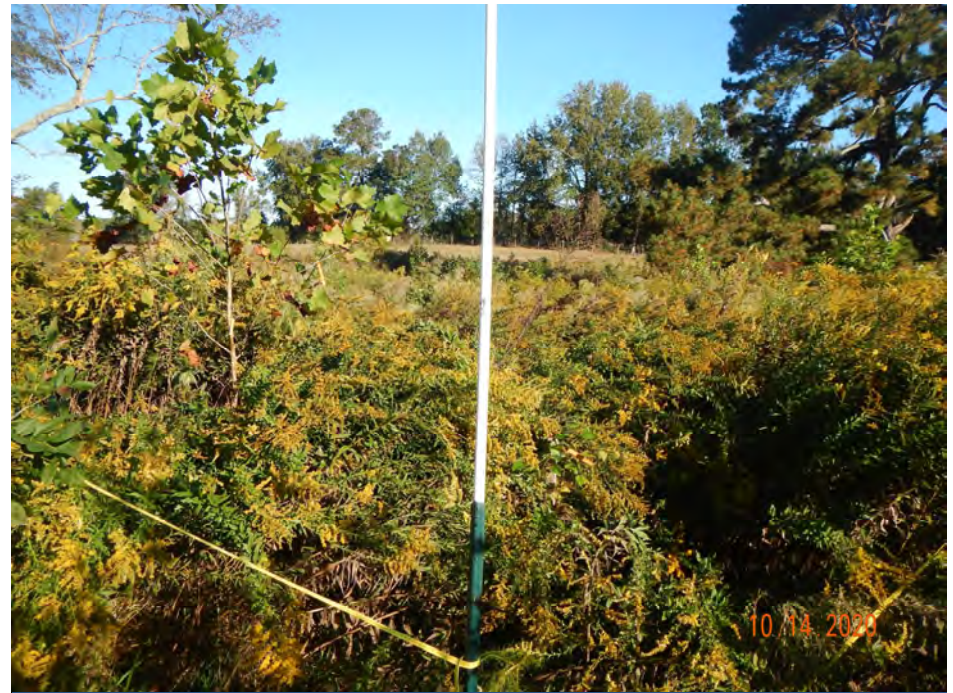
Veg Plot 2, October 14, 2020 (MY-03)

Plot 2 had an average stem density of 283.3 stems per acre which does not meet the year 3 minimum of 320 stems per acre. Plot 2 contains seven stems total, one stem below the requirement to meet success criteria. Loss in stem density from MY2 to MY3 is due to poor soil conditions. During MY4, Plot 2 will be monitored closely, and WLS will assess the need for supplemental planting in MY4. All other vegetation plots met MY3 interim success criteria.

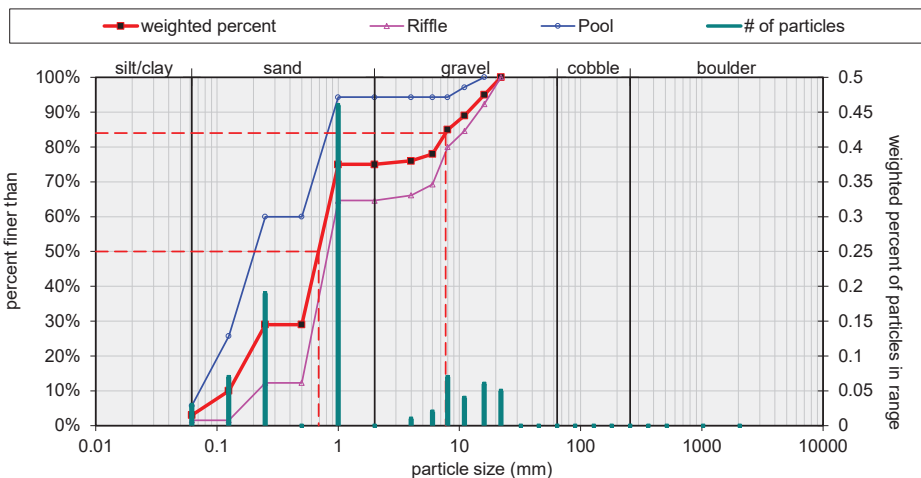
Lake Wendell
Figure 3: Pebble Count

A representative sediment sample was collected in R3 at a constructed riffle to assess streambed material condition and stability. The dominant substrate for the project was verified as coarse sand (Figure 3). The post-construction riffle substrate sampling indicated no significant change in streambed material condition or stability during MY3.

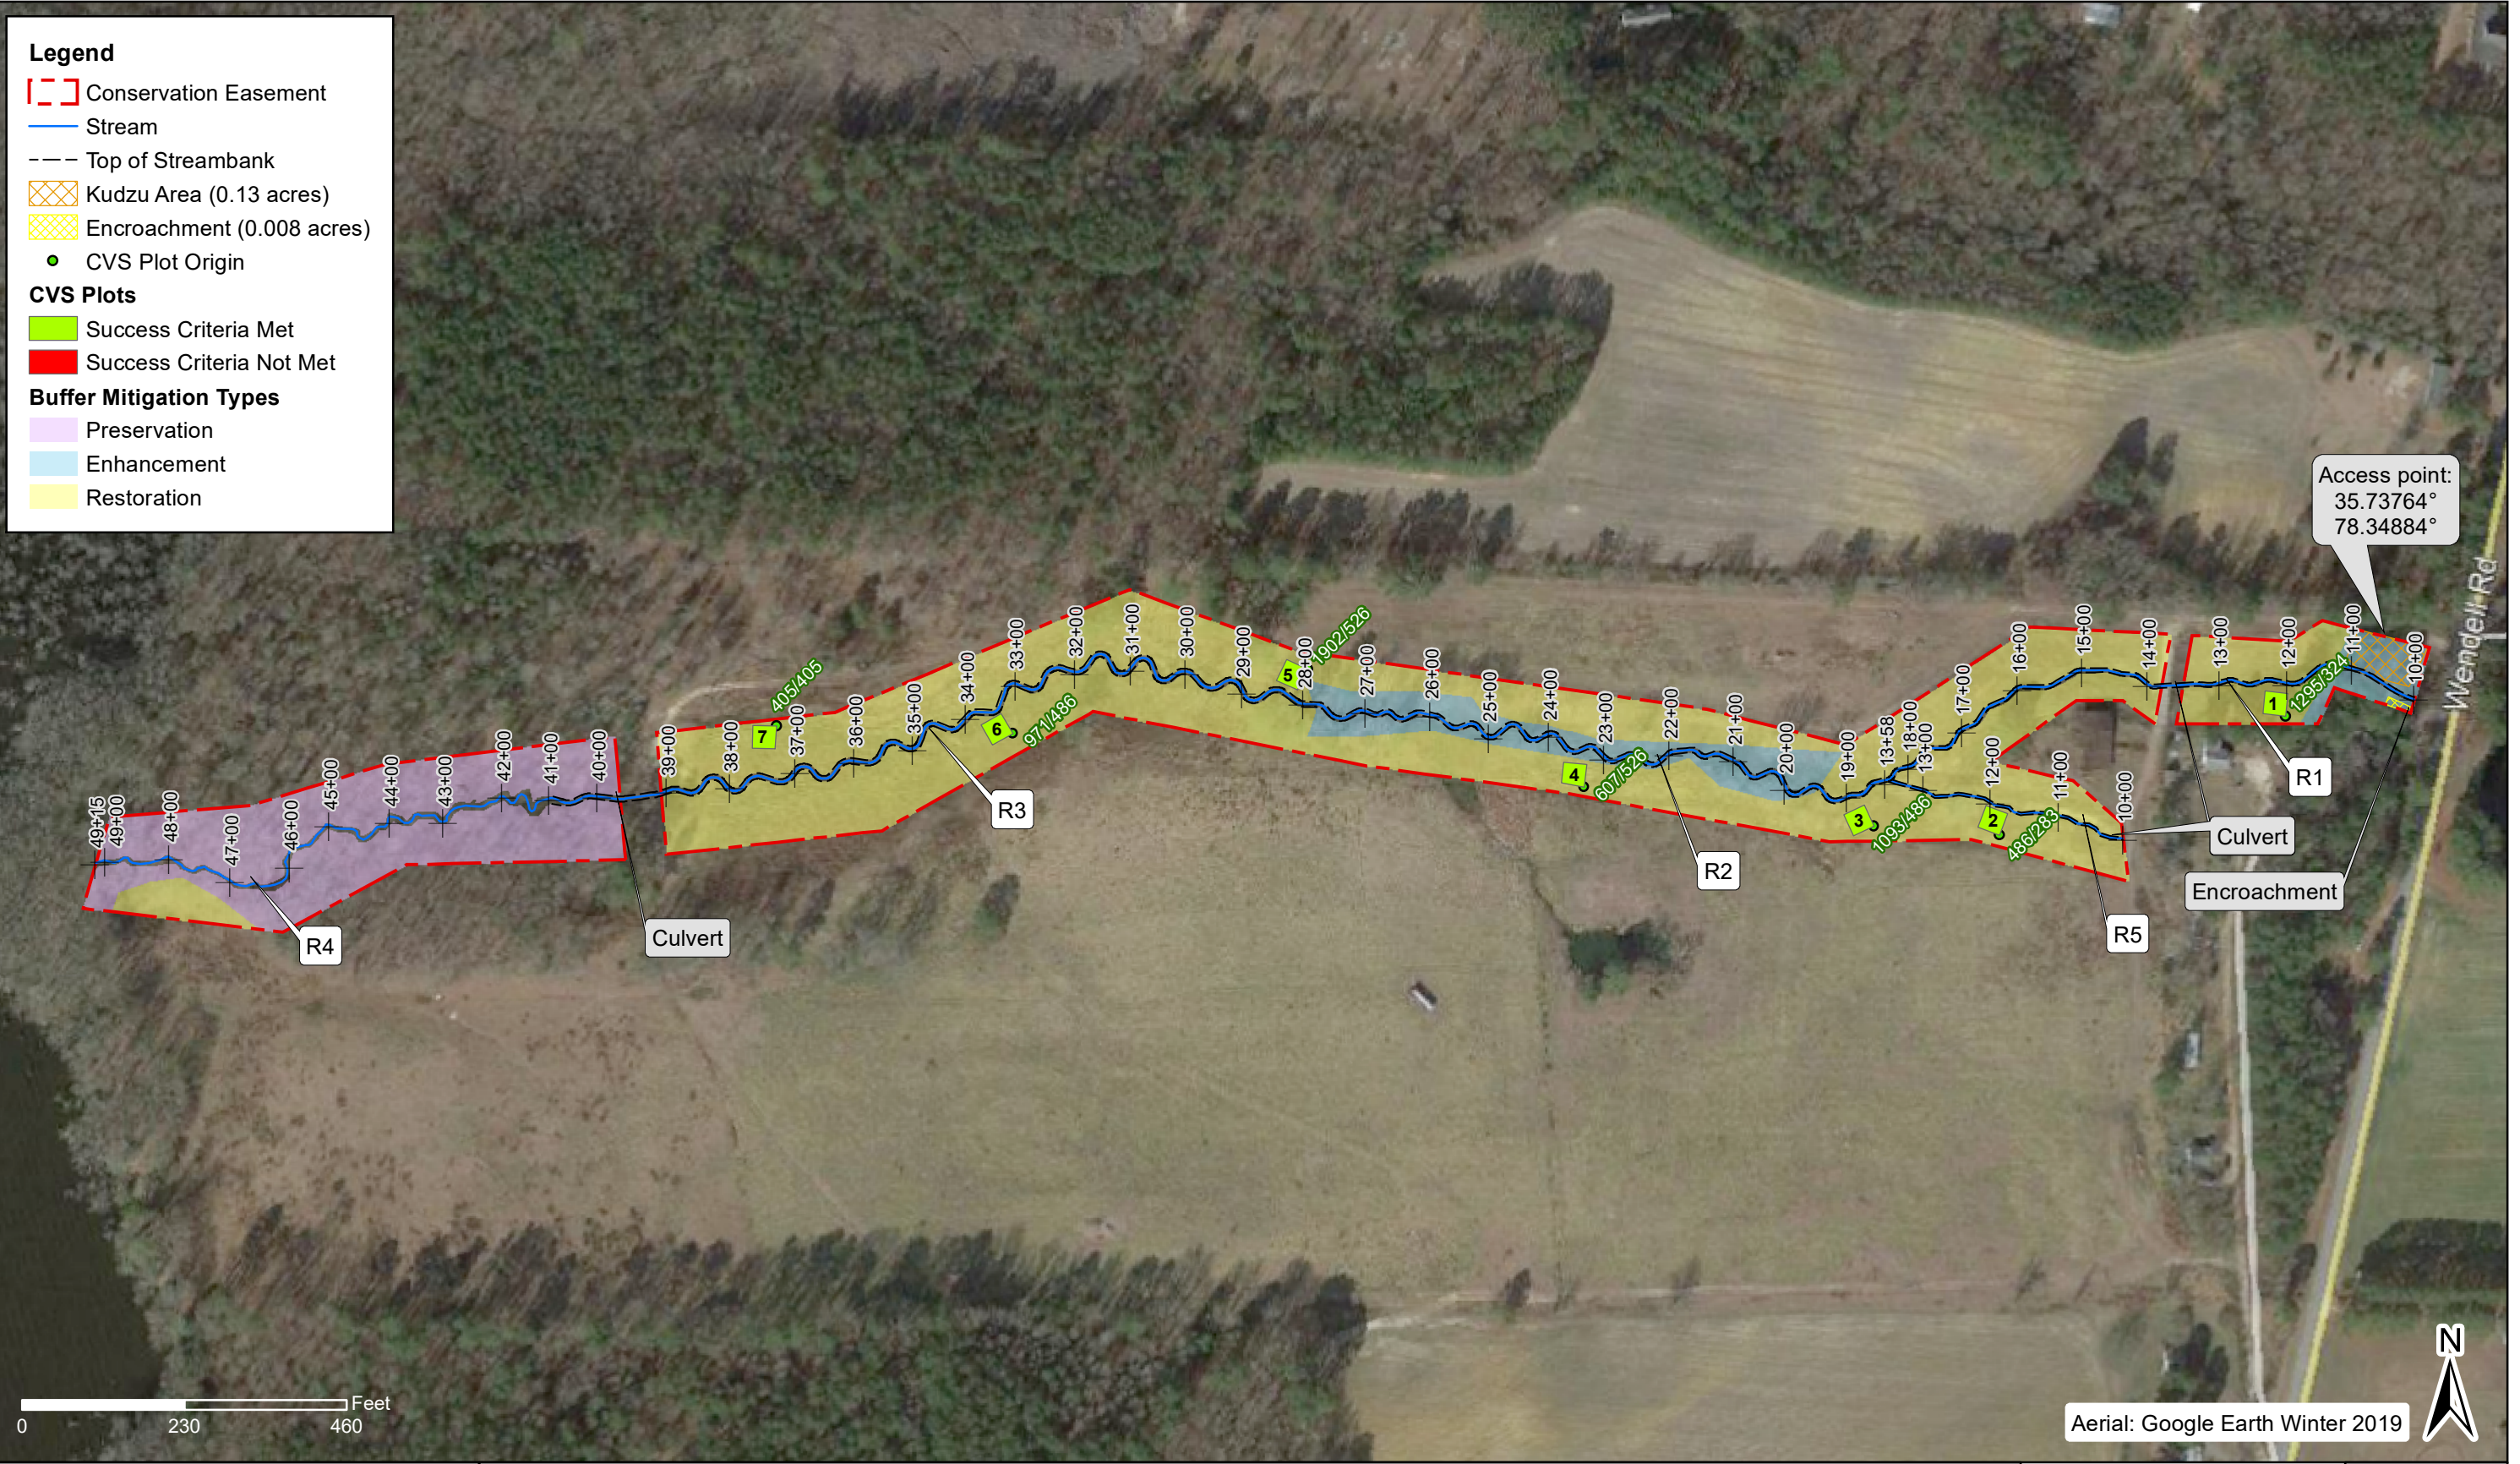
The MY3 vegetation monitoring was also conducted utilizing visual assessment throughout the easement. The results of the visual assessment did not indicate any negative changes to the existing vegetation community. An area of encroachment approximately 0.008 acres was found along R1, see Figure 1. This area has been mowed by the adjacent homeowner and is currently vegetated with fescue. Management of this area has already begun and includes additional signage and a physical barrier (horse tape) to delineate the easement boundary and discourage further mowing. During MY4 additional trees will be planted in this area to ensure tree cover is achieved. Trees planted will be from the approved list in the mitigation plan. A previous area of concern is located along R1 buffer as shown on the CCPV (noted first in MY1). This area was utilized as a temporary staging area during construction and contains invasive vegetation (kudzu) along the right buffer. The area was treated twice during the 2020 year, once in March and once in October (see table below for treatments). Following these treatments, the percent cover of kudzu was reduced to approximately 5%. This area will continue to be treated during MY4 and documented in future reports.

During the project construction, invasive species exotic vegetation was either mechanically removed or chemically treated both to control its presence and reduce its spread within the conservation easement areas. During MY3 an area of concern was observed along R1 buffer as shown on the Figure 1. This area was utilized as a temporary staging area during construction and contains invasive species vegetation (kudzu) along the right buffer. This area was managed twice during MY3, with kudzu crown removal happening during the summer and foliar spray of the limited remaining stems in October using a 3 percent solution of Garlon 3A (see table below for treatments). Following these treatments, the percent cover of kudzu was reduced to approximately 5%. WLS will continue to monitor and treat the kudzu during MY4.

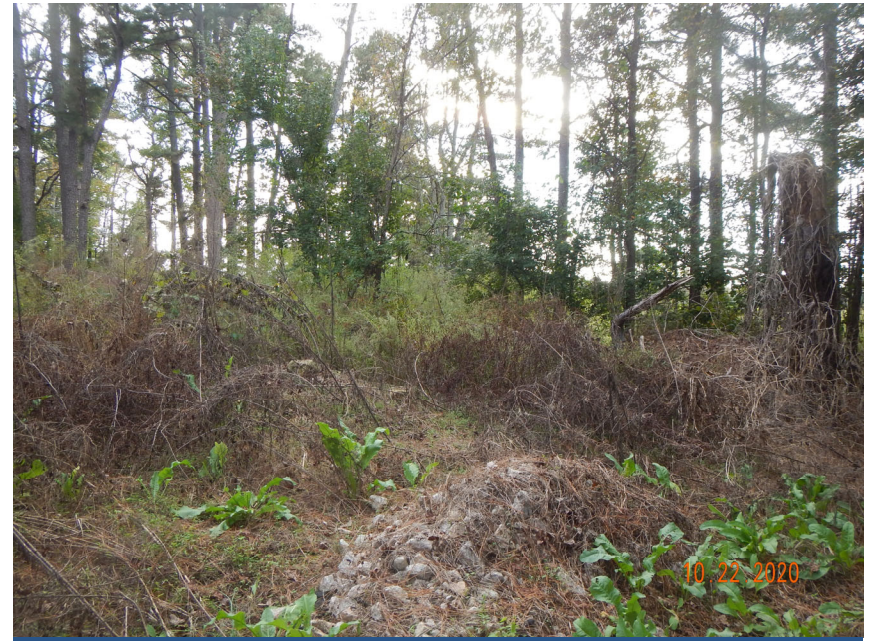
Kudzu Problem Area, October 22, 2020 (MY-03)

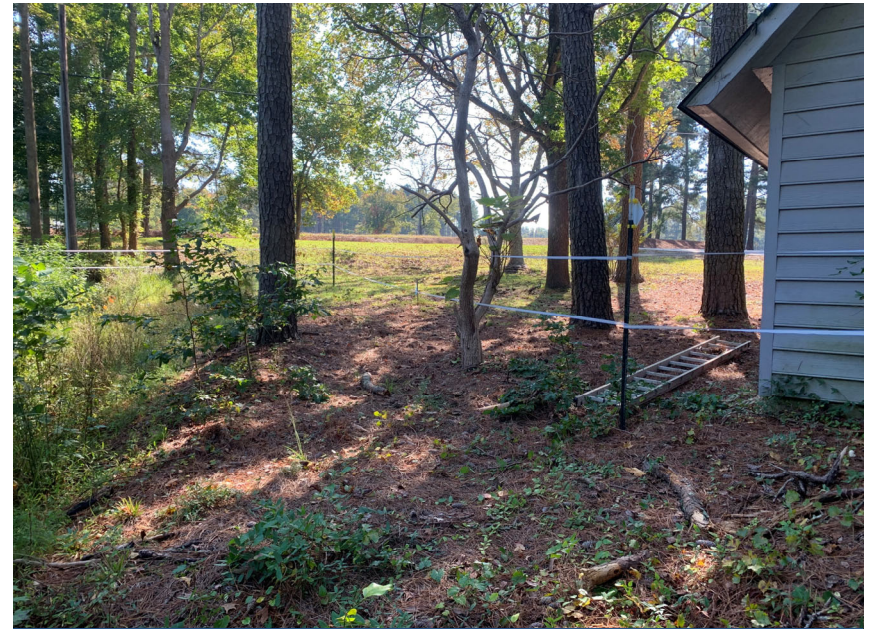
Encroachment Area, October 7, 2020 (MY-03)
