Monitoring Report – MY4  
FINAL VERSION  
Lake Wendell Mitigation Project  
Calendar Year of Data Collection: 2021

NCDEQ DMS Project Identification # 97081  
NCDEQ DMS Contract # 6826  
Neuse River Basin (Cataloging Unit 03020201)  
USACE Action ID Number: SAW-2016-00876  
NCDEQ DWR Project # 2016-0385 V2  
Johnston County, NC  
Contracted Under RFP # 16-006477  
Data Collection Period: September 2021  
Submission Date: October 20<sup>th</sup>, 2021

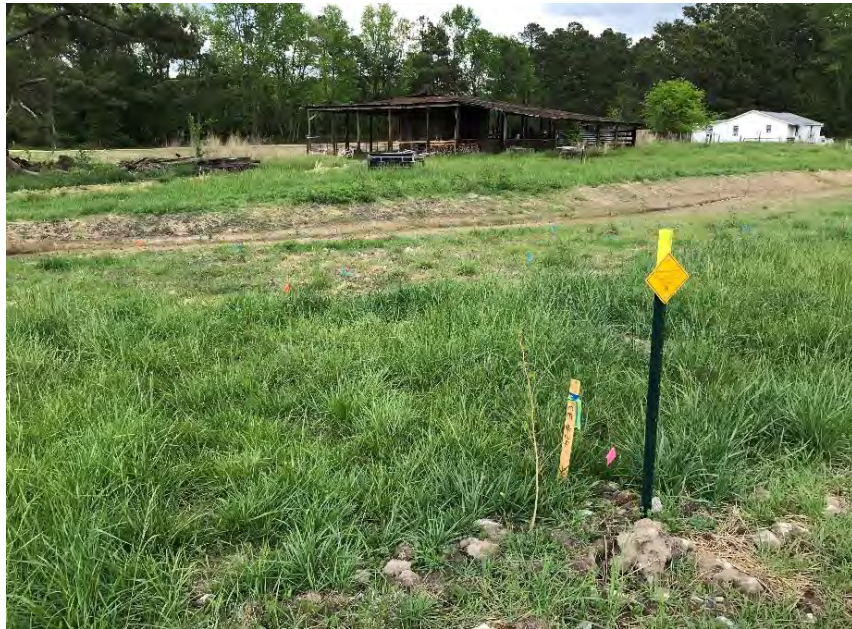
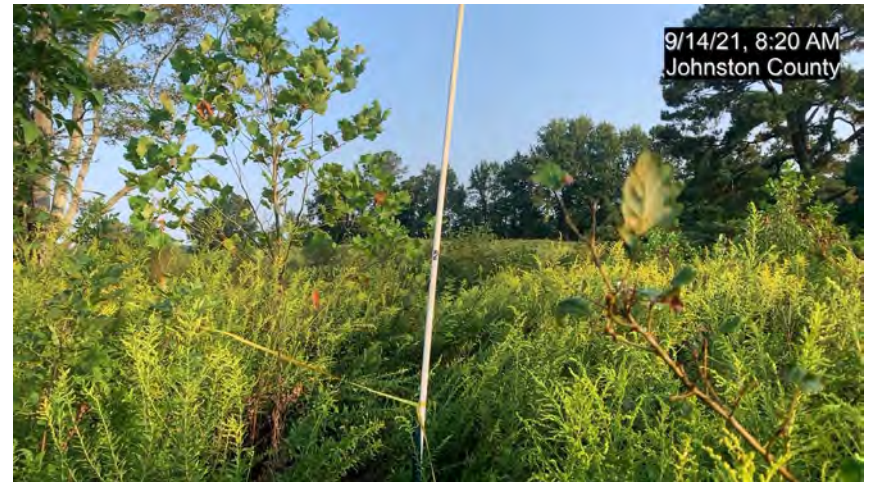
Veg Plot 2, April 27, 2018 (MY-00)

Annual monitoring was conducted during MY4 in accordance with the monitoring plan as described in the approved mitigation plan to document the site conditions. All monitoring device locations are depicted on the CCPV (Figure 1). MY4 results are provided in the appendices. The Project meets the MY4 success criteria for stream hydrology and jurisdictional stream flow. Visual surveys indicate that the stream horizontal and vertical stability are meeting requirements. All vegetation plots except plot 2 meet the required success criteria.

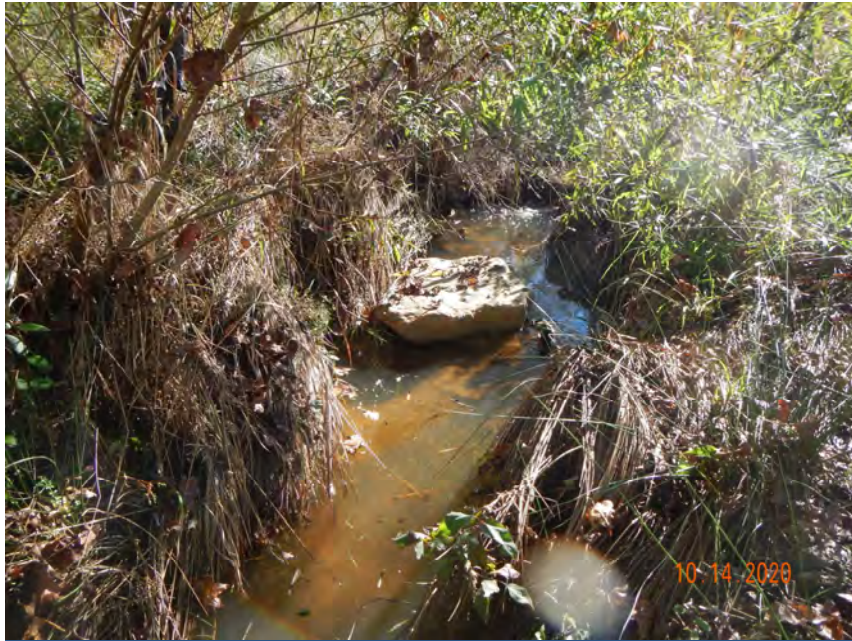
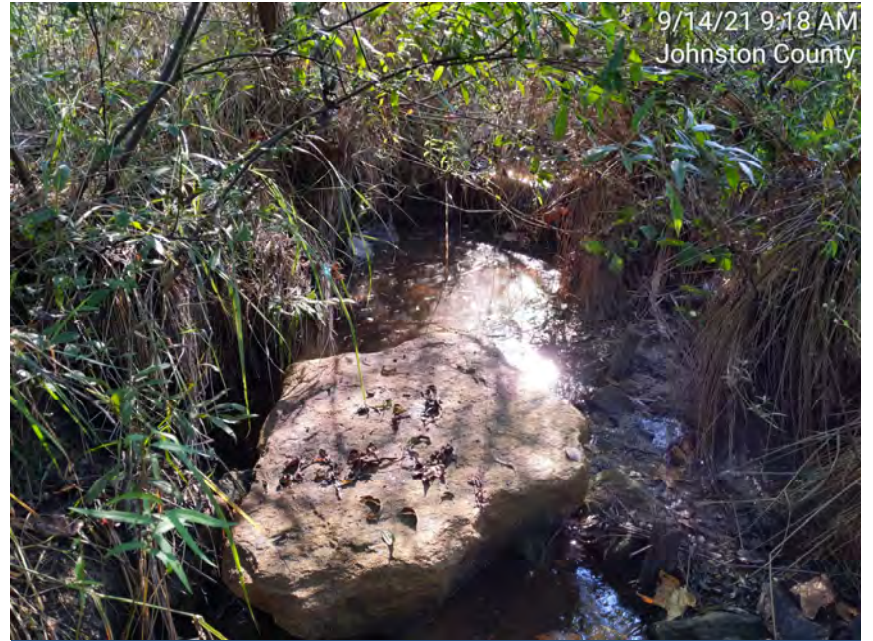
Minor piping was noted in MY3 at two instream structures near approximate stations 26+00 (SPA1) and 26+50 (SPA2). During MY4 these areas were live staked to prevent further erosion and provide bank stability. Both structures are failing, but there is not a systemic problem upstream or downstream and no immediate remedial action is proposed at this time. Monitoring of these areas will continue in MY5.

SPA1, October 14, 2020 (MY-03)

SPA1, September 14, 2021 (MY-04)

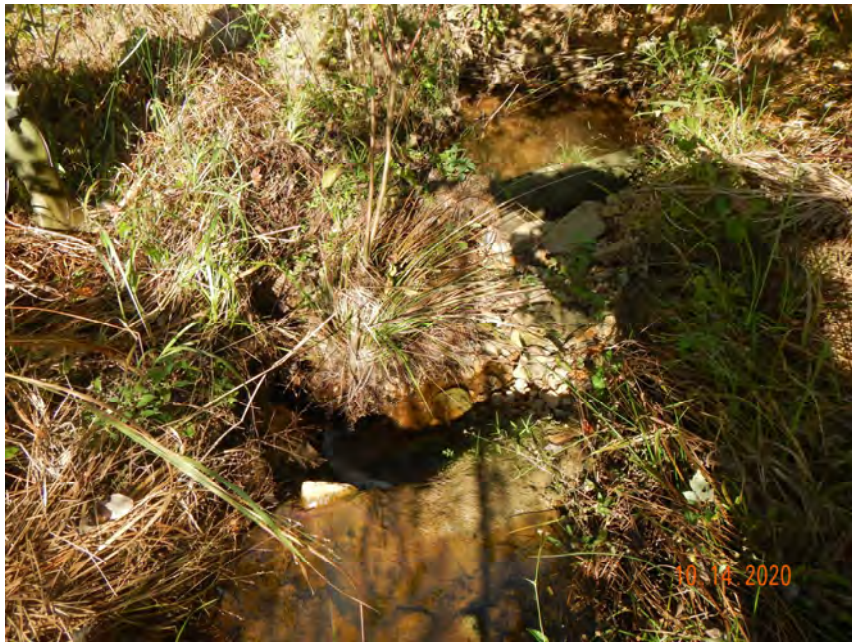
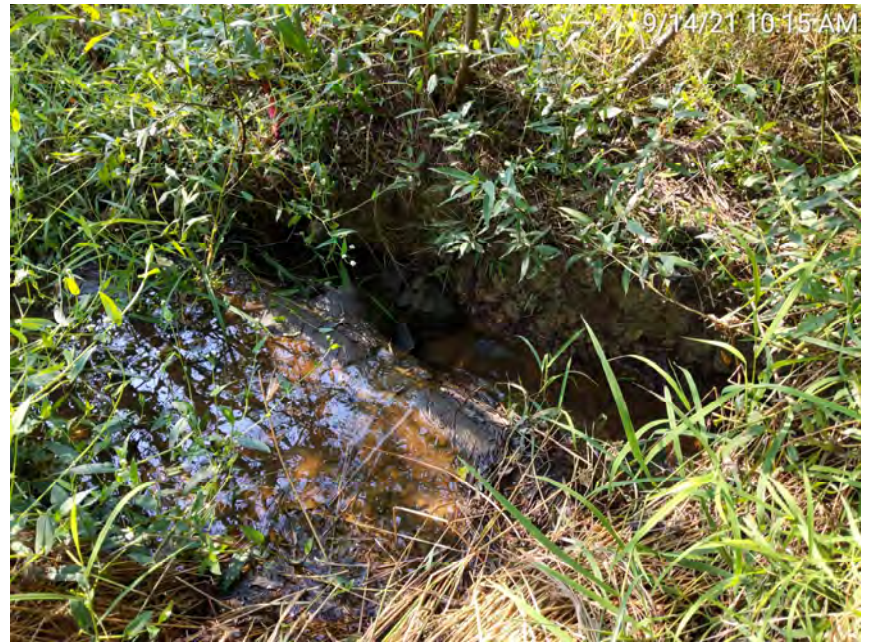
SPA2, October 14, 2020 (MY-03)

SPA2, September 14, 2021 (MY-04)

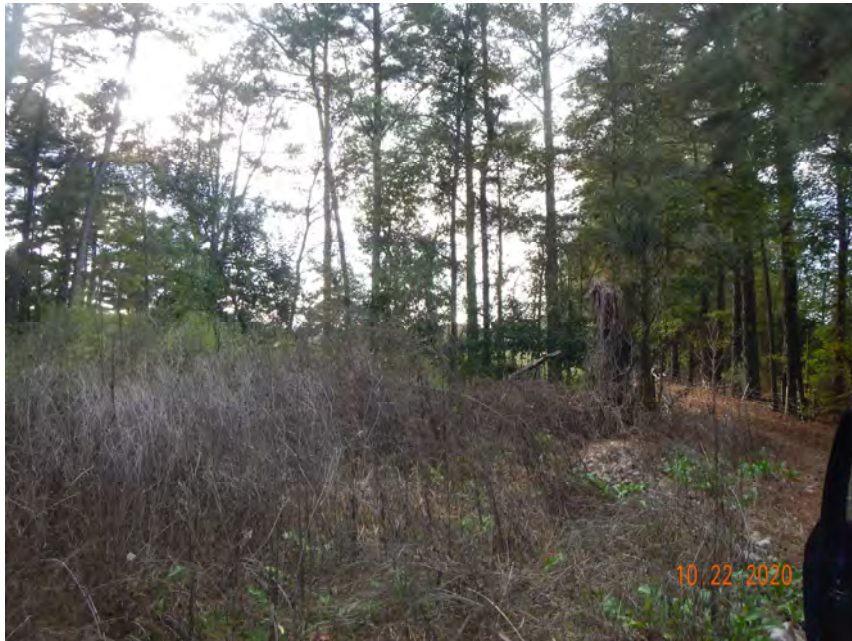
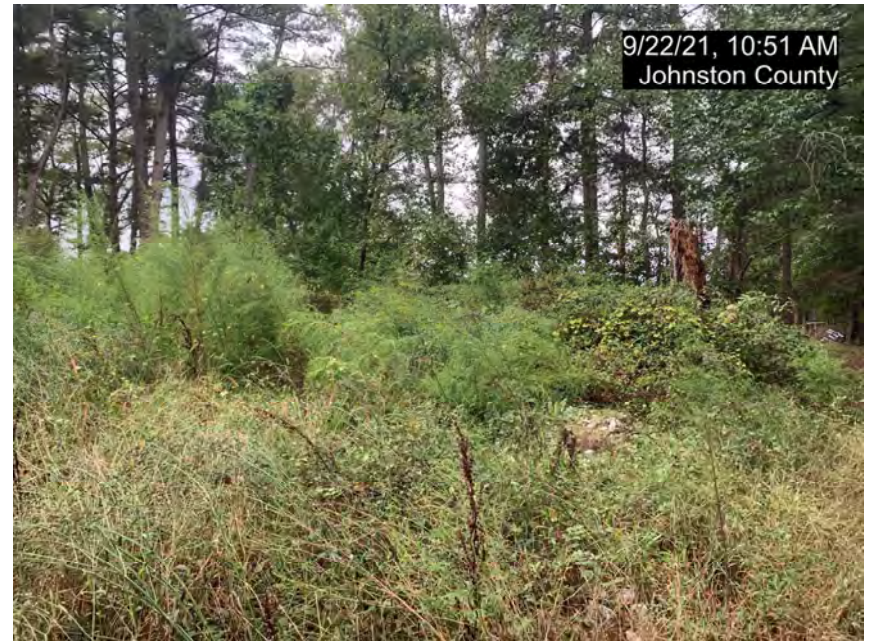
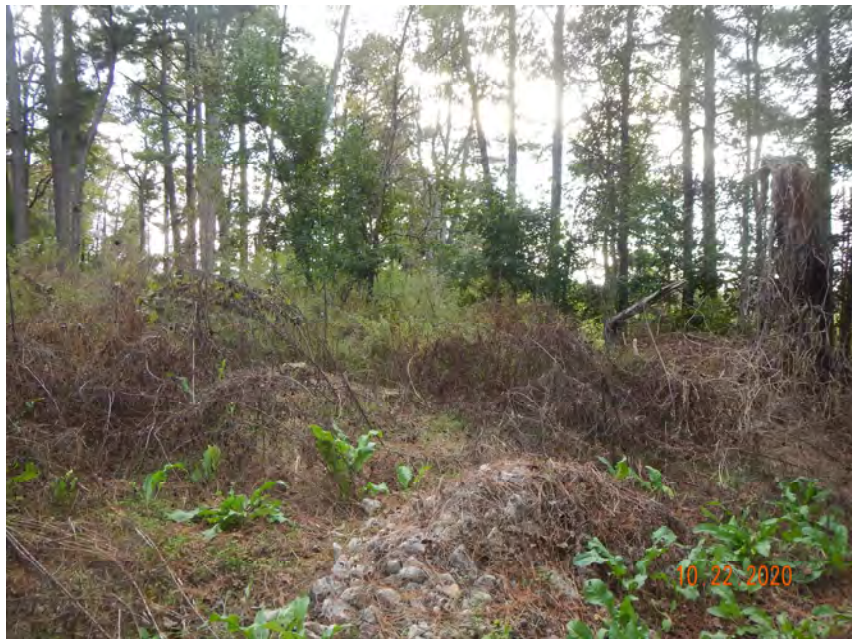
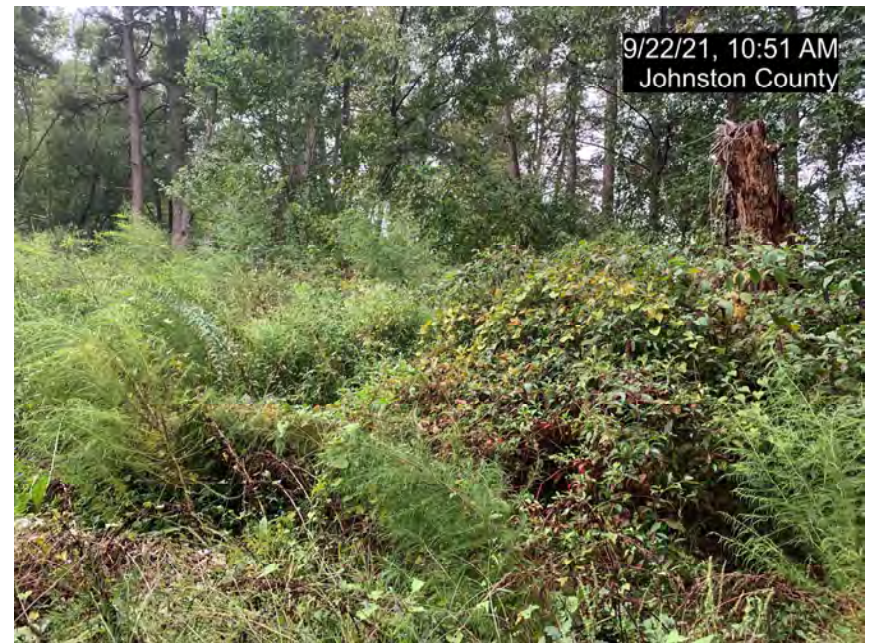
Kudzu Problem Area (VPA1), October 22, 2020 (MY-03)

Kudzu Problem Area (VPA1), September 22, 2021 (MY-04)

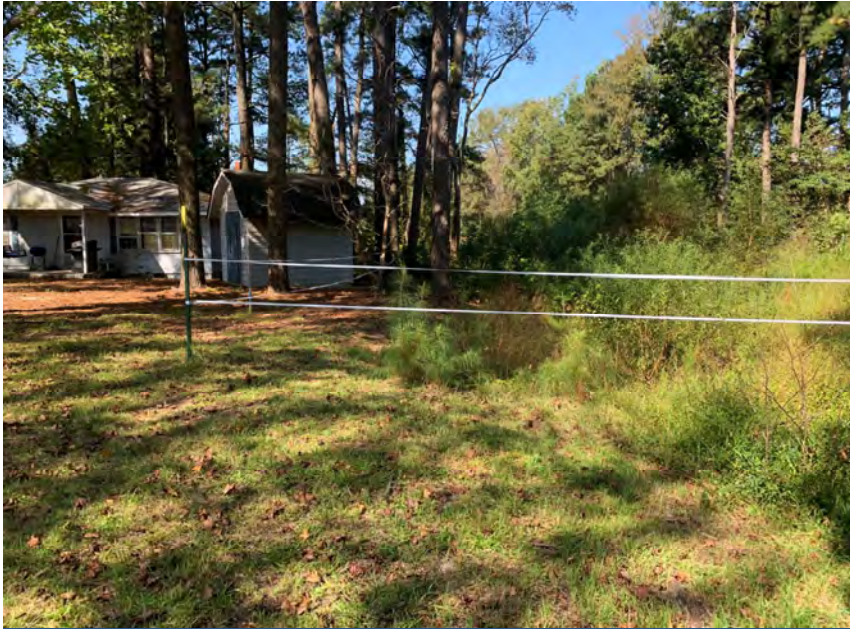
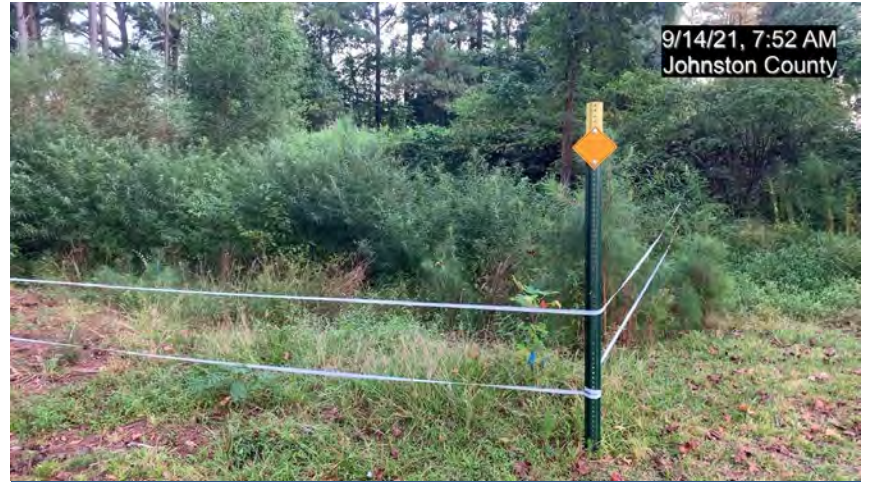
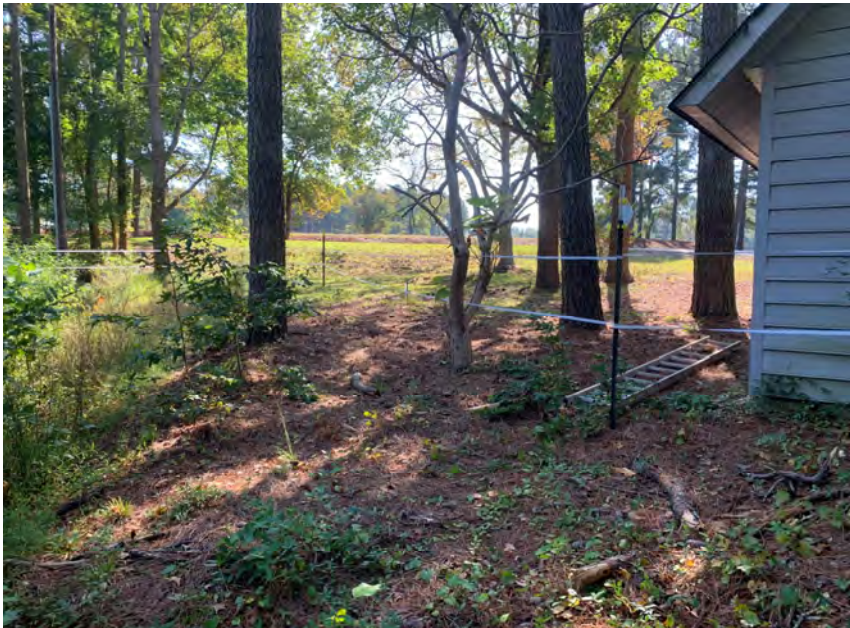
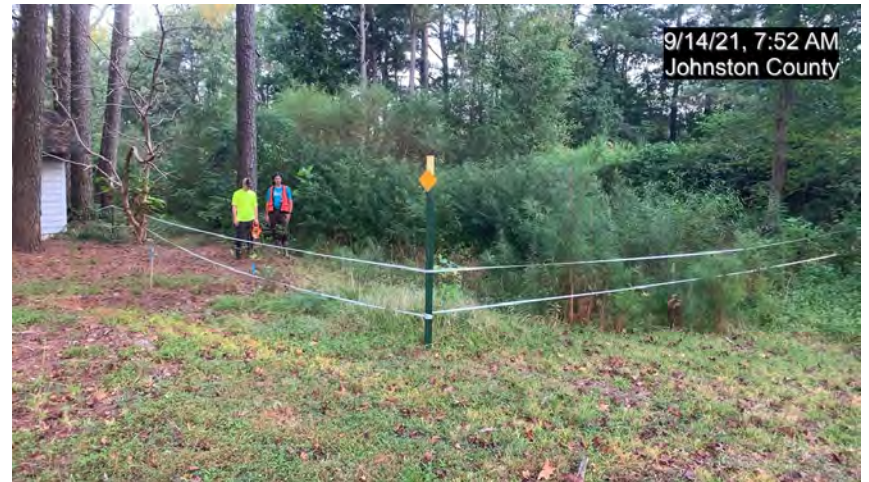
The MY4 vegetation monitoring was also conducted utilizing visual assessment throughout the easement. The results of the visual assessment did not indicate any negative changes to the existing vegetation community. An area of encroachment approximately 0.008 acres was found along R1 in MY3, see Figure 1 (VPA2). This area had been mowed by the adjacent homeowner and was vegetated with fescue. Management of this area in MY4 included additional signage and a physical barrier (horse tape) to

Encroachment Area (VPA2), October 7, 2020 (MY-03)

Encroachment Area (VPA2), September 14, 2021 (MY-04)

delineate the easement boundary and discourage further mowing. During MY4, additional trees were planted in this area to ensure tree cover is achieved (February 1st, 2021). Trees planted were from the approved list in the mitigation plan (see plant list below). A previous area of concern (VPA1) located along R1 buffer as shown on the CCPV (noted first in MY1) was utilized as a temporary staging area during construction and contains invasive vegetation (kudzu) along the right buffer. The area was treated once during the 2021 year in July (see table below for treatments). Following these treatments, the percent cover of kudzu was reduced to approximately 1%. The VPA1 area was planted with trees from the approved list in the mitigation plan on February 1<sup>st</sup>, 2021 (see plant list below). This area will continue to be treated during MY5 and documented in future reports.
