MONITORING YEAR 1 ANNUAL REPORT FINAL

LAUREL VALLEY MITIGATION SITE

Burke County, NC
Catawba River Basin
HUC 03050101

LAUREL VALLEY MITIGATION SITE
Monitoring Year 1 Annual Report

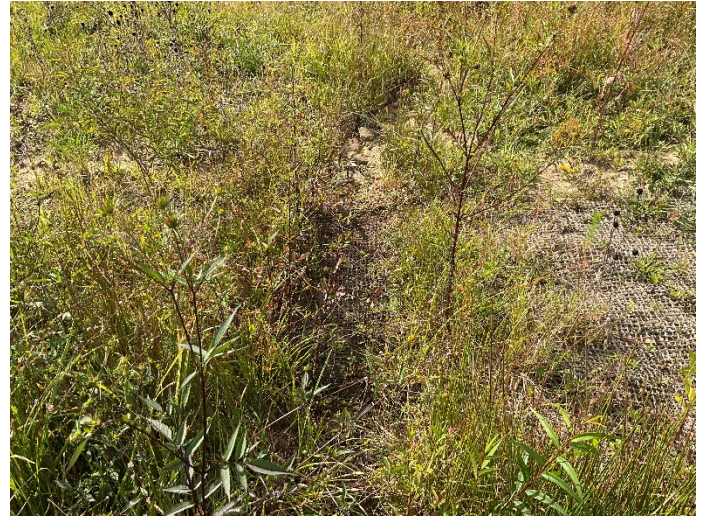
UT1 STA 224+05 – rock stabilization (9/22/2023)

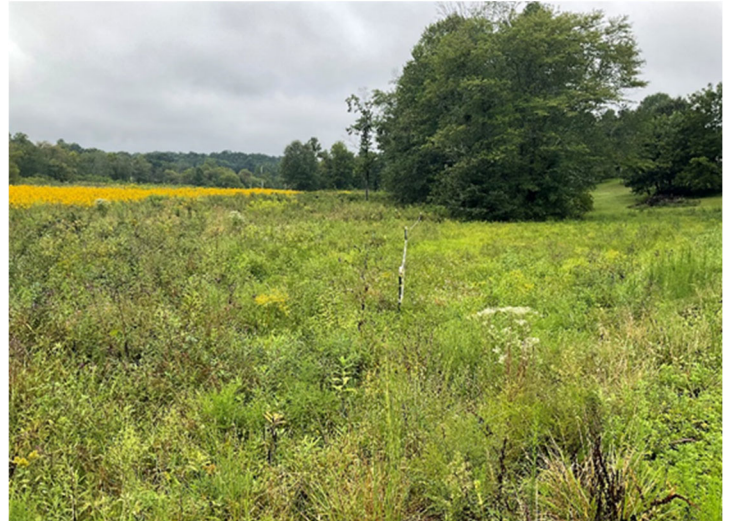
East Prong Hunting Creek R1 – Established mow line (9/22/2023)

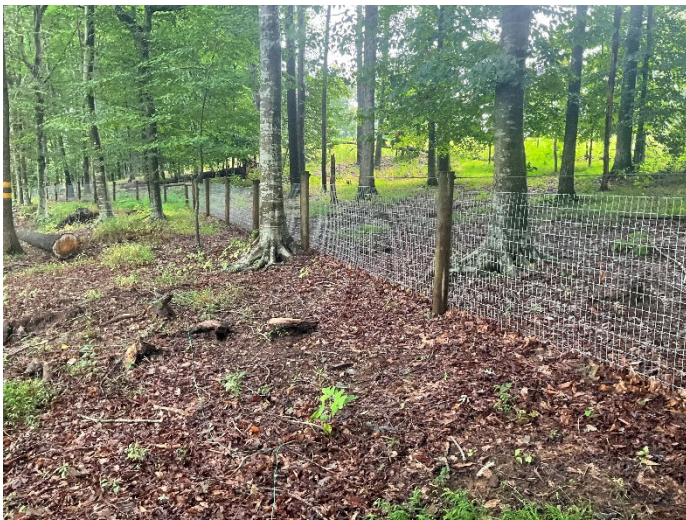
UT1 – Fence repair (8/29/2023)

- *The French drain and fence repairs look great, thank you.*

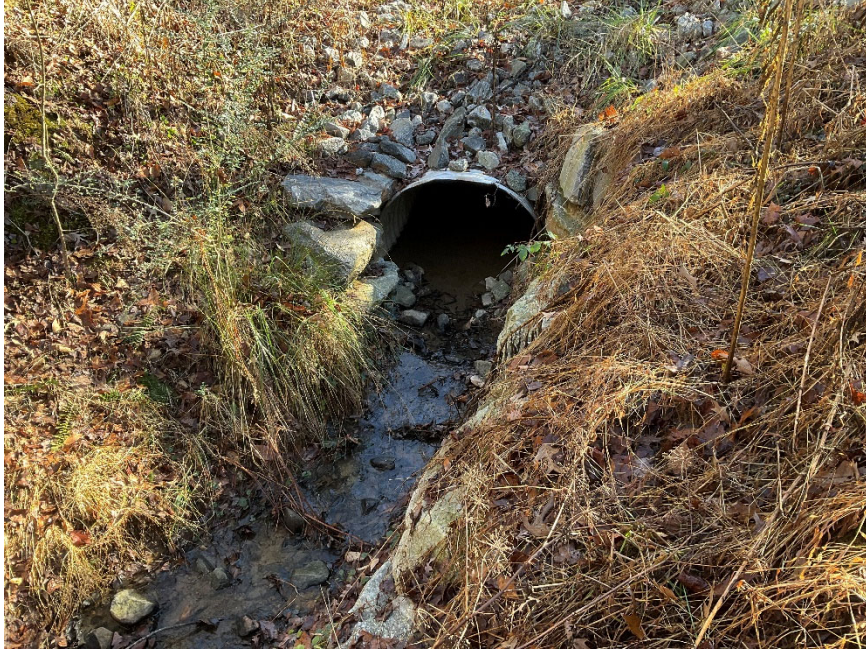
Photo Point #1 - view upstream (12/12/2023)

- *Photo Point #1 (UT1 Reach 1 culvert) shows some sediments in the culvert (it looks like 30-40%); photo dated 8/29/23. Compared to the MY0 photo (2/20/2023) this has worsened. Please continue to photograph, and please add a brief discussion in this report. If possible, for the culvert photos please include a photo from each side of the culvert, looking at the culvert from each direction, especially where there is a potential issue (sedimentation, debris jam, perching, etc).*

Wildlands Response: Wildlands will continue to photograph and monitor this area and will include culvert photographs of both sides in future monitoring reports. A brief discussion will be included in the final report. Photographs taken on 12/12/23 at Photo Point #1 are shown below.
