**FINAL  
MY1 (2022) MONITORING REPORT**

**LAUREL SPRINGS STREAM AND WETLAND MITIGATION SITE**

Avery County, North Carolina  
French Broad River Basin  
Cataloging Unit 06010108

DMS Project No. 100122  
Full Delivery Contract No. 7890  
DMS RFP No. 16-007725 (issued 11/13/18)  
USACE Action ID No. SAW-2019-00835  
DWR Project No. 2019-0865

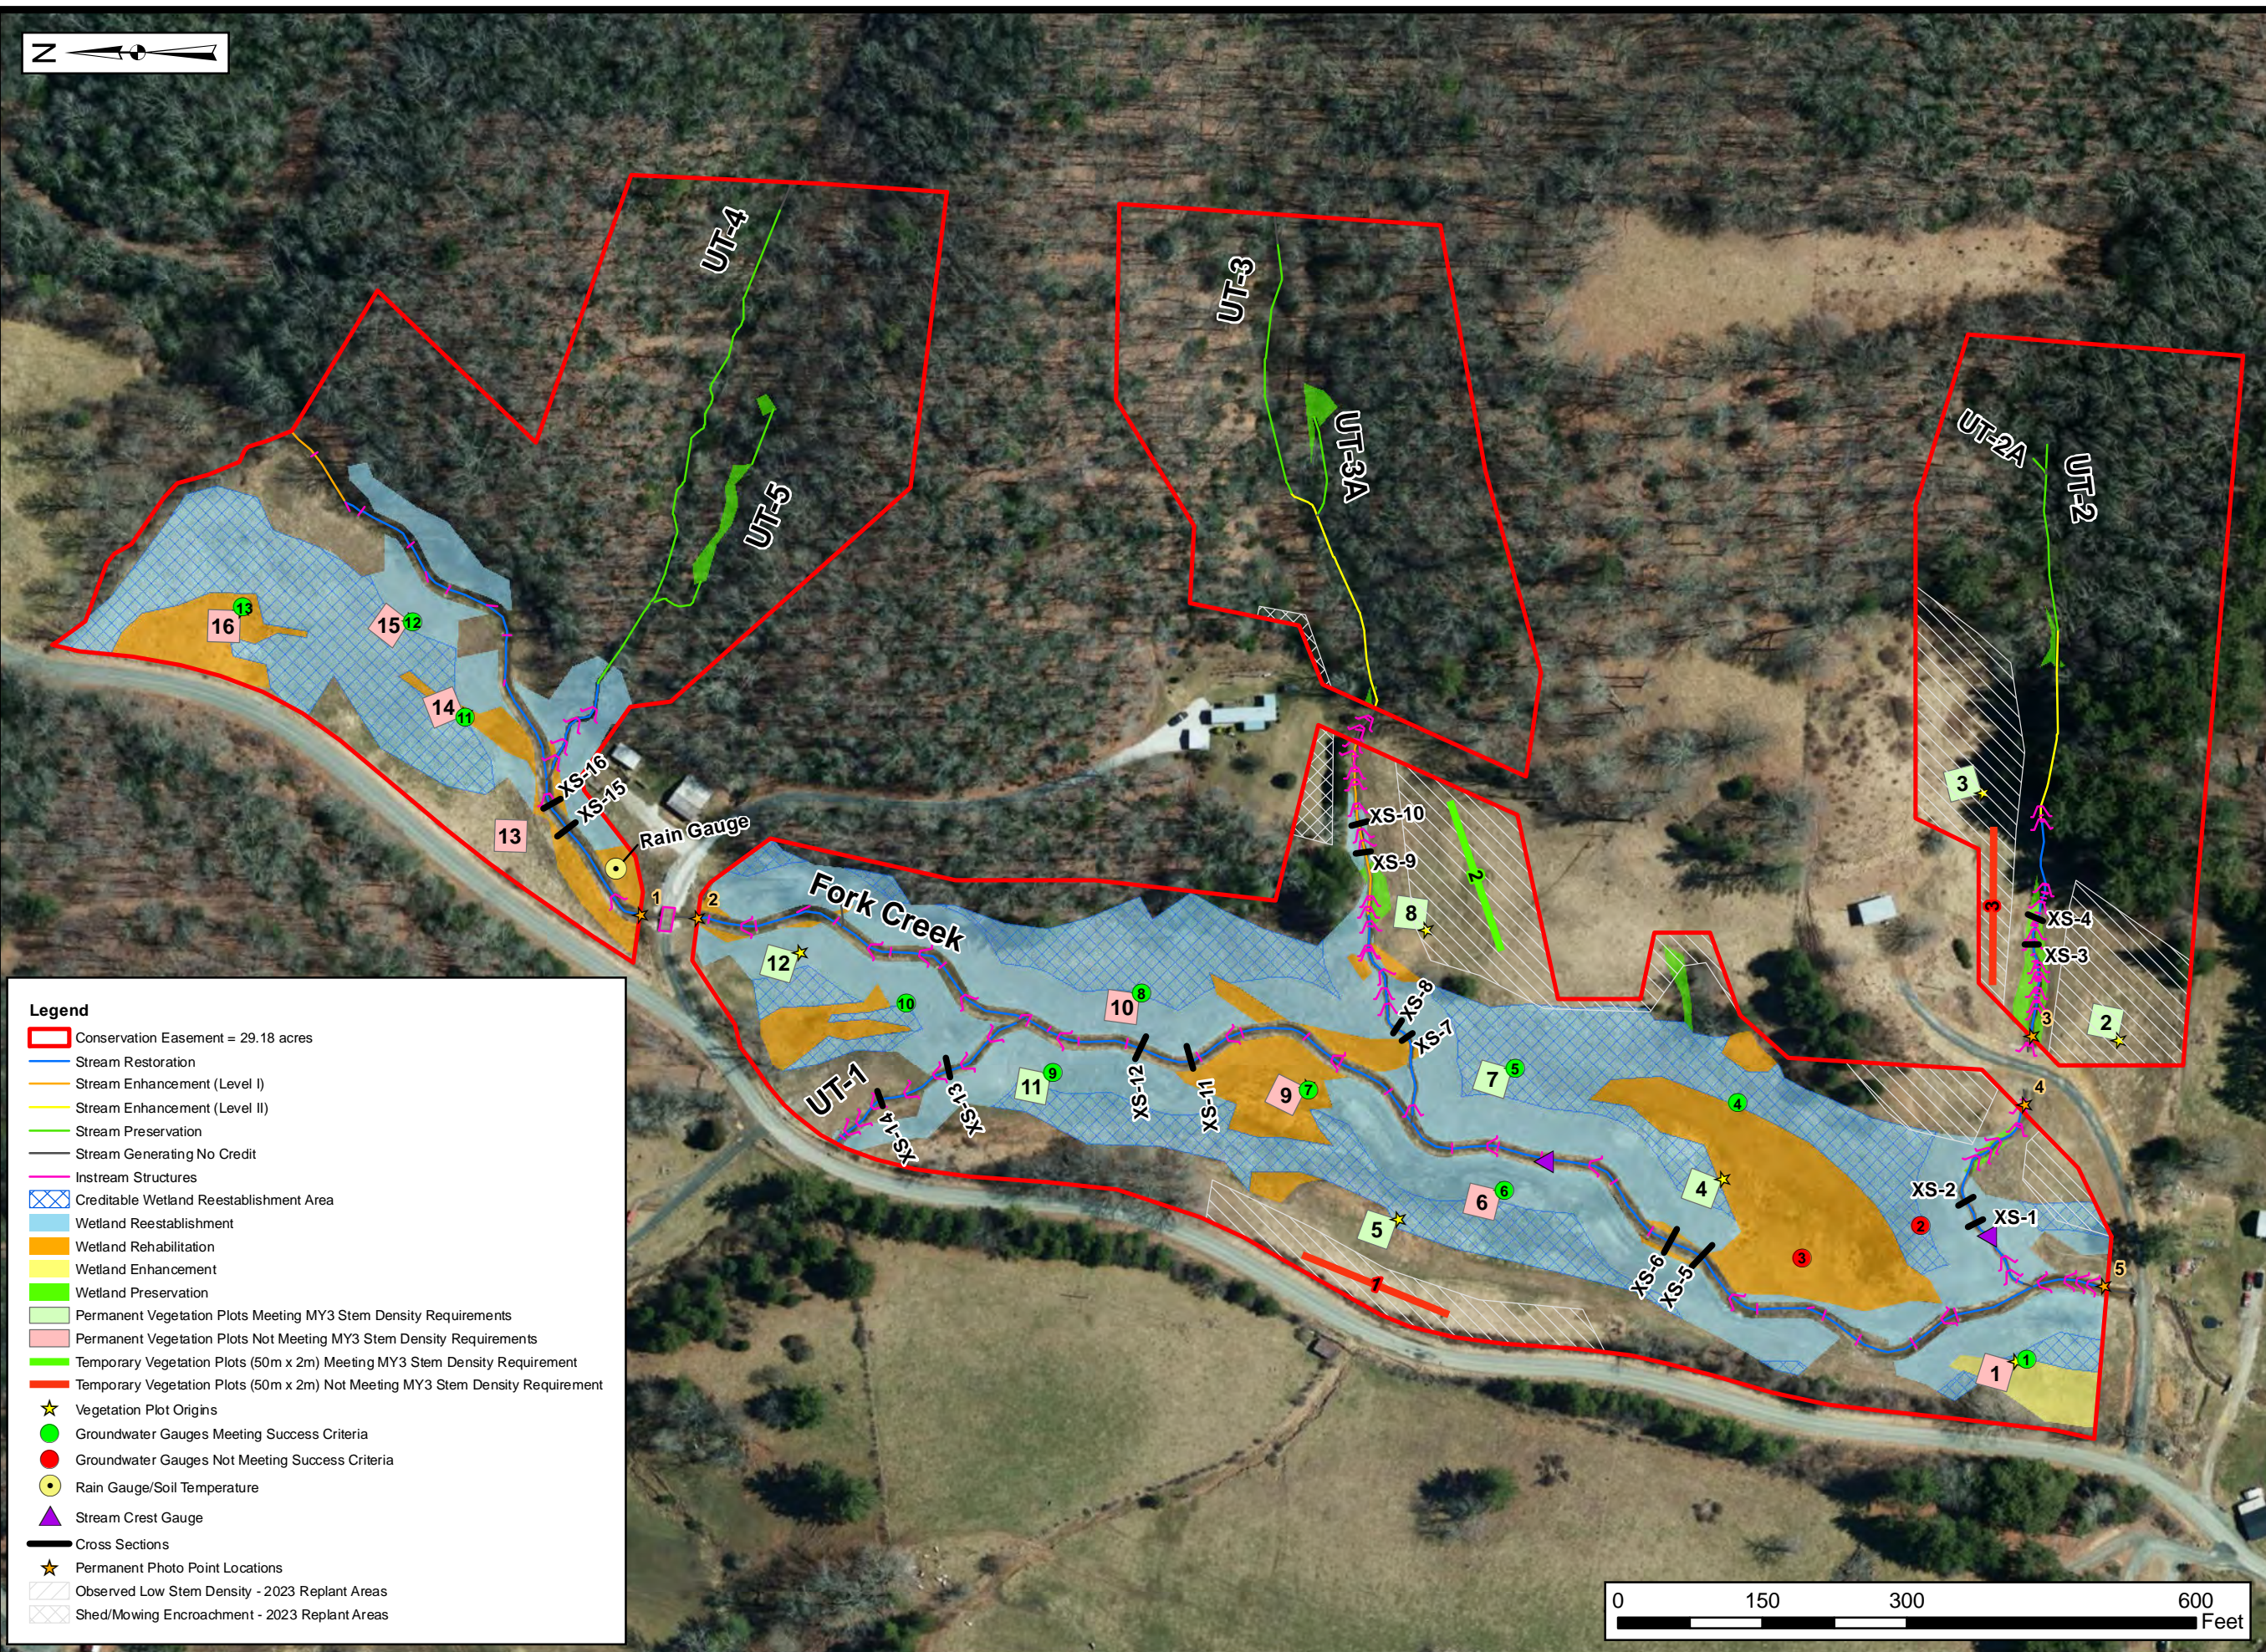
# 1

- Two areas of encroachment were documented and addressed during Year 1. Along UT3, RS worked with the adjacent landowner to remove the shed from the easement, clear the area of debris, and mark the easement boundary with 6-inch treated wood fence posts. The areas will be replanted in early 2023, per the IRT review adaptive management plan, Appendix F.
- No evidence of nuisance animal activity (i.e., heavy deer browsing, beaver, etc.) was observed.

- Measurements of all 16 permanent plots and three (3) temporary plots resulted in an average of 300 planted stems/acre. Additionally, 9 of the 19 individual plots met success criteria during year 1 (Appendix B).
- Several areas of low stem density were observed during year 1 (2022), predominantly along the upland slope (Acidic Cove Forest) areas. RS plans to supplementally plant 2.67 acres of the Site with 1800 bare-root stems during the dormant season 2022/2023. The area includes the 0.107-acre area of encroachment. Species and quantities of stems to be planted are summarized in the table below. The complete plan is provided in Appendix F, along with IRT correspondence.

RS has ordered trees to replant 2.67 acres at a density of 670 stems per acre within observed low stem density areas, which includes the 0.107-acre area of encroachment. These areas are within the Acidic Cove Forest Association. The following species and quantities were secured for Q1-2023 planting.

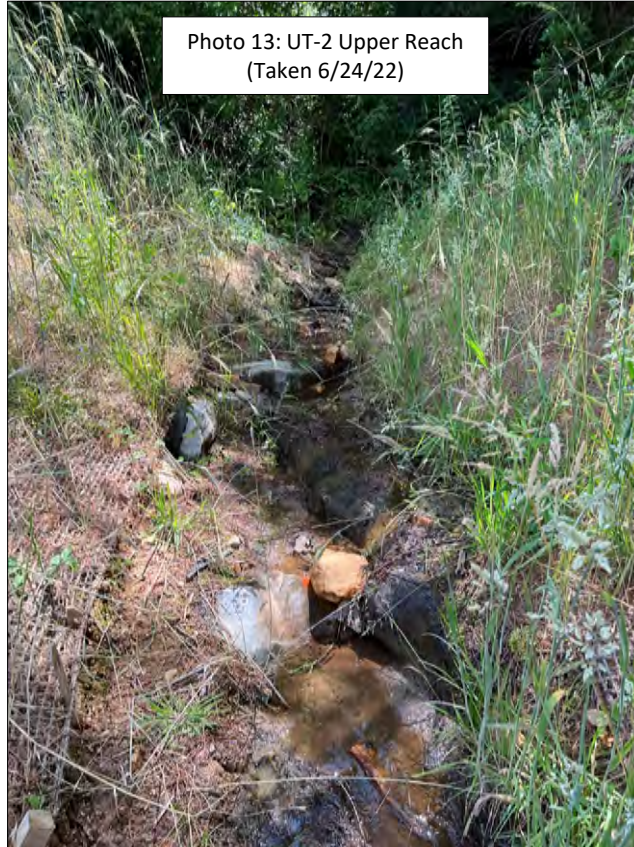
Photo 13: UT-2 Upper Reach  
(Taken 6/24/22)

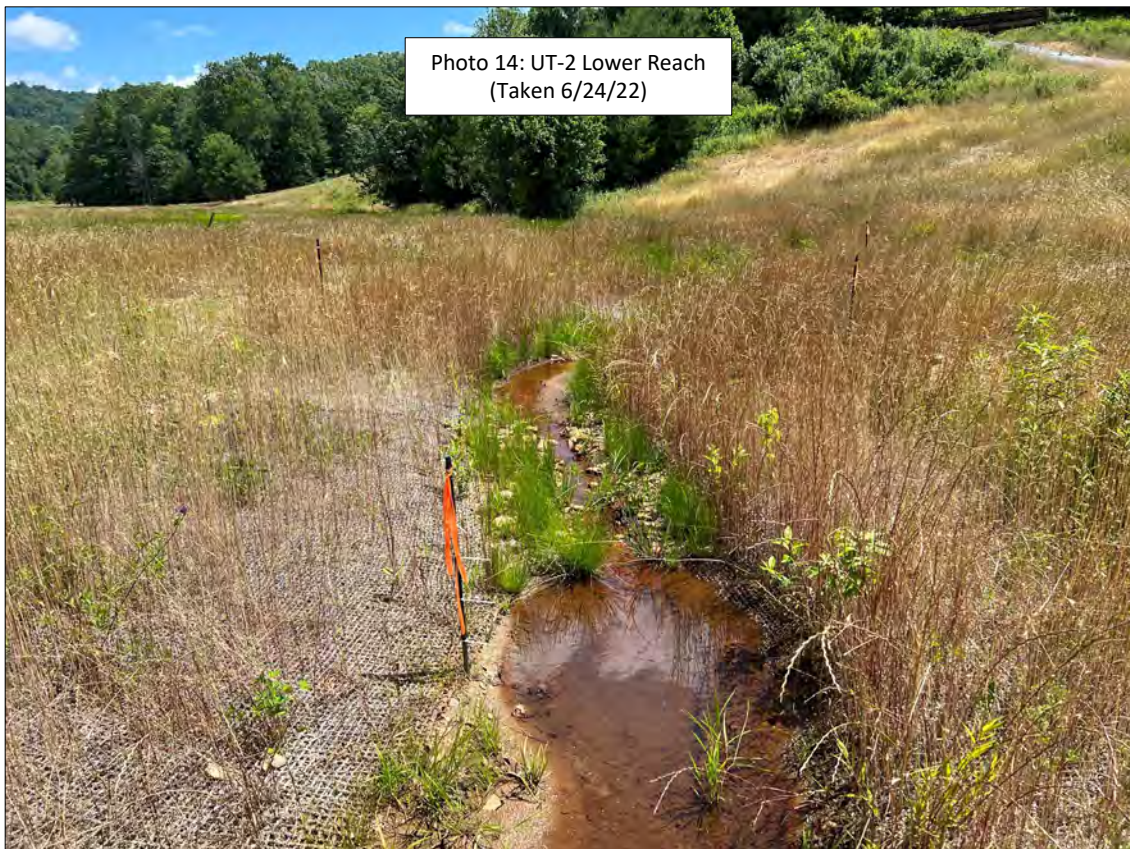
Photo 14: UT-2 Lower Reach  
(Taken 6/24/22)

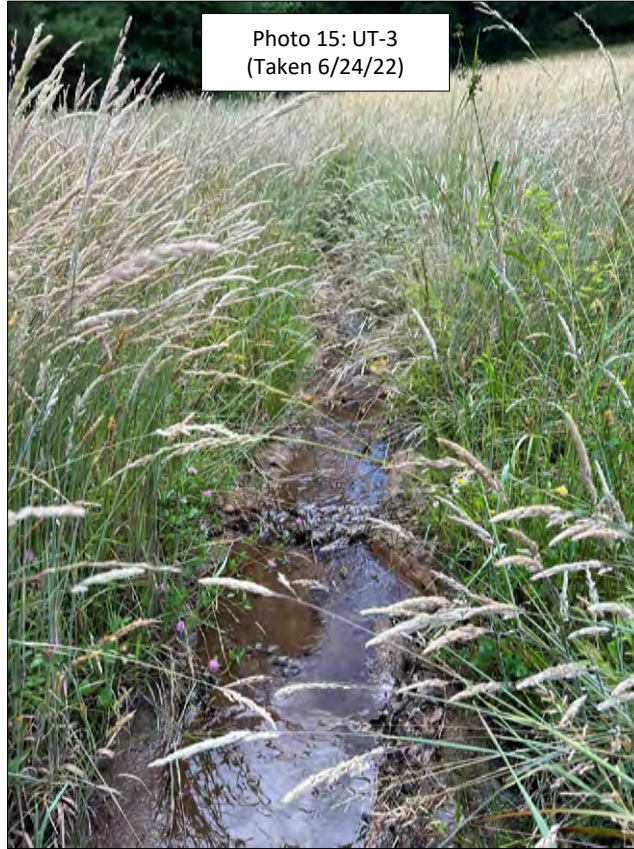
Photo 15: UT-3  
(Taken 6/24/22)

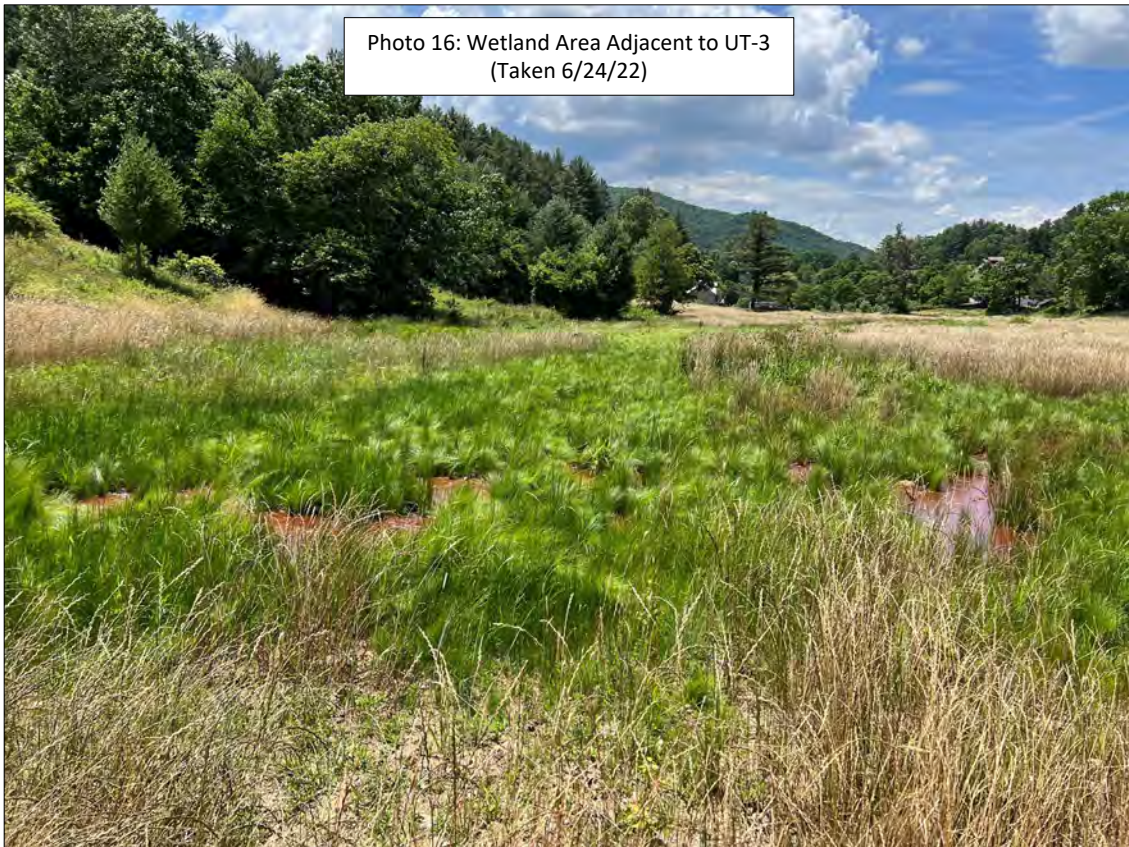
Photo 16: Wetland Area Adjacent to UT-3  
(Taken 6/24/22)
