Lewis Creek Stream Restoration Henderson County, North Carolina

DMS Project #733
NCDEQ Contract #5631

MY – 05 Monitoring Report

Data Collected: September-November 2015
Submitted: December 2015

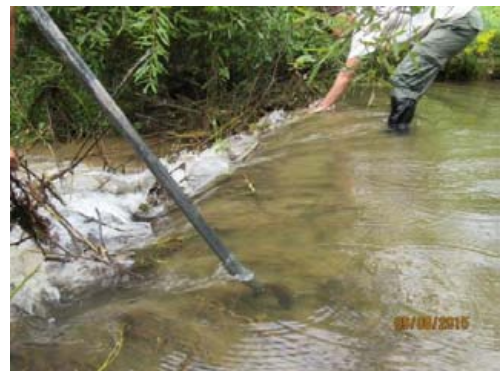
During our fall site visit in September, MMI observed evidence of an active beaver dam at approximately station 7+75 just upstream from VP-03 that was backing up water for roughly half

the project. MMI staff manually removed this dam to facilitate the longitudinal survey, and informed DMS about the presence of beaver at that time. A DMS contractor was subsequently notified in September 2015 and is conducting monthly site visits to trap beaver and remove dams as necessary.

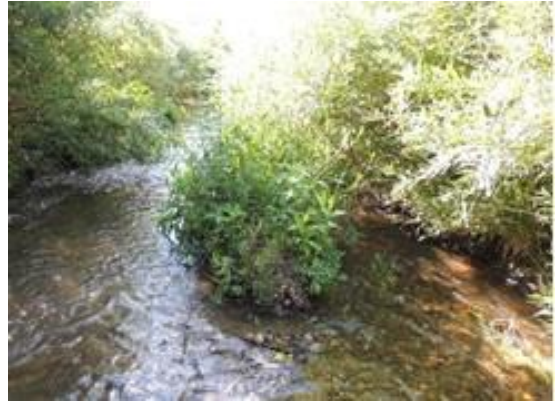
Several center bars persist in the stream channel and have been closely watched in all monitoring years. Larger bars occur at approximately Stations 8+50 and 11+50. Smaller center bars that had been observed downstream in past years were flooded this year due to the beaver activity. In general, these center bars are not a cause for concern as the streambank vegetation along these reaches is preventing lateral migration of the stream. The stream flows continue to be adequate to keep most in-stream vegetation from overtaking the stream channel even in summer months.

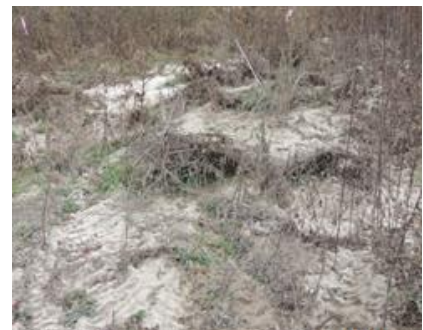
With respect to planted vegetation, the only minor problem we observed in 2015 is the continuing sand deposition in isolated flood plain areas, as noted in previous years. Cumulatively, these areas represent a relatively small amount of the site area below the mapping threshold (~0.1 acres), as noted on table 6. These

areas of sand deposition tend to support annual herbaceous vegetation that can root quickly in the new sand piles.
