# MONITORING YEAR 0 ANNUAL REPORT FINAL

## Liberty Rock Mitigation Site

Randolph County, NC  
Cape Fear River Basin  
HUC 03030003

DMS Project No. 100135  
NCDEQ Contract No. 7877-01  
DMS RFP No. 16-007877  
NCDWR Project No. 2020-0035 v1  
USACE Action ID Number 2020-00047

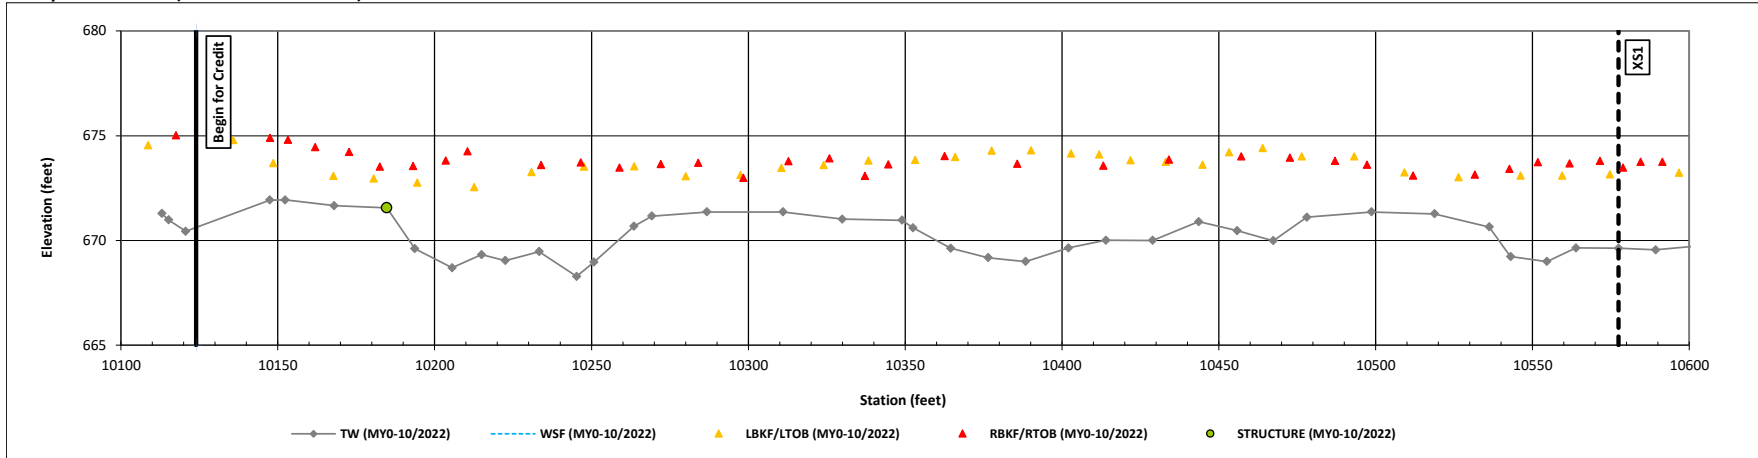
**Rocky River Reach 1 (STA 101+24 to 106+00)**

\*No water present in channel at the time of survey, water surface not shown.

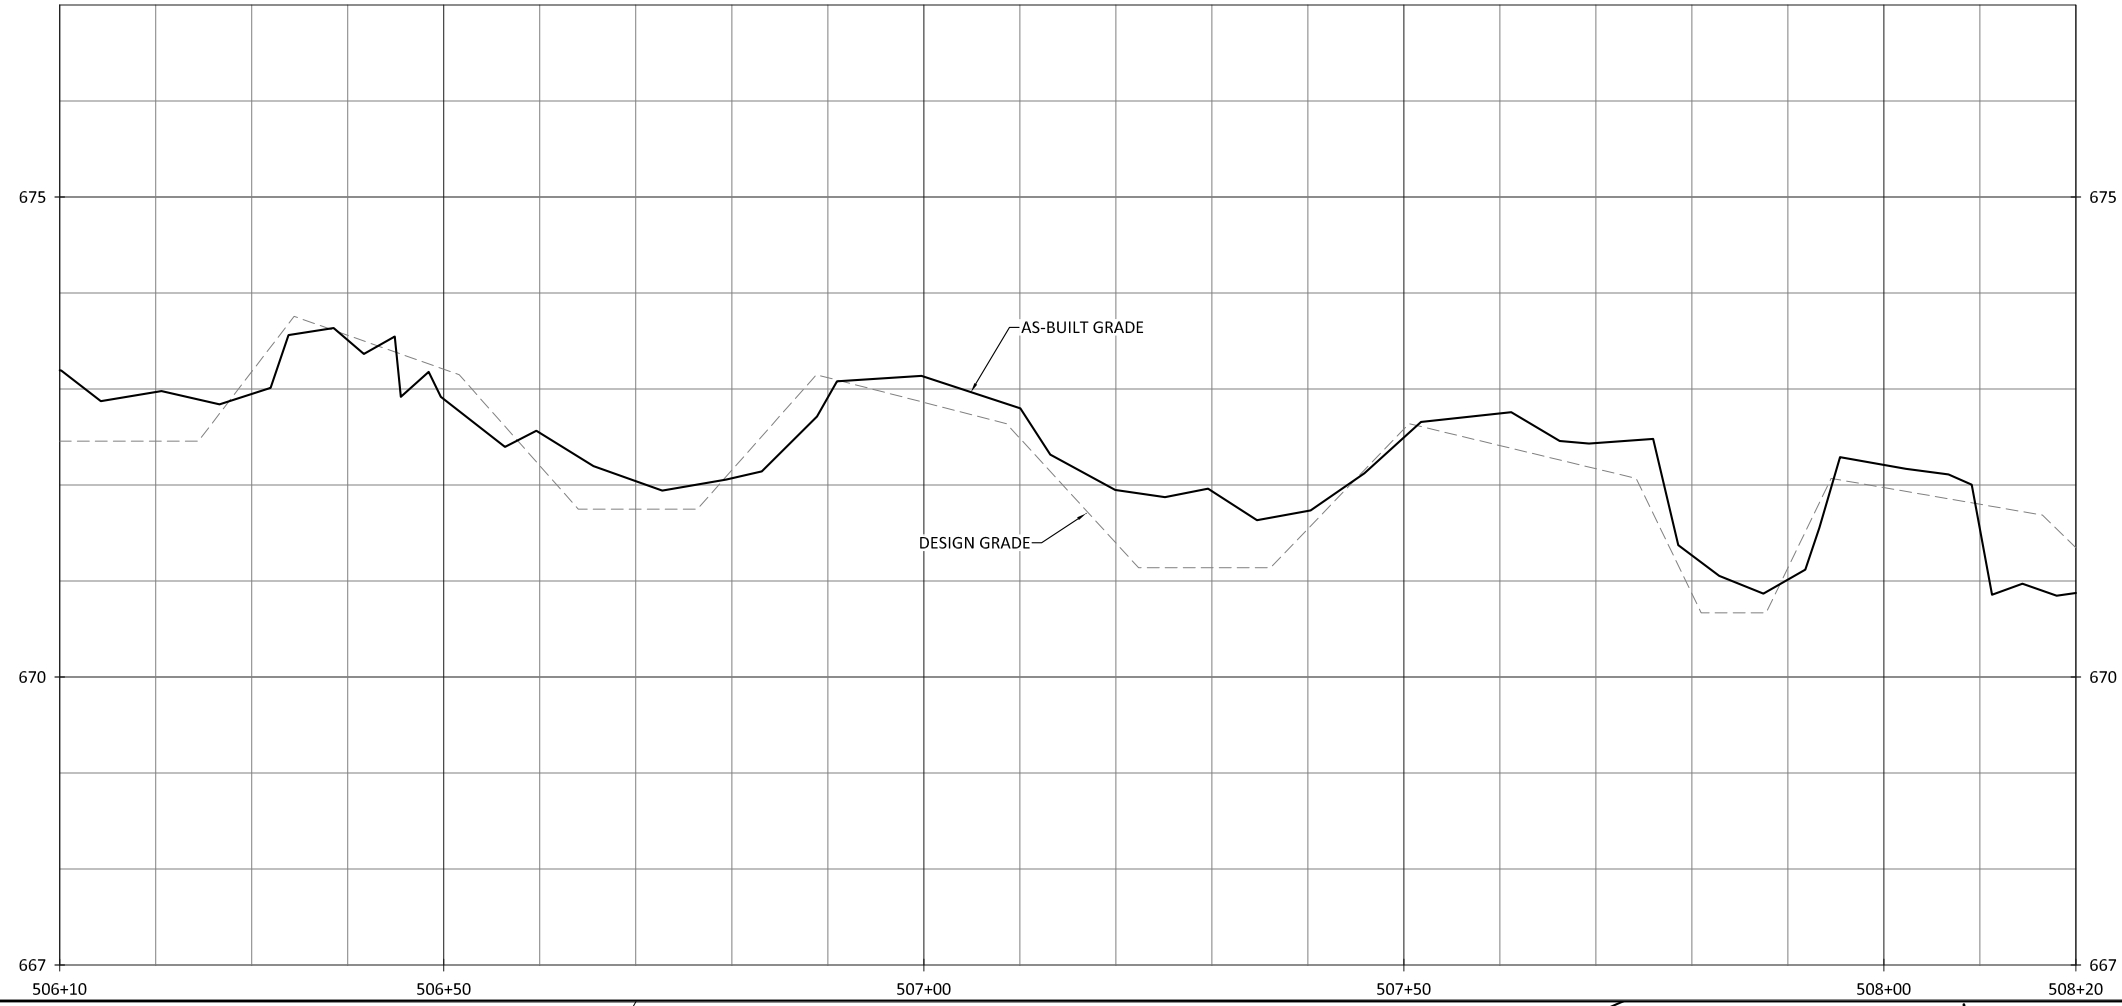
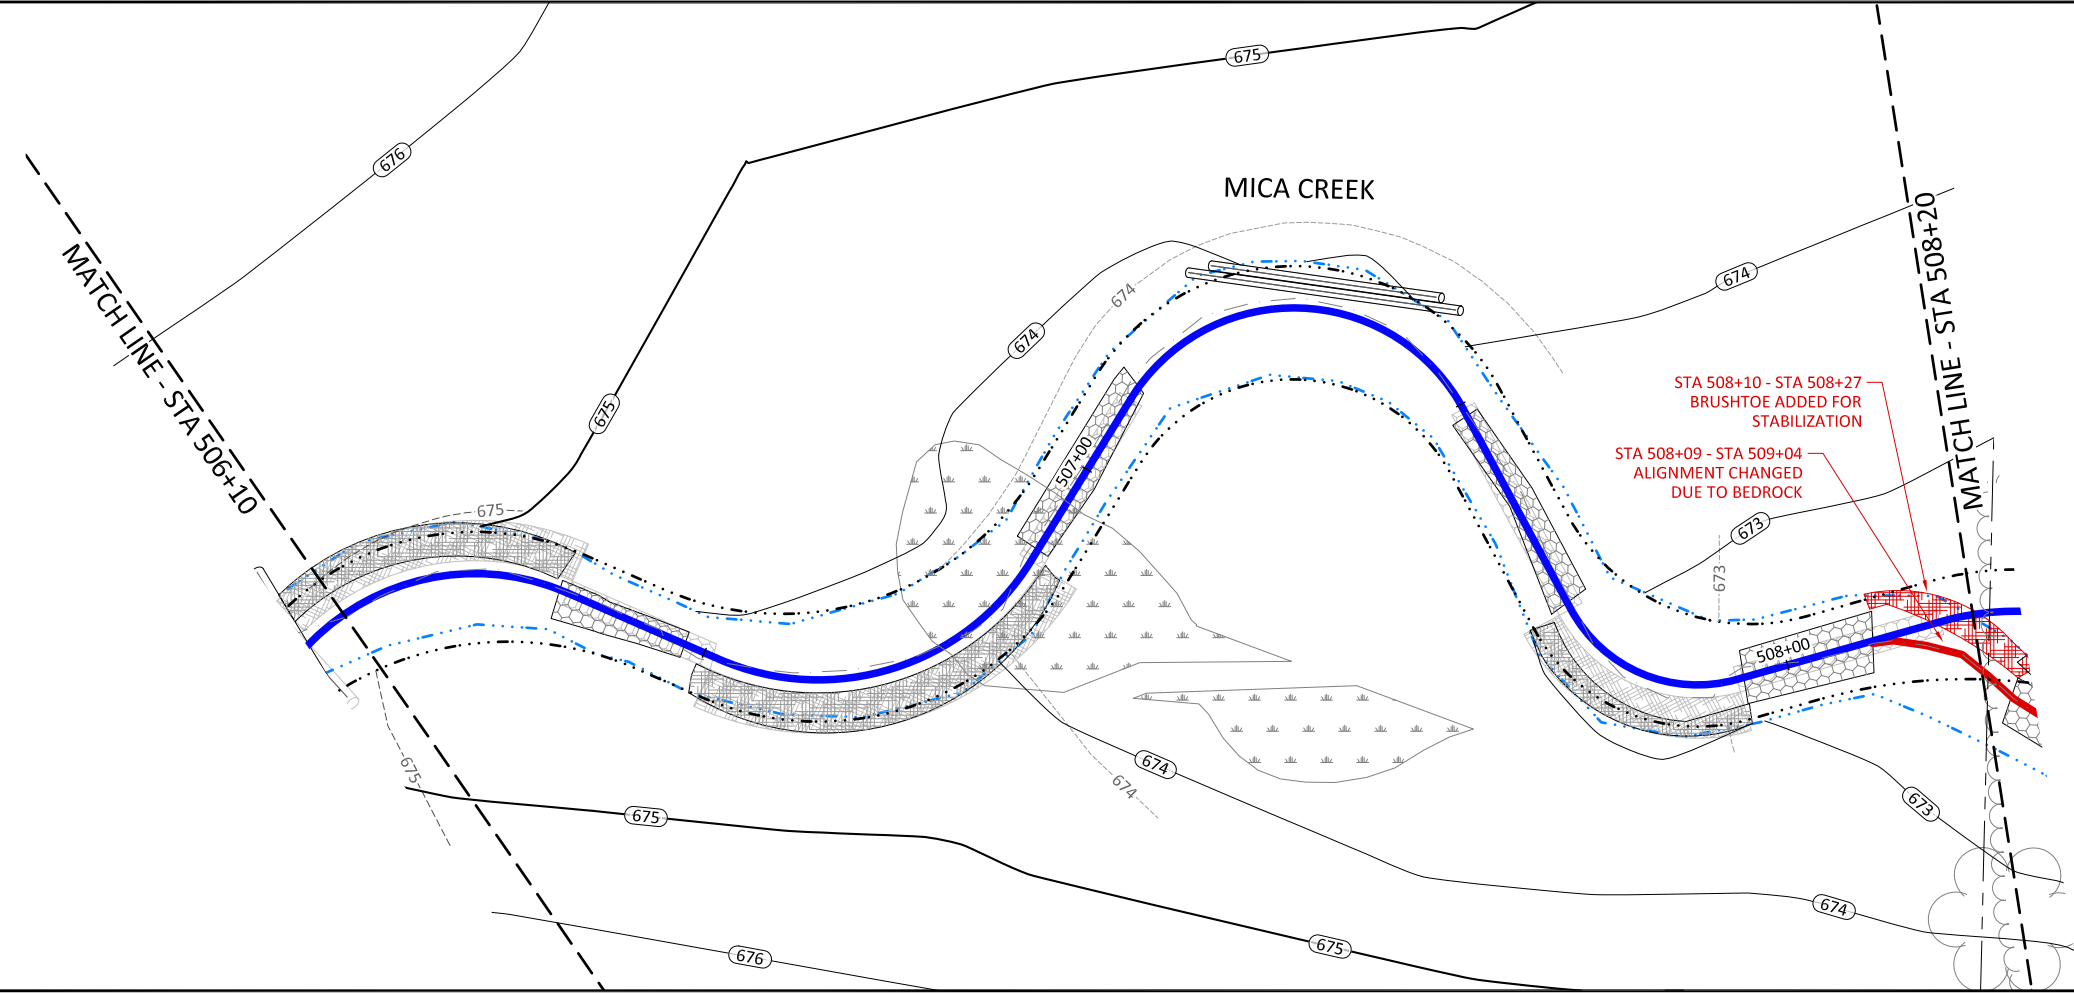
5. Sheet 1.15 – Similar to comment above. A log sill is shown on the first riffle (~506+50) that is not shown on the mit plan drawings, and is not colored red.

*The structure shown is included in an existing angled log riffle shown and approved in the mitigation plan drawings; the additional symbology has been removed to maintain consistency.*
