Lick Creek Stream Restoration Site MONITORING REPORT 2007 (Year 2)

Cataloging Unit: 0303004 EEP Contract #: D04013-1

December 7, 2007

Wolf Creek Engineering, PLLC
30 Ben Lippen School Rd.
Asheville, NC 28806

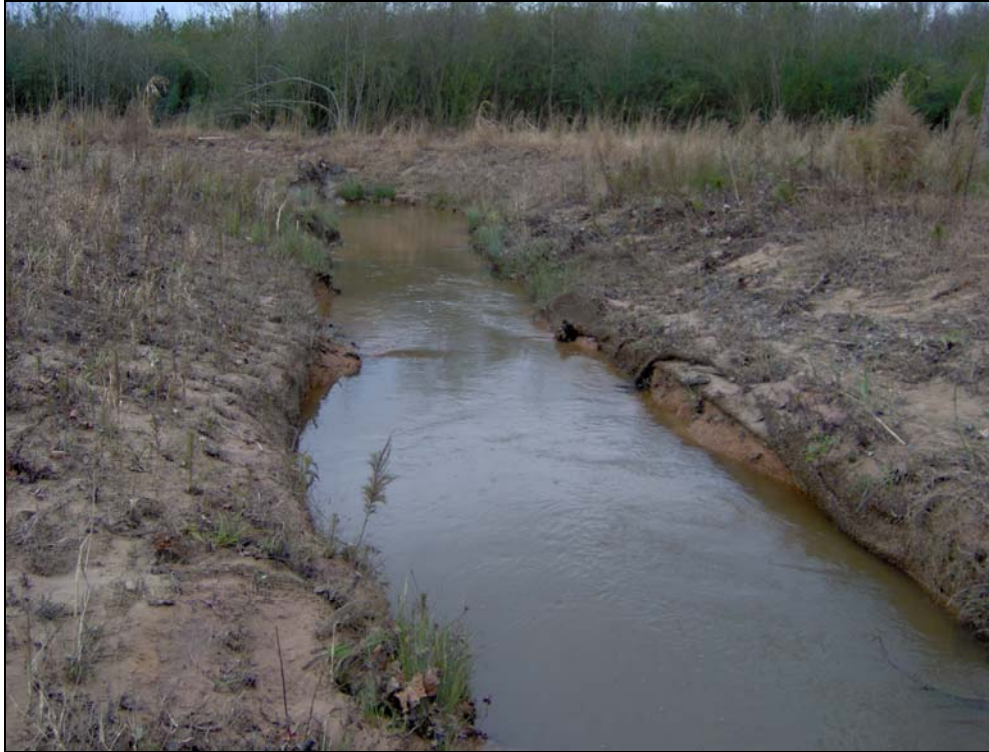
Toe Scour on Lick Creek, STA 23+00 12/03/06
Photo No. 17

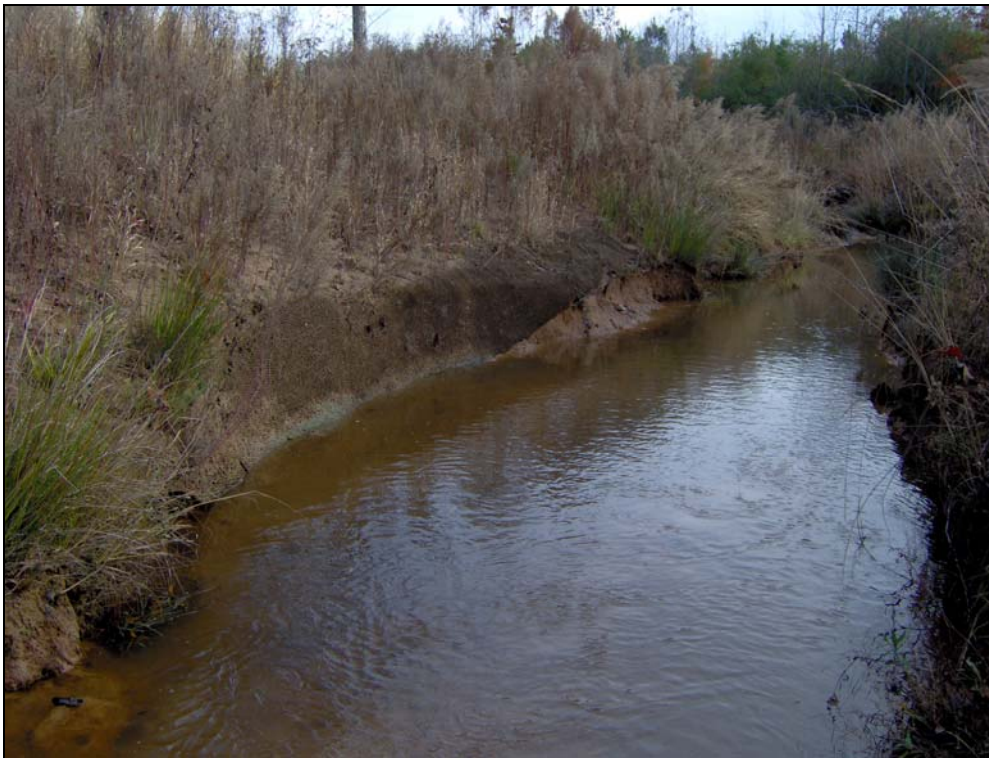
Toe Scour on Lick Creek, STA 23+00 11/27/07
Photo No. 18

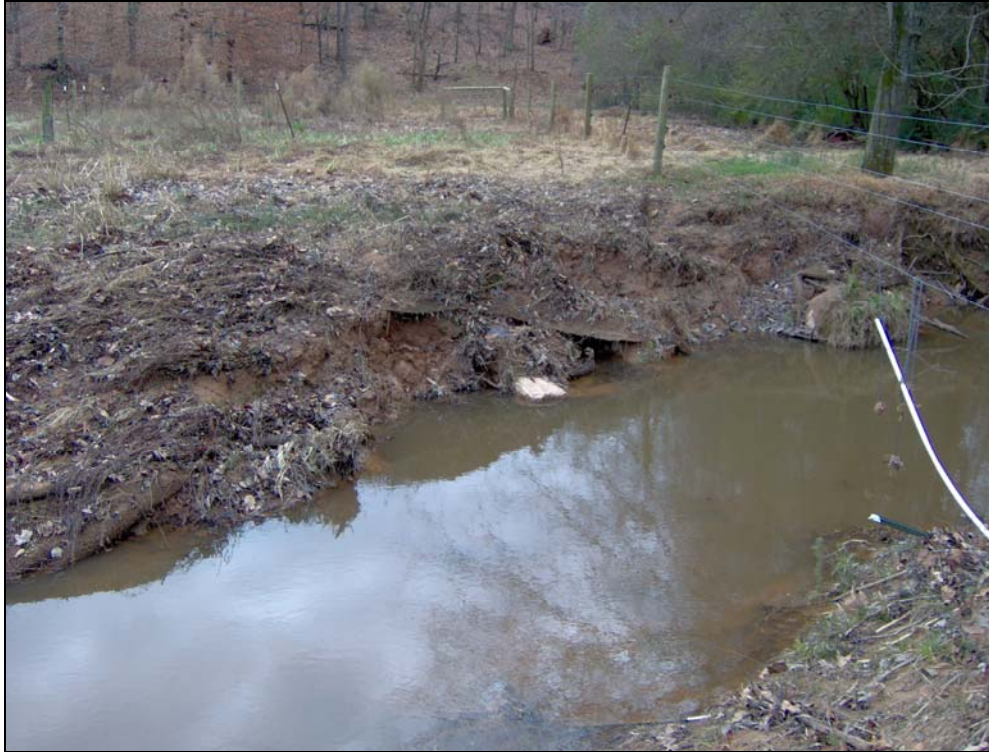
Bank Erosion at Wallace Branch, STA 10+00 12/03/06
Photo No. 19

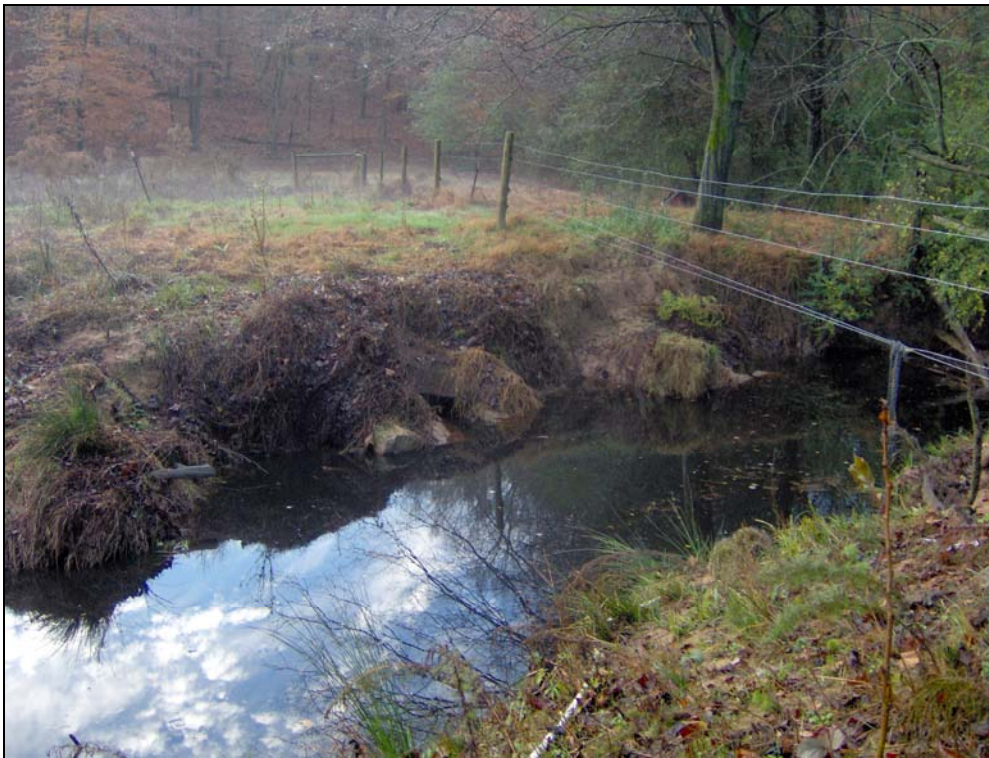
Bank Erosion at Wallace Branch, STA 10+00 11/27/07
Photo No. 20

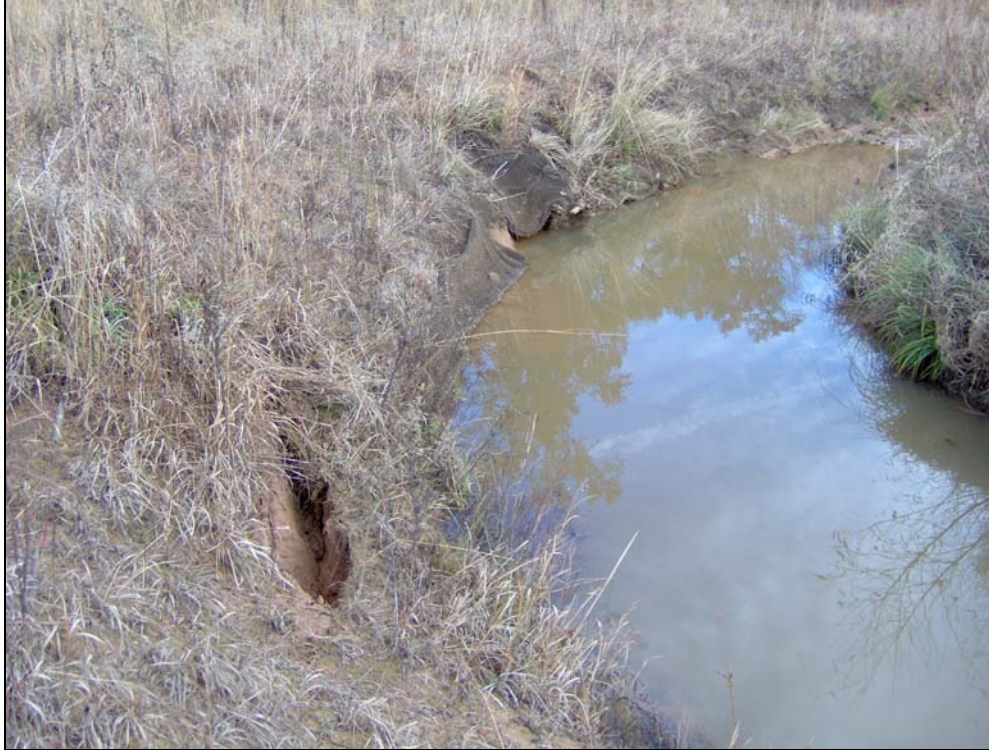
Representative toe scour on outside of bend, Lick Creek STA 40+50 11/27/07
Photo No. 24

Physical repair of structures or eroded toe and bank areas does not appear to be warranted at this time. As noted in the vegetation assessment of this report, supplemental live staking will be installed in areas along the toe or bank exhibiting bare soil.

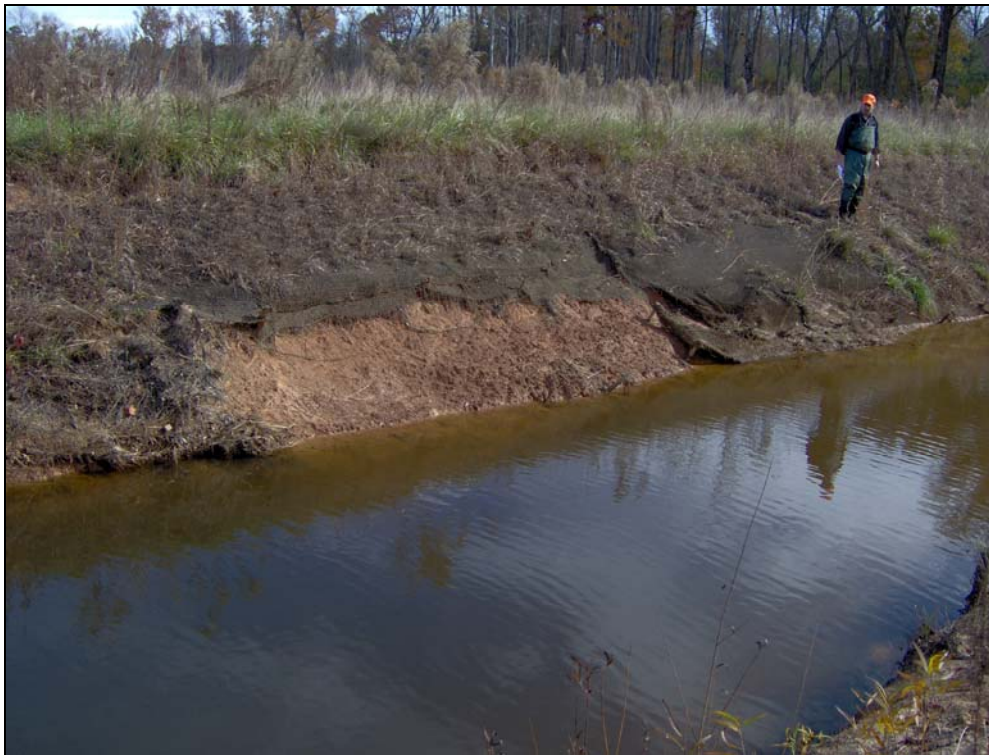
Loss of Matting, Lick Creek STA 37+50, 11/27/07
Photo No. 25

There are a number of localized areas where the combination of shear stress, loss of matting, and drought conditions have resulted in bare banks and toes. Supplemental live staking will be installed in these areas this winter.
