# Lick Creek Stream Restoration Site MONITORING REPORT 2009 (Year 4)

Cataloging Unit: 0303004 EEP Contract #: D04013-1

**December 11, 2009**

Wolf Creek Engineering, PLLC  
51 North Knob Lane  
Weaverville, NC 28787

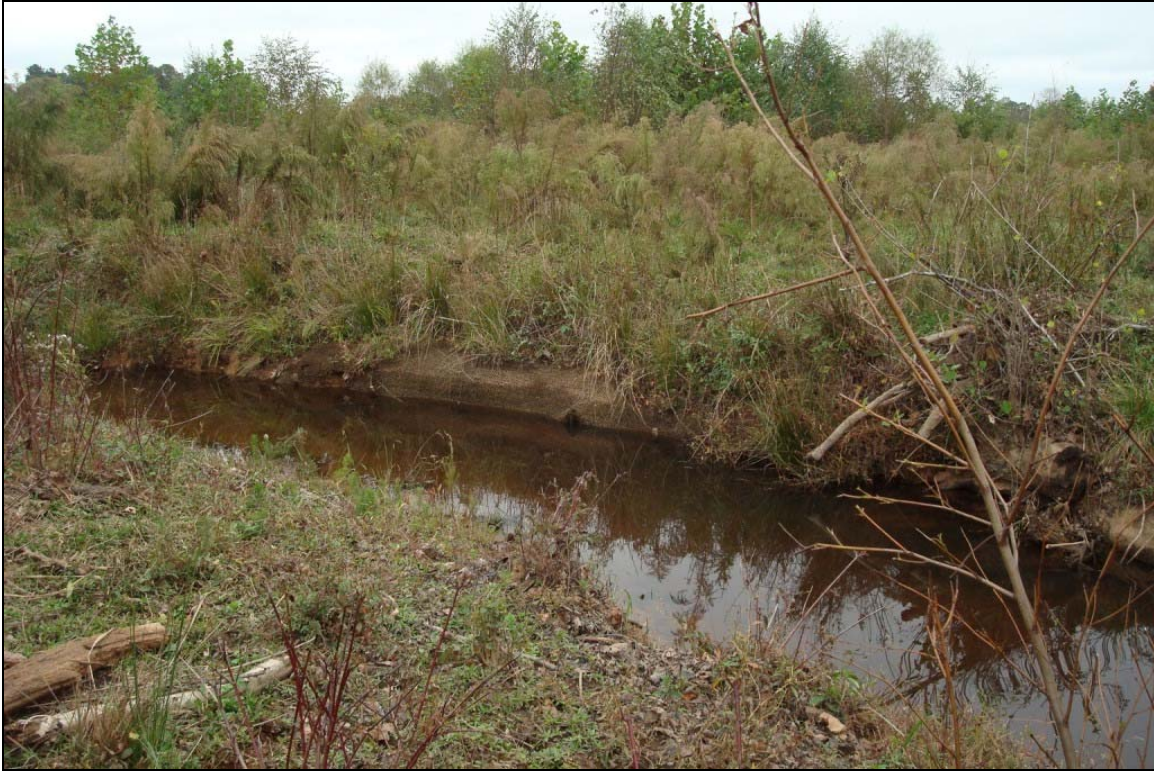
Photo No. 17

Bank Erosion at Wallace Branch, Sta 13+90

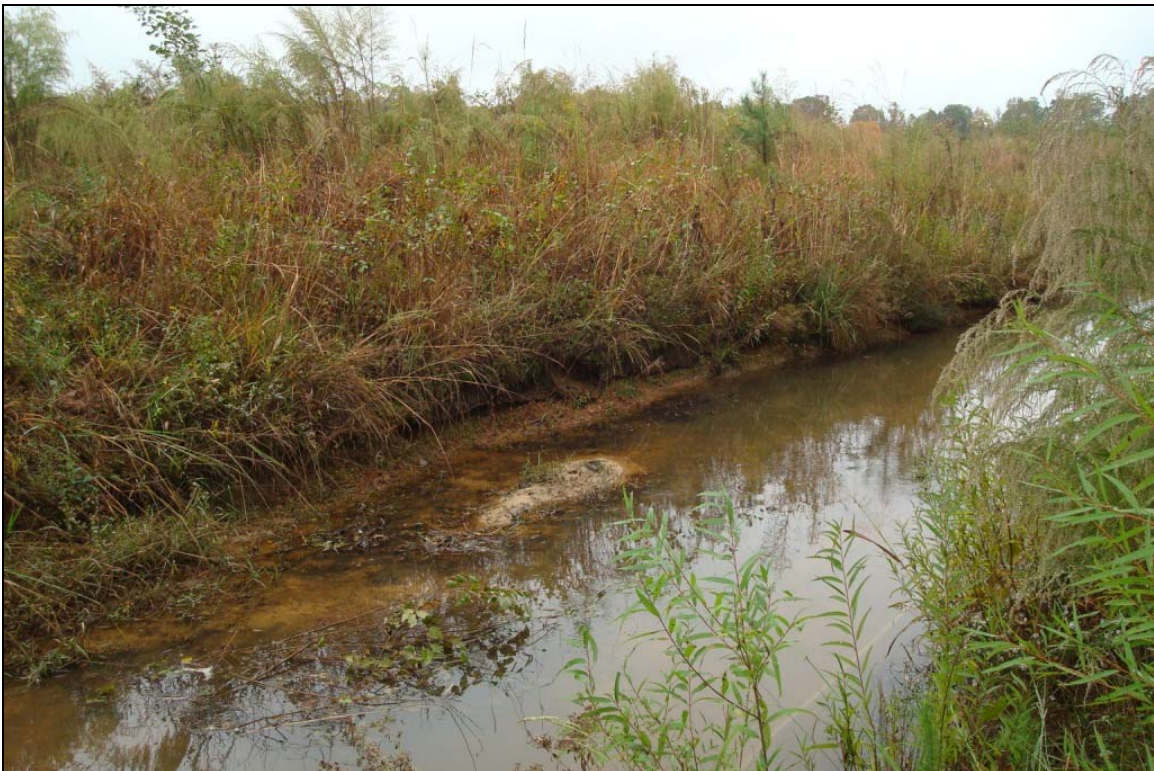
Photo No. 18

Toe Scour at Lick Creek, Sta 40+25

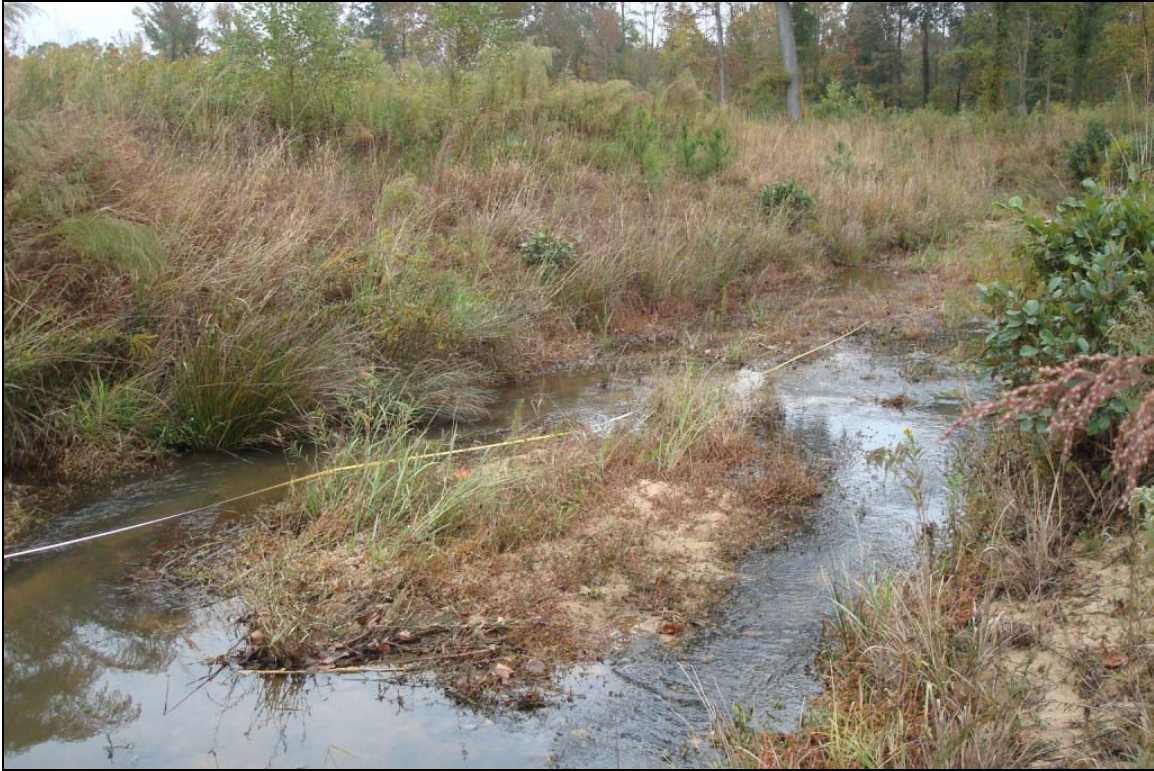
Photo No. 19

Formation of Mid-Channel Bar on Lick Creek, Sta 44+90

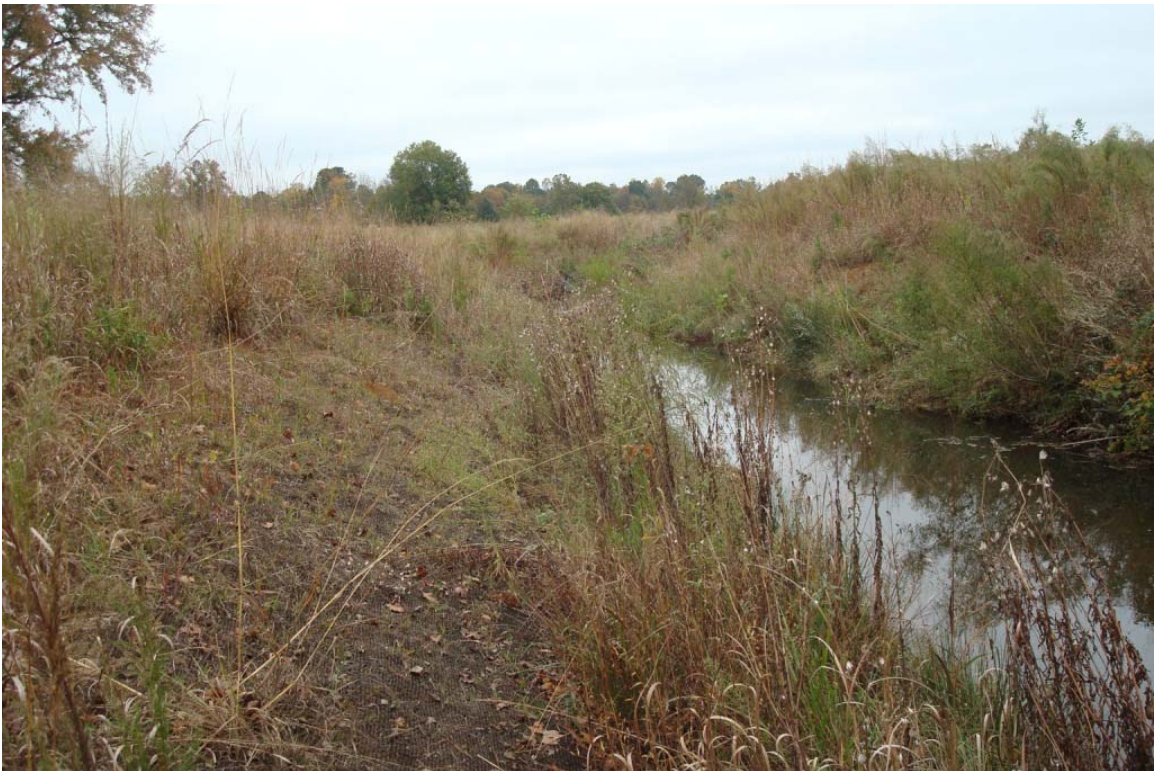
Photo No. 20

Weak Bank Vegetation on Wallace Branch, Sta 42+40

- 1) Continued visual monitoring of areas of concern.
- 2) Re-seed areas of weak vegetation along banks and terrace.

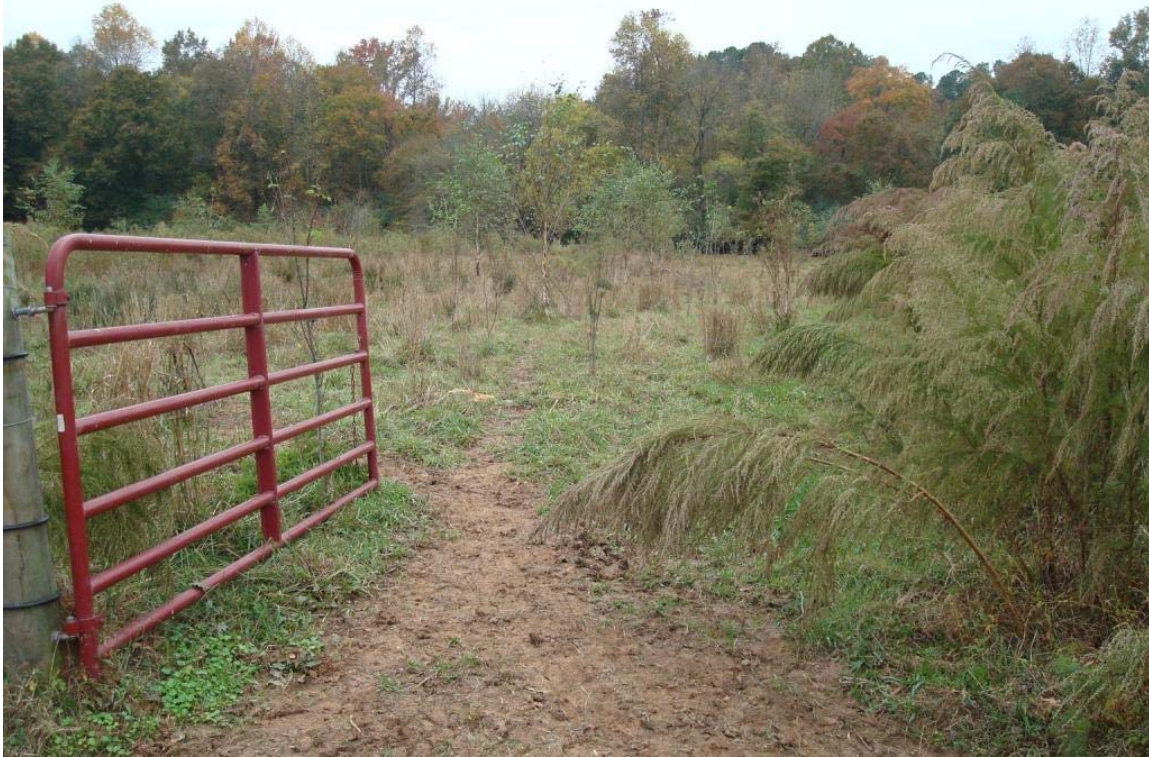
Cattle have had access to the upstream portion of Wallace Branch for what appears to be a prolonged period. During performance of the Year 4 monitoring survey, it was observed that an agricultural gate was open allowing unrestricted livestock access to the planted buffer adjacent to the agricultural ford crossing. Woody and herbaceous vegetation was severely impacted by over-grazing. The livestock were removed from the easement and the gate has been secured.

Cattle Access on Wallace Branch, Sta 15+50  
Photo No. 21

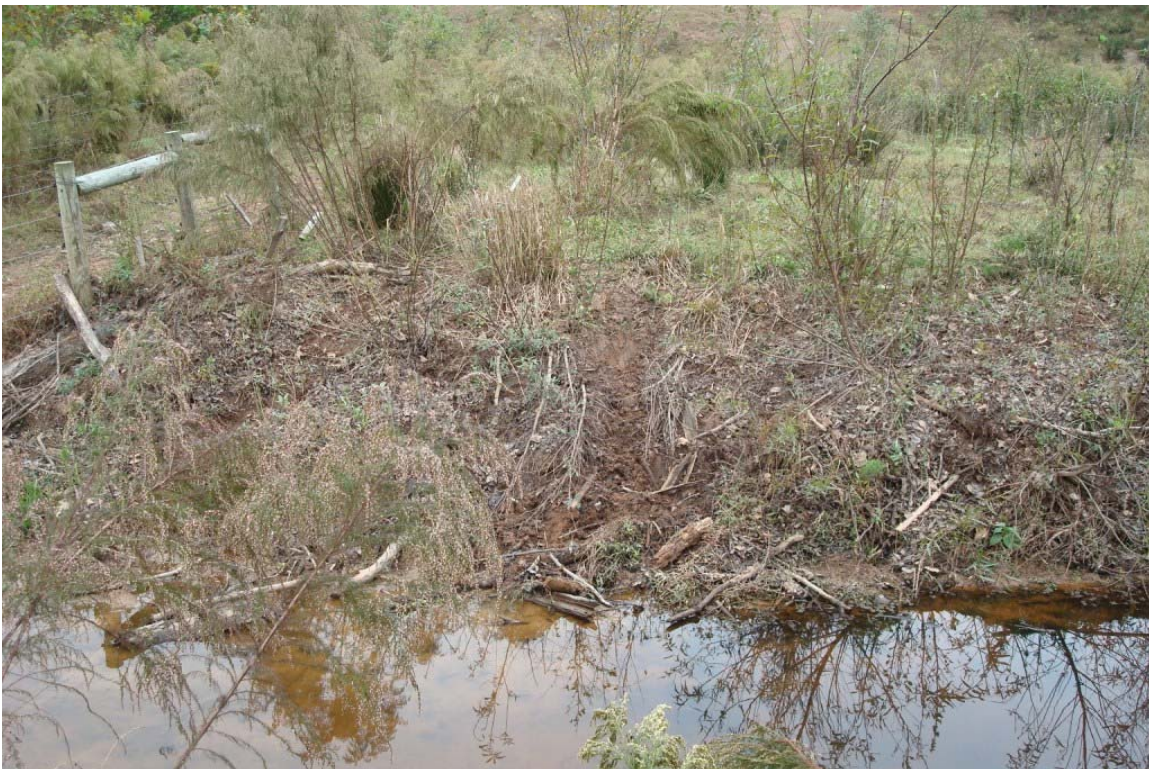
Banks Impacted by Cattle on Wallace Branch, Sta 14+30  
Photo No. 22

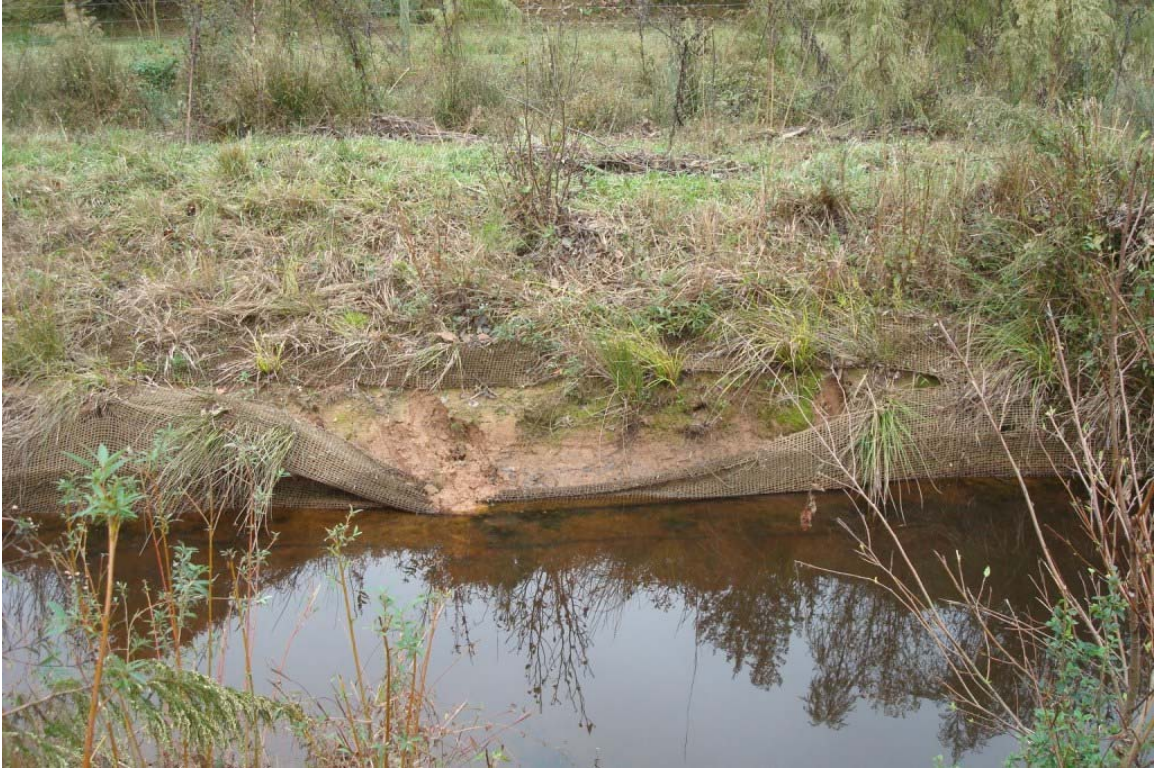
Banks Impacted by Cattle on Wallace Branch, Sta 12+30  
Photo No. 23

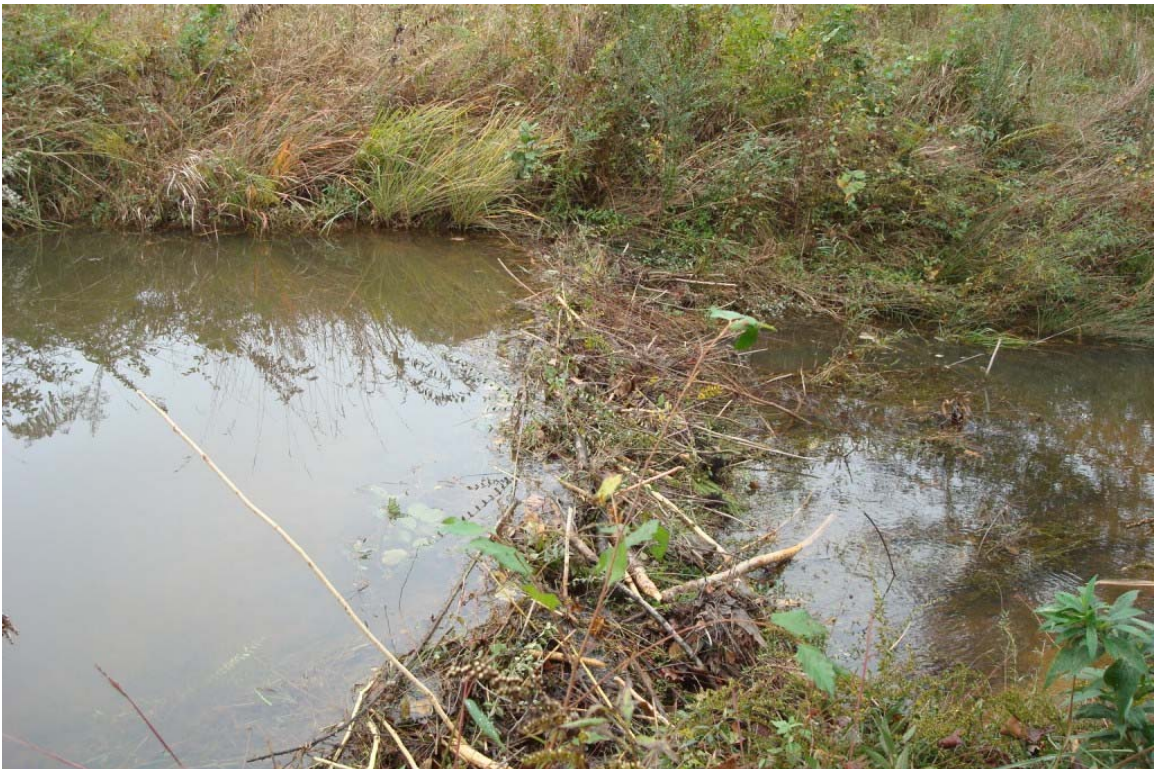
Photo No. 24

The Year 3 monitoring report identified several problem areas as part of the stream assessment. Of these areas, thirteen (13) are no longer areas of concern as they have been repaired and six (6) have stabilized through natural channel process or vegetation growth. However, livestock access and beaver activity have resulted in new areas of concern. Livestock access at the upstream end of Wallace Branch resulted in severe impacts to riparian buffer vegetation and there are several locations where cattle directly impacted the channel banks. At the lower end of Lick Creek, two beaver dams have been constructed, one at Sta. 61+00 and one immediately downstream of the Site which were creating backwater within the channel banks on approximately 800 ft. of the site. The dam at Sta 61+00 has since been removed and the area will be monitored for beaver activity.

Beaver Dam on Lick Creek, Sta 61+00
