Lick Creek Stream Restoration Site MONITORING REPORT 2010 (Year 5)

Cataloging Unit: 0303004 EEP Contract #: D04013-1

October 21, 2010

Wolf Creek Engineering, PLLC
51 North Knob Lane
Weaverville, NC 28787

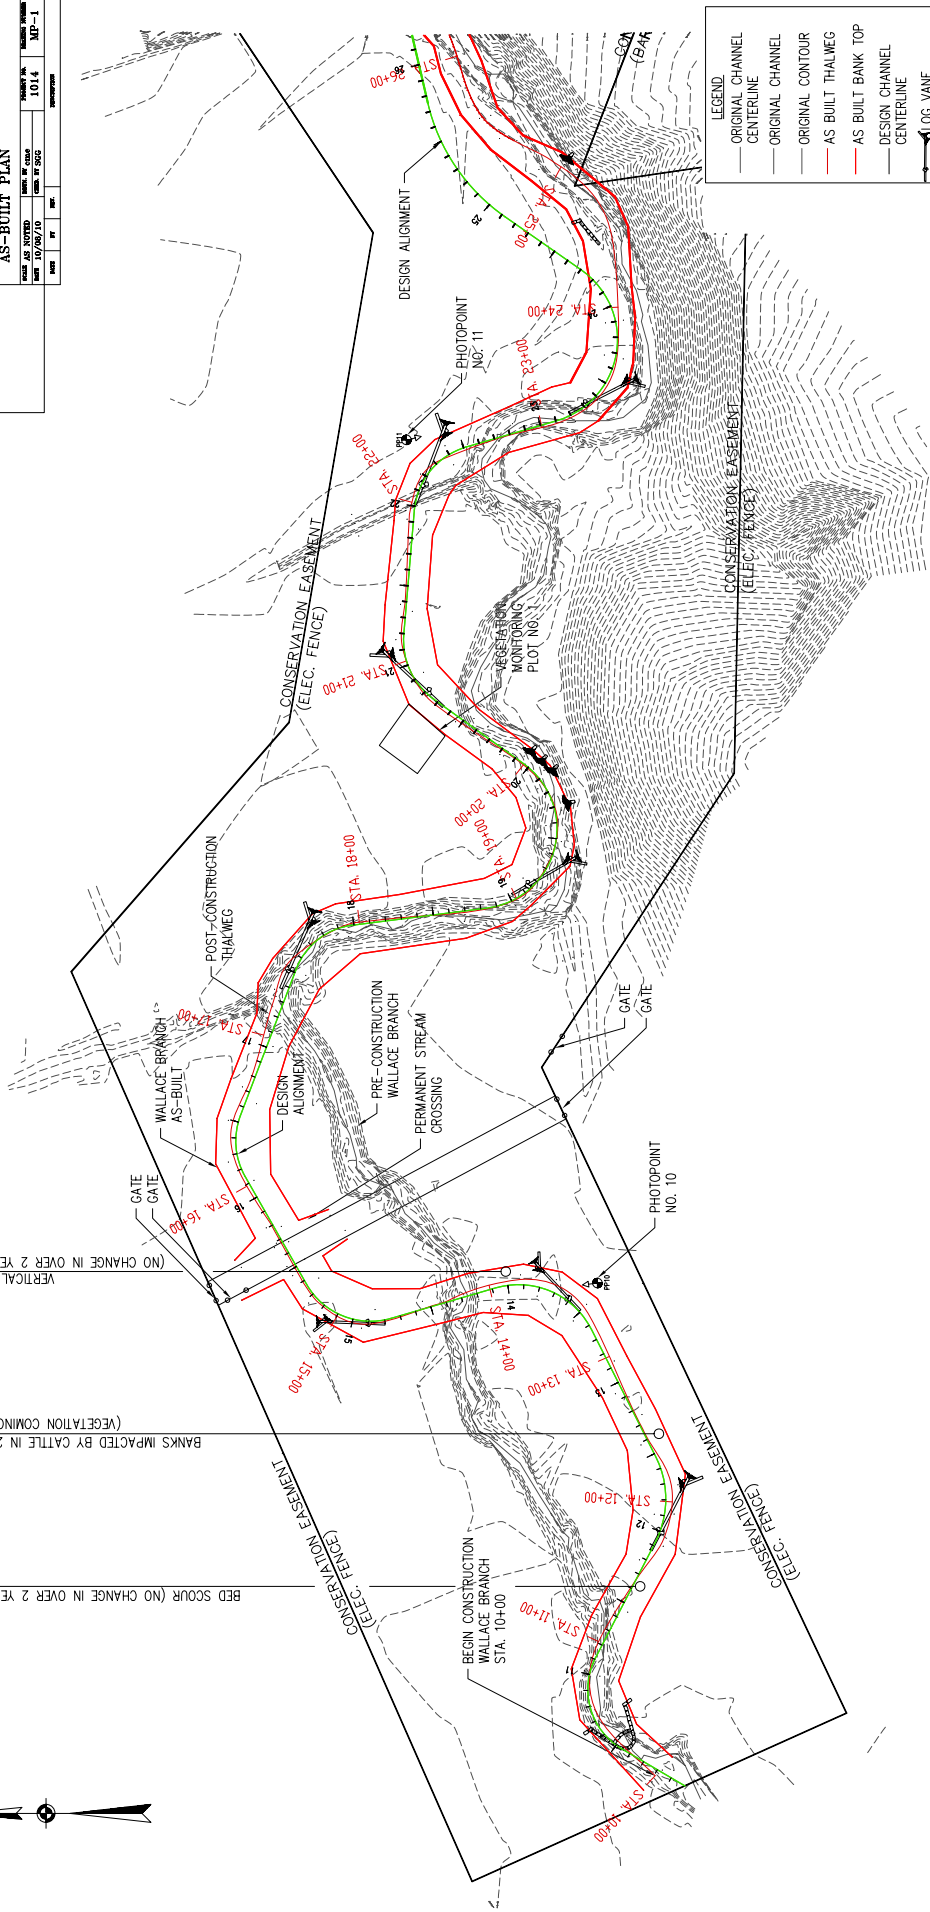
PROJECT NO: 1014
 SHEET NO: MP-2

BANKS IMPACTED BY CATTLE IN 2009
 (VEGETATION COMING IN)

VERTICAL TOE
 (NO CHANGE IN OVER 2 YEARS)

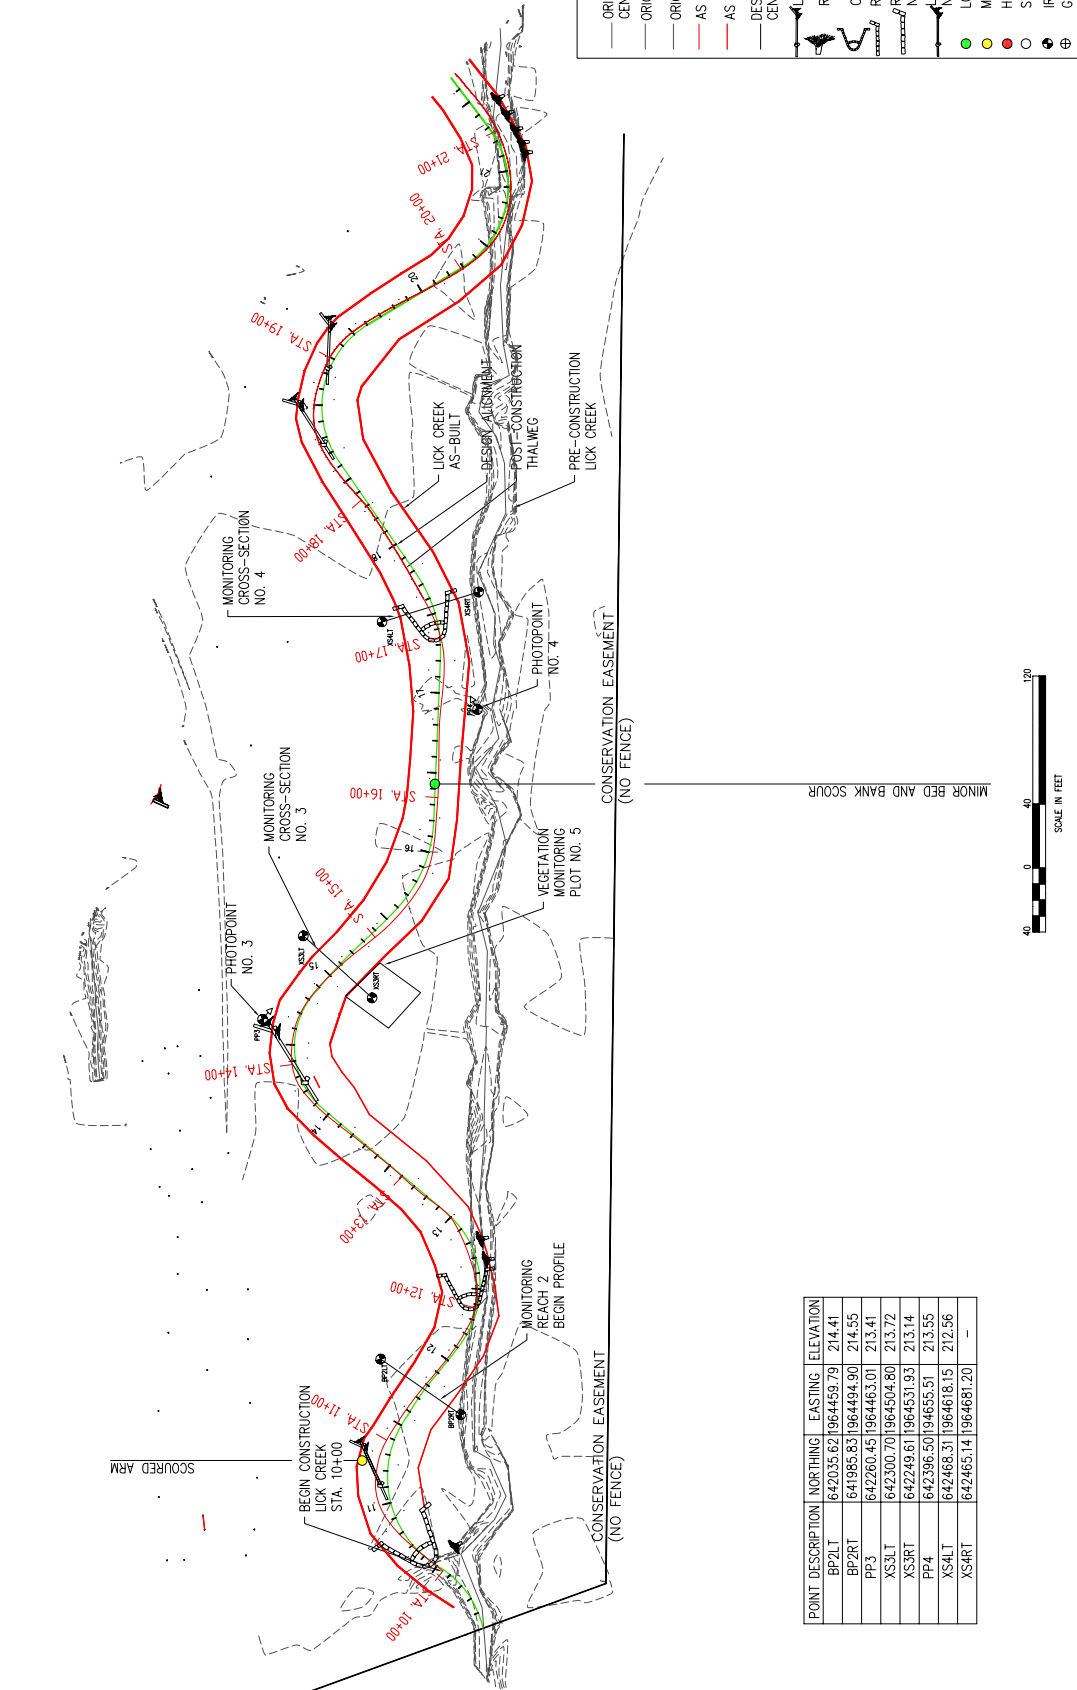
WEAK BANK VEGETATION
 BED SCOUR (NO CHANGE IN OVER 2 YEARS)
 BEAVER DAM
 BED SCOUR (NO CHANGE IN OVER 2 YEARS)
 MINOR BED SCOUR (NO CHANGE IN OVER 2 YEARS)

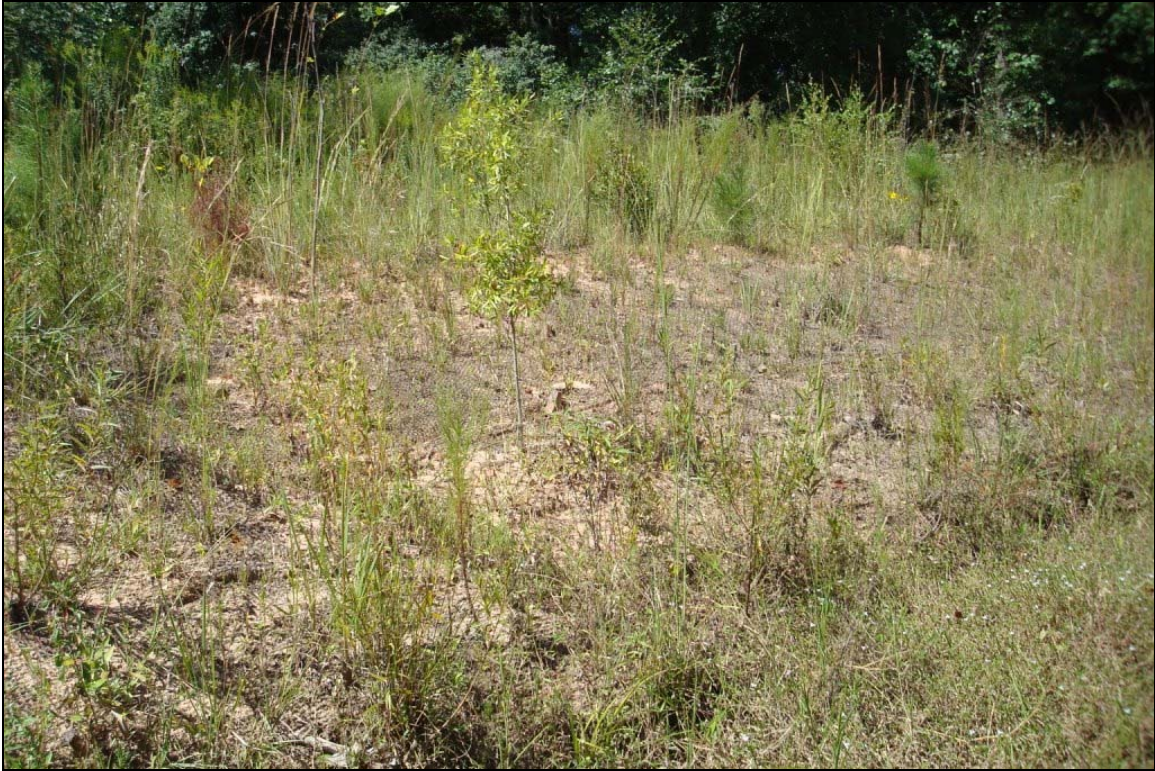
During the performance of the Year 5 monitoring survey, it was confirmed by the landowner that a few cattle occasionally breach the fence and access the upper portions of Wallace Branch. The vegetation appears, however, to have recovered from the severe grazing which was noted the previous year. The woody and herbaceous vegetation in this location appears to be healthy and robust.

Weak Bank Vegetation on Wallace Branch, Sta 42+40
Photo No. 17

Location	Issue	Status	Recommended Response
Wallace Branch			
42+40	Bed & Bank Scour	Repaired/Stable	Additional seeding
43+90	Bed Scour	No Change	
Lick Creek			
10+90	Log Vane	Arm Scour	Repair
16+10	Bed & Bank Scour	Minor Scour	
25+30	Beaver Dam	Newly Constructed	
49+80	Bare Bank	Recovering	
61+00	Beaver Dam	Rebuilt

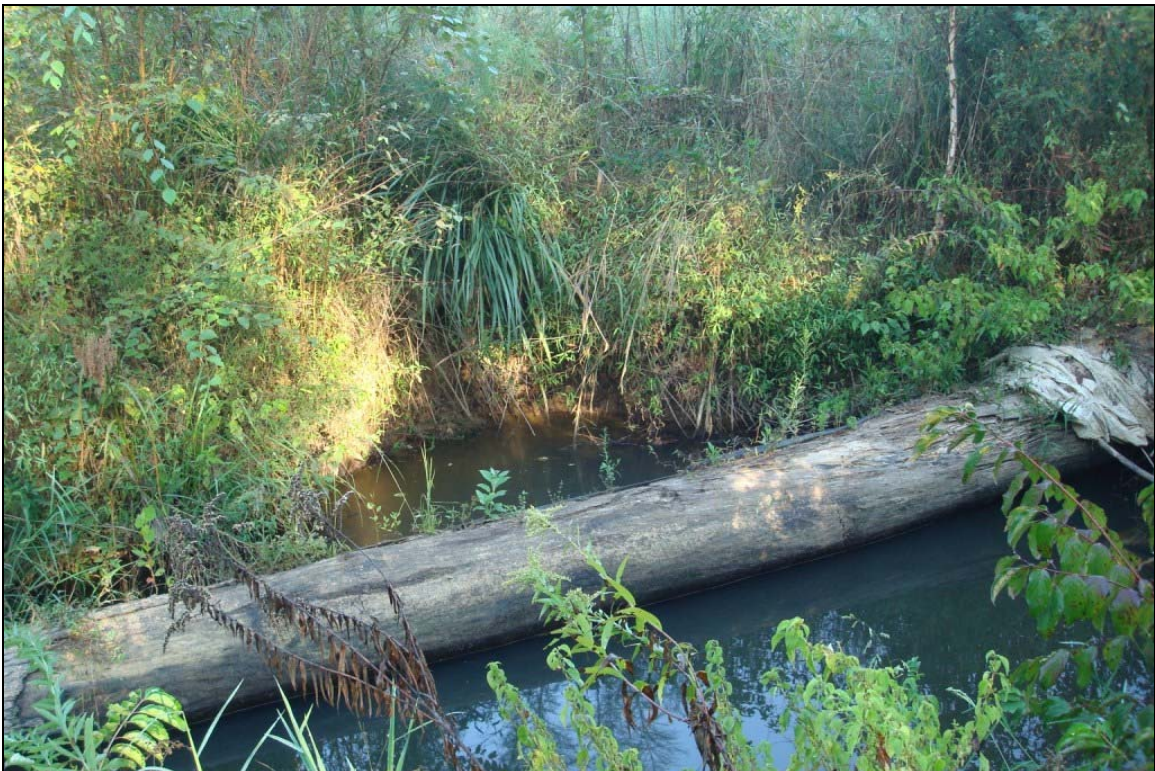
One new area of bank scour has developed along the arm of a log vane at Sta 10+90 on Lick Creek. This appears to be an isolated occurrence related to the structure that can easily be repaired.

Scoured Log Vane Arm, Lick Creek, Sta 10+80
Photo No. 18

Restoration Systems will repair the scoured log vane arm, remove the on-site beaver dams, and over-see areas of sparse vegetation.

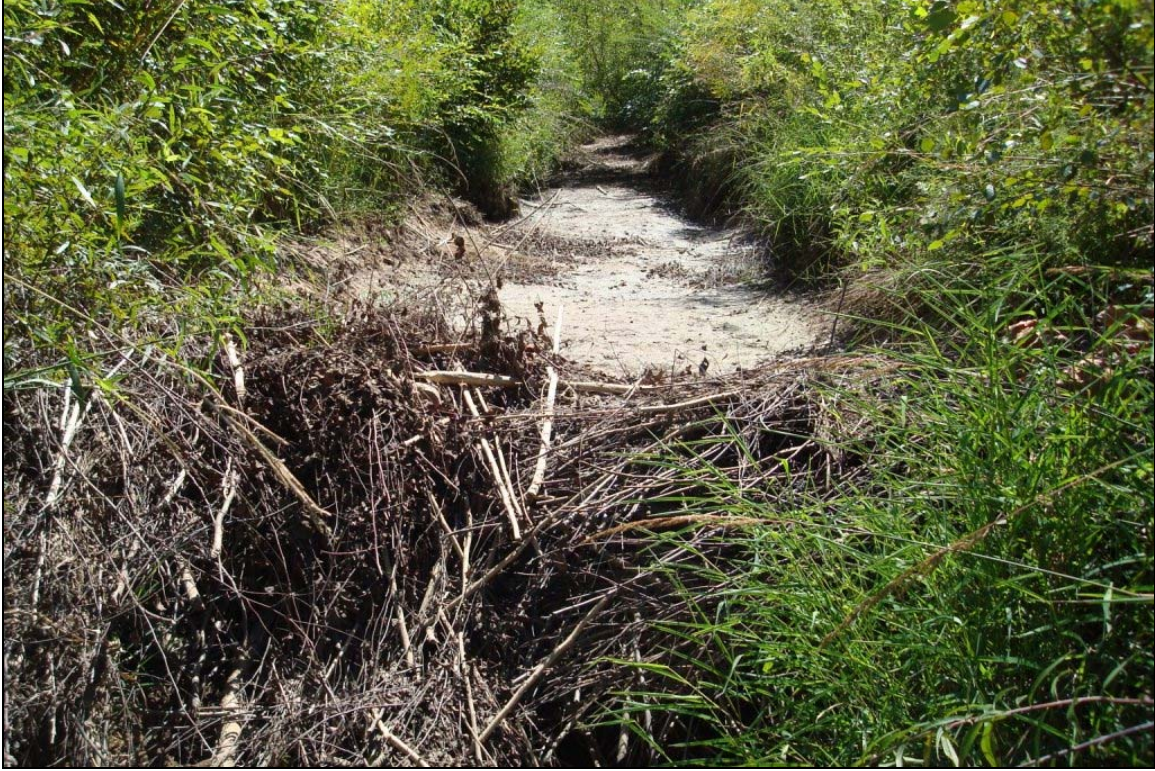
Photo No. 19

Year 4 monitoring survey. Of the two beaver dams observed at the downstream end of Lick Creek (Sta 61+00 and 63+00), the one at Sta 61+00 was removed during the winter of 2009-2010. This dam has since been rebuilt and both dams continue to have a backwater effect on the site when base flow is present. A new, third beaver dam was documented in the middle portion of Lick Creek at station 25+00 during the collection of Year 5 monitoring data.

Beaver Dam, Lick Creek, Sta 25+25

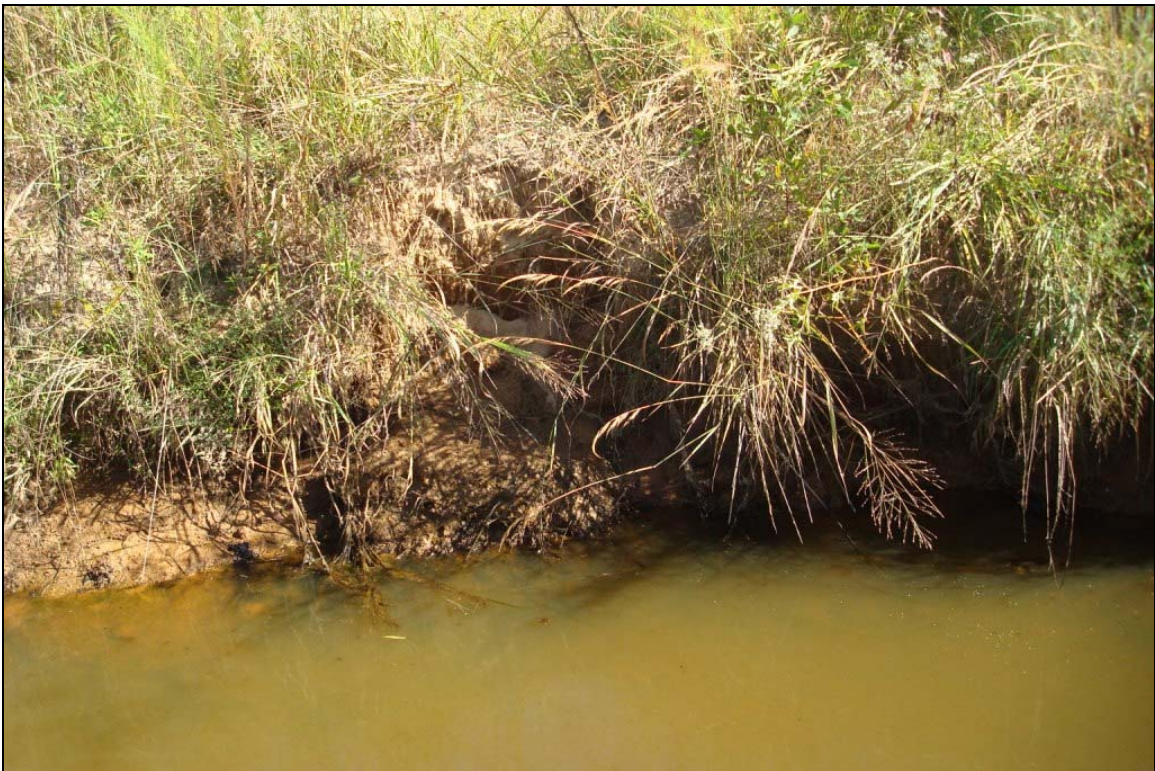
Photo No. 20

Minor Toe Scour, Lick Creek, Sta 50+30
