# Annual Monitoring Report

## Little Pine Creek II

### Monitoring Year 2 of 7

NCDMS Project No. 856

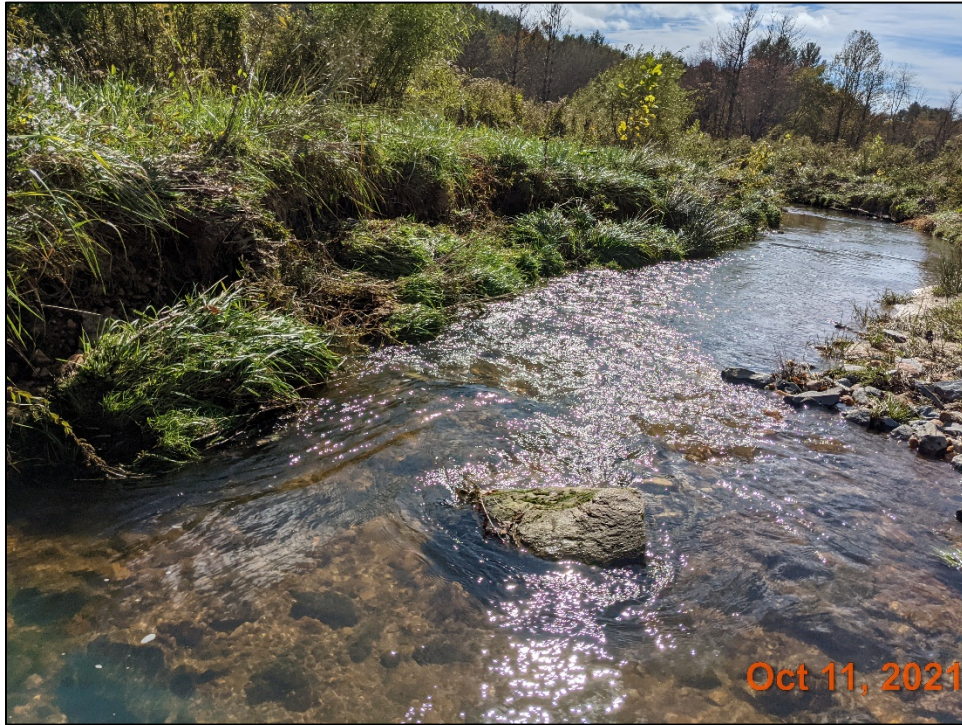
Three areas of bank scour or slumping (110+25, 120+75, and 121+50) were identified at the LPC II Project in MY2. At Station 110+25 the outside bend has notable scour and some bank slump. The second area of instability (Station 120+75) has a similar amount of scour along the outer bend leading to the confluence with Trib D. At the final problem area (Station 121+50) in Reach 2b, the bank at the first set of log-drop structures has a significant amount of scour (Problem area photos and Table 5, Appendix B). This scour is not currently impacting the stability of the structure. The site will continue to be monitored for signs of instability.

LPCII Reach 2A undercut bank and slump, Station 110+25

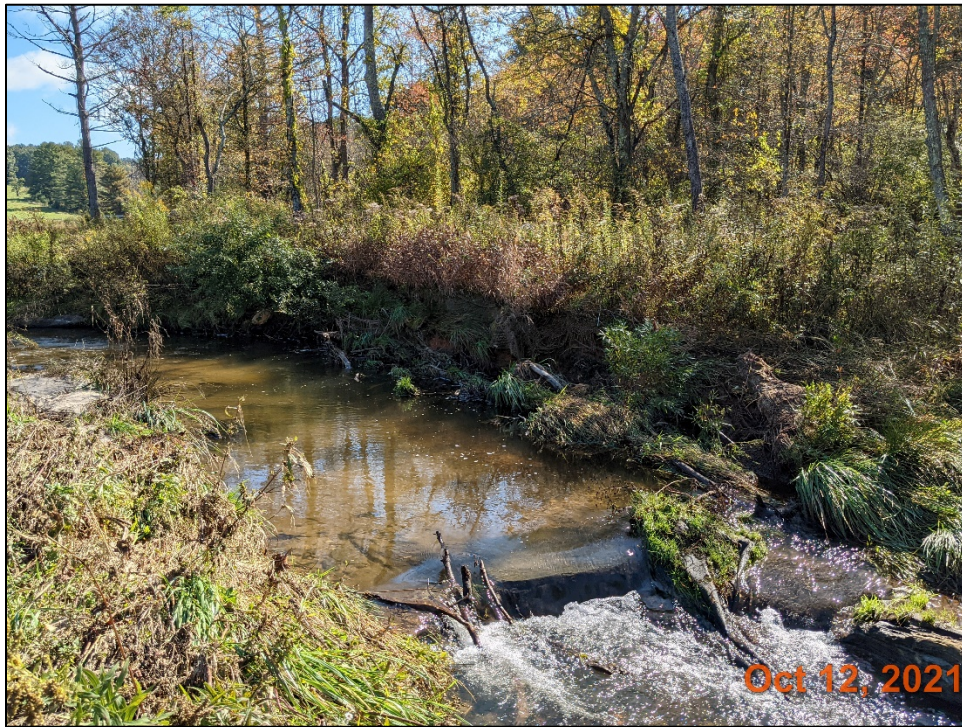
LPCII Reach 2A Bank Scour, Station 120+75

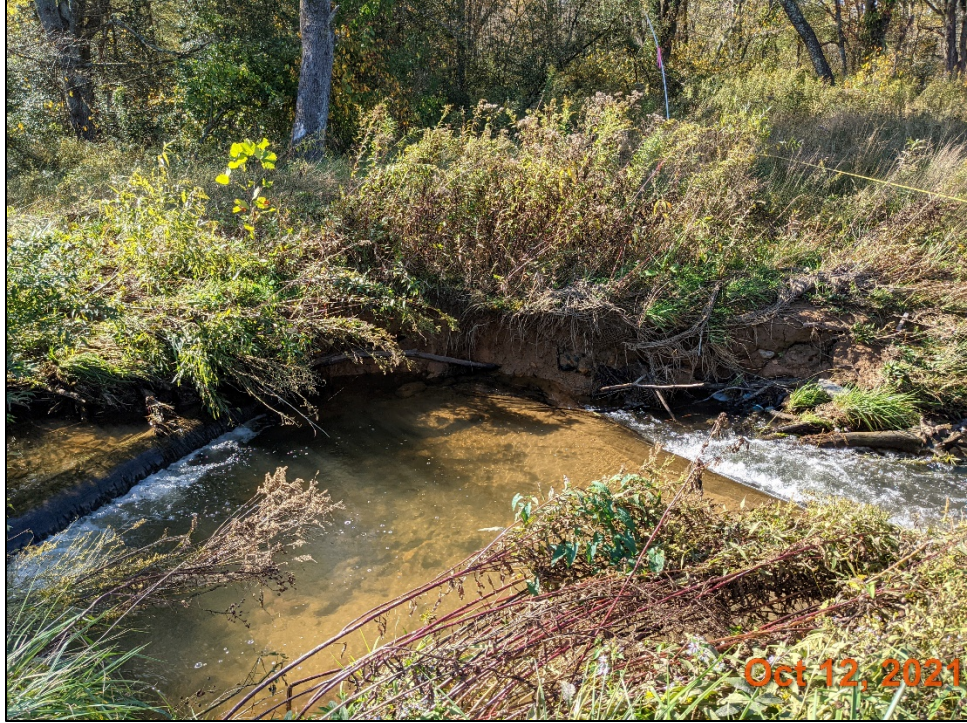
LPCII Reach 2B, Bank Scour, Station 121+50

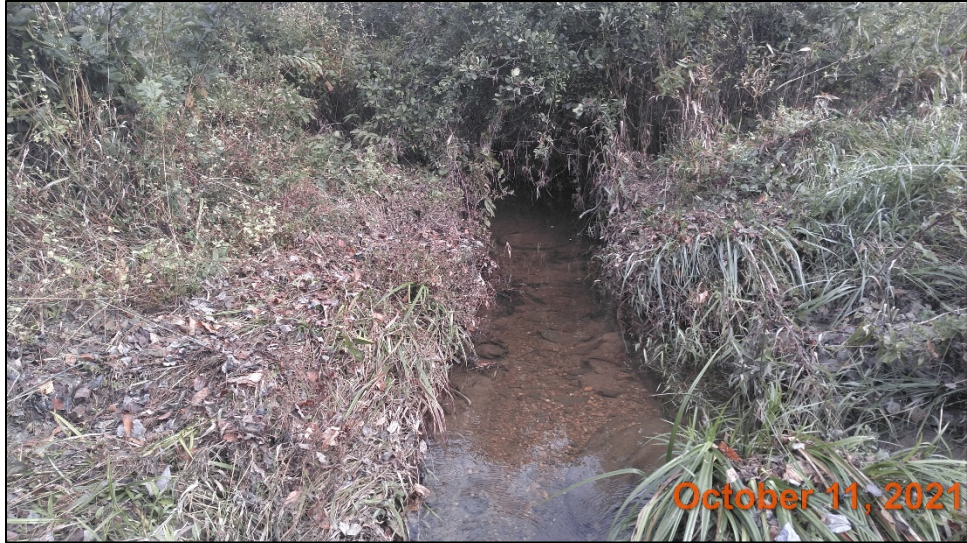
1. Wrack lines and sediment deposits, LPCII Tributary A.

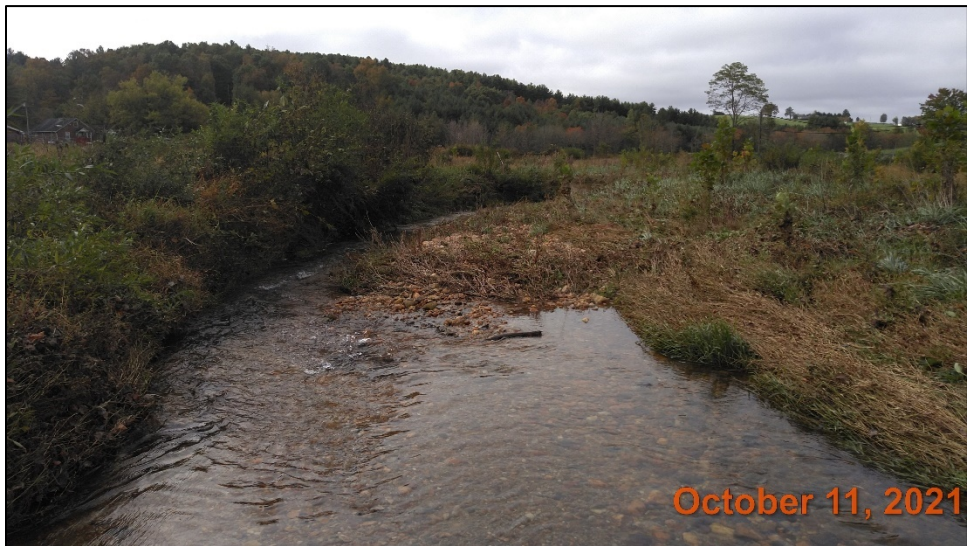
2. Residual wrack lines and sediment deposits, LPCII Reach 1

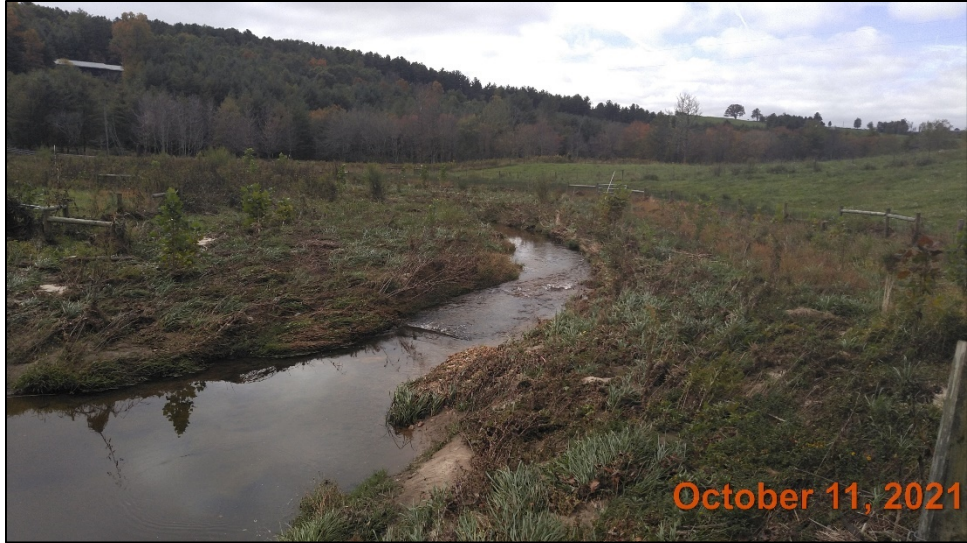
3. Residual wrack lines and sediment deposits, LPCII Reach 2a
