Annual Monitoring Report

Little Pine Creek II

Monitoring Year 3 of 7

NCDMS Project No. 856

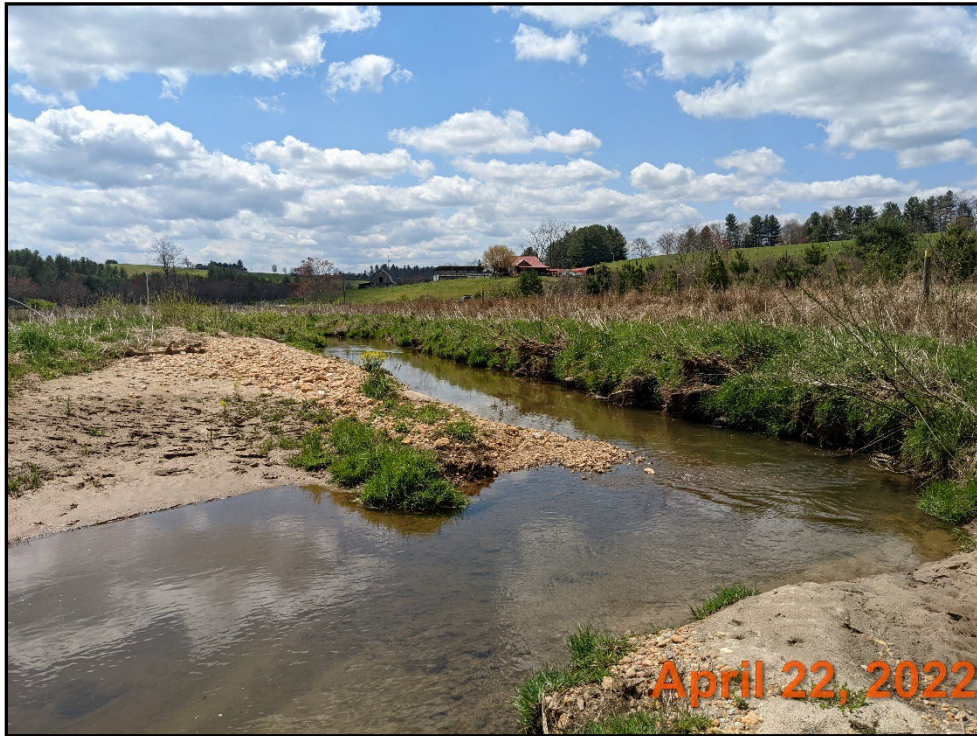
One exposed structure (113+30) and 6 areas of bank scour or slumping (100+10, 110+20, 118+00, 121+00, 121+75, and 406+26) were identified at the LPC II Project in MY3. At Stations 113+30 - 113+60 the toe logs of an outer bend structure have been exposed and there is an area of bank slump immediately downstream. Bank scour noted at Stations 100+10 and 110+20 were identified in MY2 and have neither improved nor worsened in MY3. At Station 118+00 the outside bend has notable scour and bank slump. The second area of instability (Station 121+00) has a similar amount of scour along the outer bend leading to the confluence with Trib D. At the final problem area (Stations 121+75) in Reach 2b, the bank at the first set of log-drop structures has a significant amount of scour. A concentrated area of scour was noted on the left descending bank at the confluence of Trib C and the LPCII Reach 2A/B (CCPV and Table 5, Appendix B). The site will continue to be monitored for signs of instability.

Little Pine Creek II Reach 1– Bank Erosion Station 100+10

Division of mitigation services has plans to initiate focused stream problem area repair and limited supplemental planting in 2023.

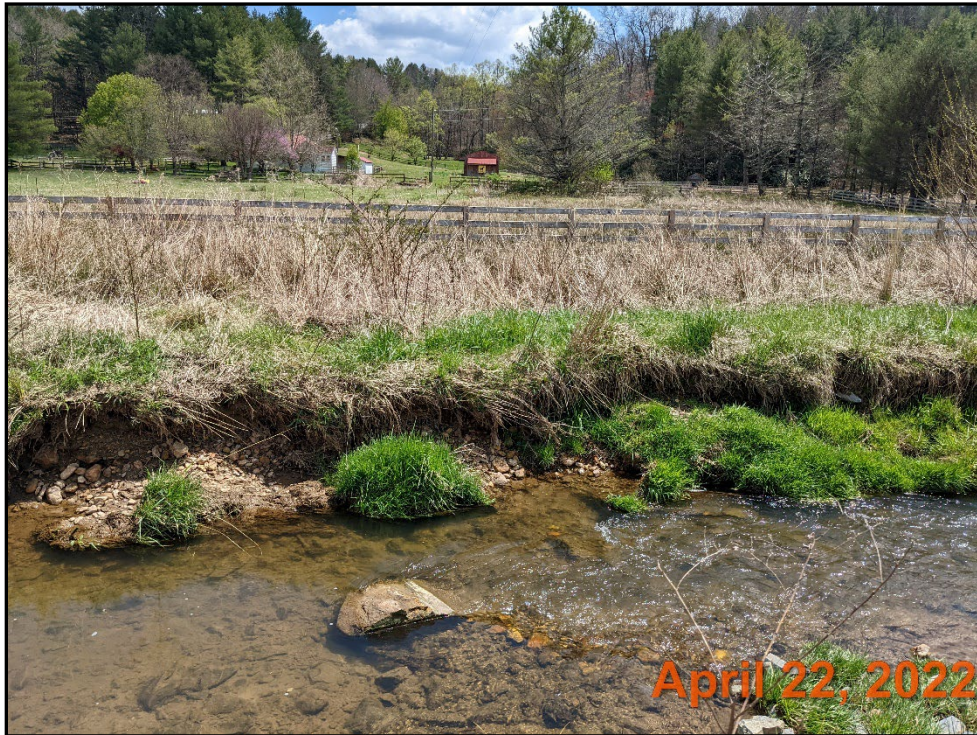
Little Pine Creek II Reach 1– Bank Erosion Station 110+20

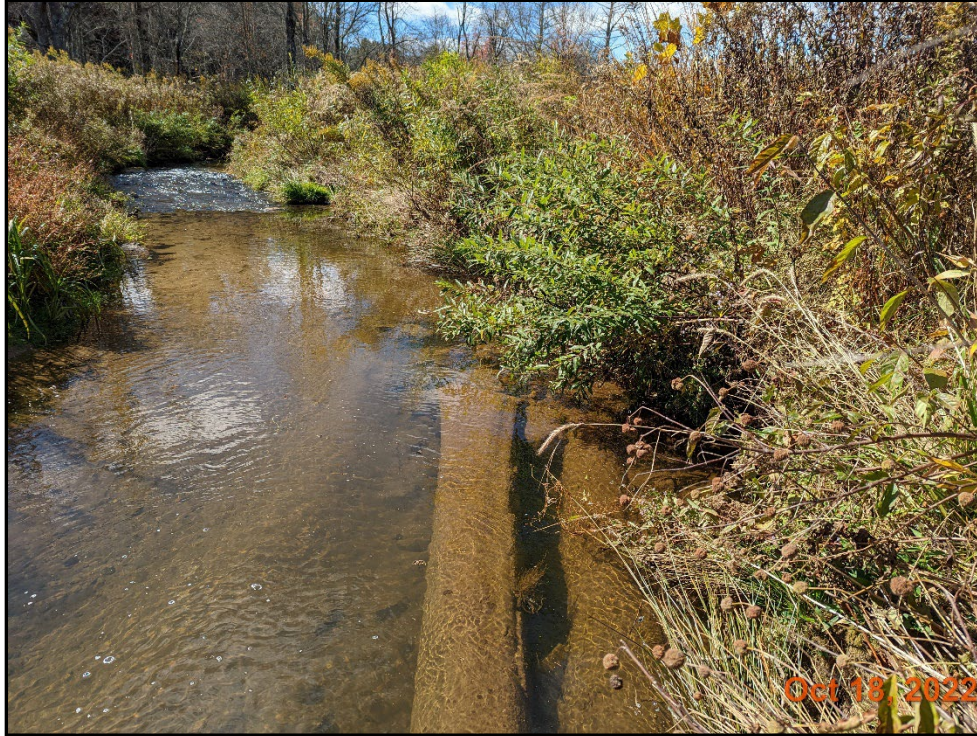
Little Pine Creek II Reach 2A – Exposed structure Station 113+30

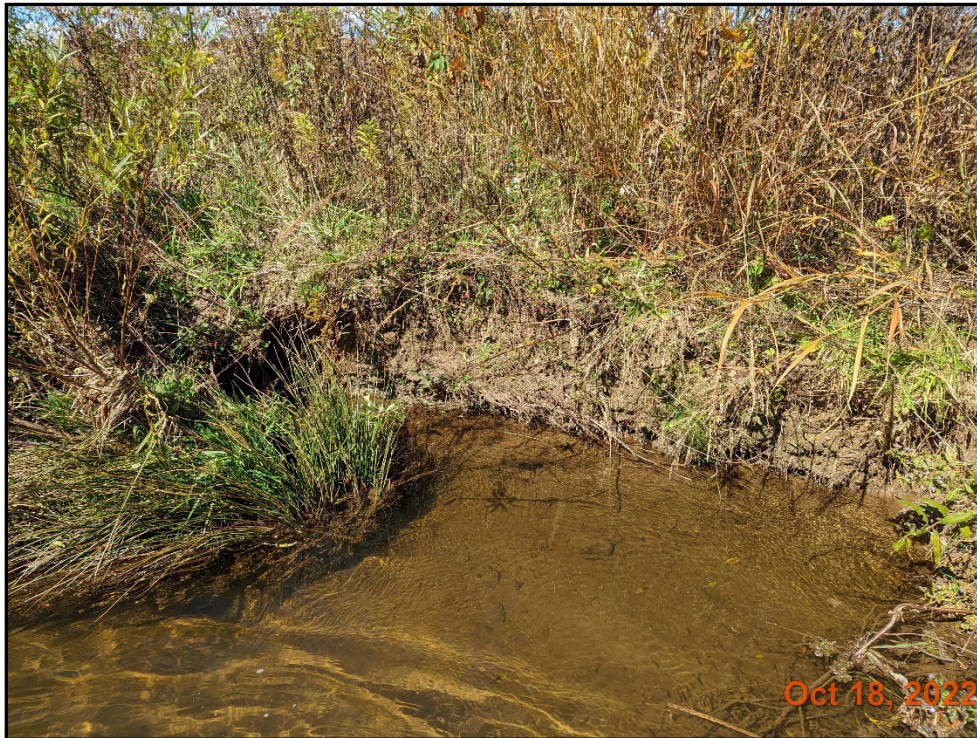
Little Pine Creek II Reach 2A – Slump Bank Station 113+60

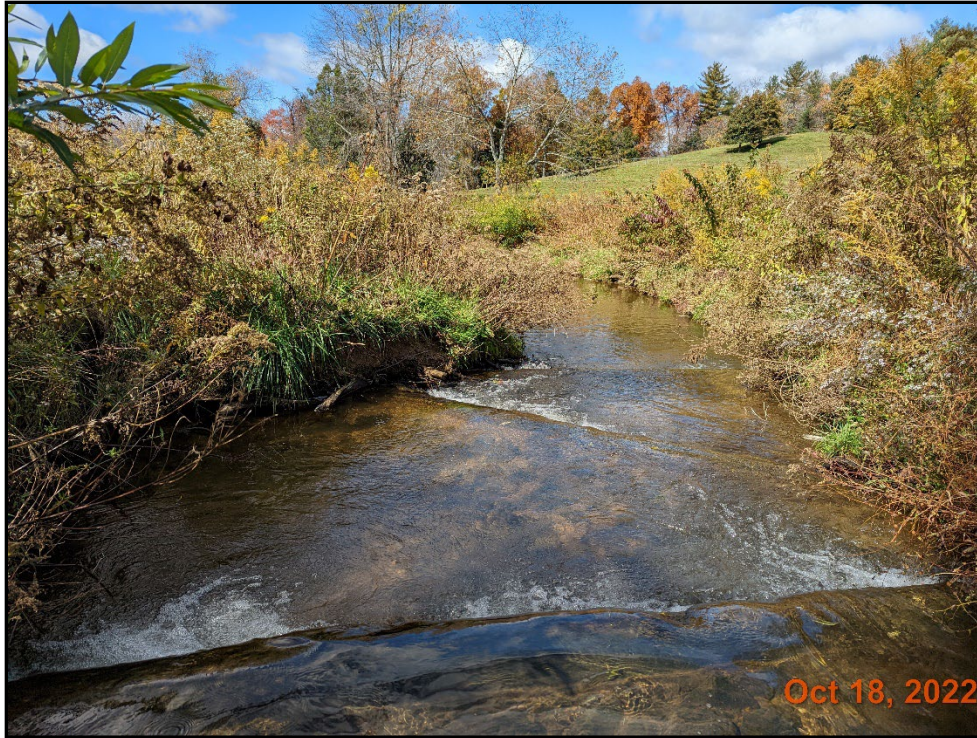
Little Pine Creek II Reach 2A – Bank Erosion 118+00, facing downstream

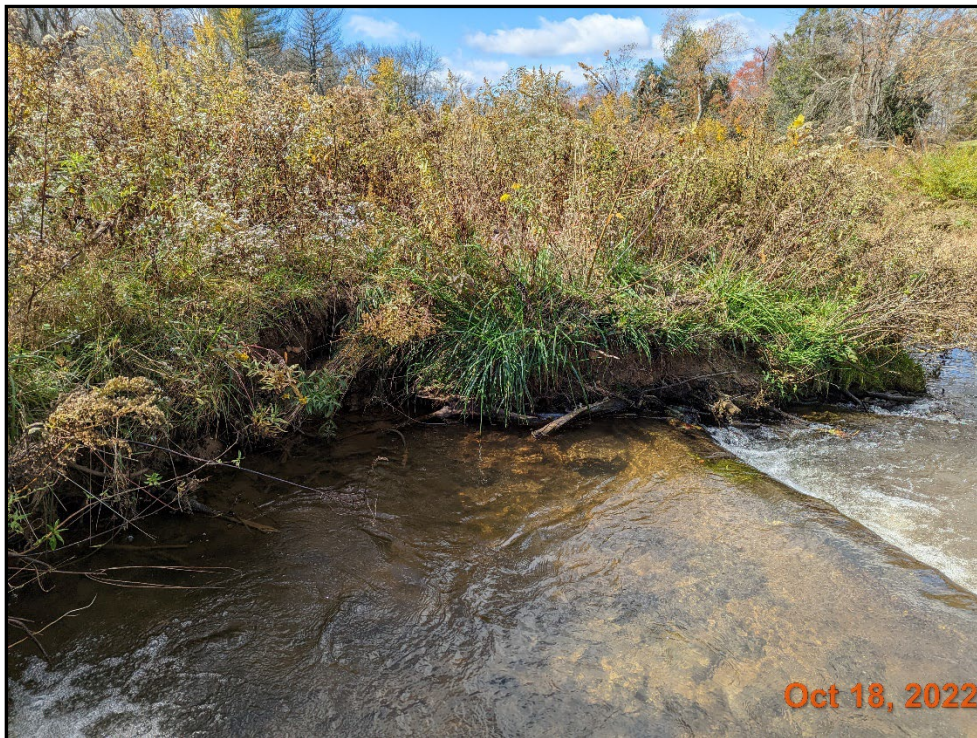
Little Pine Creek II Reach 2A –Bank Erosion Station 118+00 facing left descending bank

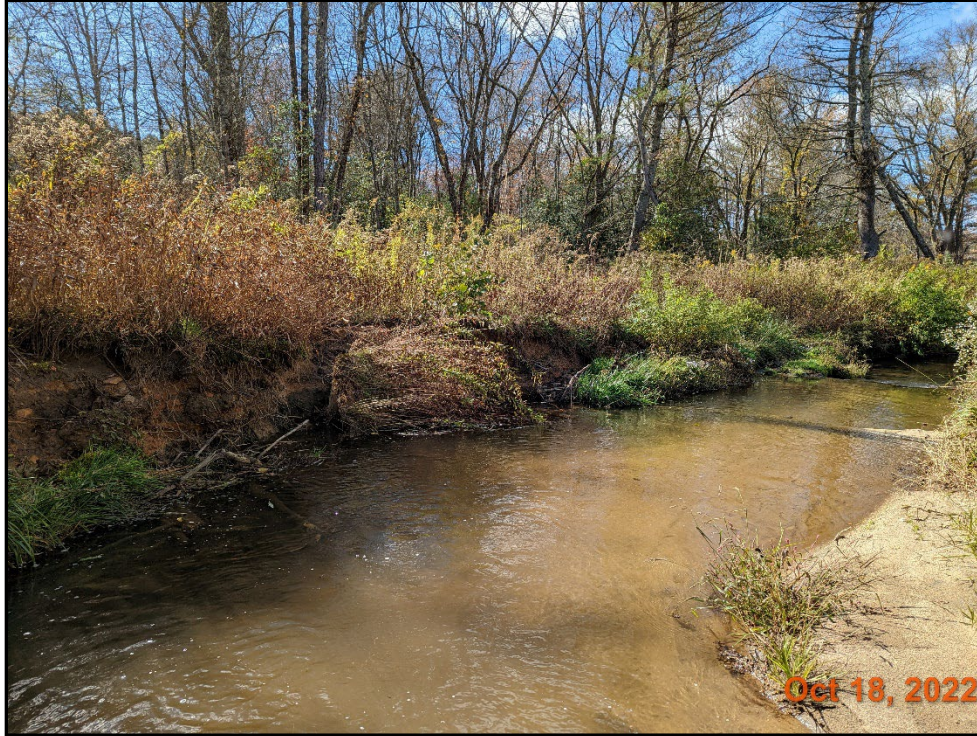
Little Pine Creek II Reach 2A – Bank Erosion 121+00, facing downstream

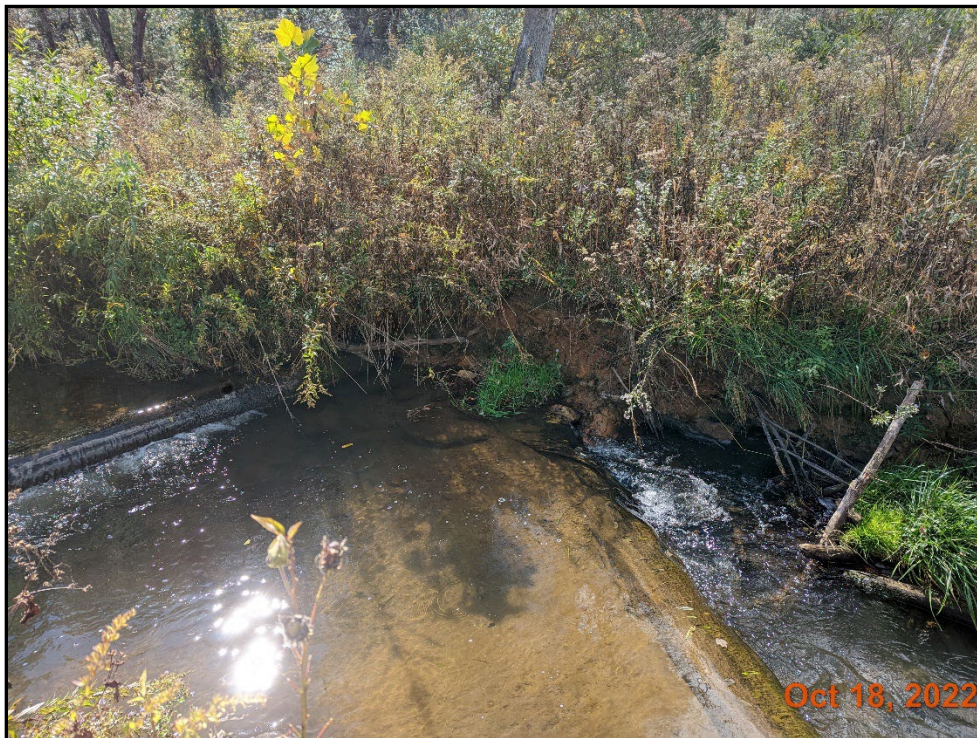
Little Pine Creek II Reach 2B –Bank Erosion Station 121+75 facing left descending bank

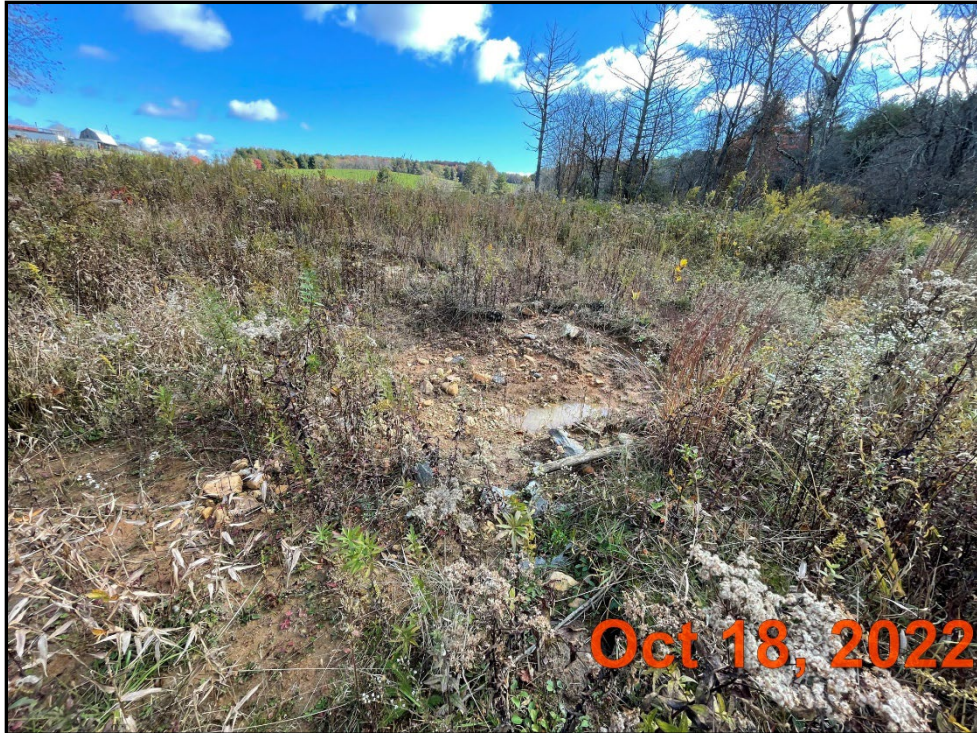
Vegetation problem areas and bare areas continue to shrink along the right descending bank of Little Pine Creek Reach 2A. These areas were still present in MY3, but occur below mapping threshold (Problem area photos, Appendix B).

Little Pine Creek II Reaches 2A/B – Example Residual Bare Areas.
