Annual Monitoring Report
FINAL
Little Pine Creek II
Monitoring Year 4 of 7

New River Basin
HUC 5050001
NCDMS Project No. 856
DWR Project No. 20090048 (v.2)
Contract No. LP082819
USACE Action ID: SAW-2009-00591
Alleghany County, North Carolina
Data Collected: April 2023 – October 2023
Date Submitted: February 2024

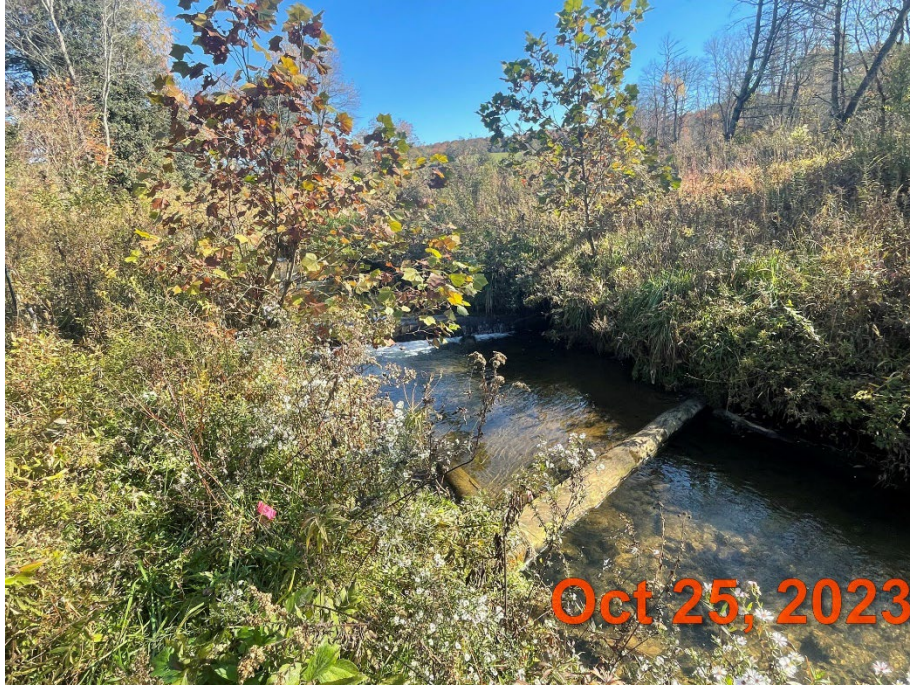
One exposed structure (113+30) and seven areas of bank scour or slumping (103+50, 110+20, 112+25, 113+30, 118+20, 121+50, and 123+30,) were identified at the LPC II Project in MY3. At Stations 113+30 - 113+60 the toe logs of an outer bend structure have been exposed and there is an area of bank slump immediately downstream. Bank scour noted at 110+20 was identified in MY3 and had somewhat improved in MY4. At Station 118+20, the outside bend has notable scour and bank slump. The area of instability at Station 121+50 has a similar amount of scour along the outer bend at the beginning of the "rock and roll" log structures. At the final problem areas (123+50), the bank at the of log-drop structures has a significant amount of erosion (CCPV and Table 5, Appendix B). The site will continue to be monitored for signs of instability.

Example undercut bank and toe structure exposure along Reach 2B.

NC Division of Mitigation Services has a contract for repairs. Repair work has been fully permitted and the repairs will begin in January 2024. A description and summary of the repairs will be included in the MY5 monitoring report.

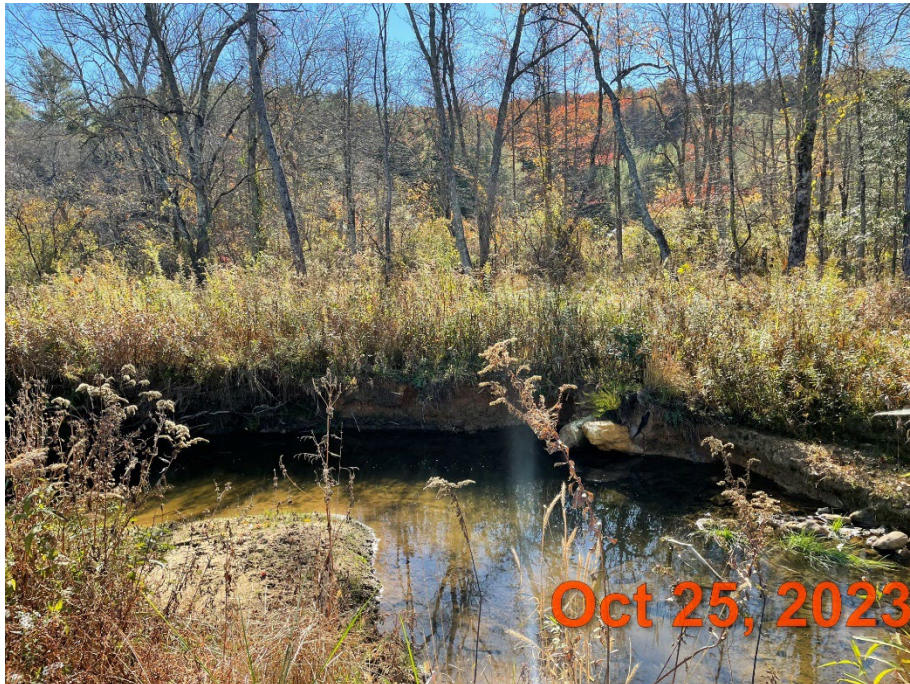
Example undercutting along Reach 2A.

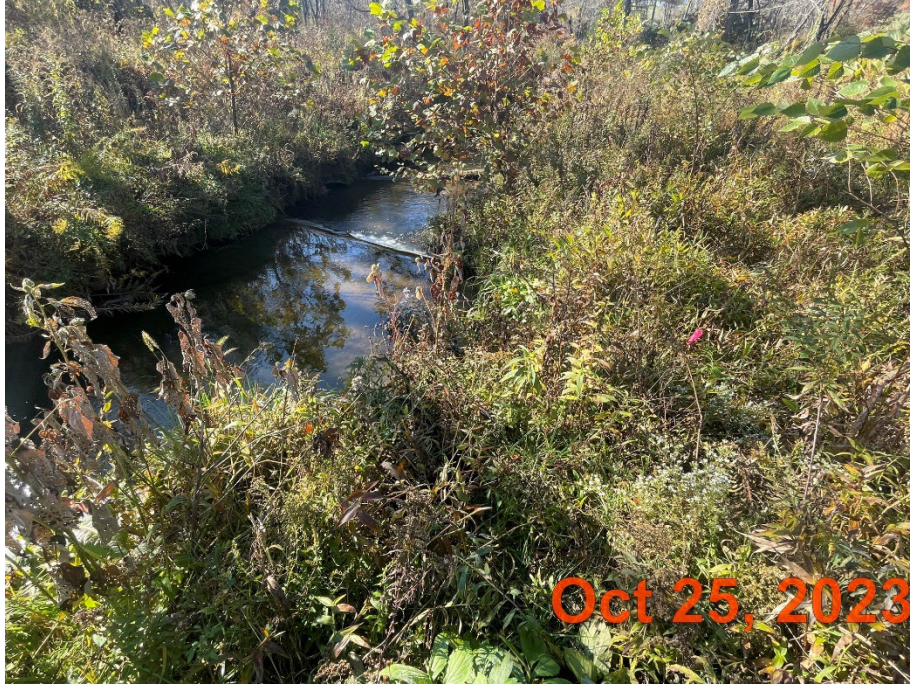
Example slump bank along Reach 2B.
