Year 2 Monitoring Report

LITTLE SEBASTIAN SITE

NCDMS Project # 100027 (Contract # 7187) | RFP 16-006993 (Issued 9/16/2016)
USACE Action ID: SAW-2017-01507 | DWR Project # 2017-1041

Surry County, North Carolina
Yadkin River Basin
HUC 03040101

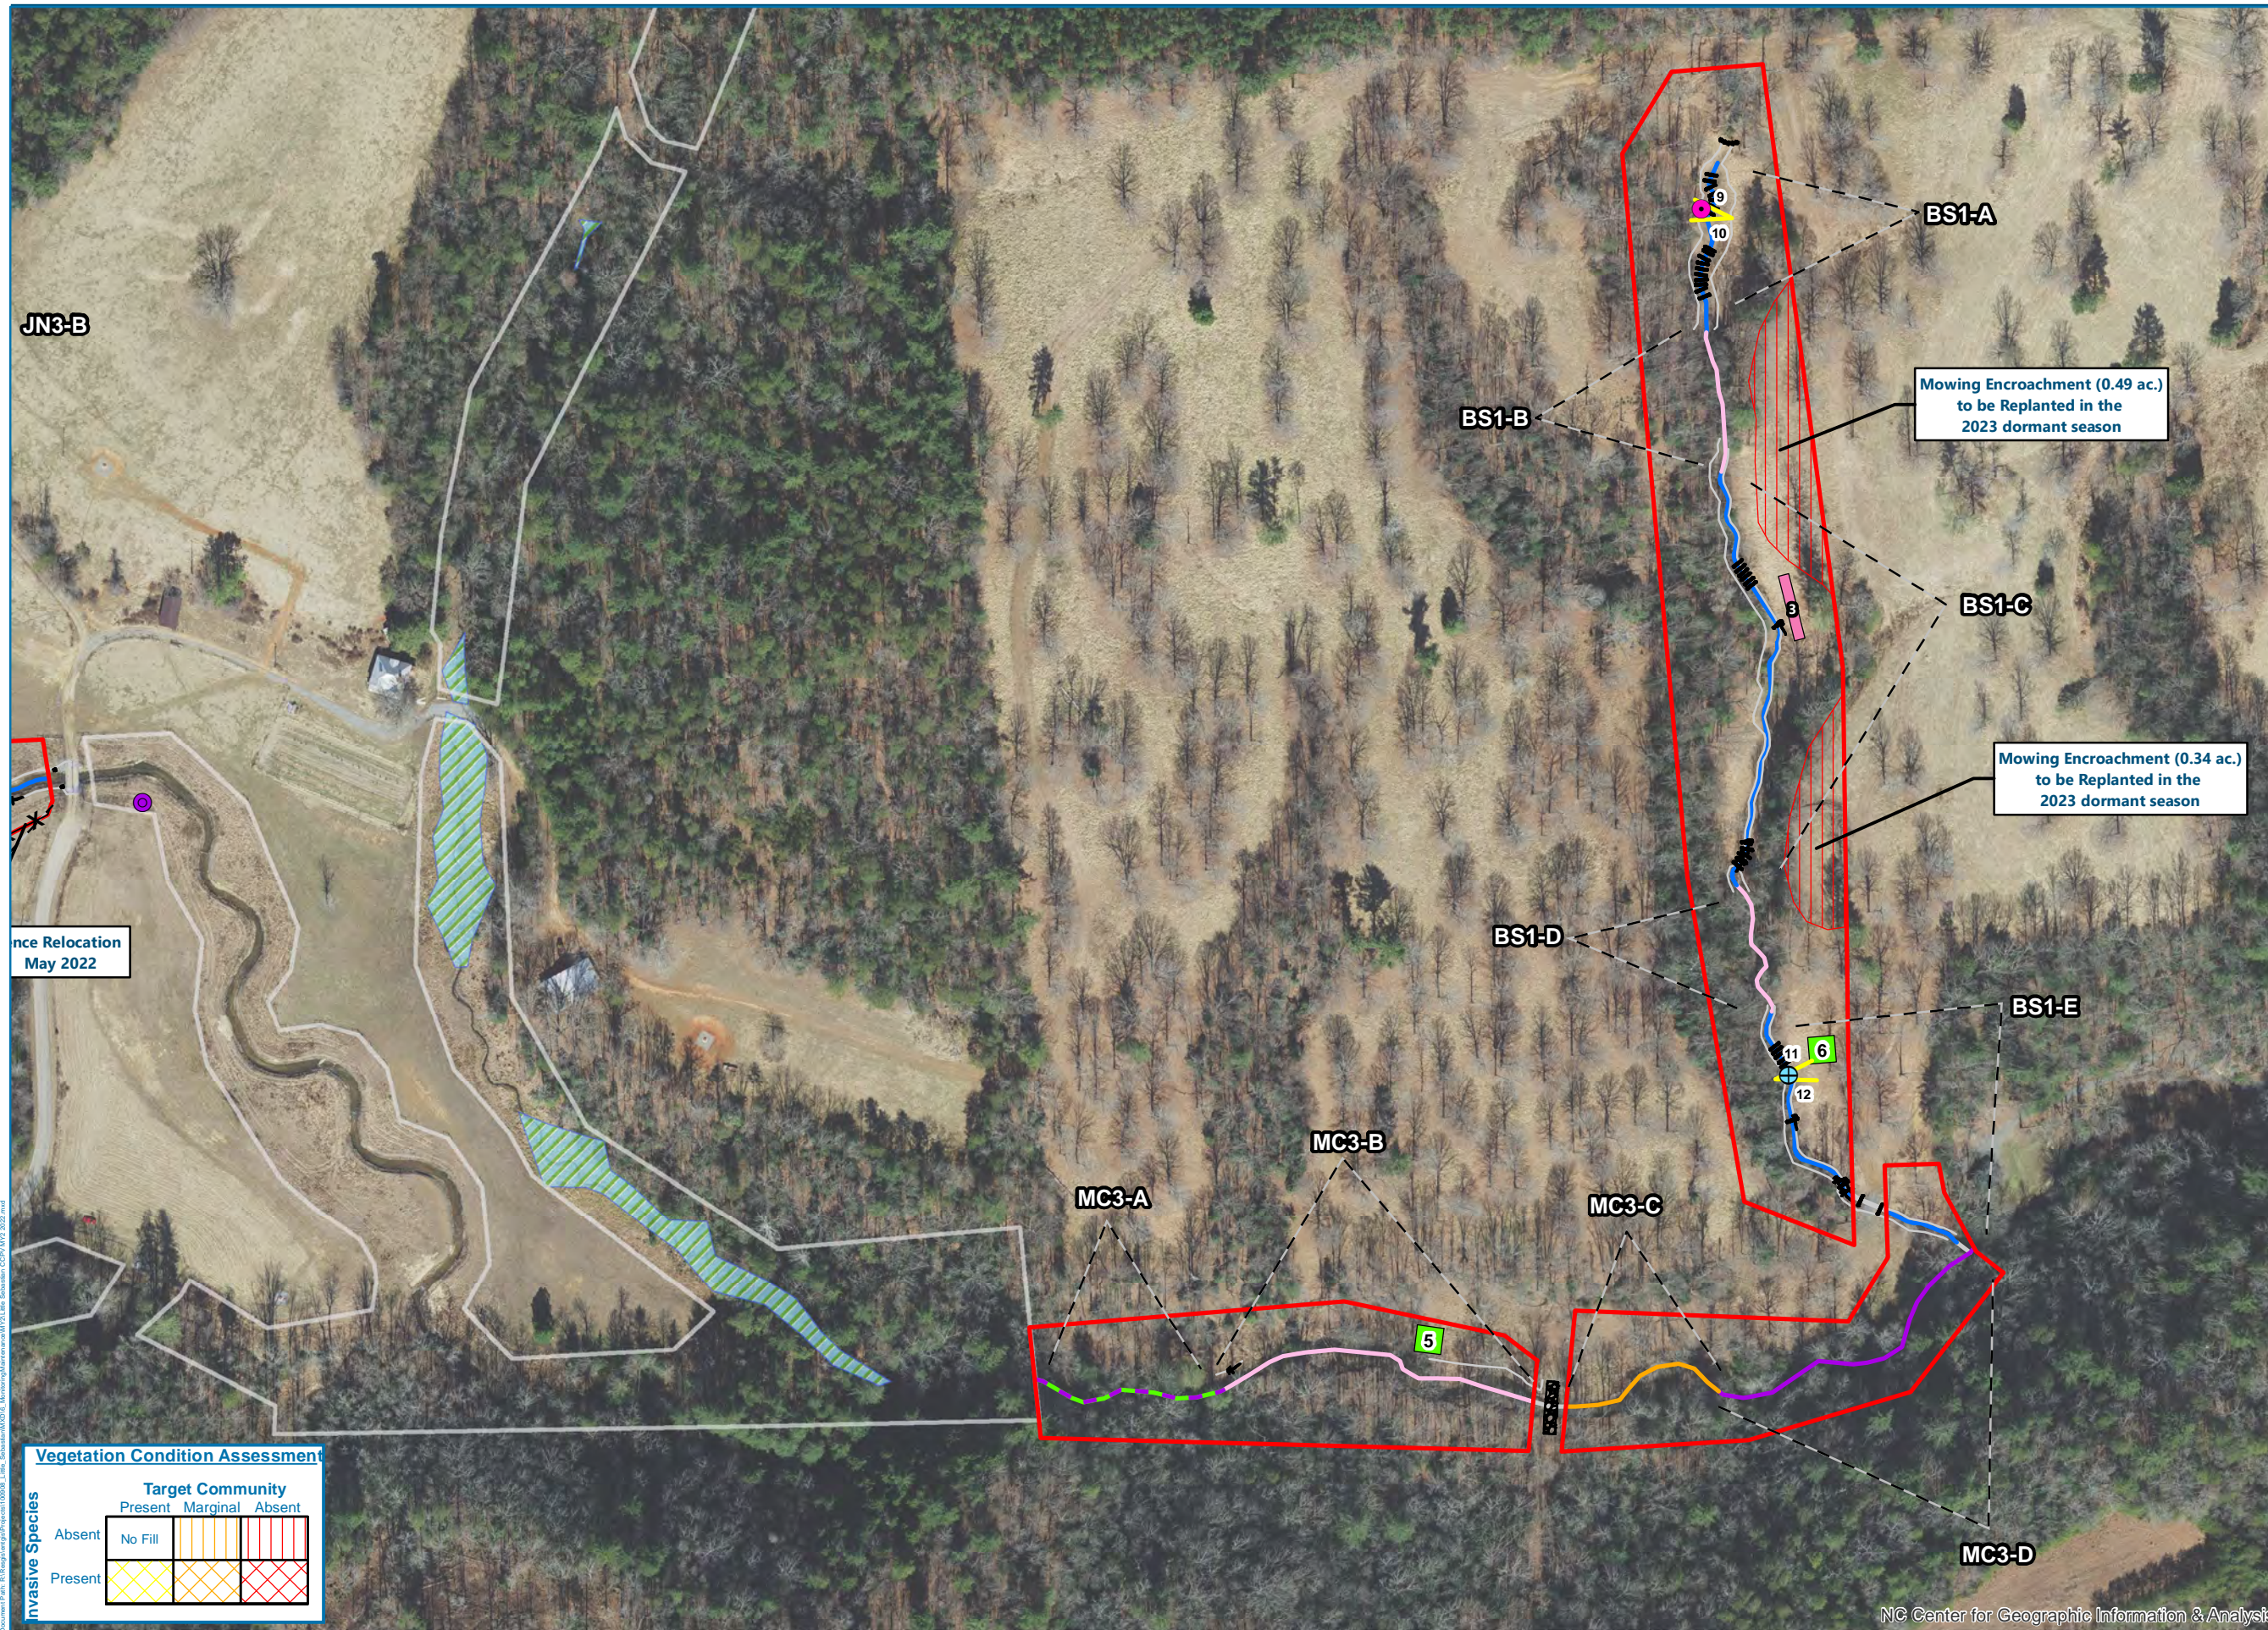
Current Conditions
Plan View

The encroachment area has now been duplicated as a low stem density area as well. Since they are linked issues, they share the same acreages. On Figure 2, the area is symbolized as red simple hatch since it is encroachment (additional orange simple hatch denoting low stem density would clutter the shapes and create symbology confusion). These were the only vegetation problem areas observed in MY2. The table and digital files have been updated.

Mowing Encroachment (0.49 ac.)
to be Replanted in the
2023 dormant season

The encroachment will be resolved with the landowner by placing clear easement markers, signage, and horse tape where necessary, in the impacted areas. If further encroachment is observed in the future, a formal letter will be sent to the landowner.

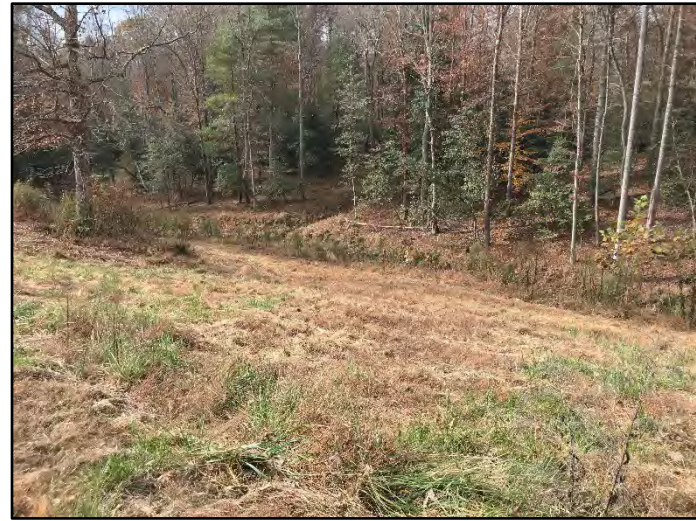
"Two areas of mowing encroachment along the eastern boundary of the Project, adjacent to BS1, were observed during Year 2 monitoring. The mowing has resulted in two areas of low stem density; one is 0.49 acres and the other is 0.34 acres. This roughly 0.83-acre area will be replanted with native container trees, chosen in reference to the original planting list (Appendix C) and based on supply availability, during this dormant season. Additional signage and horse tape (in areas where visibility between markers may be limited) will be installed along this side of the easement to mark a clear boundary to prevent further mowing."

Bare area along eastern side of BS1 (mowing/encroachment)

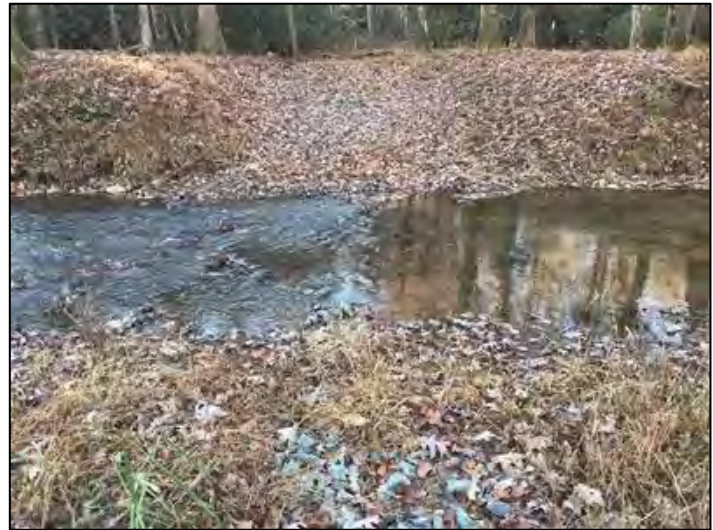
MC3-B/C

CCPV Maps – Figure 2: A steep stream bank was observed on MC3-B/ MC3-C near the crossing during the last DMS monitoring site visit (2021). Please confirm that the bank continues to remain stable.

This bank continues to remain stable.
